Treeworks Application

Land to the rear of 43 Langdon Park Road,  
London N6 5PT

22 March 2024

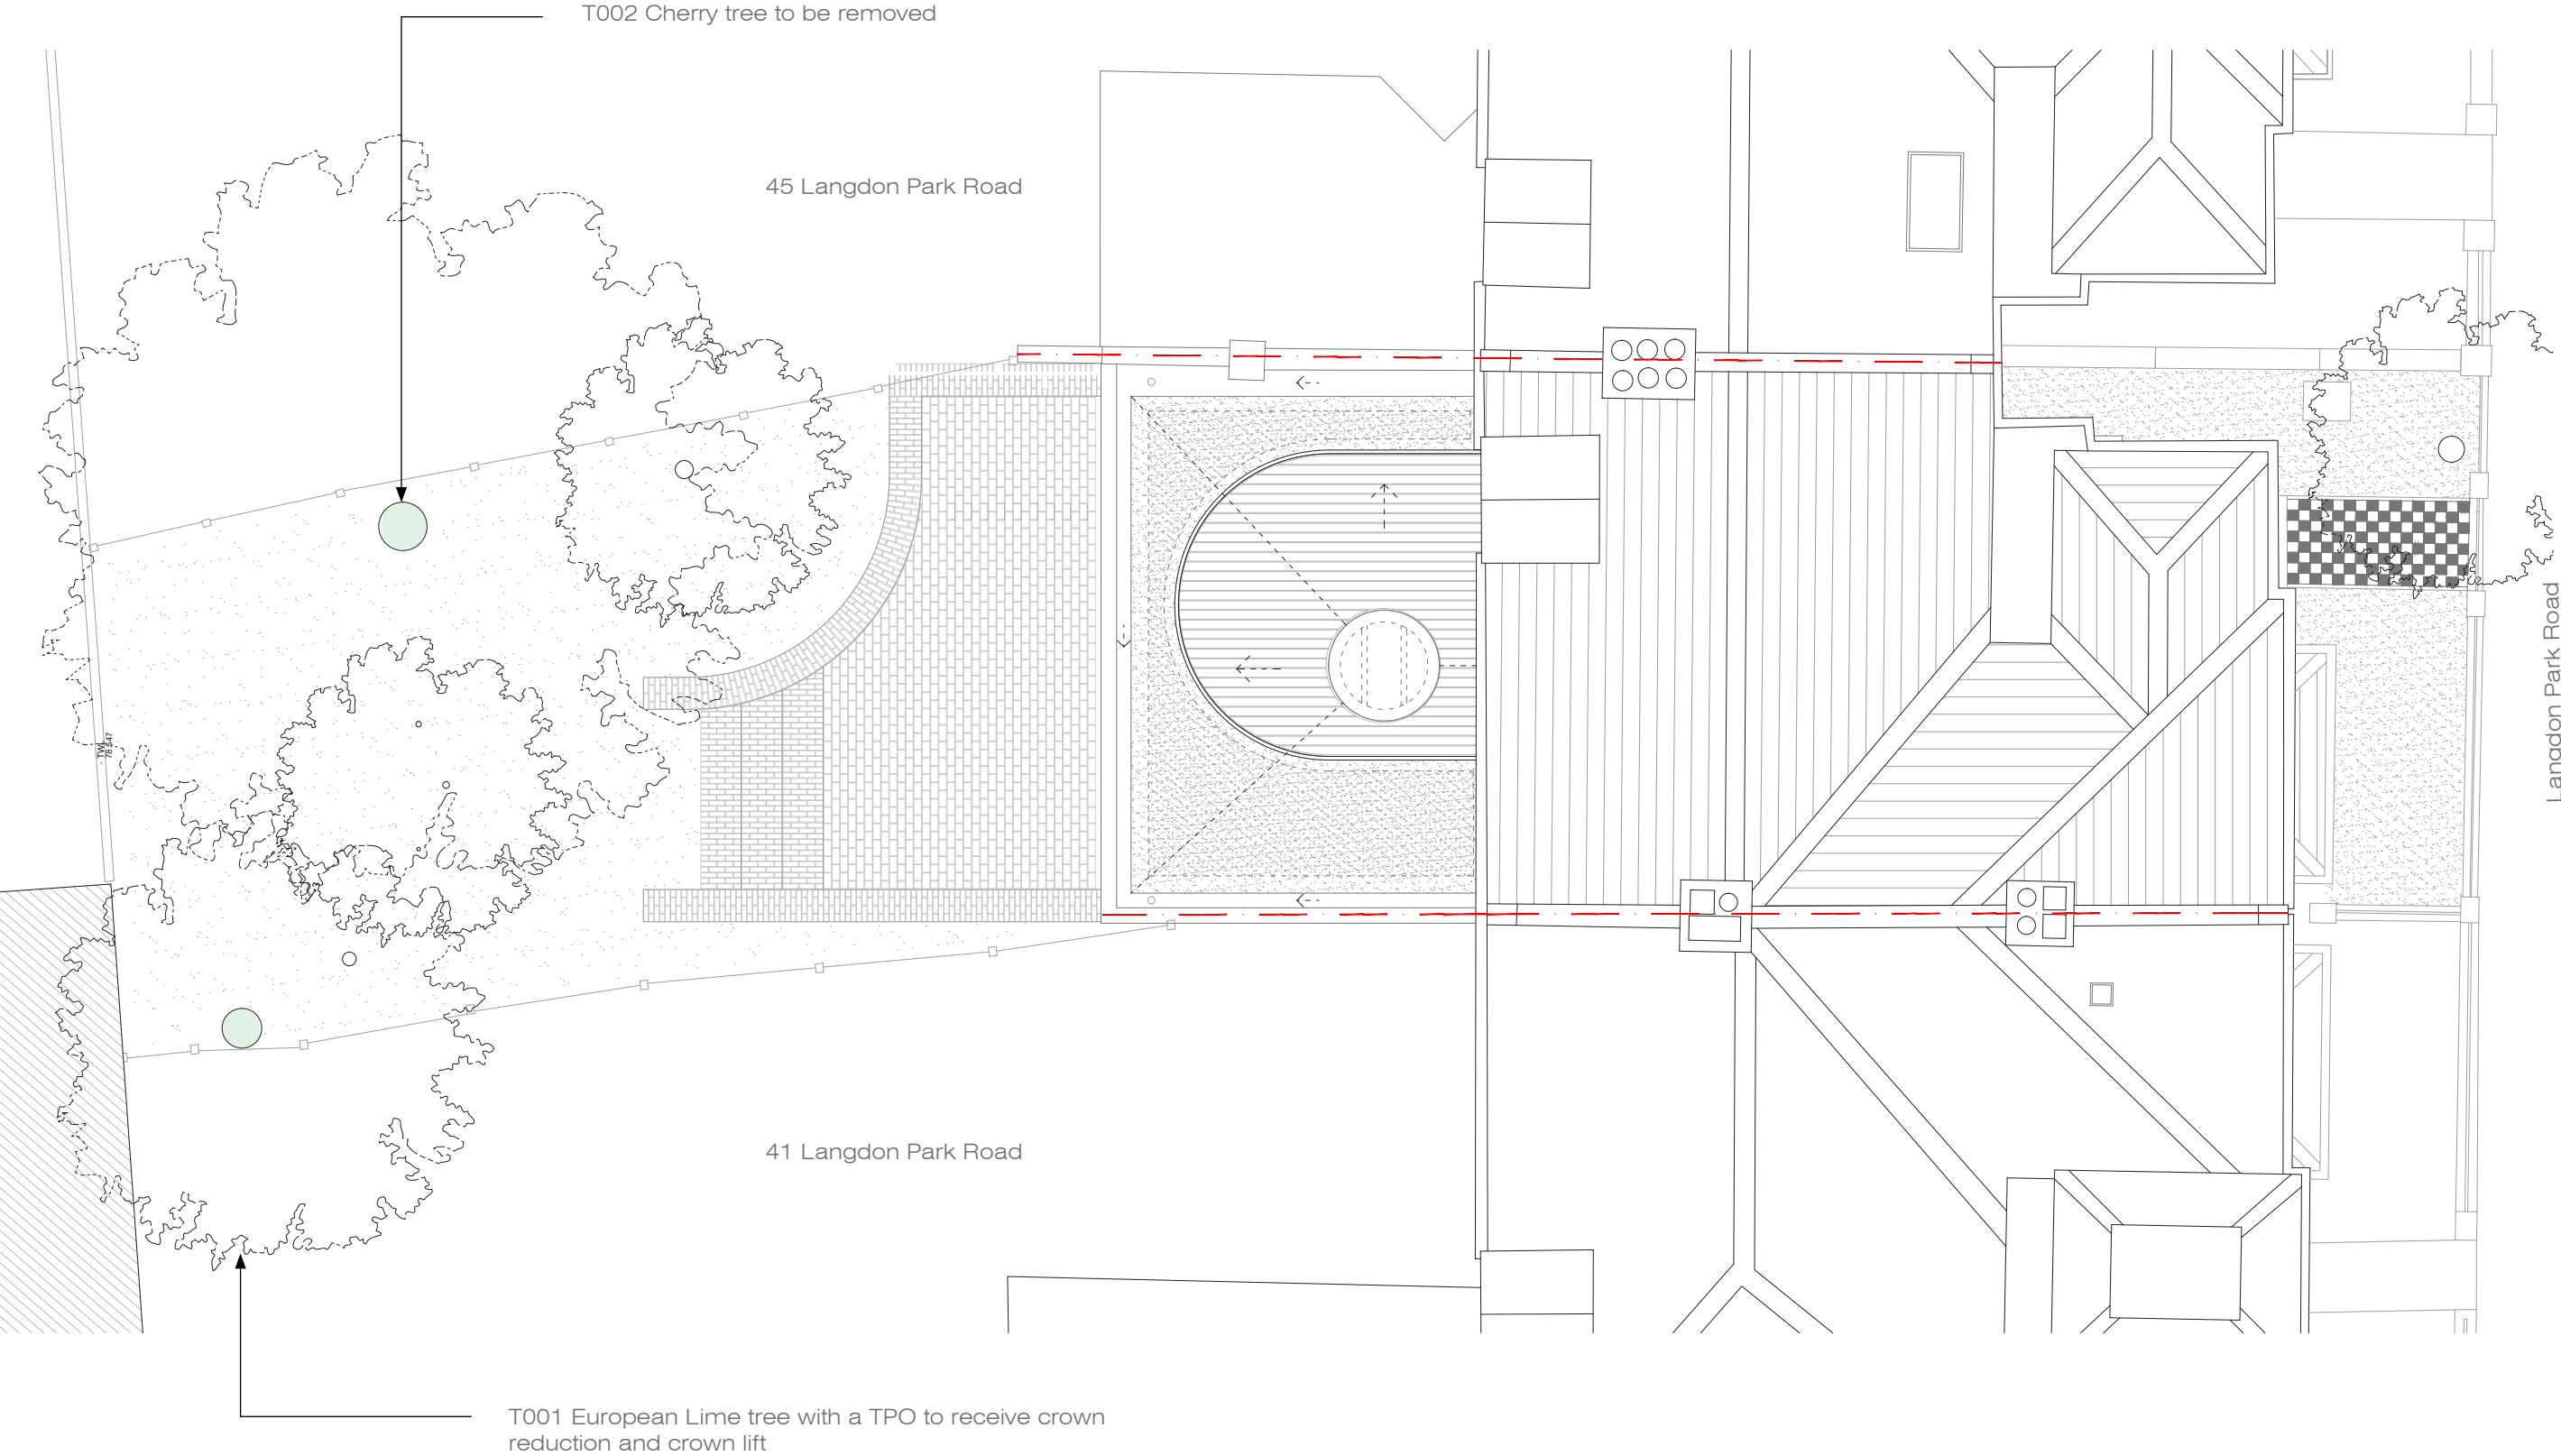
Site: 43 Langdon Park Road  
Plan: Tree Constraints Plan  
Ref: BS/099  
Rev: A  
Date: 19/12/2023  
Scale: 1:150  
Size: A1

T001 Lime tree on boundary wall of 43 and 41 Langdon Park Road has a TPO and is in fair physiological and structural condition. This application proposes to lift and reduce the crown of the tree.

T002 Cherry tree on boundary wall of 43 and 45 Langdon Park Road is not listed and is in fair physiological and structural condition. It has been compromised by prolific ivy growing around its trunk whilst historic suppression has led to the tree leaning over the garden of the neighbouring property, 45 Langdon Park Road. This application proposes to remove this tree.

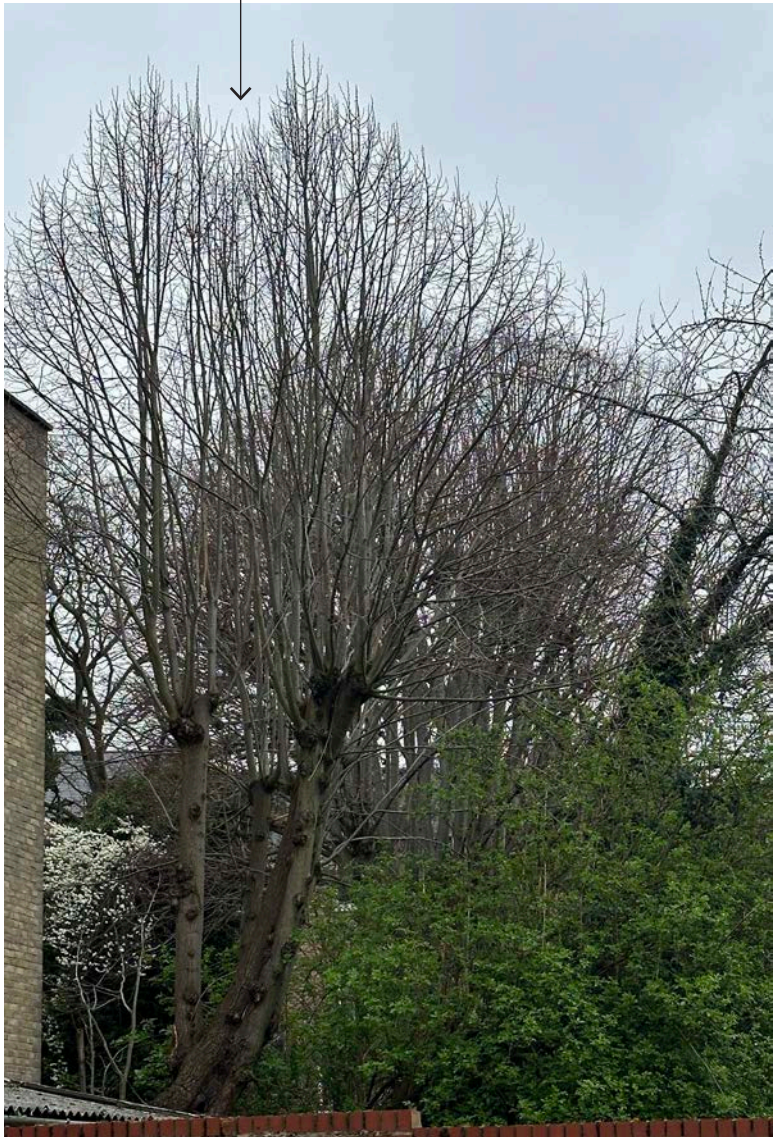
View looking South West into rear garden of 43 Langdon Park Road and adjoining garden fence of 41 Langdon Park Road.

T001 Lime tree on boundary wall of 43 and 41 Langdon Park Road has a TPO and is in fair physiological and structural condition. This application proposes to lift and reduce the crown of the tree

T001 Lime tree

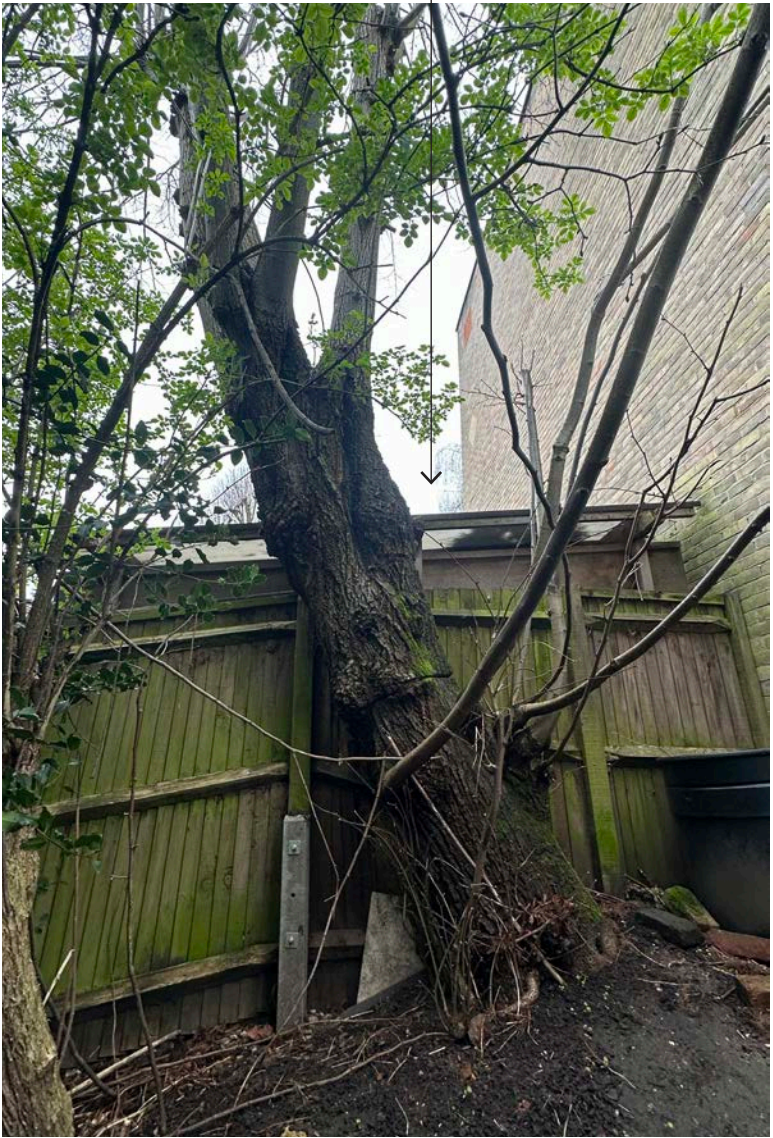
View looking North into rear garden of 43 Langdon Park Road.

T001 Lime tree trunk showing historic girdling likely from washing line

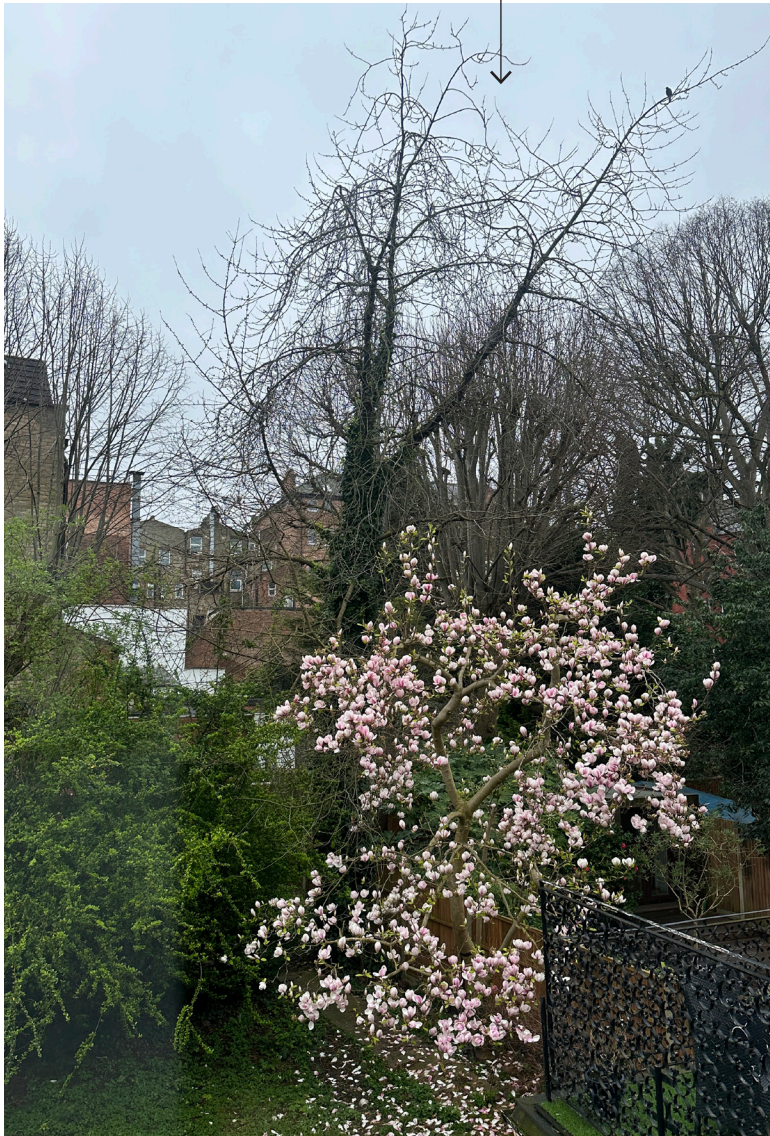
View looking South from within rear garden on 43 Langdon Park Road.

T002 Cherry tree on boundary wall of 43 and 45 Langdon Park Road is not listed and is in fair physiological and structural condition.

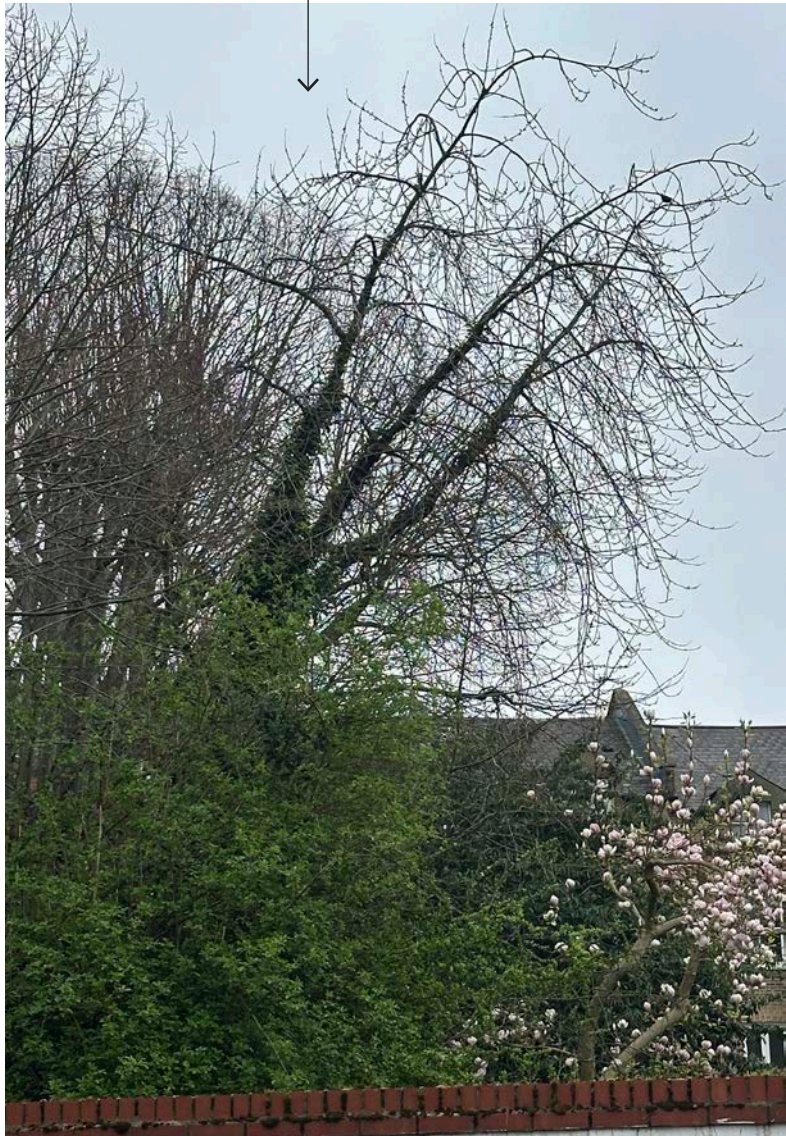
View looking West into rear garden of 43 Langdon Park Road.

T002 Cherry tree has historic suppression that has led to the tree leaning over 45 Langdon Park Road. This application proposes to remove this tree.

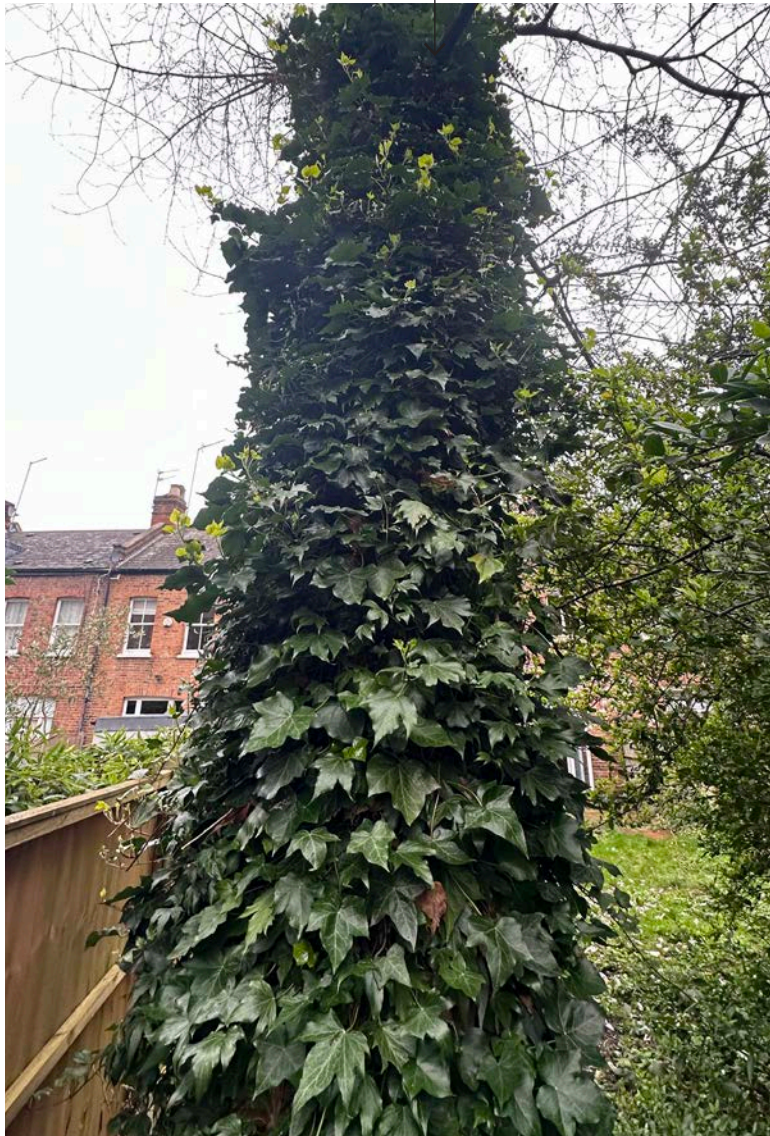
View looking North into rear garden of 43 Langdon Park Road.

T002 Cherry tree has been compromised by prolific ivy growing around its trunk.
