RE: No. LBC HGY/2024/0074

Project address: 42 Southwood Lane, London, N6 5EB

Discharge of Condition 03

PLANNING STATEMENT: Discharge of Condition 03

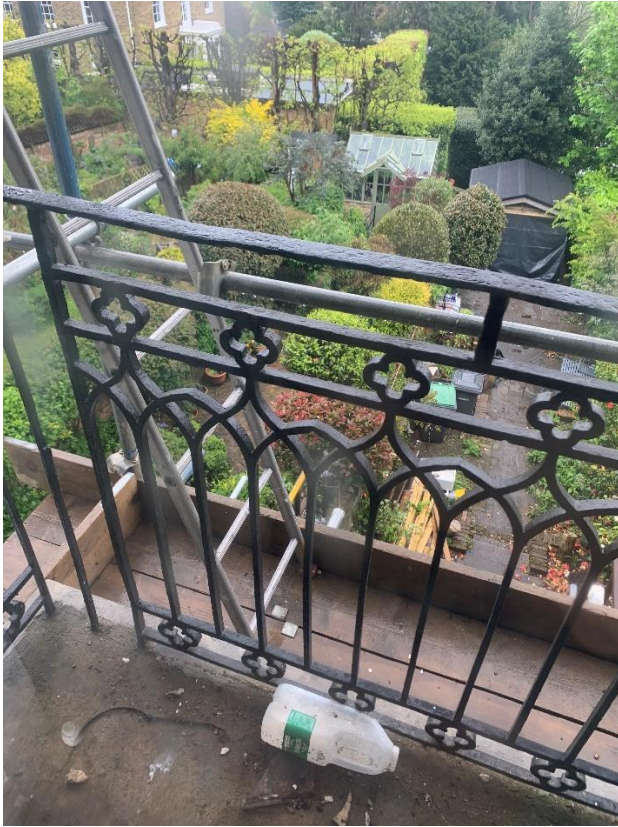
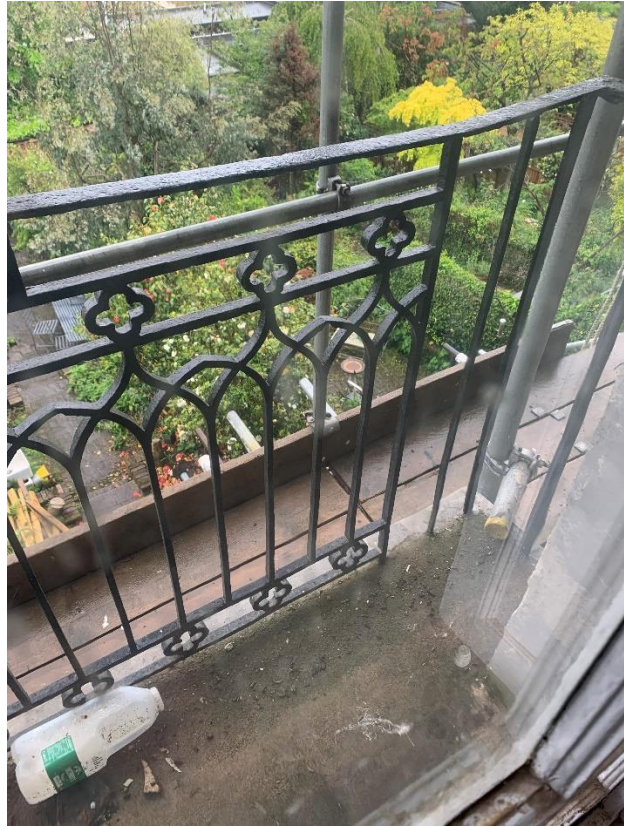
- The existing balcony railings have been checked and are in relatively good condition.
- Maintenance works have been carried out as follows:

The base of the balcony have had moss/ vegetable matter removed and have been rubbed down and had loose paint removed in preparation for redecoration. These and the existing render to rear elevation of the house will follow the approach under 3.1.3 – 3.1.12 above to carryout maintenance work to make good and prepare for redecoration.

Above: Current photos of balcony to rear first floor room (to LHS when standing in the room).

- Remove existing paint, rust, and debris from the iron balcony using by wire brushing.

- The railings have been repainted with black Hammarite metal paint.

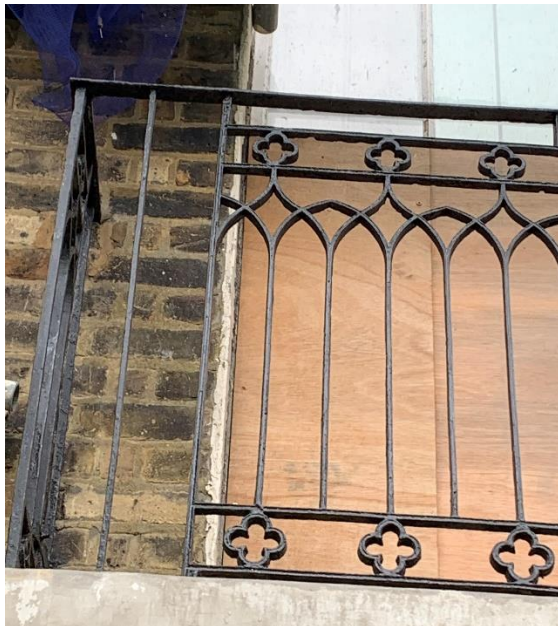
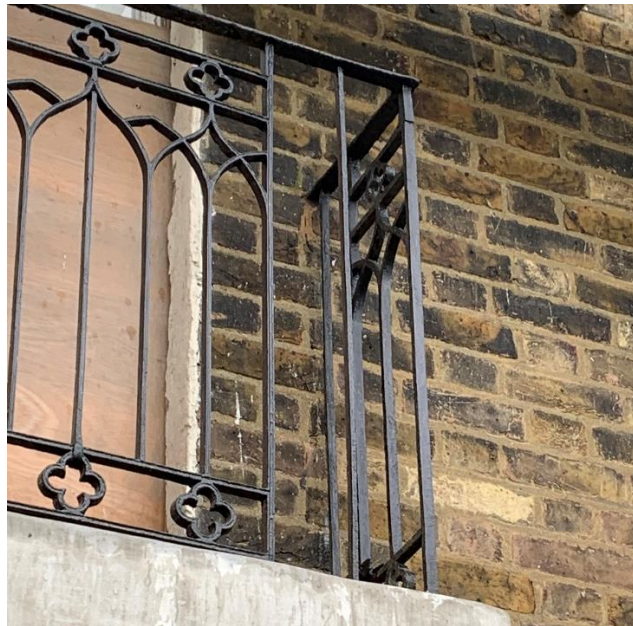
Above: Current photos of balcony to rear first floor room (to RHS when standing in the room).

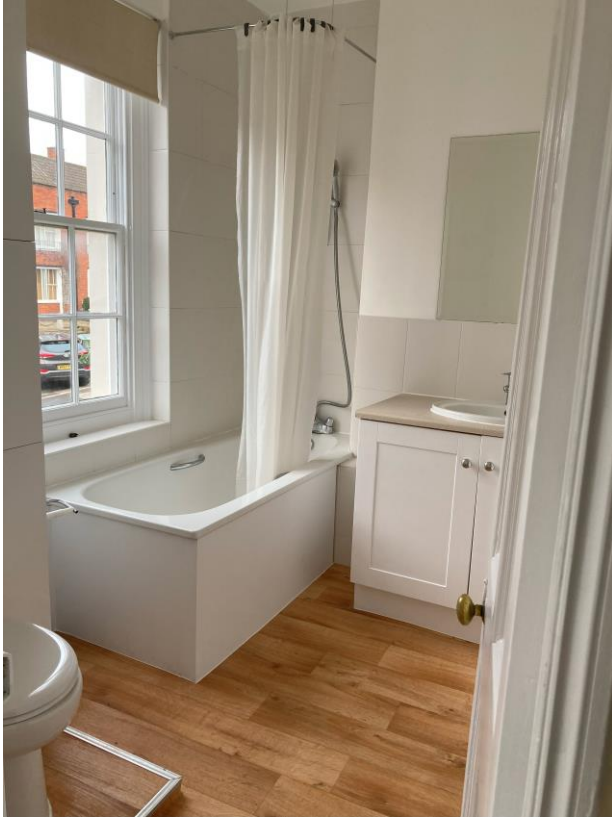
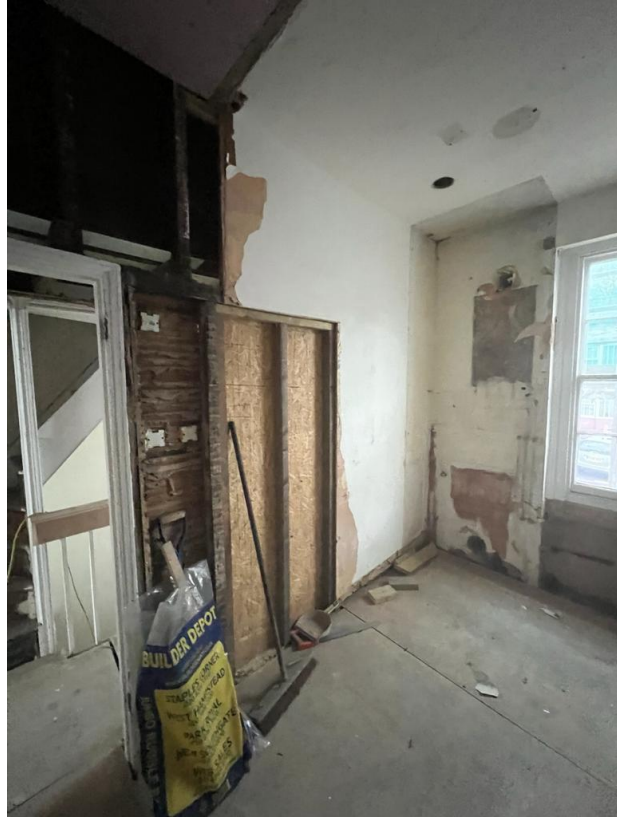
3.7.1 The front room had previously been subdivided to form two bathrooms, with modern fixtures and finishes. The dividing wall has been removed as part of the consented scheme. In order to reinstate the room as one large space and to repair damage caused by the previous partition, the walls have been re-plastered in preparation for new bathroom fixtures and finishes.

Above Left: Photo of 1<sup>st</sup> floor bathroom prior to works. Above Right: With partition wall removed.

3.7.3 This wall was carefully dismantled firstly removing the tiles then unscrewing the tile board. Finally, the studs were carefully removed.

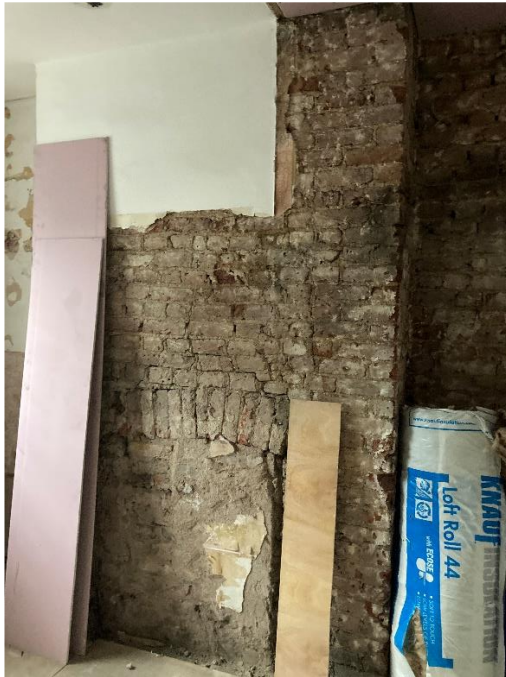
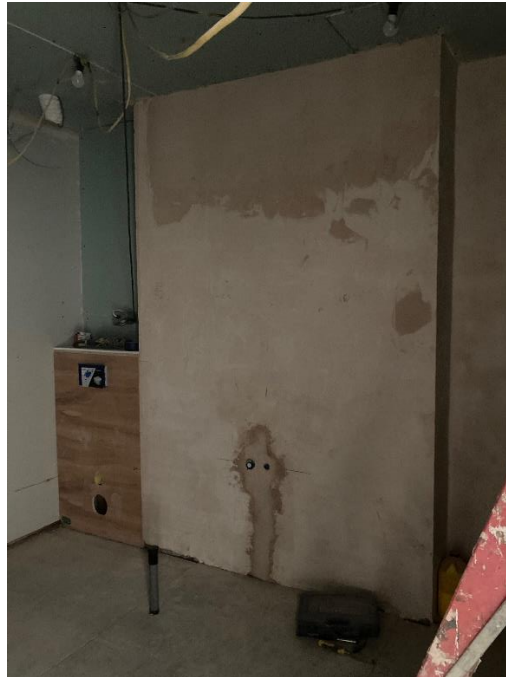
Above Left: Photo of 1<sup>st</sup> floor bathroom wall with sanitaryware, stud partition wall and surrounding finishes removed. Above Right: With new plasterboard/ plastered finish to the wall.

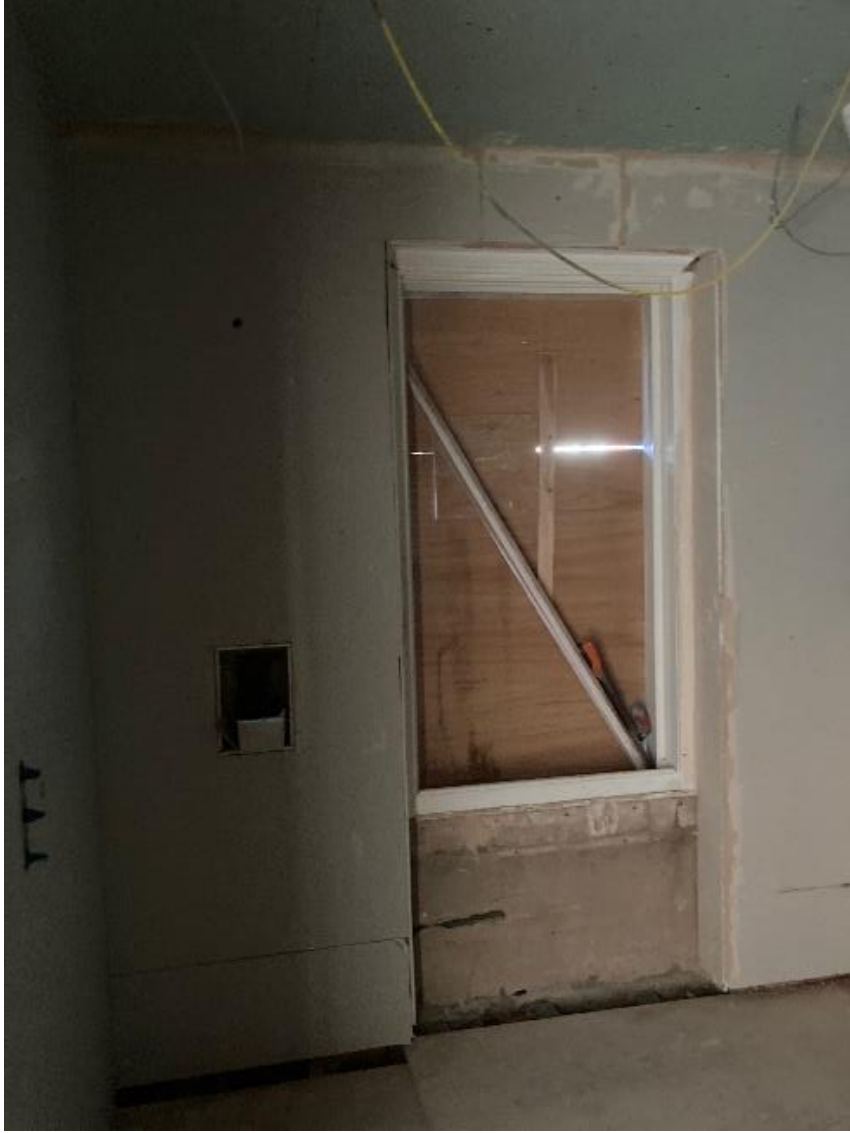
Below, new plasterboard to walls where sanitaryware and tiling have been removed.
