## **APPENDIX B**

### **Site Walkover Photographs**

| Name | Lock Keepers Cottages |
| Location | Ferry Lane, London, N17 9NE |

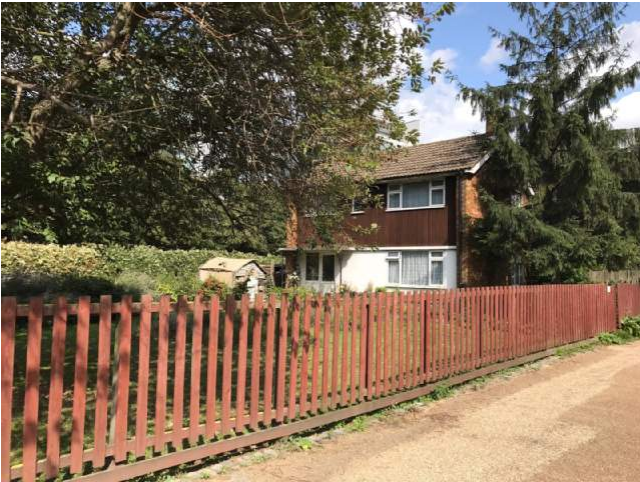
Photograph Title      Southern side of property

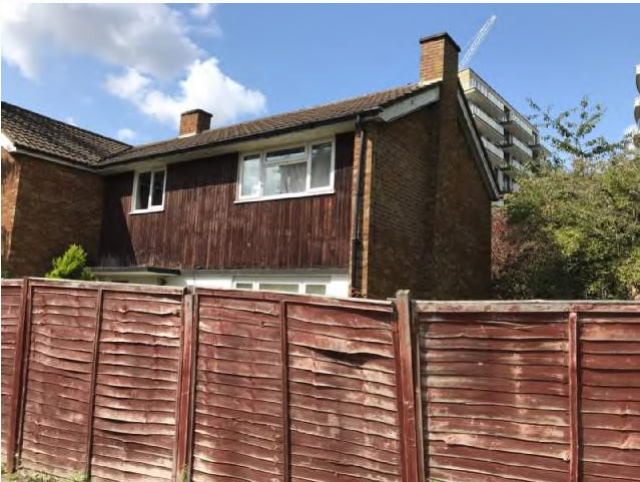
Photograph Title      Northern side of property no obvious signs of structural distress

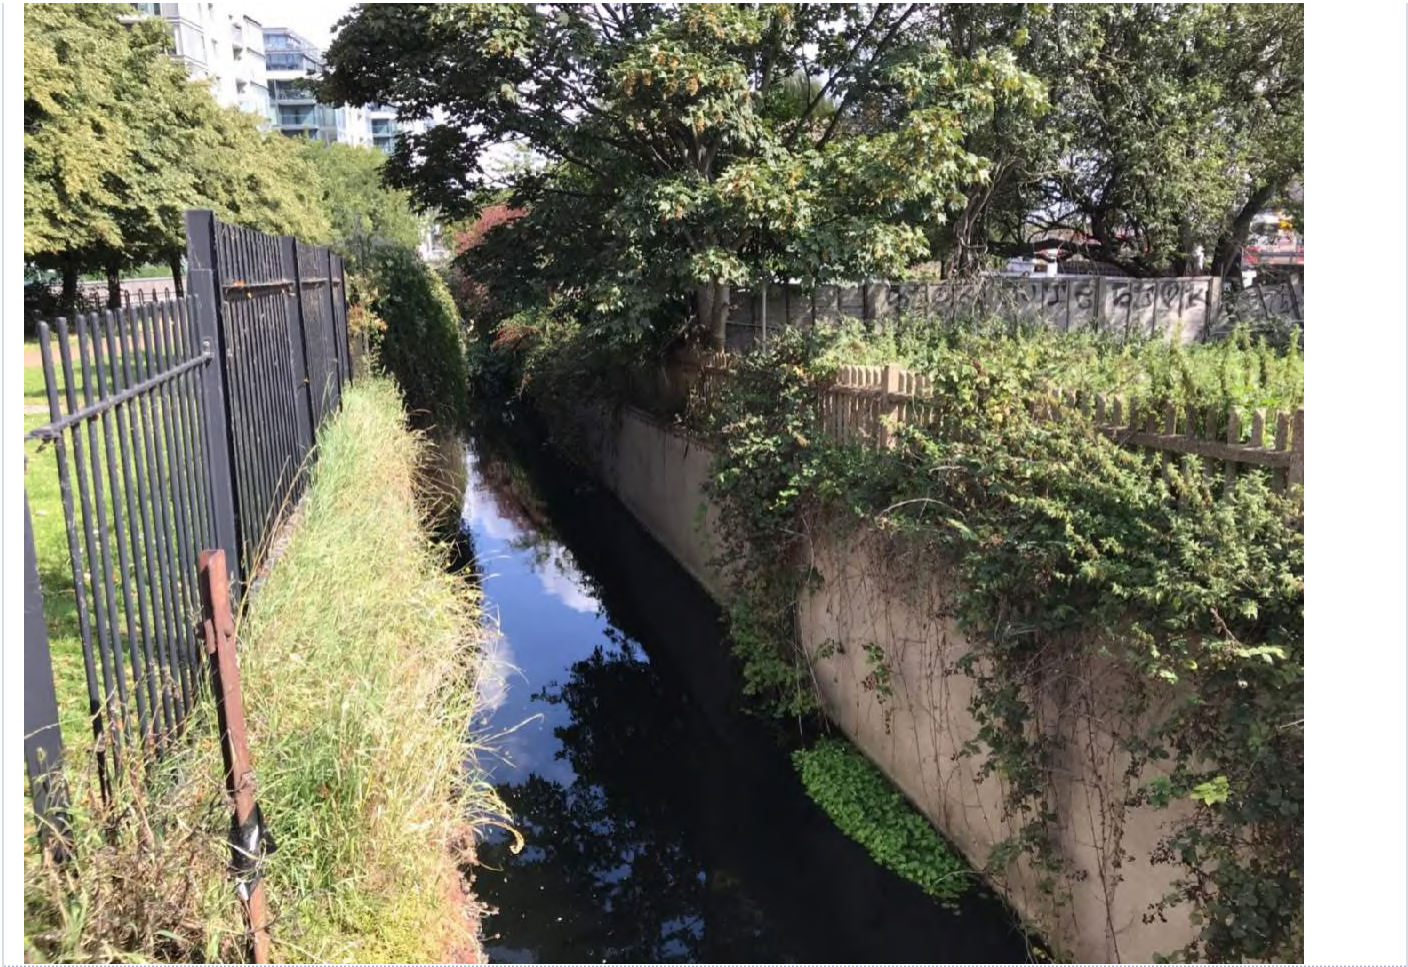
| Retaining Wall | 1 |

| Description | View north along canalised river flowing north-south on the western side of the site. |

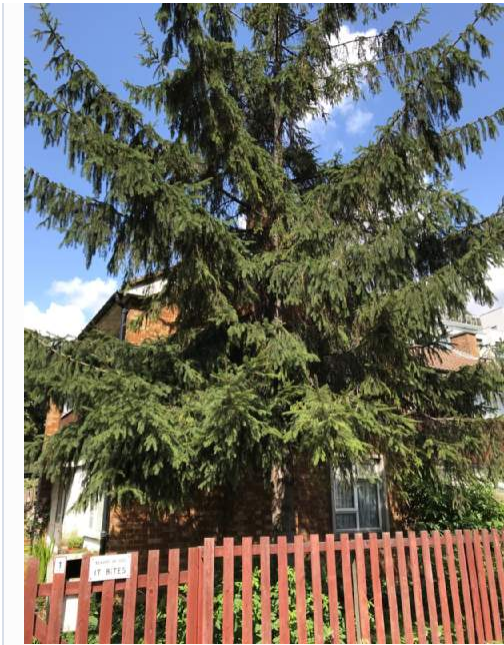
| Trees | 2 |

| Description | Evergreen tree on eastern side of property |

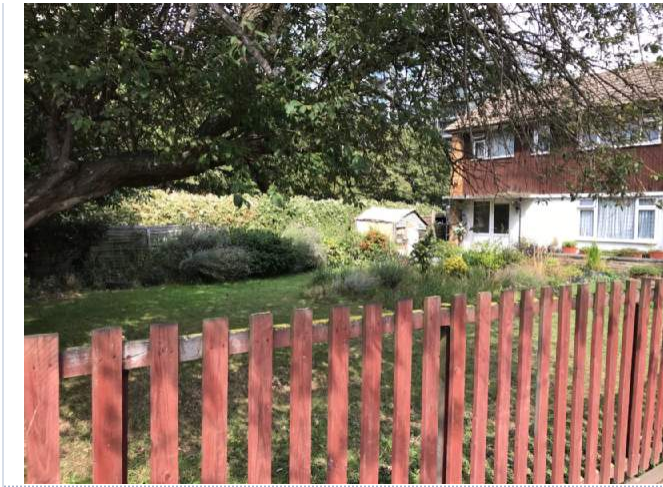
| Soft Landscaping | 1 |

| Description | The garden is laid to lawn with flower beds and borders and shrubs |

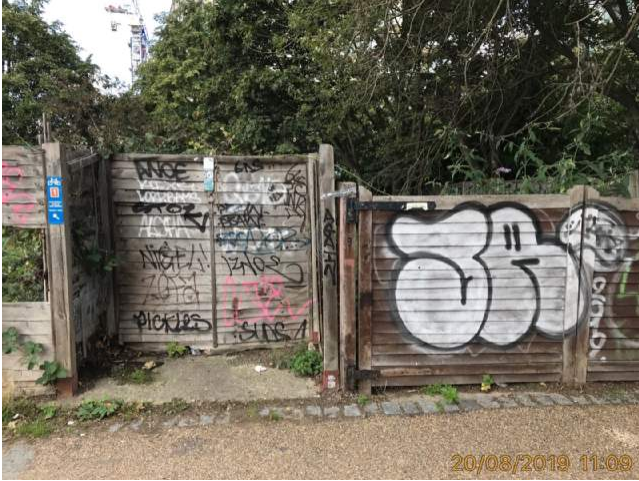
| Other | 3 |

| Description | Access to southern side of cottages |

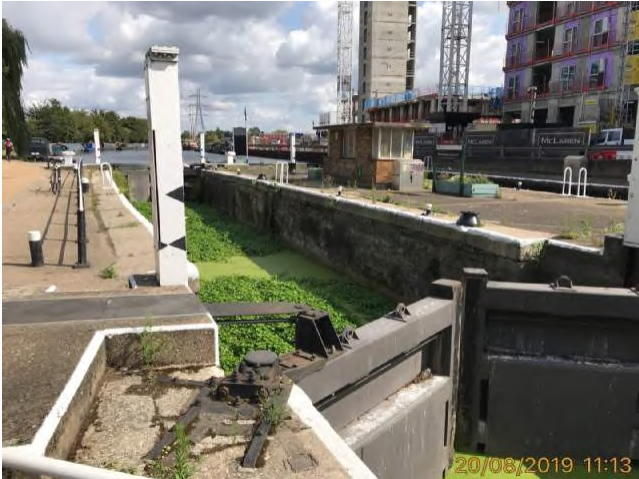
| Other | 4 |

| Description | Lock on eastern side of site |

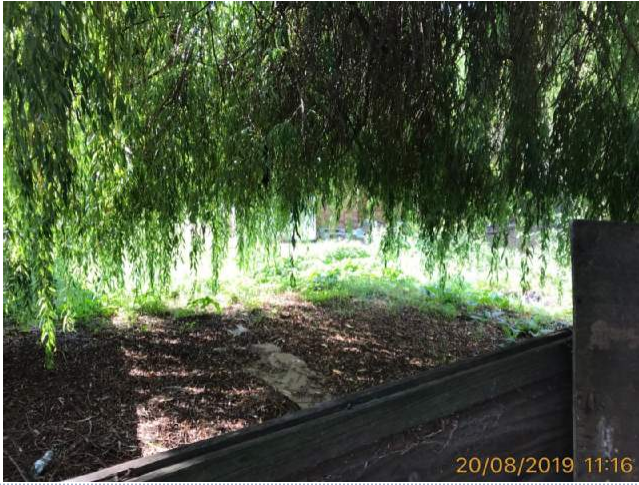
| Other | 5 |

| Description | Garden on northern side of property |

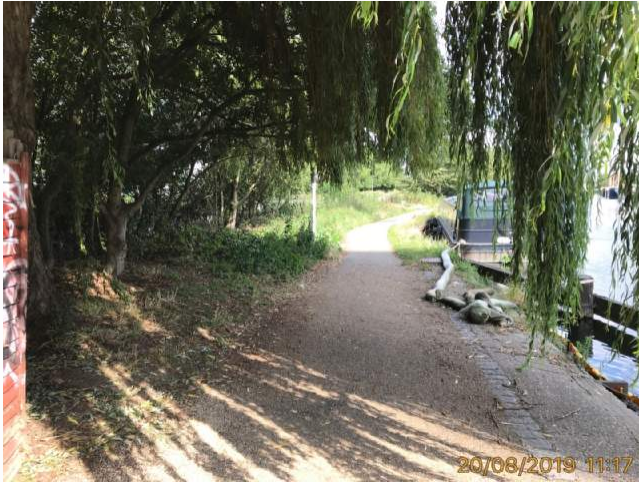
6

Land to the north of the property. A tent was noted possibly with someone rough sleeping.

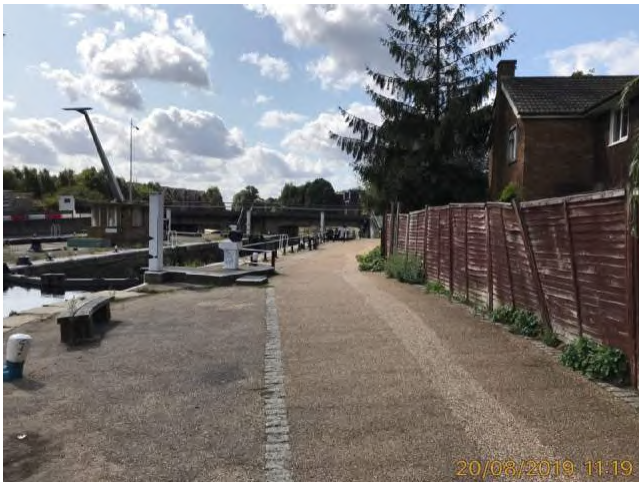
7

View south along tow path with property to the west

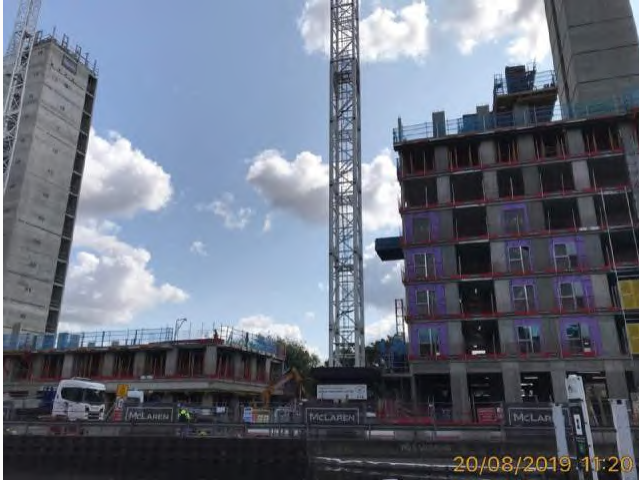
8

Description View of construction site to the east

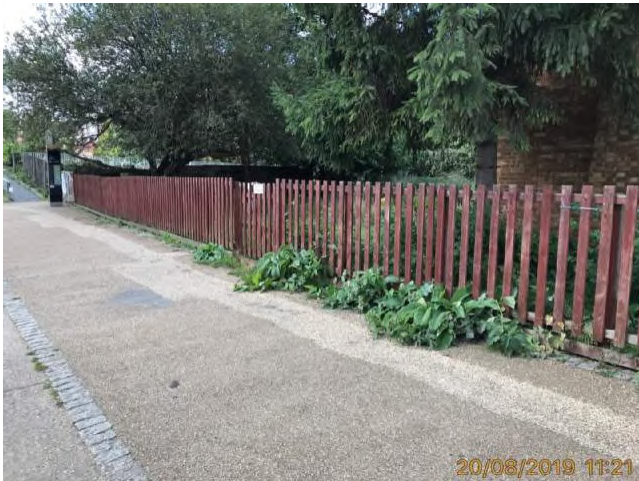
Other 9

Description Access gate into site

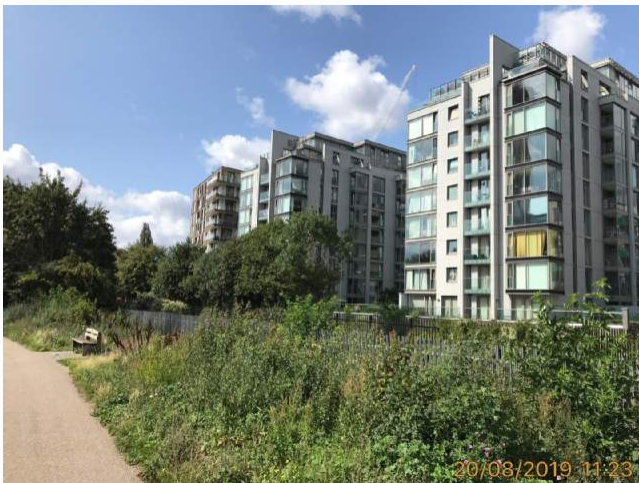
Other 10

Description View of residential development to the west of the site

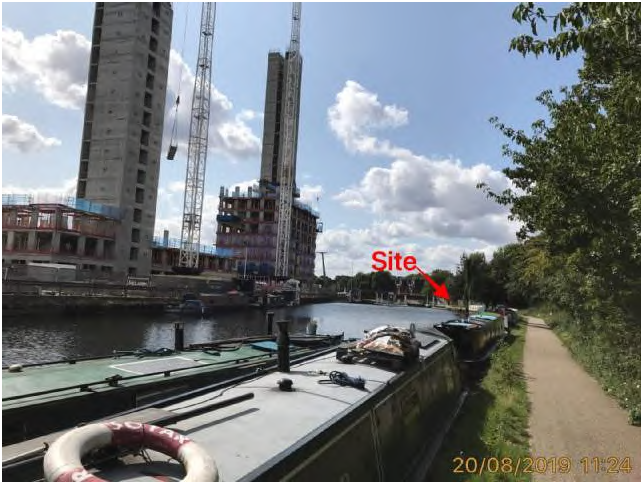
| Other | 11 |

| Description | View from the north looking towards the south |

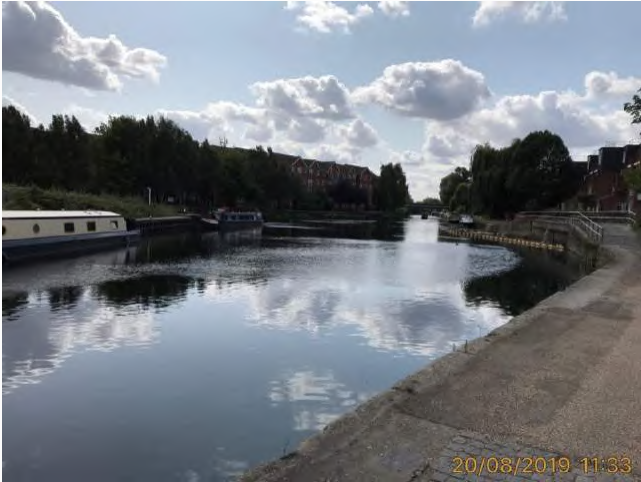
| Other | 12 |

| Description | Due south of the site along the canal |
