1.1 This submission has been prepared to support a retrospective application for Listed Building Consent at no.42 Southwood Lane, London N6 5EB. It has been compiled in addition to and to the fully explain and set out the points raised in the previously issued report by The Heritage Practice, which is included in this submission and Devise Chartered Structural Engineers whose report and calculations are included as part of this submission.

During the course of the works that have been carried out to date, a number of works have taken place to the property which are outside the scope of the consented scheme and thus do not currently benefit from Listed Building Consent. This application seeks to regularise and rectify the position with clear evidence-based reasoning where appropriate and reinstatement where appropriate.

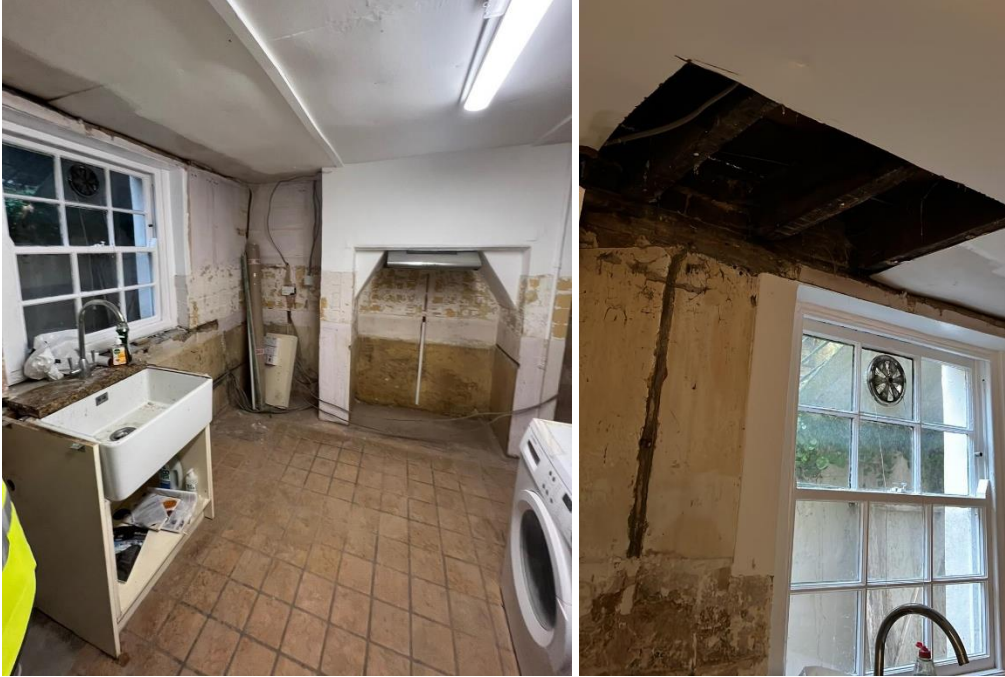
Above left: A photo of the front room prior to the works where the kitchen was located.

Above right: A photo to show how the existing ceiling was modern plasterboard.

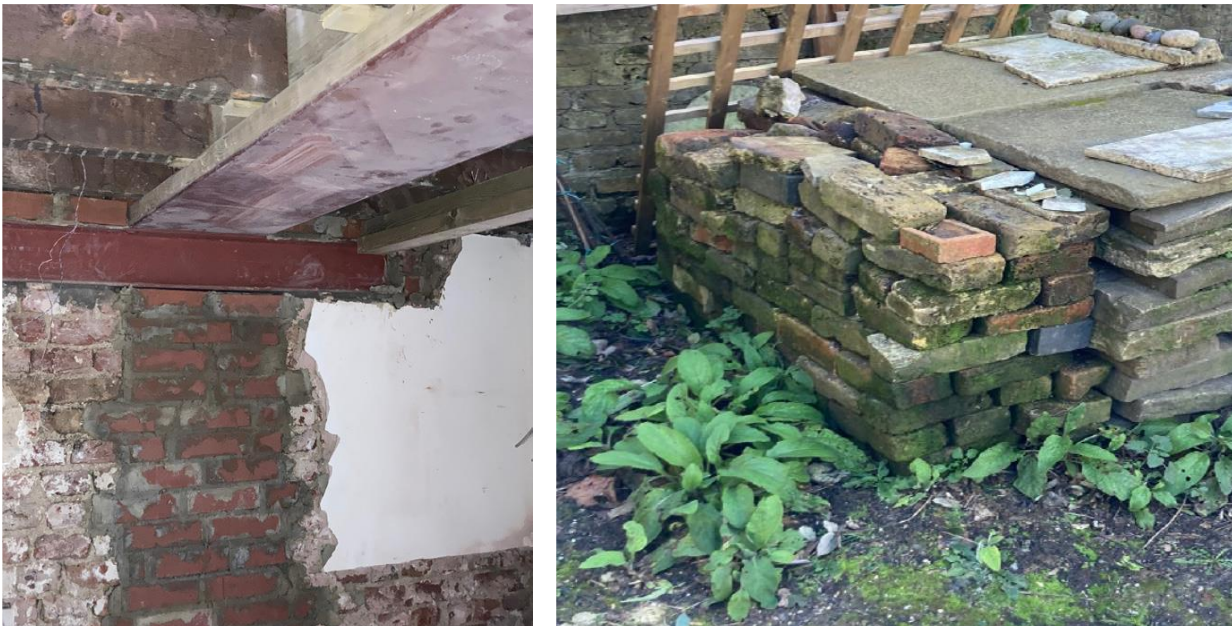
Above left: A photo of the steel beam that has been installed in the location of the spine wall showing the bearing on the party wall to the north of the property.

Above right: Brickwork from the works to the masonry spine wall that has been retained for reinstatement.

The proposed works of the consented scheme (under Listed Building Consent HGY/2022/2556) included for two new openings to the spine wall, one to be an internal window and the other to provide access between the front and rear areas of the lower ground floor. Having carried out a structural assessment of the existing spine wall by the Structural Engineers (Devise), they advised that the existing masonry wall does not have the capacity to form such openings without strengthening works being undertaken. This advice has been followed and a new steel beam has been installed, spanning from party wall to party wall. This enables the wall to be reinstated below to match with the design of the consented application.

As indicated on the drawings attached, the wall is to be rebuilt using the existing bricks that have been removed or reclaimed bricks to match the existing. The masonry wall and steel beam will then be encapsulated with plasterboard and painted plaster skim to cover, to totally conceal the structural strengthening works that have been carried out.

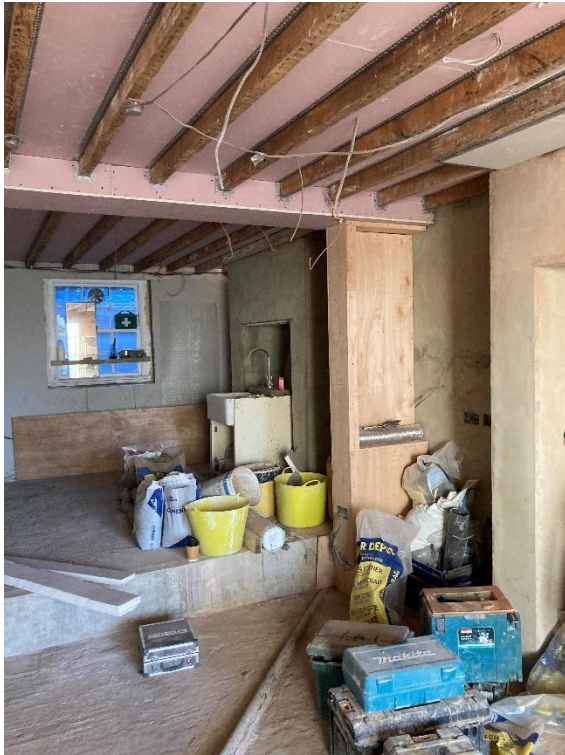
Above left: A photo of the steel beam now encapsulated with plasterboard. Note that the temporary ply wall nib has now been removed. The existing plaster board ceiling has been removed elsewhere in the room and replaced with a new plasterboard ceiling set between the existing joists to expose the original beams and benefit the room from additional ceiling height.

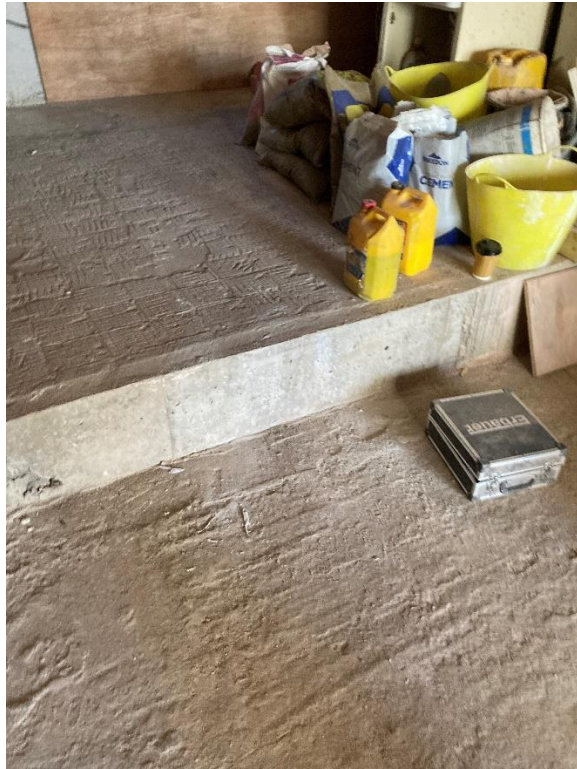
Above right: The existing floor at LGF level was a modern concrete floor slab.

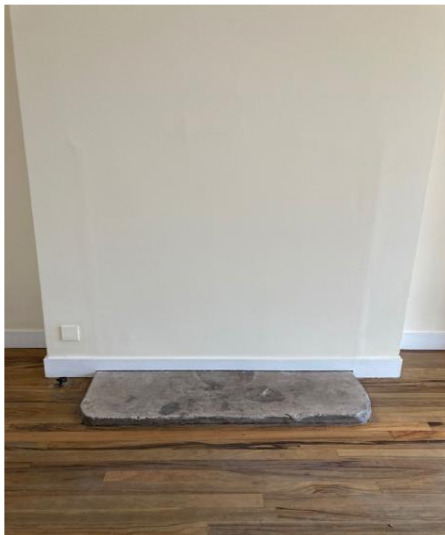
3.2 The existing hearth to the rear room chimneybreast was proposed to be retained as part of the consented works. The hearth has however proved to be concrete, and thus not a period piece. This has been removed to be replaced with a Yorkstone Hearth, which is considered to be of higher quality than the modern concrete hearth that it replaces.

Below: The concrete hearth to the rear lower ground floor room prior to the works.

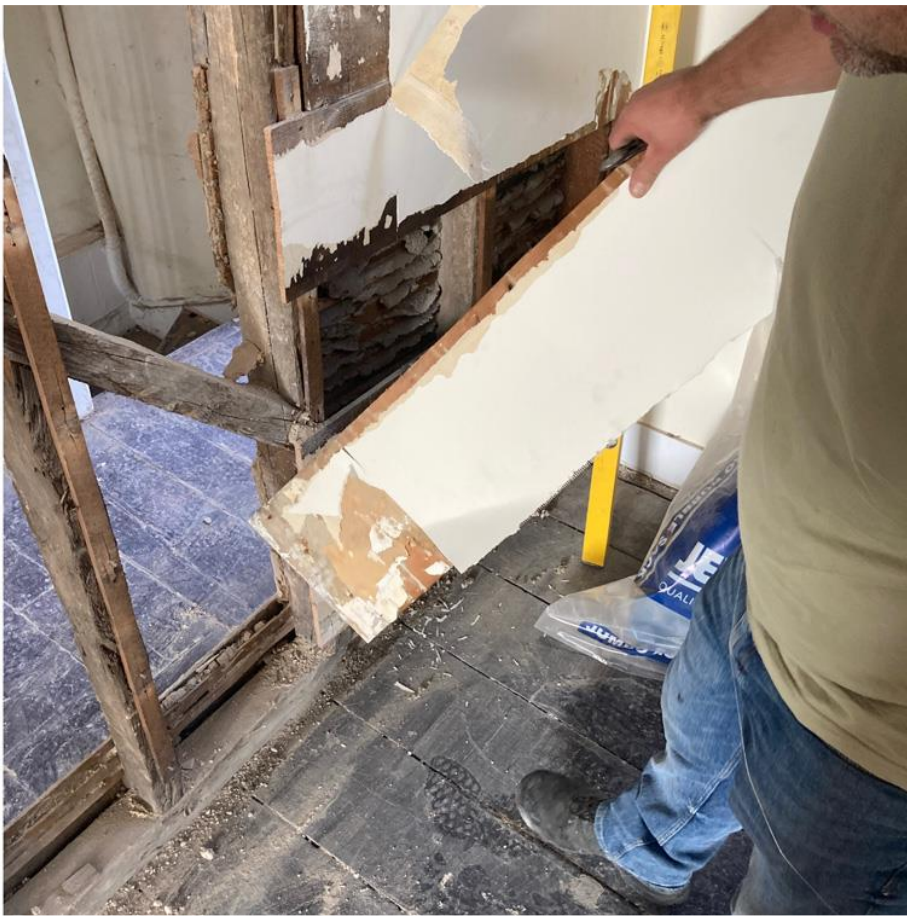
Above: Photo of the modern timber boarding that was used to clad the internal partition wall between the front room and hallway.

4.1 A wide opening has been created in the partition wall between the hallway and front room. This has been formed using timber studs to frame. It is proposed to reinstate the area of wall removed and to reinstate the door opening back to how it was. The door leaf has been maintained and the painted timber architrave will be reinstated to match the existing (and profile of the other ground floor architraves), as will the timber skirting. There was no cornice present in this room. The wall will be reinstated in Lath and Plaster. The area of the wall removed was covered on the front room side with modern timber boarding as seen in the photo below and thus a lath and plaster finish will restore the period appropriate finish to replace the modern finish that had been used in this location.

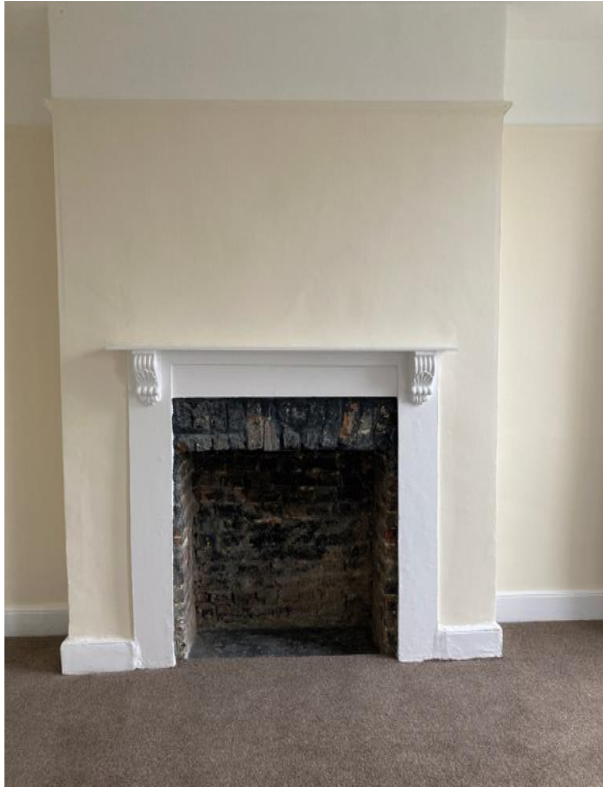
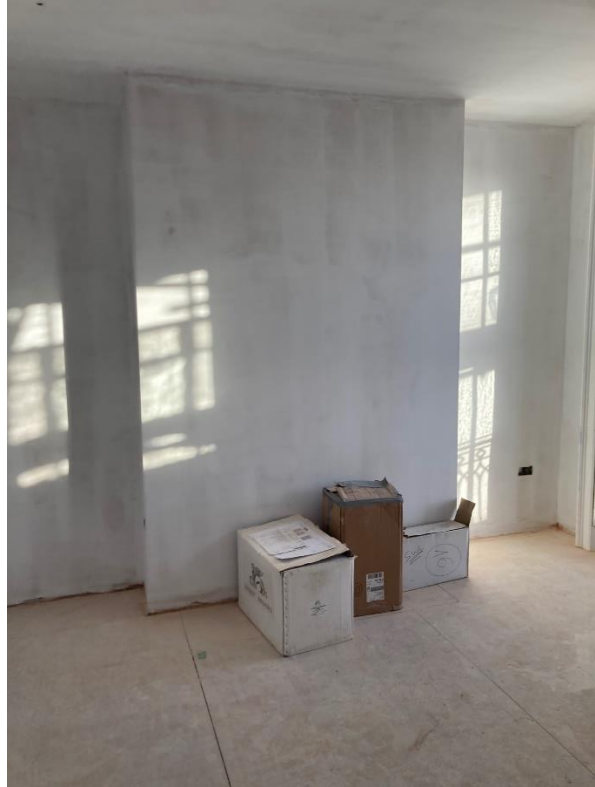
5.1 To the rear bedroom, a fireplace surround has been removed. This was a modern timber surround. The brick fireplace and hearth has been retained and protected behind an internal wall build up. This will allow a bed to be positioned against this wall to enable better enjoyment and use of the room for the occupants.

Above left: Photo of the first floor rear room fireplace surround – which is a modern timber piece.  
Above right: Photo of the chimney breast as it stands, with the fireplace opening boarded over (with the opening retained behind).

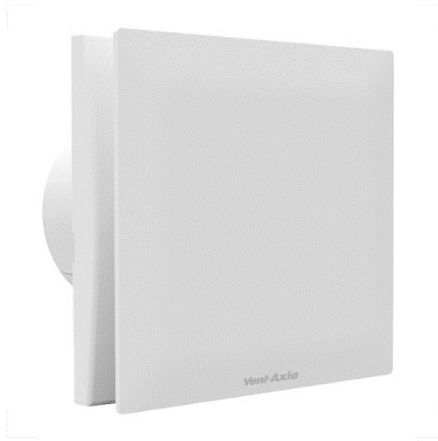
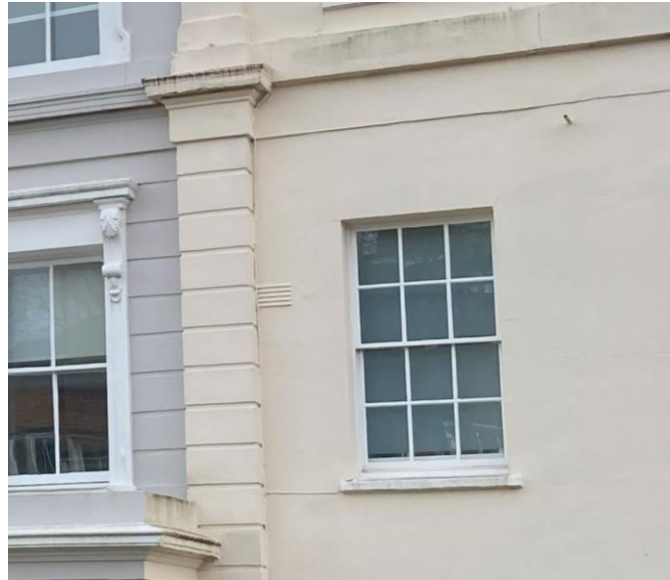
Above left: Photo of the internal element of the bathroom extractor fan.

Above right: Photo of a fan vent to the property two doors along at No. 38, painted to match the finish of the elevation and to a similar location as proposed.

5.2 The bathroom within the front room has had mechanical ventilation installed for Building Regulations compliance. A Vent Axia Silent wall mounted fan is proposed internally. See image below of this product. This requires a vent on the front facade of the building for the external fan to sit behind. This will be a traditional, terracotta air brick, (215mm wide by 140mm high) with a painted finish to match and blend in to the elevation. Given its traditional appearance and modest size, this will be a minimal feature on the elevation and will not detract from its architectural quality or significance. There are other examples of such along the street. The consented works included for removal of redundant pipework to the front elevation, including the old boiler flue's wall vent and so overall the front elevation will be greatly improved under this application and the previous consented application.

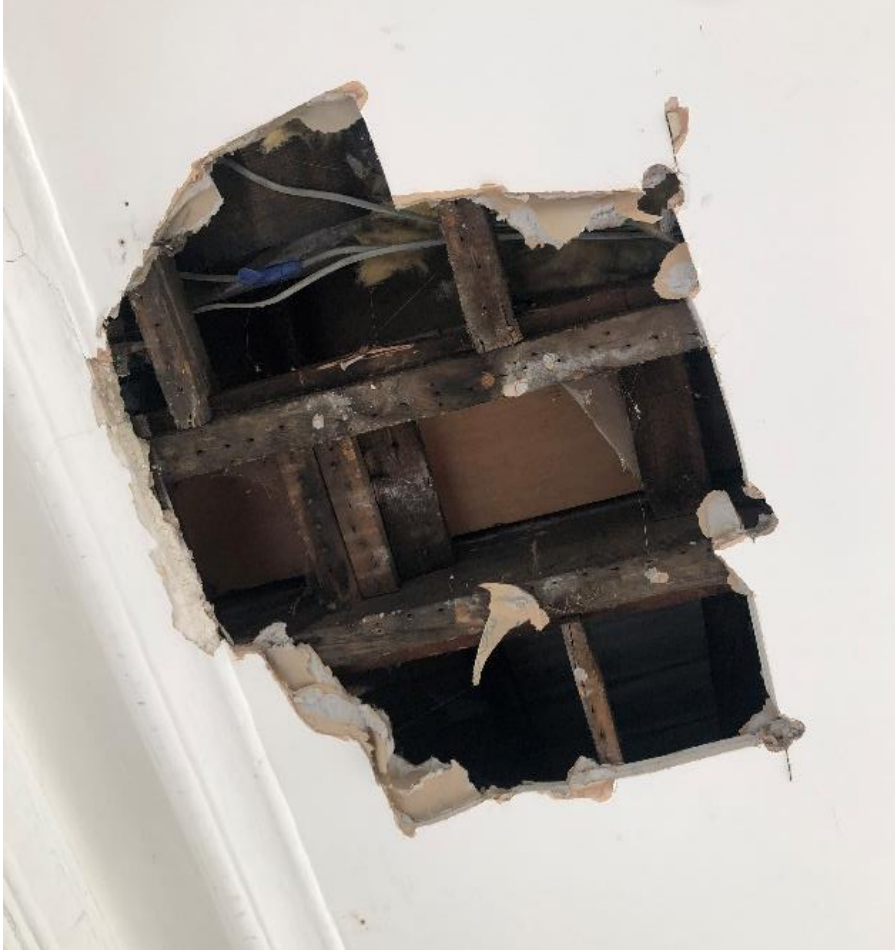
Above: Photo of the ceiling to the rear room to show the existing ceiling was plasterboard.

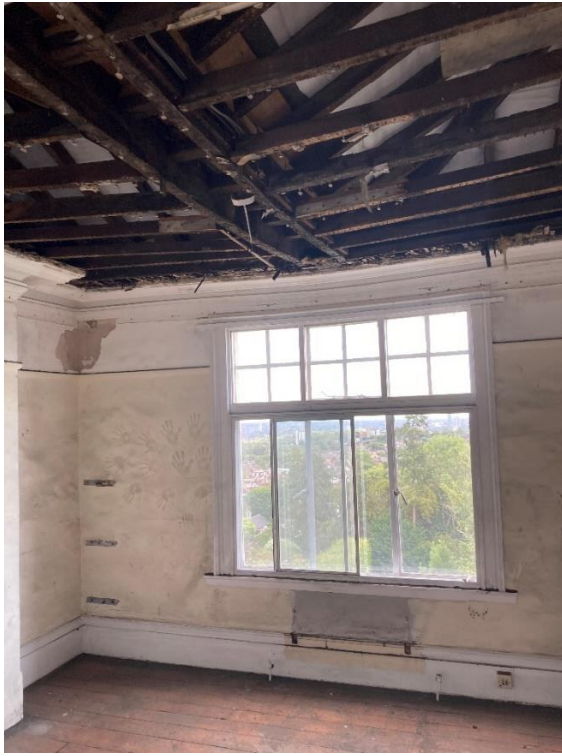
Above the rear room's window, the existing timber lintel had become rotten, bowing in the middle of it and a new concrete lintel has been used to replace this to support the two central steels. This can be seen in the photos below (and indicated on the drawing).

Above Left: Photo of with the timber lintel in place above the rear window.

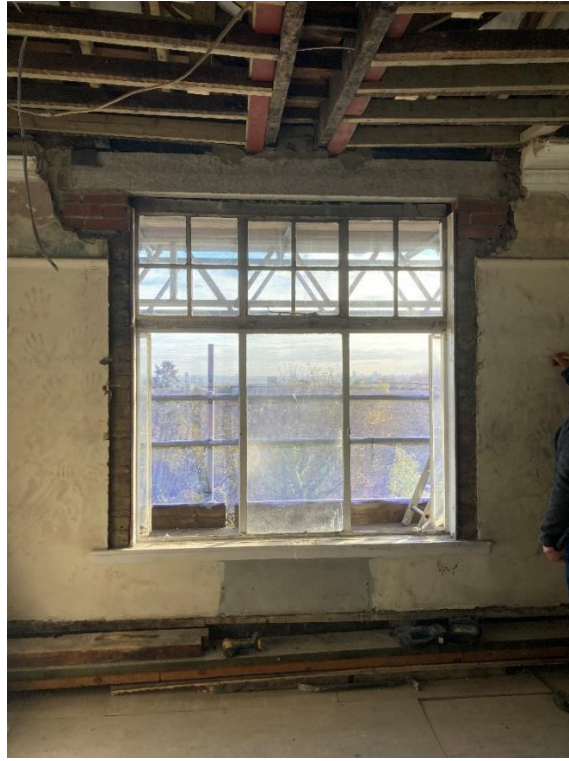
Above Right: Photo of the concrete lintel installed to replace and new steels installed to strengthen the roof structure. Note the cornice section that had been removed.

6.1 Further to assessment of the roof structure by Devise, the structural engineers for the project, strengthening works have been carried out to the timber roof structure. The existing roof profile and historic timber structure has been retained by inserting three steels as indicated on drawing 24405 – 0223 Second Floor Plan. Two cranked steels run from the front to the rear of the property with a cross bracing steel used between to run from party wall to party wall.

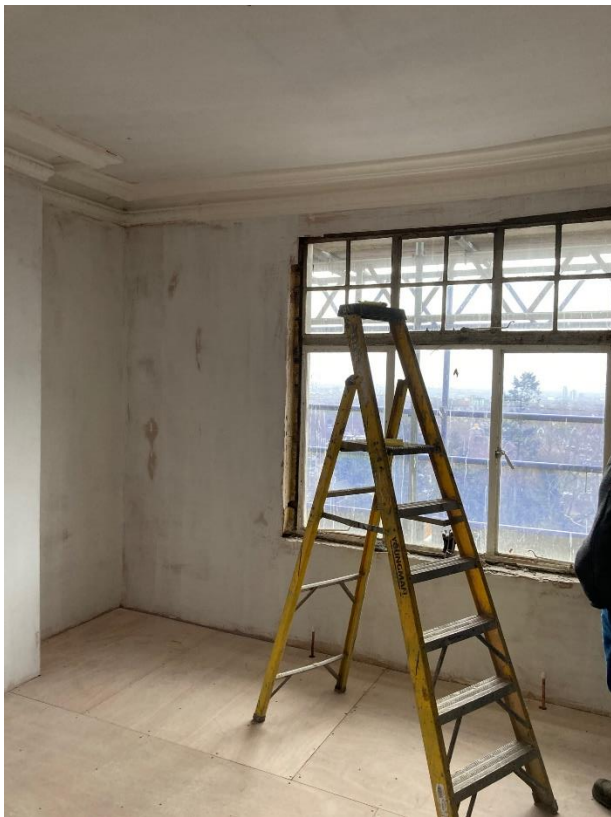
Photo of reinstated ceiling and cornice above rear window.

6.3 The existing plaster cornice at this floor level has been retained other than where necessary to remove due to the structural works. See photos below to show this. Where removed, the existing cornice has been replicated and reinstated to restore the rooms back to their original appearance.

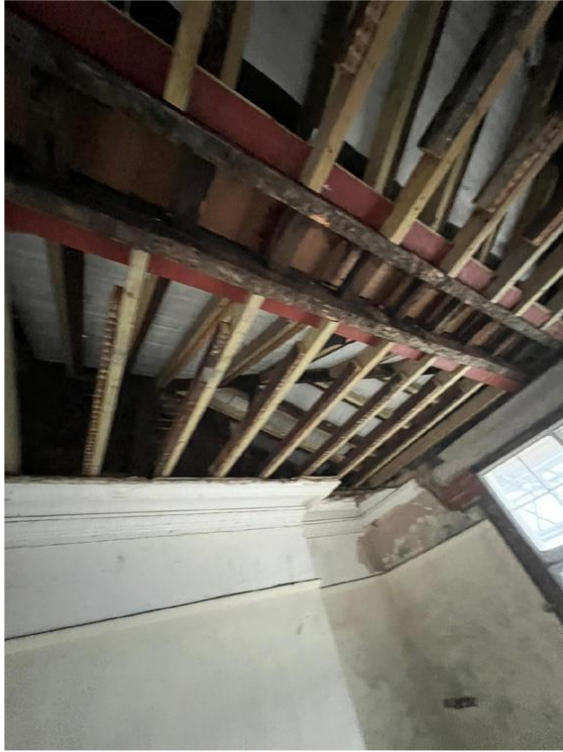
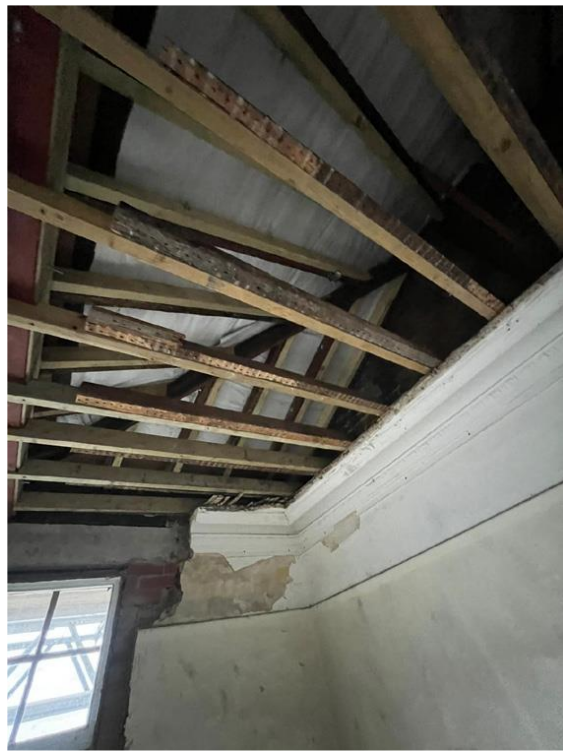
Above Left: Photo of new steelwork above rear room with chimney breast shown in foreground

Above Right: Photo of new steelwork above rear room with wall opposite chimney breast shown in foreground.

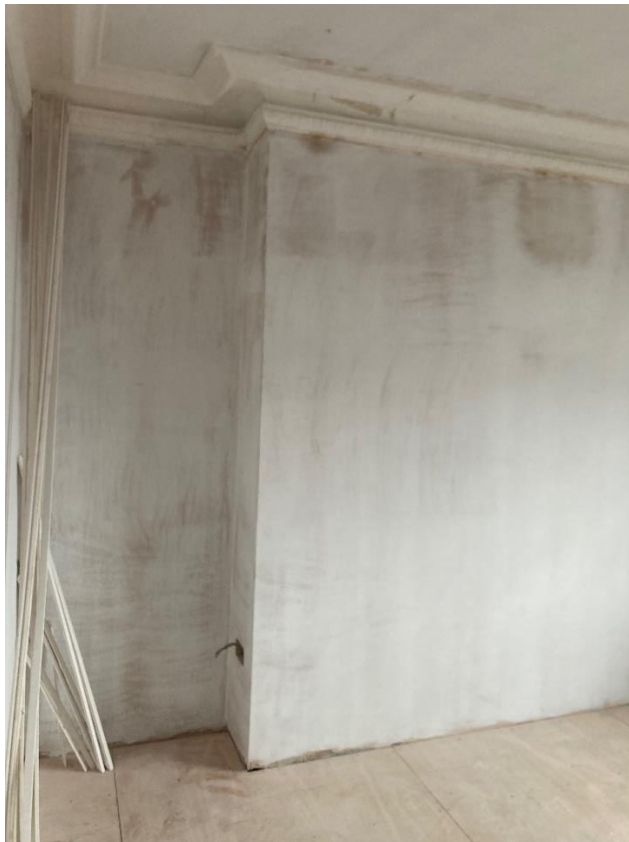
Above: Photo of chimney breast wall with ceiling and cornice reinstated.

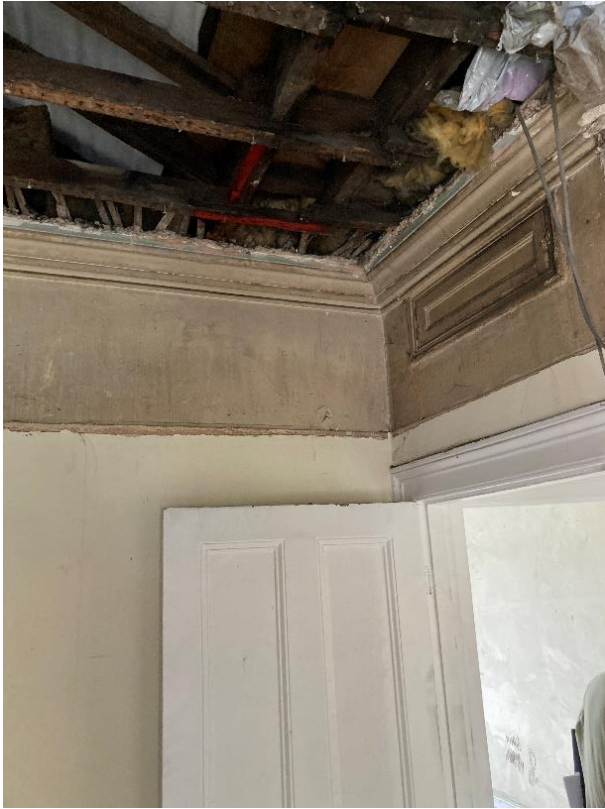
Above left: photo showing front room with steels installed above and sections of cornice retained where possible.

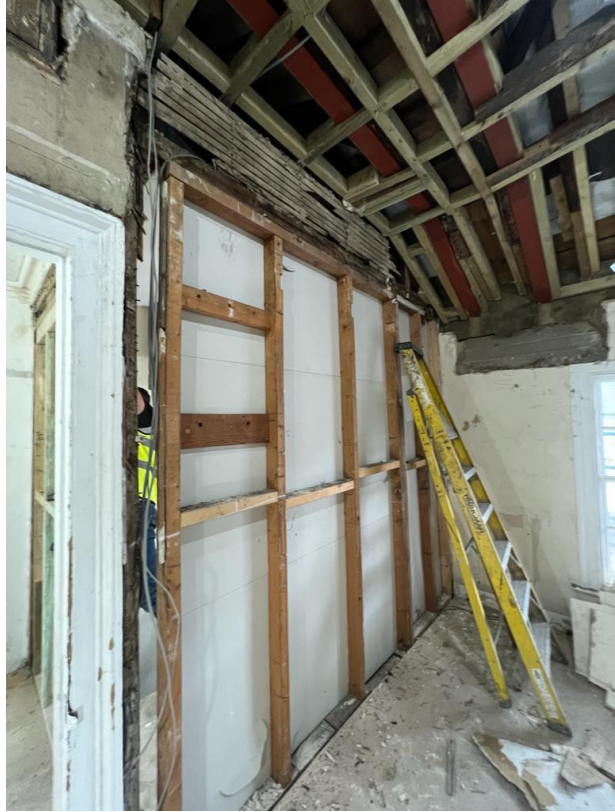
6.2 In addition, all finishes have been removed to the wall between the front bedroom and the stair compartment. This is almost entirely of modern timber studwork and a plasterboard finish, with only a very small section of lath and plaster surviving above it. New plasterboard has been installed to this wall and a plaster skim coat has been applied to both rooms in order to achieve a cohesive and unified appearance.

Above right: Wall in front room backing onto hallway, showing how this was modern timbers with only a small section of lath and plaster remaining at the top of the wall. The concrete padstone installed for the new steelwork can be seen to the rear.

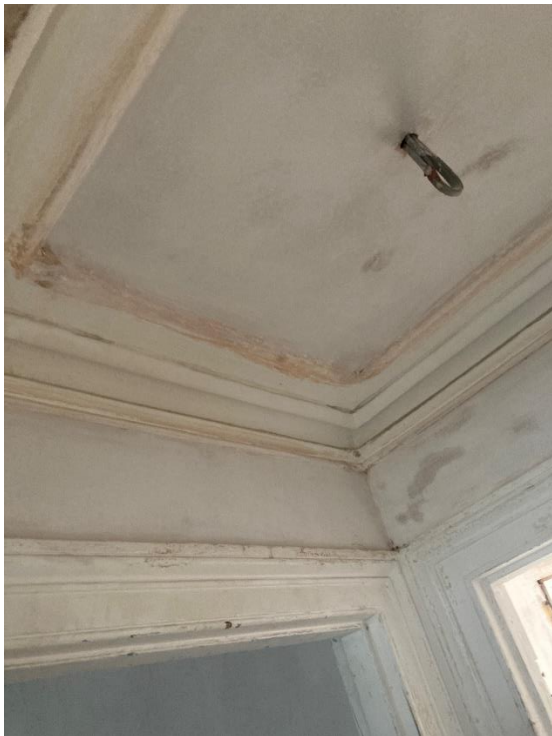
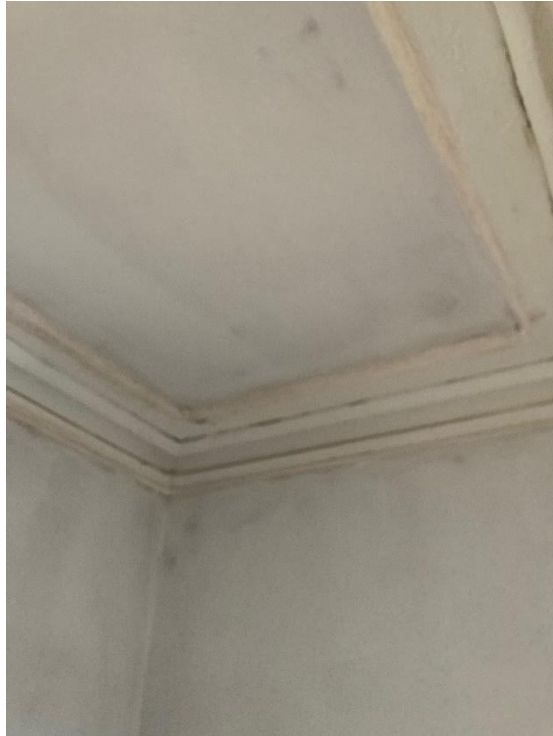
Above: Photos of the reinstated ceiling and coving in the landing area of the 2<sup>nd</sup> floor level.
