# Arboricultural Report

Tree Survey  
Arboricultural Impact Assessment  
& Tree Protection Plan

Land at  
Shepherd's Close  
London  
N6

AR/75319 – Land at Shepherd's Close  
London, N6

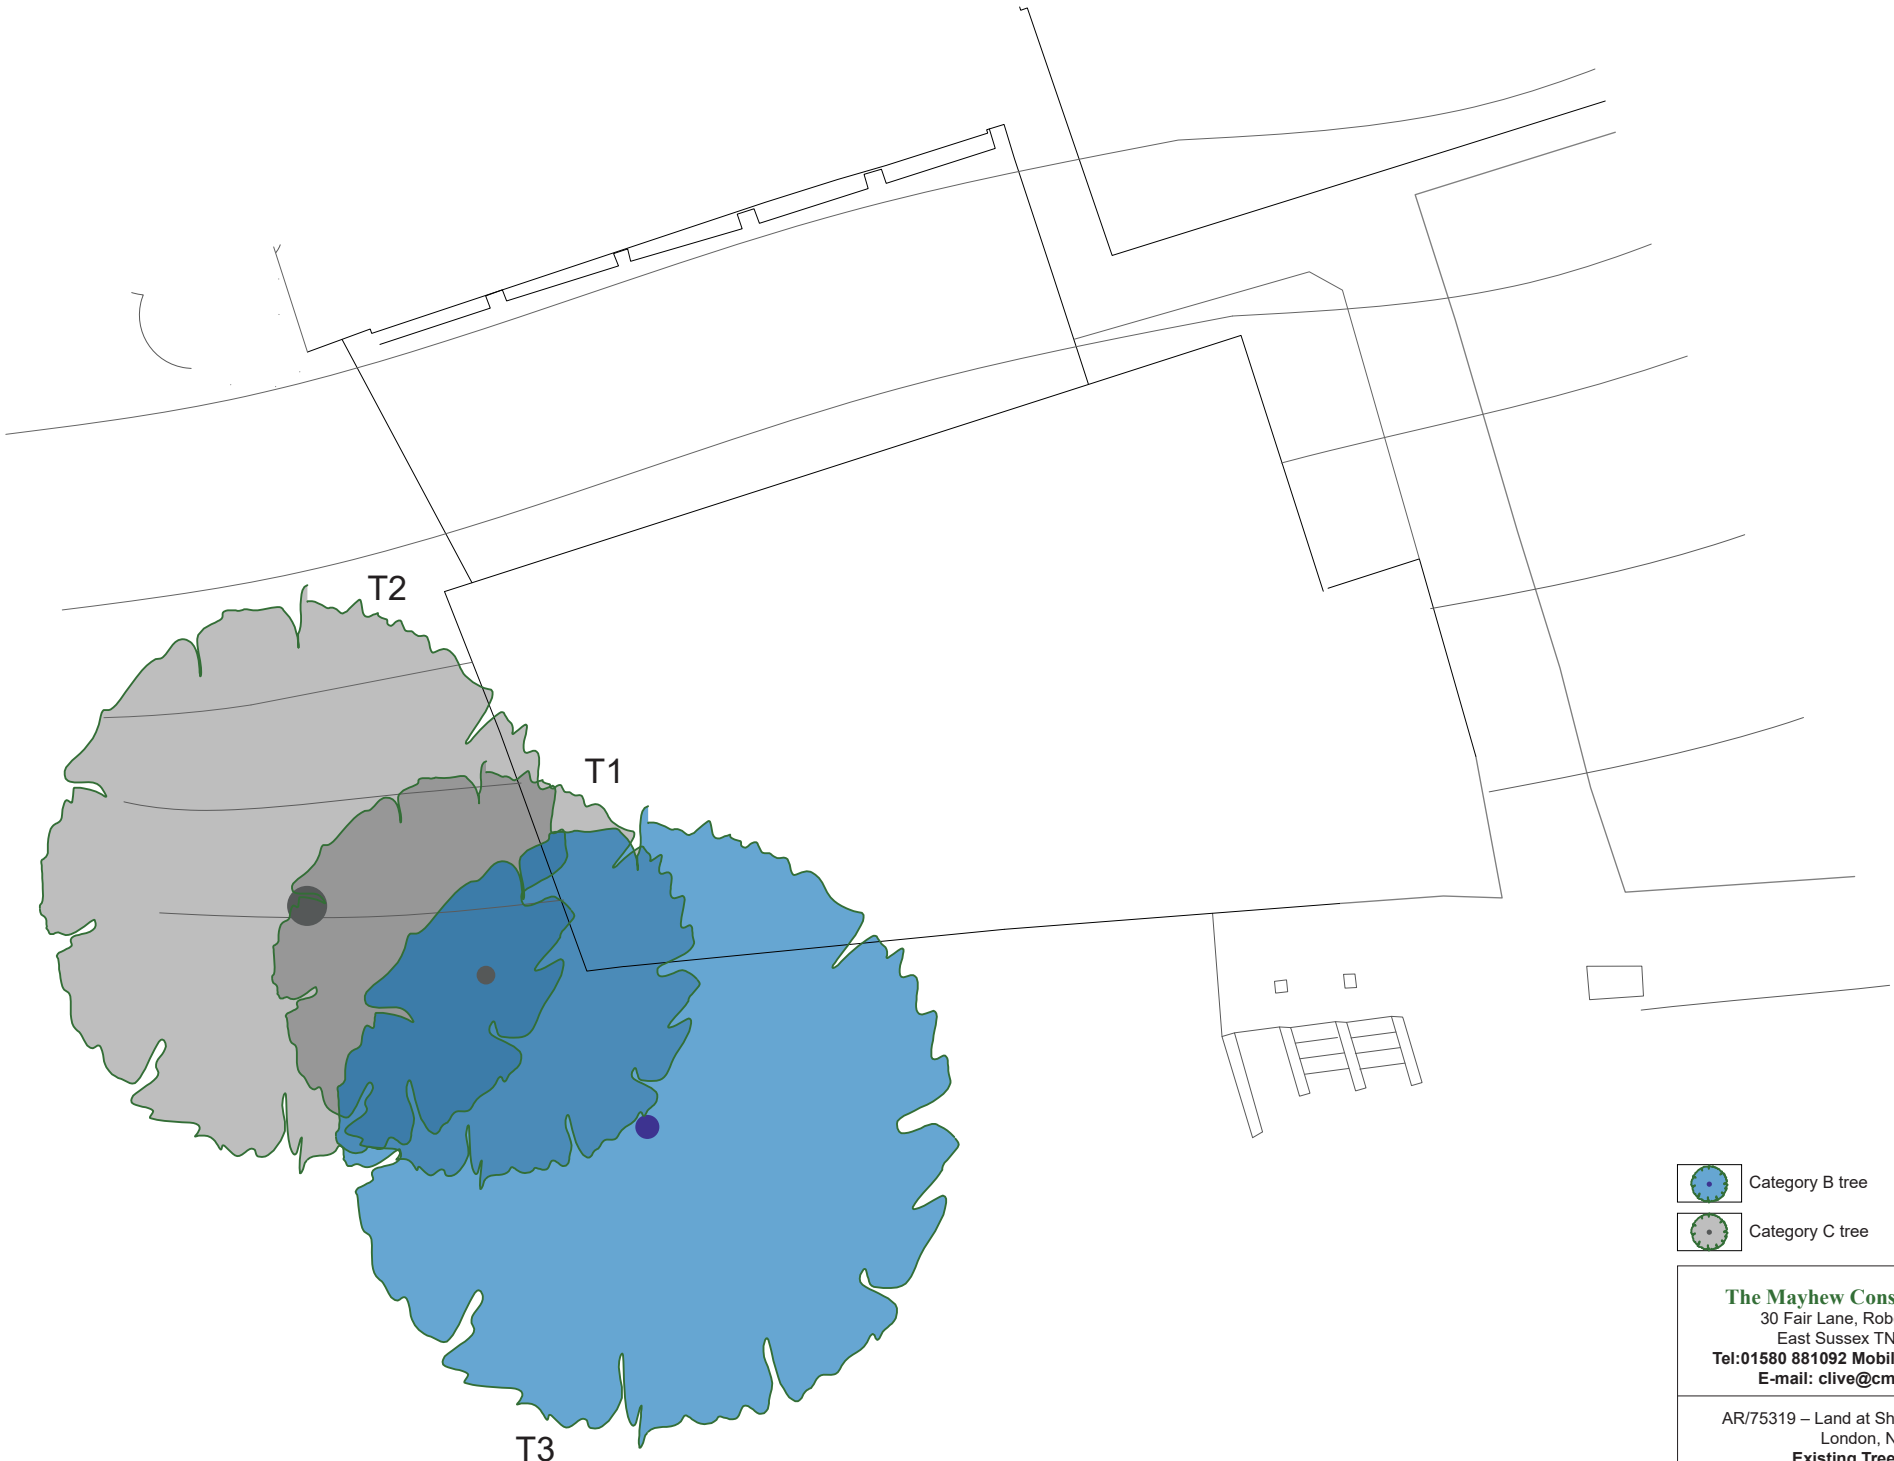
**Existing Tree Plan**

| No | Species | Ht. | Stem dia. | RPA Rad | RPA Area | Crown spread<br>N – S – E - W | | | | CB | Age class | Phy con | Str con | ECR | Class | Observations & recommendations |
|---|---|---|---|---|---|---|---|---|---|---|---|---|---|---|---|---|
| T1 | Sycamore | 14 | 35 | 4.2 | 55 | 4 | 4 | 4 | 4 | 6 | SM | F | F | M | C | Established, but unexceptional sycamore, off-site to the west. Dense ivy to crown. |
| T2 | Ash | 16 | 75 | 9.0 | 255 | 6 | 5 | 5 | 5 | 6 | M | F | F | S | C | Off-site. Triple stemmed @ 1.5m. Evidence of ash dieback in crown in 2019, which continues, and the crown appears to be generally thin. Dense ivy to crown. |
| T3 | Lime | 16 | 45 | 5.4 | 92 | 6 | 6 | 6 | 6 | 8 | M | G | F | M | B | Established off-site tree to south of site. Previously the crown was reduced. |

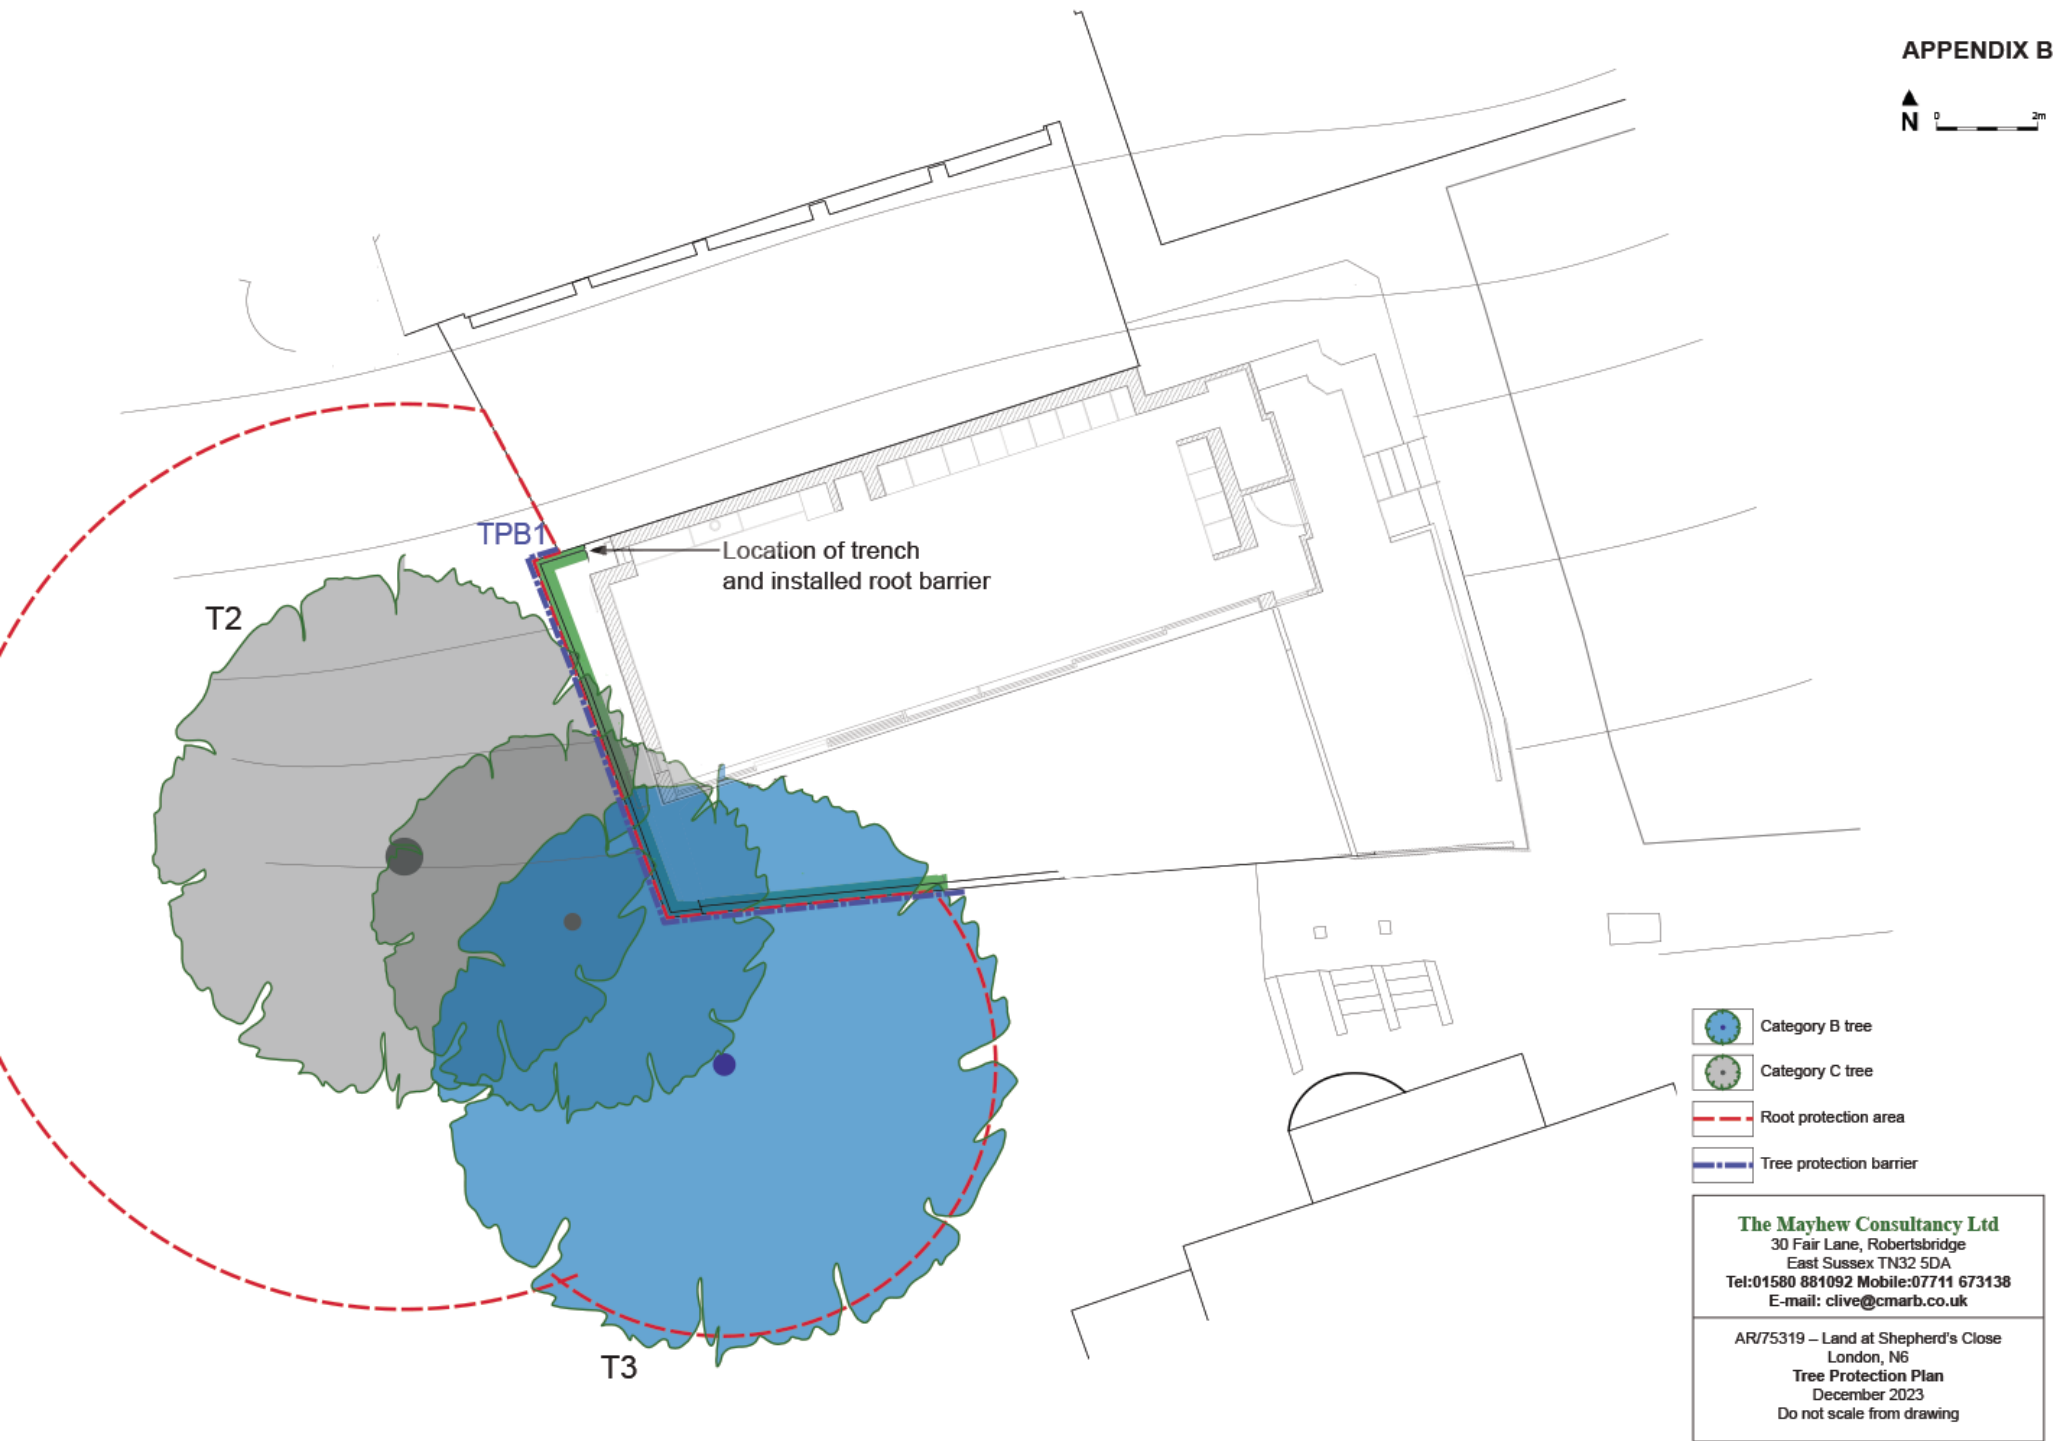
APPENDIX B

- The proposal plan at Appendix B illustrates a degree of encroachment of the nominal RPAs of two trees beneath the dwelling. However:
  - The contiguous soils to the west of these trees appear to be capable of supporting root growth.

- The proportion of encroachment is only a small percentage of the total RPAs – specifically 13% of T2 and 11% of T3.
  - In addition to the above, any roots from third party trees can be considered to be trespassing over the site's boundaries, and as such the owner of the property may be able to exercise their right in common law to remove those encroaching roots should they desire to do so.

11.3.2 **The subject site:** The requirement for one Tree Protection Barrier has been identified and this has been illustrated at Appendix B.

- **TPB 1** - This barrier is located along the site's southwestern and western boundaries. It is designed to protect the RPAs and stems of trees from potential damage during the construction period.

11.4.1 It is intended to install a root barrier along the site's western and southwestern boundaries. The footprint of this barrier has been illustrated in green at Appendix B.

- 1) A trench at least 30cm wide and 1.5m deep will need to be excavated within the footprint illustrated at Appendix B.
- 2) The sides and base of the trench should be lined with a semi-permeable geotextile material.
- 3) The trench should be backfilled with an inert material such as graded beach stone.
