# EXPLODED ORDNANCE DESK TOP RISK ASSESSMENT

PARTRIDGE WAY,  
GOOD GREEN,  
HARINGEY,  
LONDON

# EXPLOSIVE ORDNANCE DESK TOP STUDY

Partridge Way, Wood Green, Haringey, London

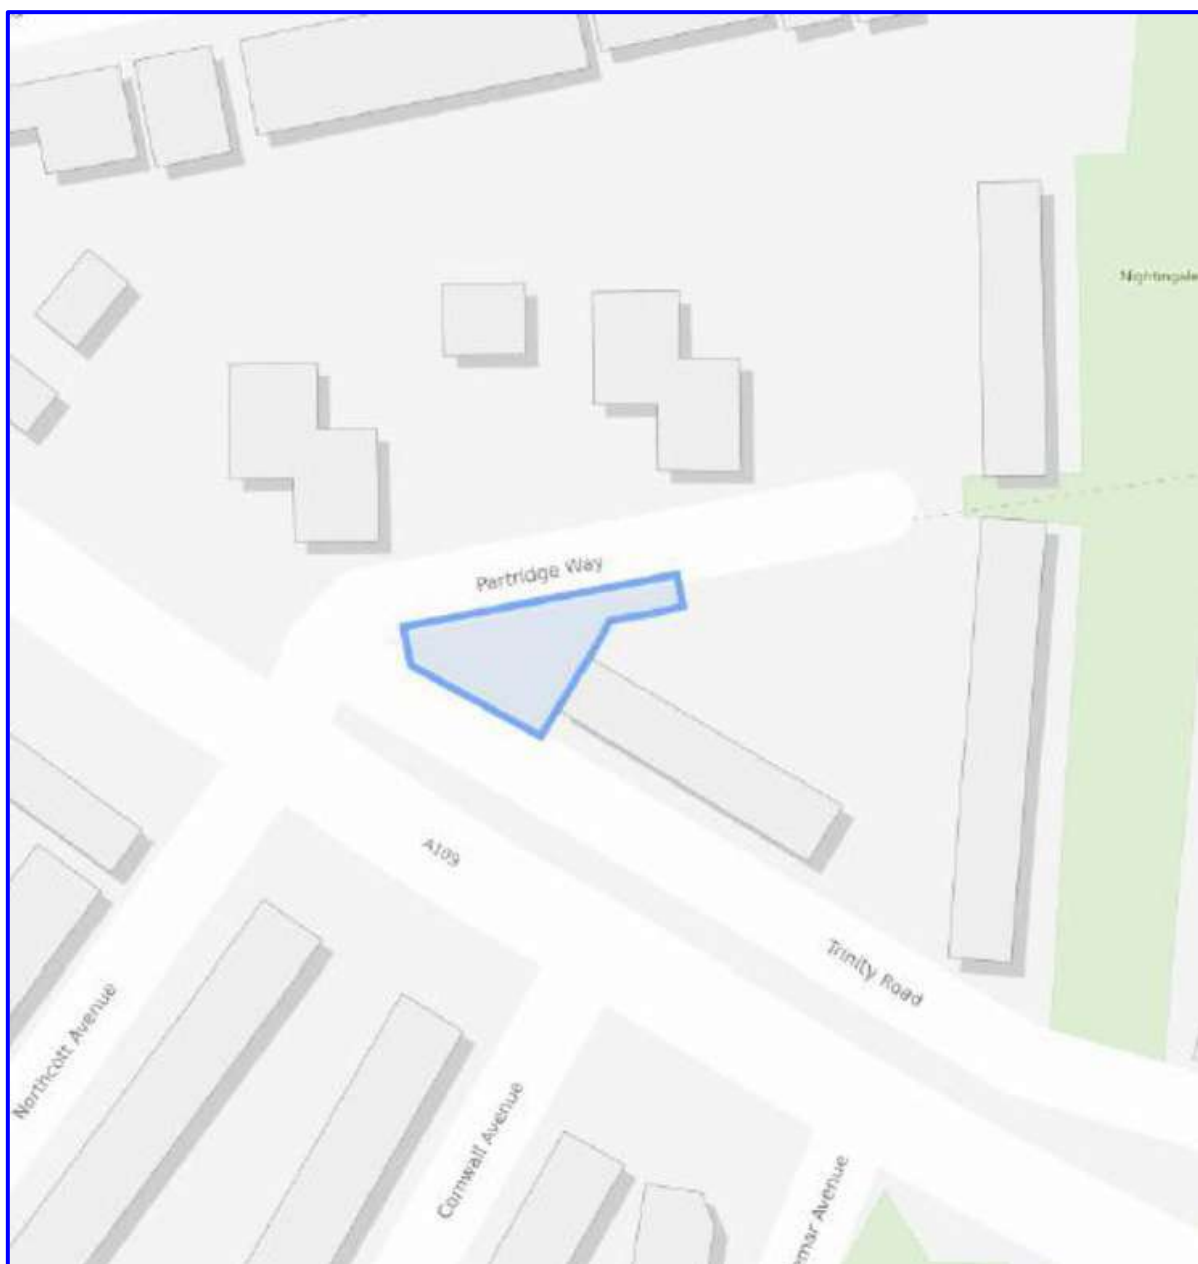
**Figure 1:** Clients Supplied Site Diagram, This DTS will be covering all areas shown within the blue highlighted area.

The scope of this EO Risk Assessment/Desk Study is to assess the likelihood of buried EO/UXO within the environs of The Site (See Figure 1), in view of further development. A further aim was to evaluate the implication from UXO contamination during any future intrusive land use.

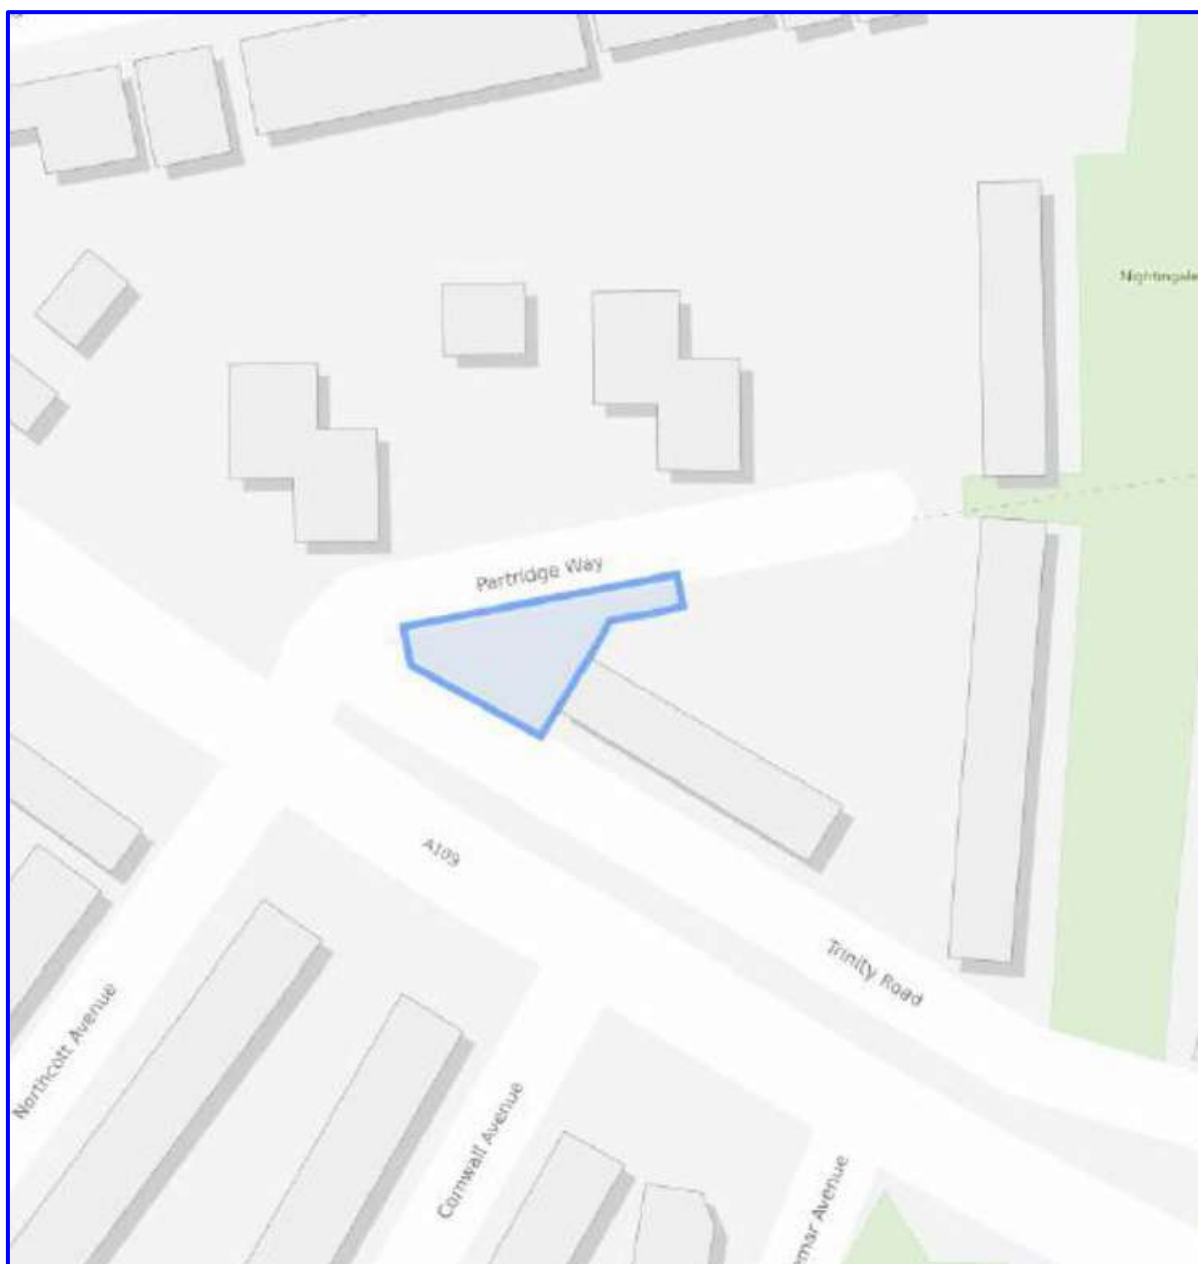
**Figure 1.1:** Clients Supplied Site Diagram, This DTS will be covering all areas shown within the blue highlighted area.

The scope of this EO Risk Assessment/Desk Study is to assess the likelihood of buried EO/UXO within the environs of The Site (See Figure 1.1), in view of further development. A further aim was to evaluate the implication from UXO contamination during any future intrusive land use.

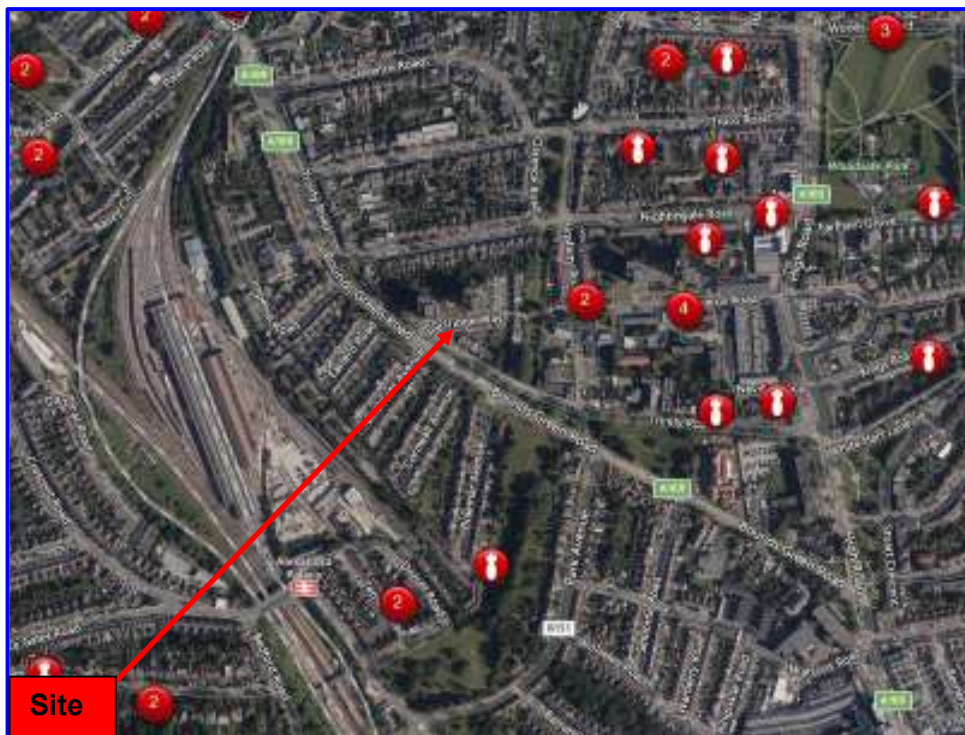
Figure 4.1 Bomb Sight Map

Bomb Sight Figure 4.1 indicates 2 x bombs at 140m from the site.

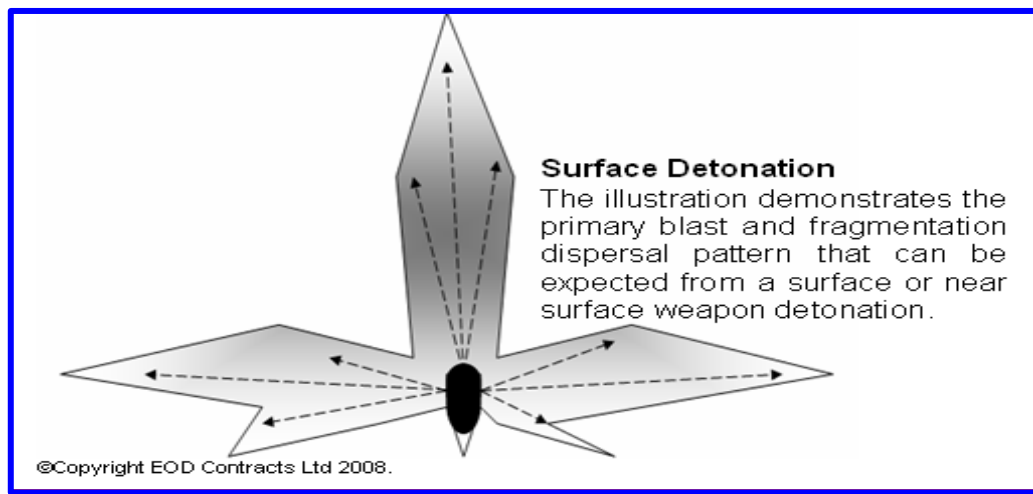
Figure 6.1: Primary Blast & Fragmentation on Land

Blast and fragmentation dispersal.

The threat to any proposed investigation or development on the site may arise from the effects of a partial or full detonation of a bomb or ordnance item. The major effects usually being shock, blast, heat and shrapnel damage. It should be noted that the detonation of a 50kg buried bomb could damage brick/concrete structures up to 16m away and unprotected personnel on the surface up to 70m away from the blast. Larger ordnance is obviously more destructive. Table 1 denotes recommended safe distance for UXO.

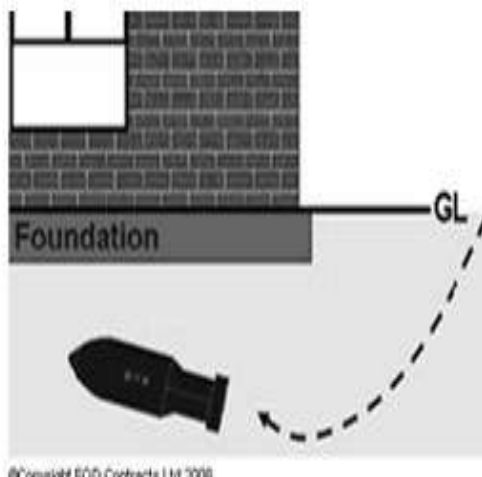
##### Common Sub-Surface Trajectory <sup>6</sup>

*Note; the common sub-surface trajectory will follow a path best described as a 'J' curve. The curve can result in a weapon coming to rest some distance from its impact point. The distance from impact point to resting place is referred to as the "Off set Distance and is normally considered to be 1/3 of the depth. This mechanism can permit a weapon to strike outside a building and travel below ground finally coming to rest within the building footprint. Where a strike is known to have occurred close to a building or structure such as a dock wall, a danger zone should be considered to exist around the area of the strike of sufficient size to accommodate the likely sub-surface travel distance for the weapon.*

Weapons penetrate a significant depth into the ground and other types of ammunition are designed to permit the weapon time to penetrate deeply into the target before detonating a short time after coming to rest or a considerable number of hours afterwards. The second reason is where the weapon has failed to function as designed becoming a UXB. A number of studies have been carried out into weapon penetration and it is an inevitable consequence of a number of variable factors acting on the bombs trajectory that figures can and do differ significantly. Careful consideration must be given to the weapon's velocity, trajectory and shape. Also surface conditions and subsurface geology. The largest of the common German bombs, (500kg) can

penetrate to significant depths given favourable conditions for penetration. In the case of projectiles and shells, the potential for deep penetration is significantly less.

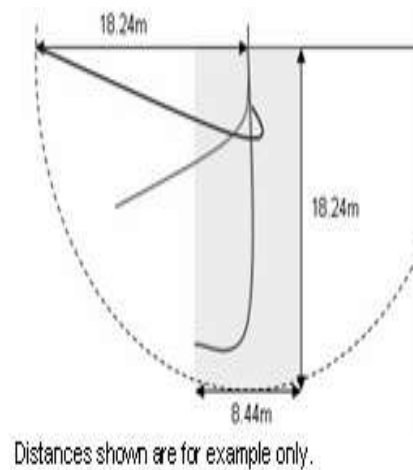
##### Anomalous Sub-Surface Trajectory <sup>7</sup>

*Note; the typical offset distance is shown as the shaded area, on rare occasions a near surface deflection of the weapon can occur and the offset distance can be substantially increased up to 5/4 of the penetration depth. This mechanism does however reduce the penetration depth considerably with the net result that while the offset is increased the overall travel distance is for the most part unaffected.*

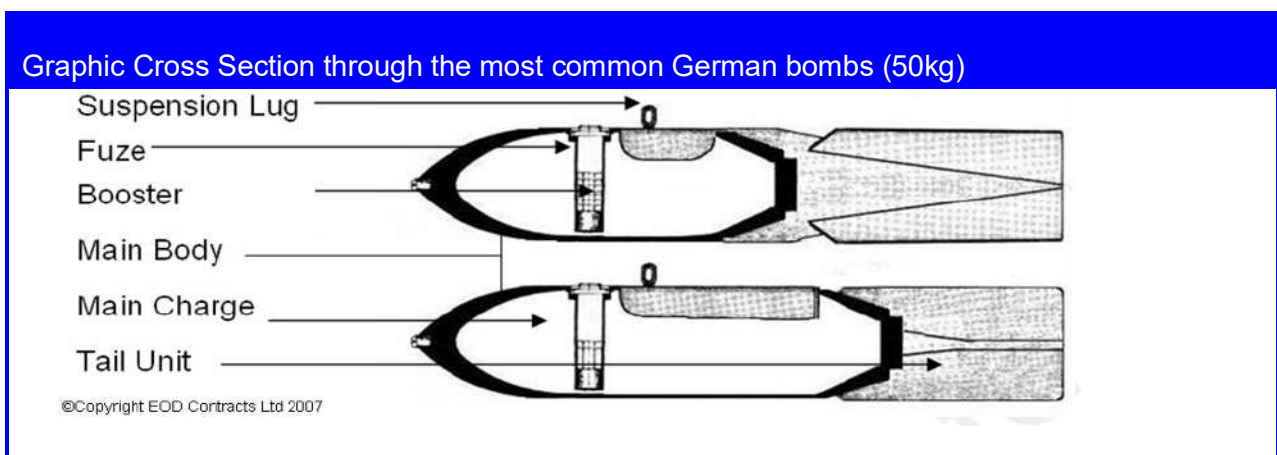
Figure 2: Generic German Bomb Design.

*Note; the diagram shows that there can be a significant difference in the quantity of High Explosive contained within bombs of similar size and shape; the Grade 1 bomb on the bottom having 30% more HE than the Grade 2 shown at the top. This serves to demonstrate the importance of an accurate identification of any item of UXO.*

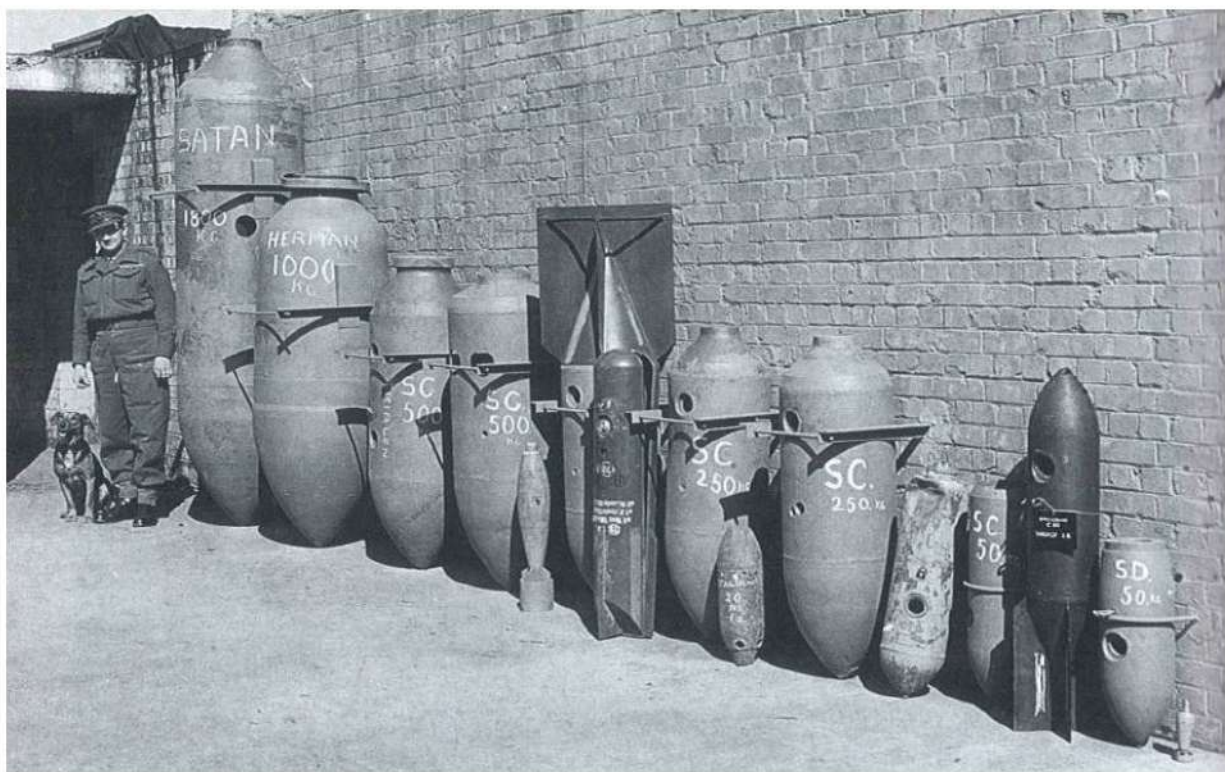
Figure 4: Range of HE bombs dropped on the United Kingdom.

*NOTE: The smaller sub-munitions (Bomblets) seen to the right, ranged in size between 1 and 3kg, were dropped in large numbers and were intended as incendiary bombs, anti-personnel bombs or as bombs filling both roles. The smaller bomblets were dropped in larger container bombs designed to hold between 360 and 620 of the bomblets. The containers were designed to burst open at a predetermined height above ground level, dispersing the bomblets over a wide area. Air raid damage was far greater by using both incendiary, and HE bombs on a single raid. The fires started by the incendiaries being rapidly spread by the blast waves from the HE bomb. This scenario was shown to devastating effect on the 14<sup>th</sup> February 1945 in the German city of Dresden. Where fires started and spread by the bombing increased to a point where the oxygen was being sucked into the flames at such a high speed that the fire became a "Fire Storm". At the time the city's population had increased due to a high number of refugees fleeing the Russian advance to the east, the exact civilian death toll from fire and suffocation will never be known, but is considered to be somewhere between 25,000 and 100,000.*

**High Explosive (HE) Bomb.** Some of the most common type of ordnance to be dropped on the United Kingdom, HE bombs are often the type encountered as UXBs. Relatively thick cased, they are still recovered in remarkably good condition. Ranging in size from 50 to 1700 kg, their typical release height (1,500m) allowed them to penetrate deep into the ground as a result of design or flaw. Towards the end of the bombing campaign, as steel became scarce the German Engineers produced a range of bombs that used steel reinforced concrete as the bomb body. Figure 4 shows the range of steel HE bombs dropped on the UK.

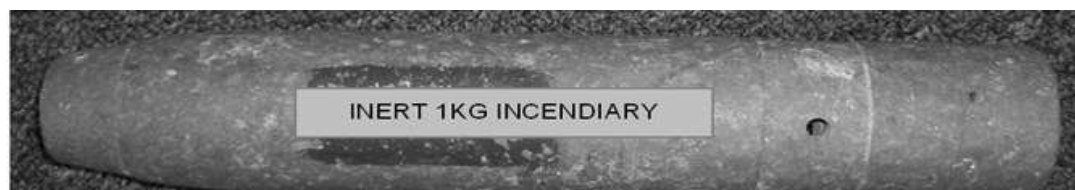
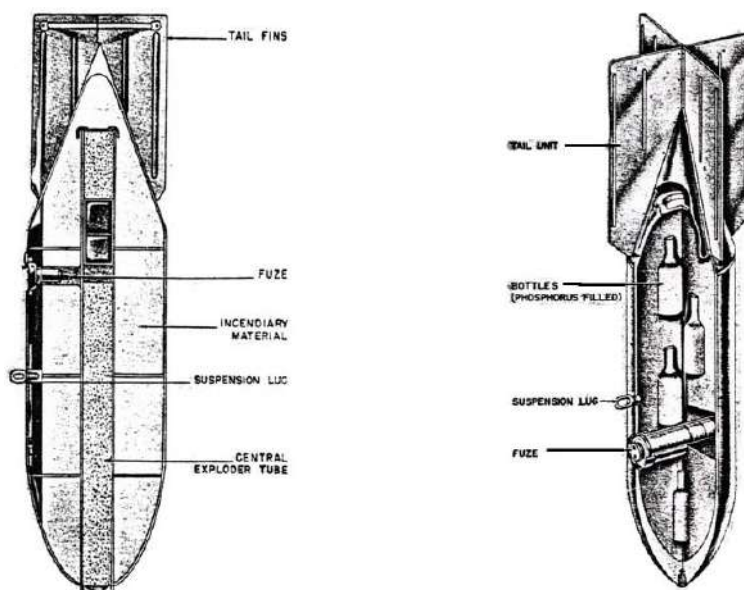
#### Common German Incendiary Bombs

Above 1kg incendiary bomblet, below left the larger 500kg incendiary bomb Below right a 50kg incendiary bomb containing bottles of white phosphorus.

*Note; Incendiary bomblets were made of a flammable alloy similar in appearance to aluminium, which resists corrosion well. The tail unit was made of thin tin-plate steel and is more prone to have rusted away. Some Incendiary models were fitted with a High Explosive (HE) steel nose. With the tail and explosive nose attached the bomb was 480mm long.*

**Incendiary Bomb.** The larger incendiary bombs, containing bottles of white phosphorus and an incendiary mixture contained within a thin steel case were designed to burst on contact with the ground. A fixed dispenser on the aircraft delivered the smaller type of bomb or 'Bomblet' to the target area in container bombs or; both types of container would open dispersing the smaller Incendiary bombs. Relatively small and light they were unlikely to penetrate the ground to any significant depth. However, once concealed in bomb damage rubble or below water they were easily missed and are still unearthed today from in-fill and drained land. Later versions of the incendiary bomb contained an additional explosive charge used as a short delay "Booby Trap" device that contained a significant amount of high explosive. The Booby Trap component was designed to kill or injure fire fighters and hinder the damage control. See Figure 5.

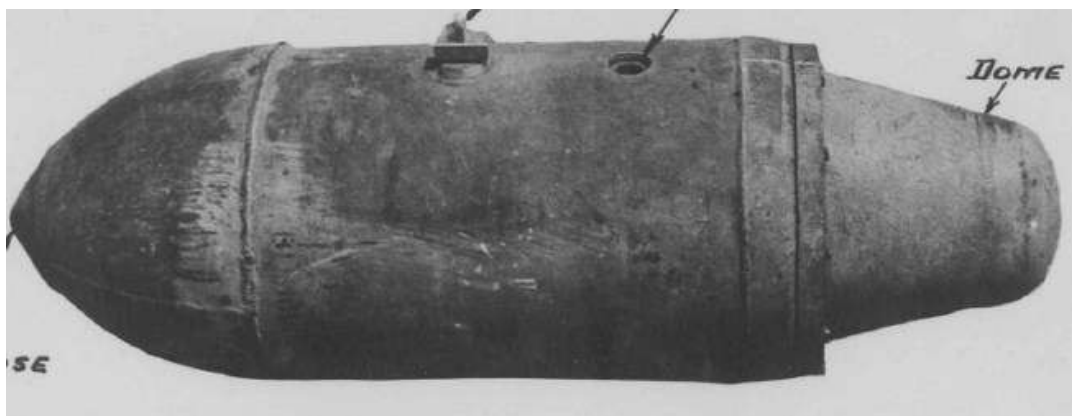
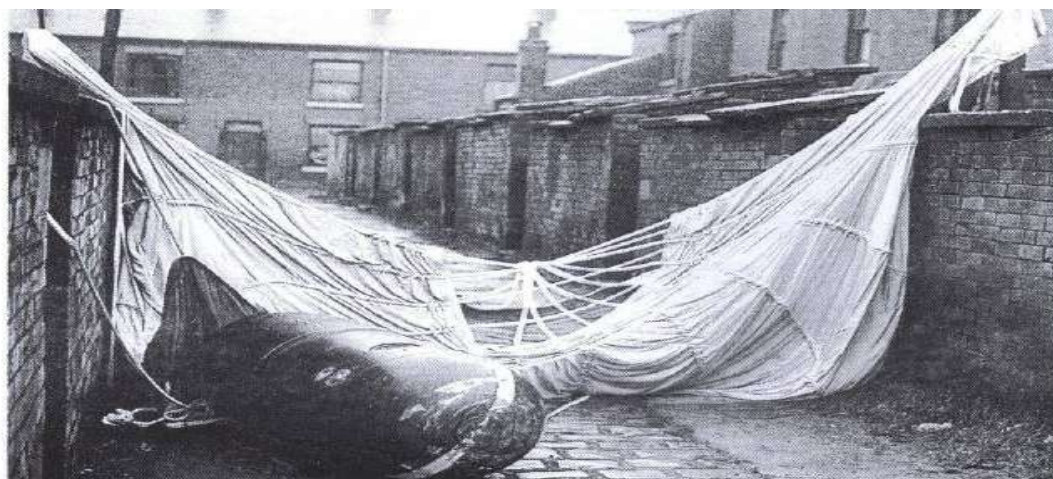
#### Parachute & Ground Mines

*Note; all mine fuzes were designed to arm after deployment from the ship, submarine or aircraft, some fuze designs incorporated anti-removal booby traps. Unexploded mines found today are the result of a failure within the arming mechanism or procedure whereby the mine never fully armed. Sudden shock or jarring of a weapon in this state has the potential to complete the arming sequence and could result in the mine detonating with lethal consequences.*

**Blast Bomb / Parachute Mine.** The parachute mine was extensively used on land and at sea and was fitted with specialist fuzes designed to trigger the weapon at a predetermined altitude, water depth or to switch on other magnetic influence mechanisms to trigger the weapon when a ship approached (Magnetic or Acoustic influence). While early versions were based on the standard 1000kg SD Bomb case others were specially designed and manufactured with an aluminium body, making them extremely difficult to detect using magnetometers. The thin cased versions would normally disintegrate on impact on land and are normally considered to pose little threat to work on land based projects, but the risk increases significantly on projects over water or in marshland. Thicker cased versions however will survive impact and pose a significant risk regardless of the local ground conditions. (See Figure 6)

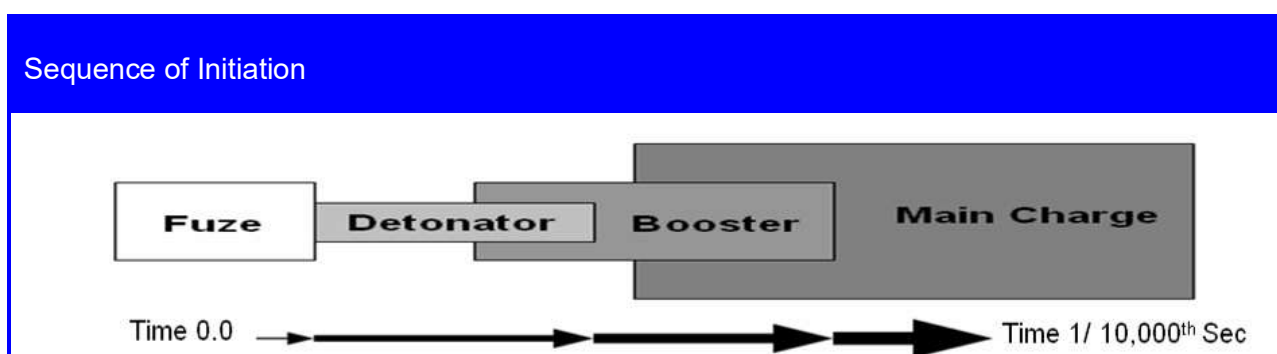
Figure 9: Explosive Ordnance Initiation Train.

**Initiation Train.** This is a means by which, once the safety features have been switched off or removed, a chain reaction occurs through the weapon. Starting within the fusing system as a small ignition or spark, causing a detonator to explode, which in turn causes the booster charge to detonate with a greater energy and ending in the full detonation of the main explosive filling. Each part of the process has in-built safety features to prevent an unintended detonation. A failure in any of the components within the Initiation Train can result in a UXO. In the case of a UXB; the chain reaction has broken down and the Initiation Train is brought to a halt, albeit, a temporary one. There are a number of ways that sufficient energy could be introduced to the otherwise stable UXB / UXO that may allow the Initiation Train to set off once more, overcoming the initial reason for failure. In addition to subjecting the weapon to excessive heat, such as a fire, the most common methods to bring about an explosive detonation in such items are considered to be:

**Initiation of Unexploded Ordnance.** Explosive Ordnance is highly unlikely to spontaneously explode. The energetic chemical compounds, (Explosives) used in weapon manufacture are chosen to be as stable as possible and they all require a significant application of additional energy to create the right conditions for detonation to occur. If stored correctly, most explosive materials are designed to remain stable for the duration of their expected lifespan (typically 20 years). During this time, the correct functioning of the weapon is achieved by means of the 'Initiation Train' (See Figure 9).
