# Bat Assessment Report

## 44 - 46 Hampstead Lane, London

10032 - 44 - 46 Hampstead Road - Bat Assessment Report - 2210-12snc rw

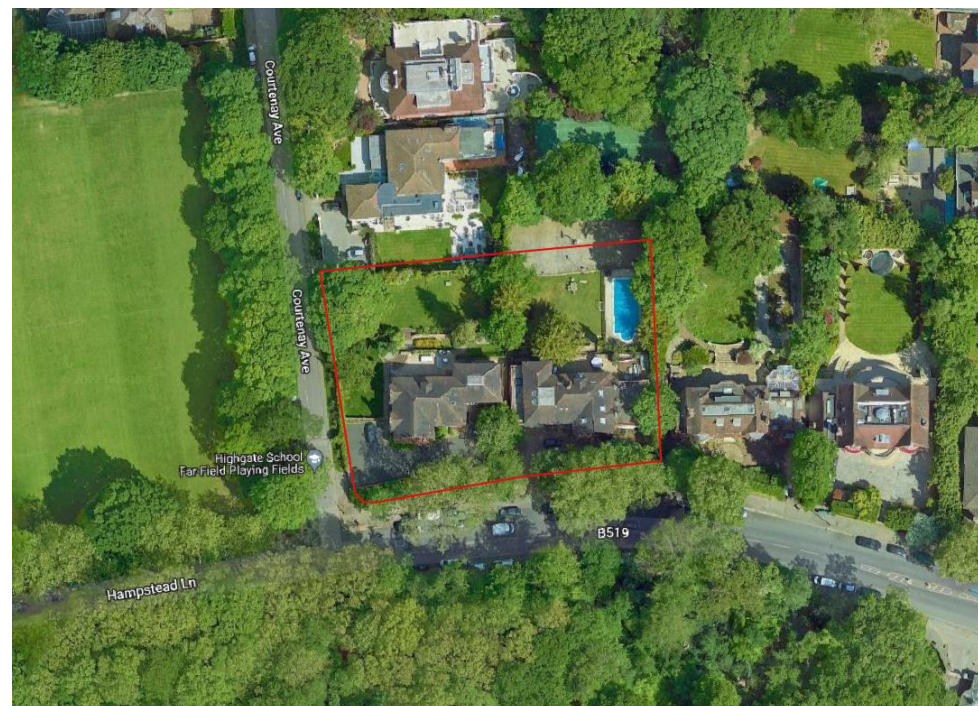
Figure 1: Site boundary (Basemap: Google Satellite, 2022)

The site currently comprises two detached residential dwellings with associated residential gardens, patios, hardstanding (driveways), tennis courts and a swimming pool. Figure 1 to the right of this page illustrates the location of each building. The site is bounded by Hampstead Lane to the south, across which is Hampstead Heath and Kenwood House and gardens, Courtney Avenue to the west and further residential dwellings with associated gardens to the north and east.

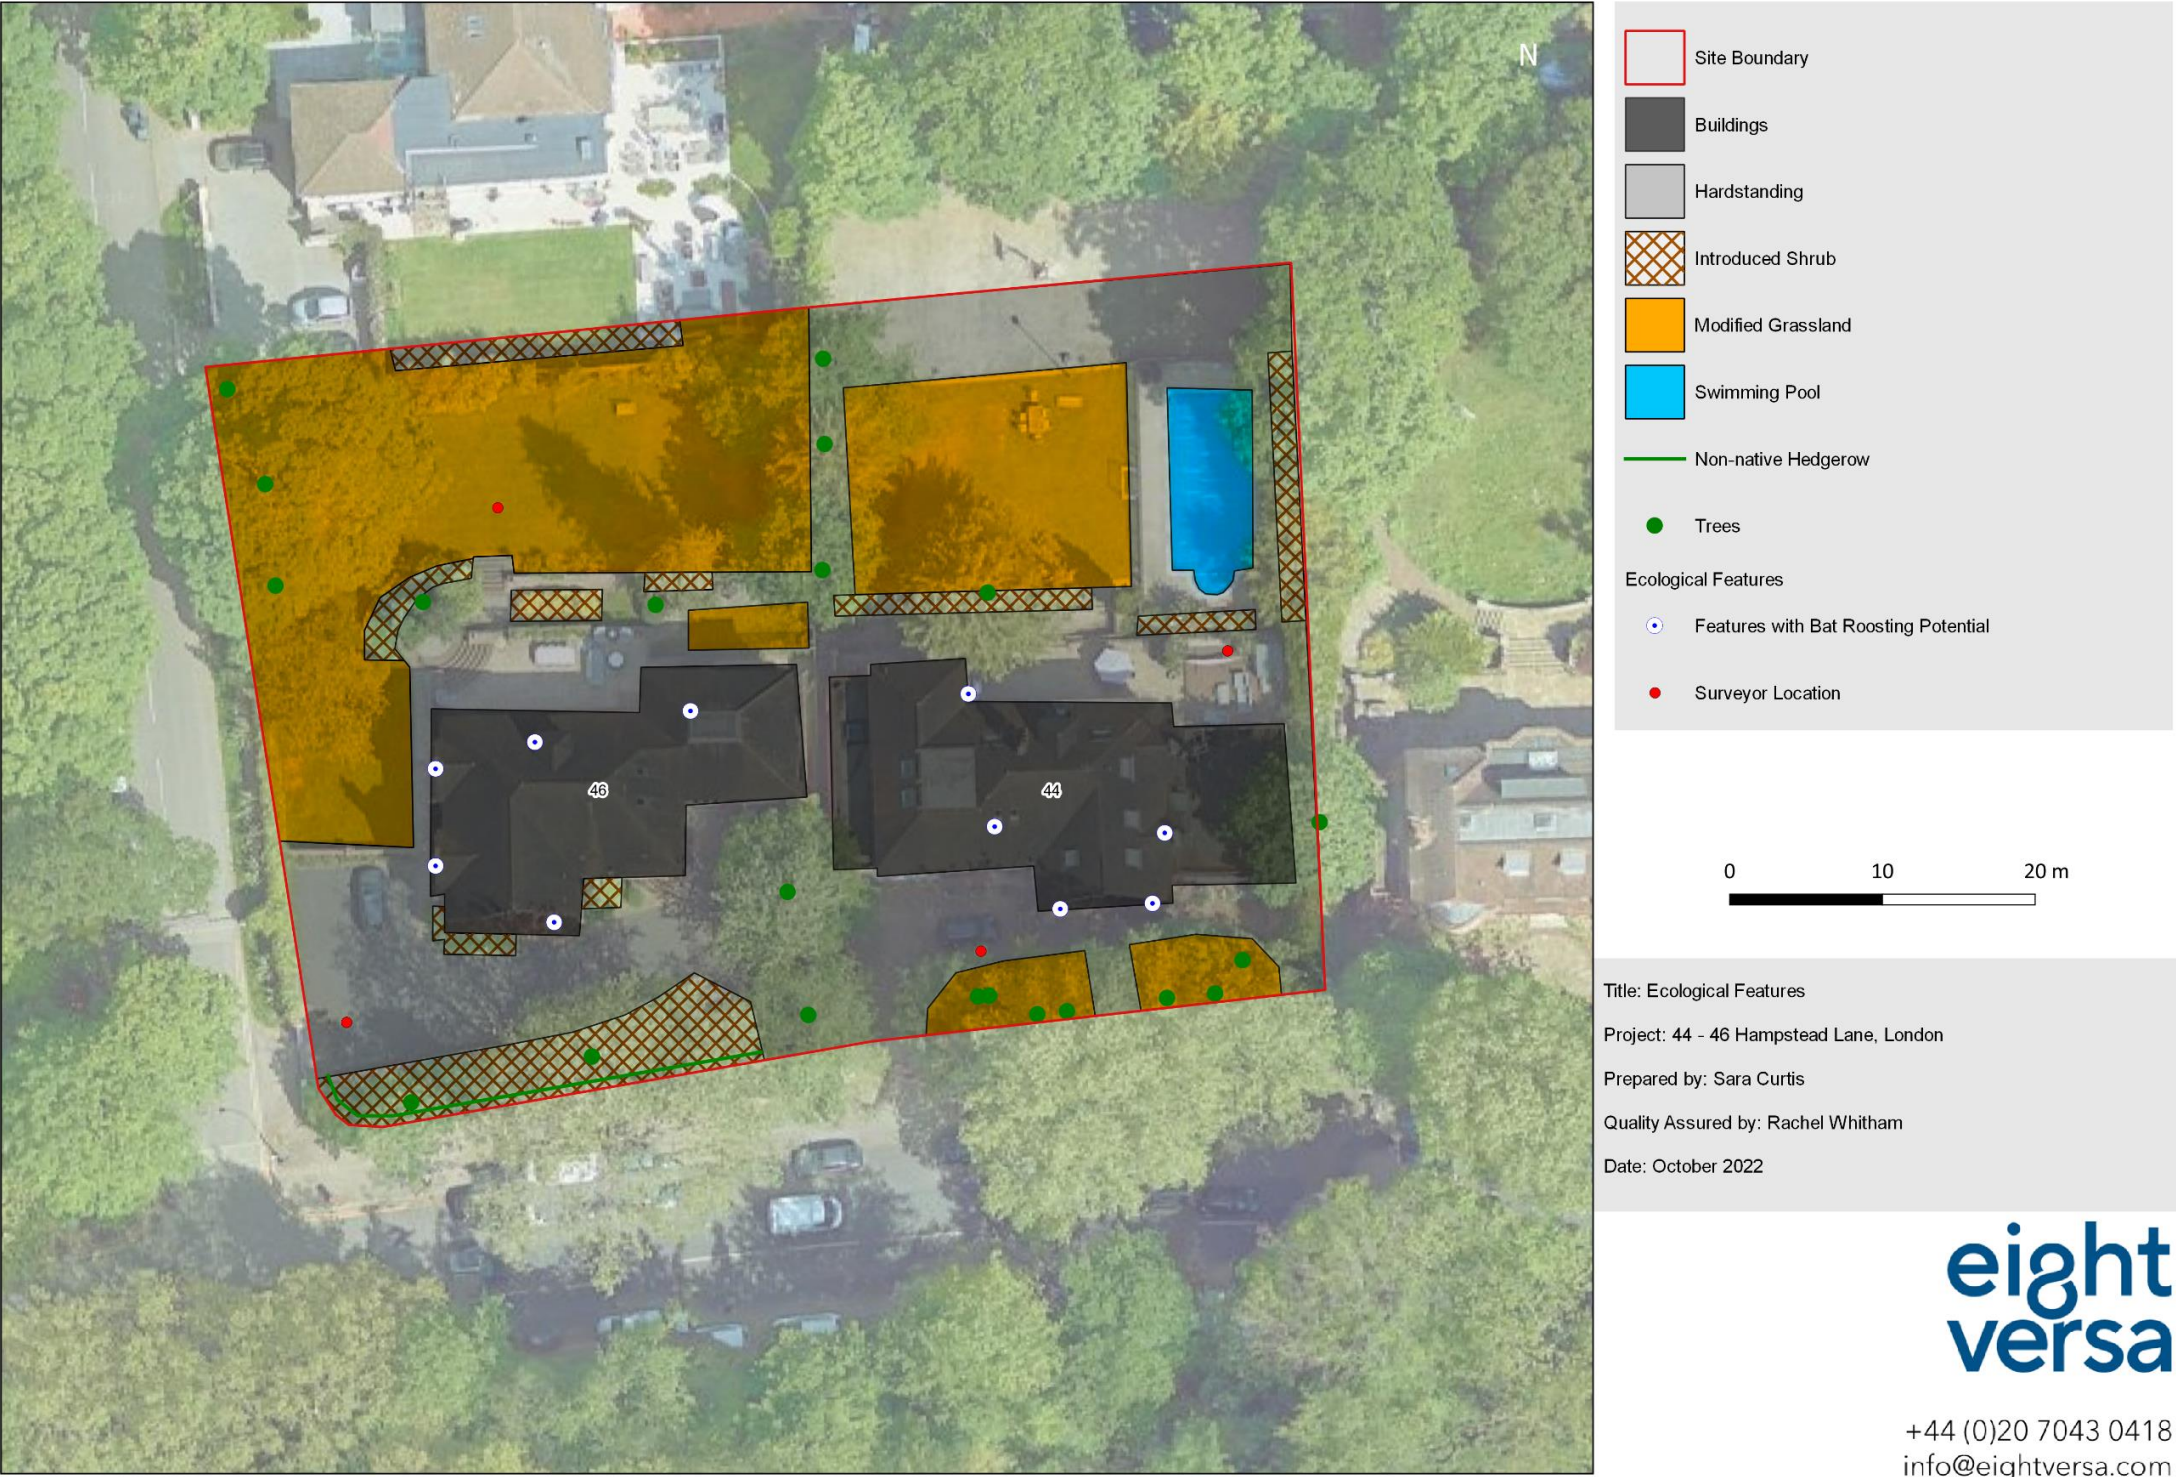
Appendix A - Map of Ecological Features and Surveyor Positions

During the survey, four surveyors and three infra-red cameras were used to inform the survey. Surveyors used a combination of visual observation and echolocation detection to identify any bats emerging from both 44 and 46 Hampstead Lane buildings. Surveyors were equipped with Echo Meter 2 Pro bat detectors and echolocation calls were analysed post survey in Kaleidoscope, a software used to analyse sonogram calls. Panasonic infra-red cameras with infrared illuminators were used to aid the survey effort where required.

No bats were observed emerging from either 44 or 46 Hampstead Lane during the survey. General bat activity was limited to individual passes along the boundaries of the site by common pipistrelle *Pipistrellus pipistrellus*, soprano pipistrelle *P. pygmaeus* and noctule *Nyctalus noctule*. Although the emergence survey was undertaken in September, a month considered to be sub-optimal for emergence surveys, none of the bat activity recorded during the survey was close to the onsite building and, together with the presence of security lighting and similar buildings with bat roosting potential in the vicinity of the site, including Kenwood House, it is considered that if a roost is present onsite, it would be by an opportunistic individual bat.
