## MAYES ROAD, WOOD GREEN

### Site Investigation & Contamination Assessment

Report Ref: BEK-22083-1

July 2022

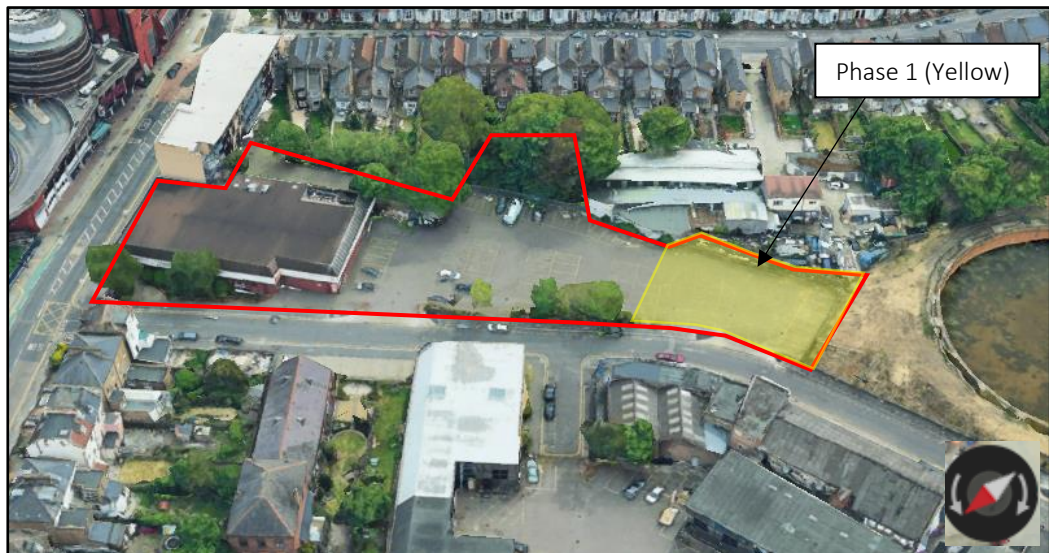
**Figure 1:** Aerial Image for the Site (full site boundary in red)

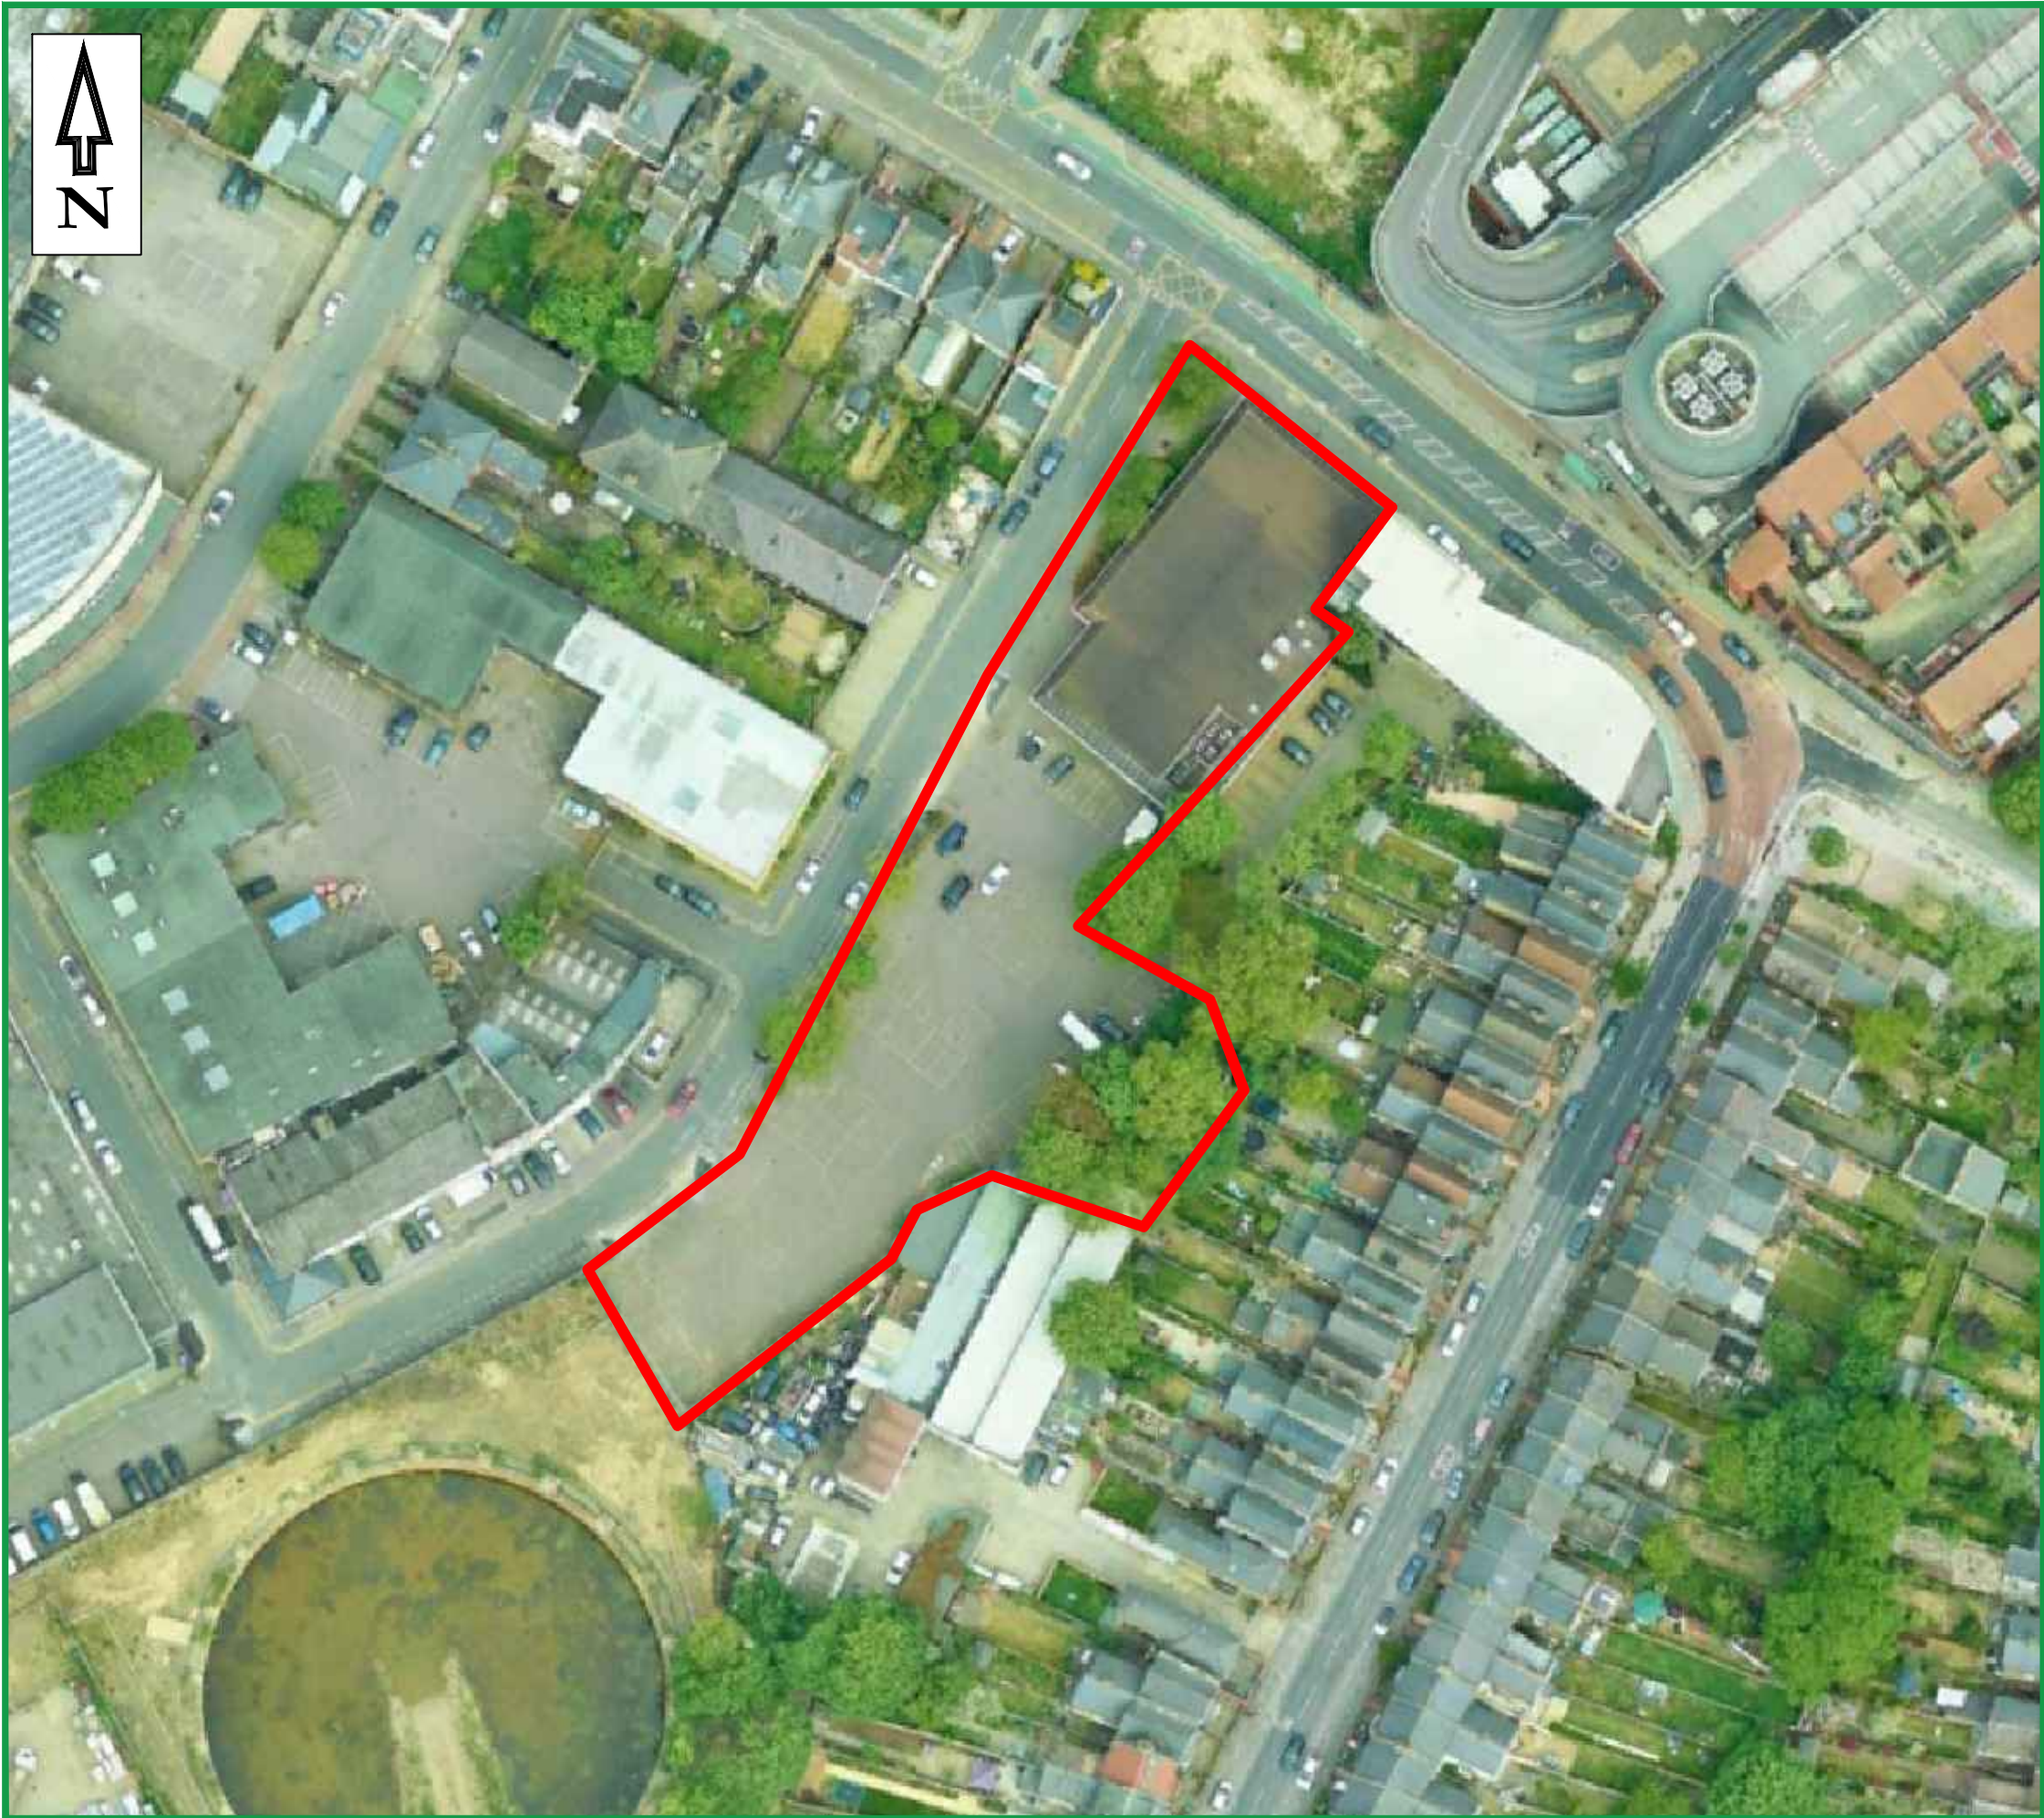
| DRAWING No.<br>22083-2 | | | REV.<br>- |

- 1.1.4 The site location layout for the whole site are presented on BEK Drawing No 22083-1 and BEK Drawing No 22083-2, respectively. Copies of these drawings are presented in Appendix E.
- ### **1.2 Proposed Development**
- 1.2.1 For the whole site it is proposed to redevelop the site into a 6 to 9 storey development which will have commercial units at the ground floor and residential apartments above with associated vehicle access/parking.
- 1.2.2 Phase 1 of the development (this report) is located in the east of the site and is shown as the yellow shaded area in Figure 1. The proposals for Phase 1 is for a two-storey medical centre, with no landscaped areas.

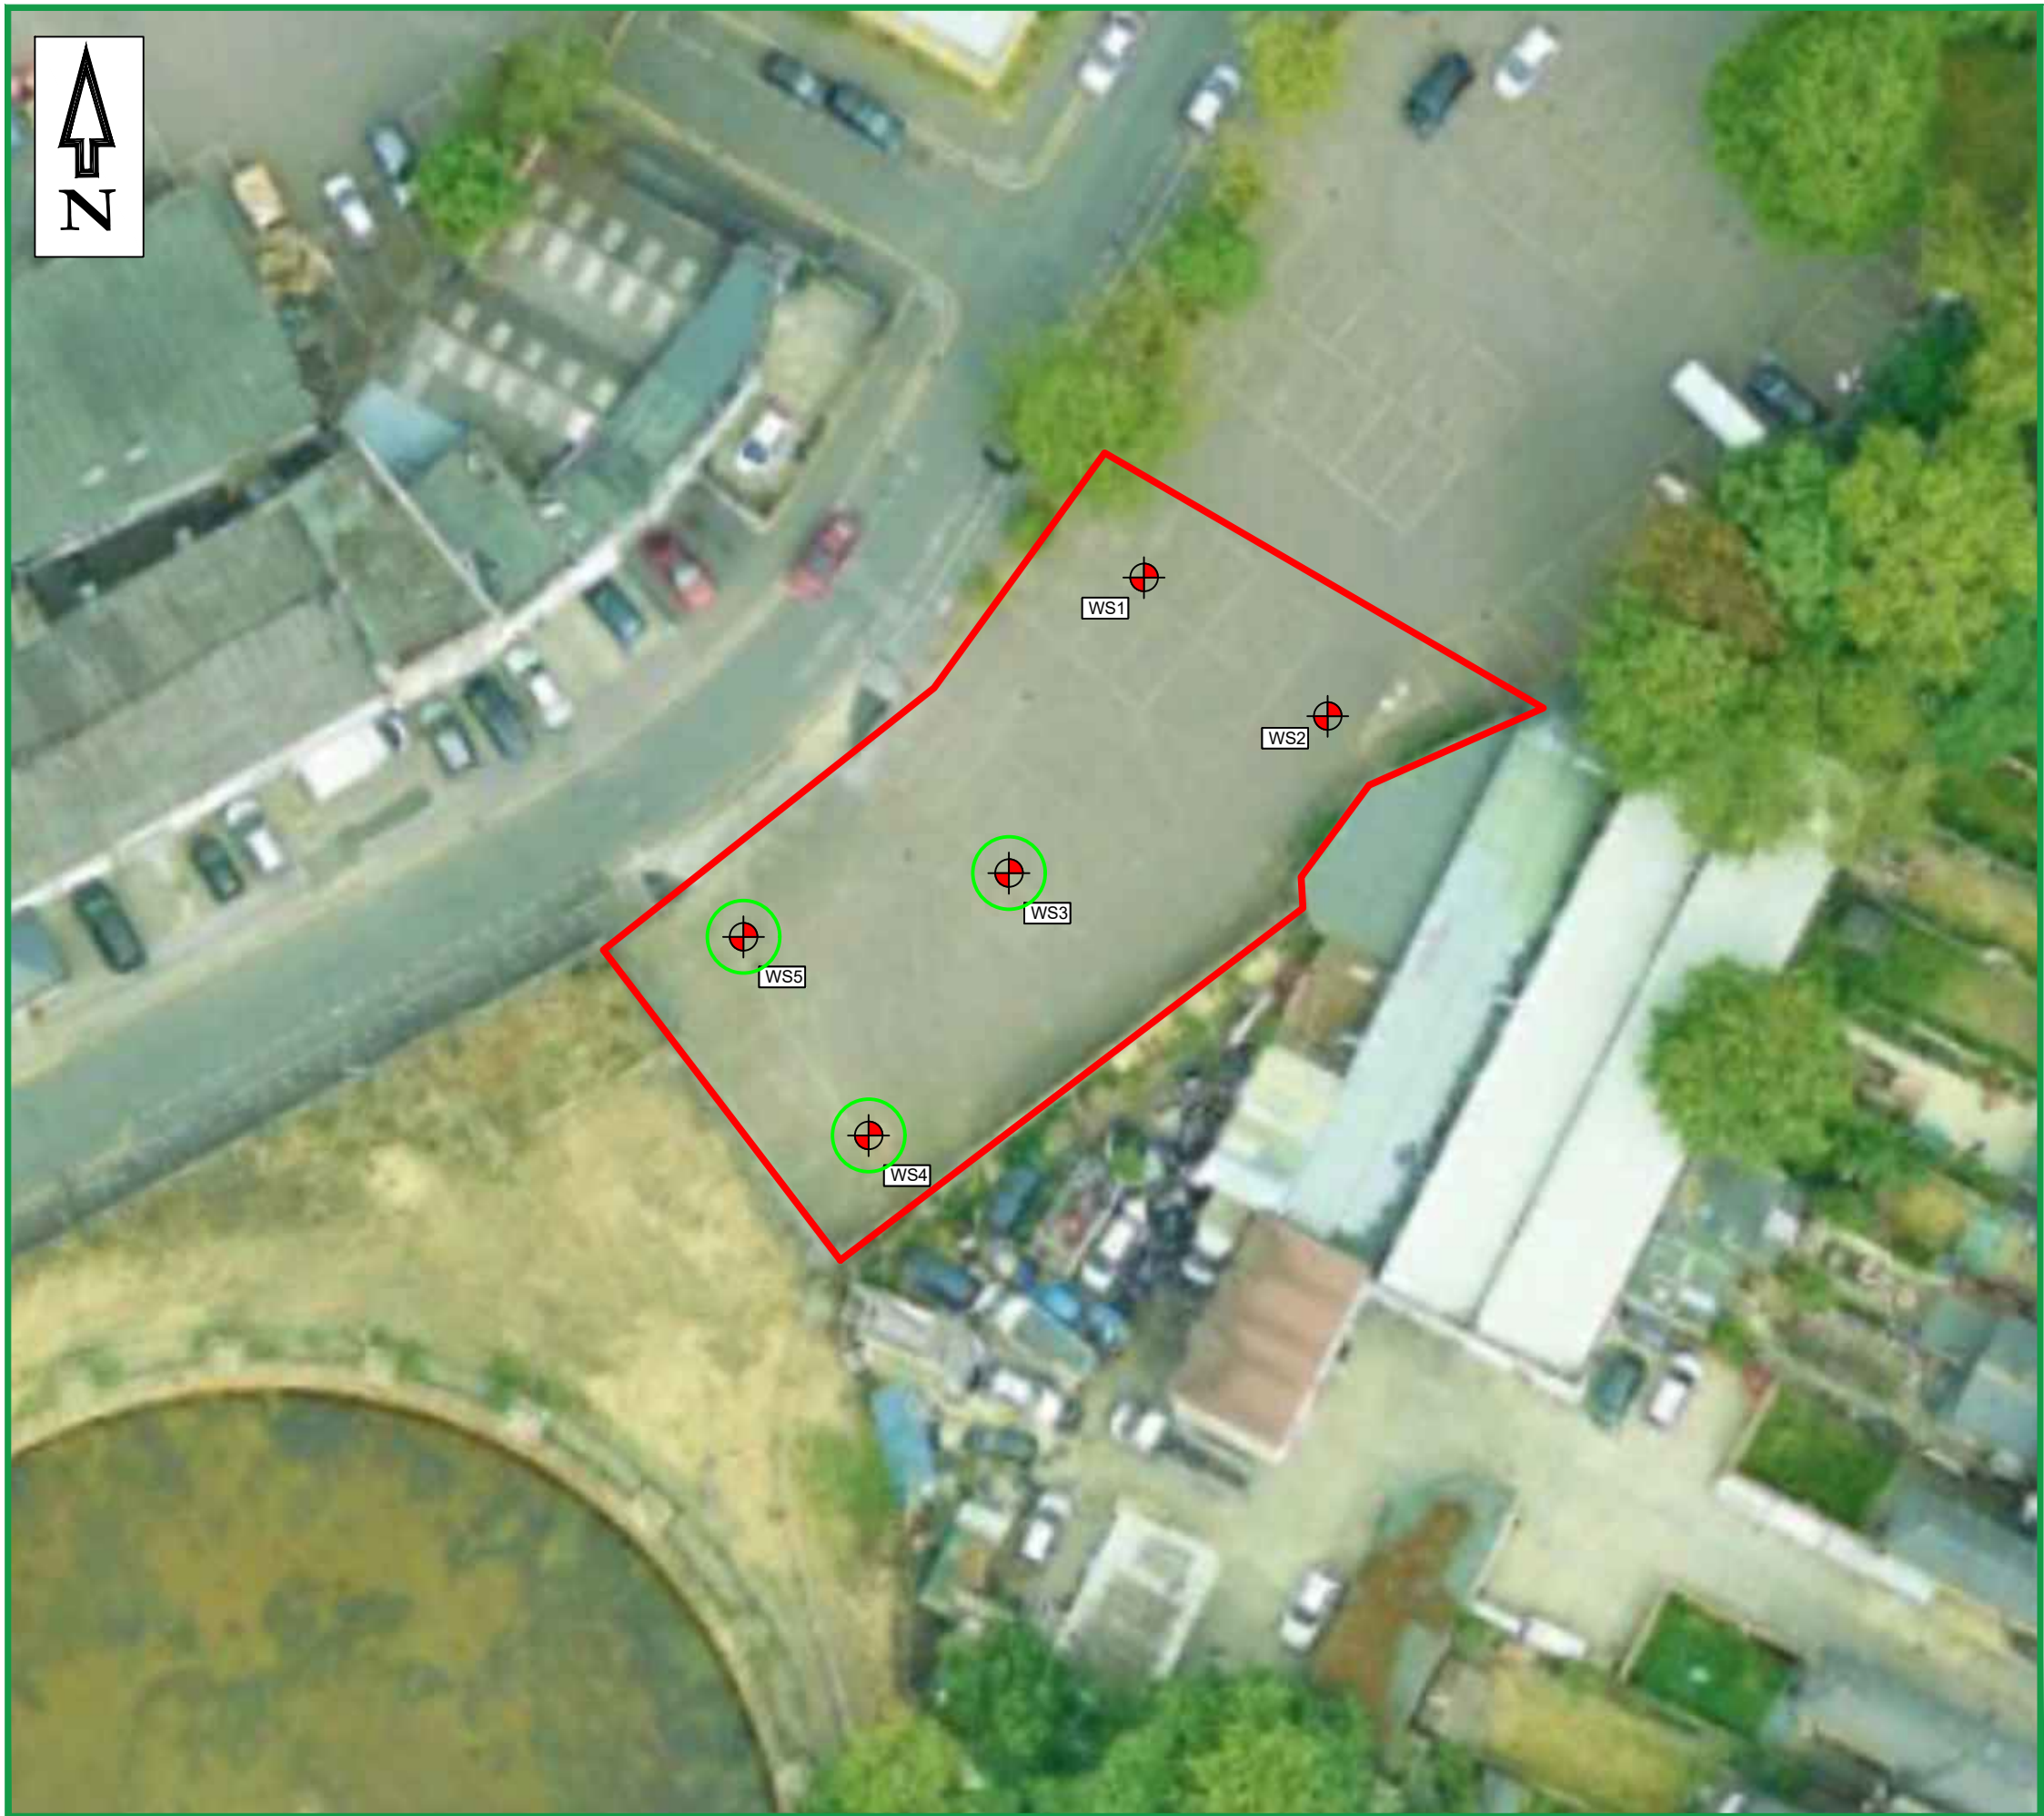
| DRAWING No.<br>22083-3 | REV.<br>- | | |

- 3.1.1 This section provides a summary of the site investigation works undertaken by BEK during June 2022.
- 3.1.2 The site investigation has been designed to provide indicative information for the ground conditions across the site and to provide a quantitative assessment of potential risks associated with contamination and ground gas.
- 3.1.3 All exploration locations were set out by the site engineer and the exploratory locations are illustrated on BEK Drawing No 22083-3 presented in Appendix E.

- 3.2.1 Five window sample boreholes were drilled using a window sample borehole rig to a maximum depth of 4.45 m. Borehole locations were set out by the site engineer in order to establish representative conditions at the site. In-situ testing (SPTs) were carried out in each of the boreholes.
- 3.2.2 Representative samples were recovered for chemical and geotechnical testing in accordance with the requirements set out in the Desk Study.
- 3.2.3 Gas and groundwater monitoring probes were installed in 3 window sample boreholes (Borehole WS1, WS2 and WS3).
- 3.2.4 The ground conditions were recorded by an engineer from BEK and copies of the Borehole records are presented in Appendix A.

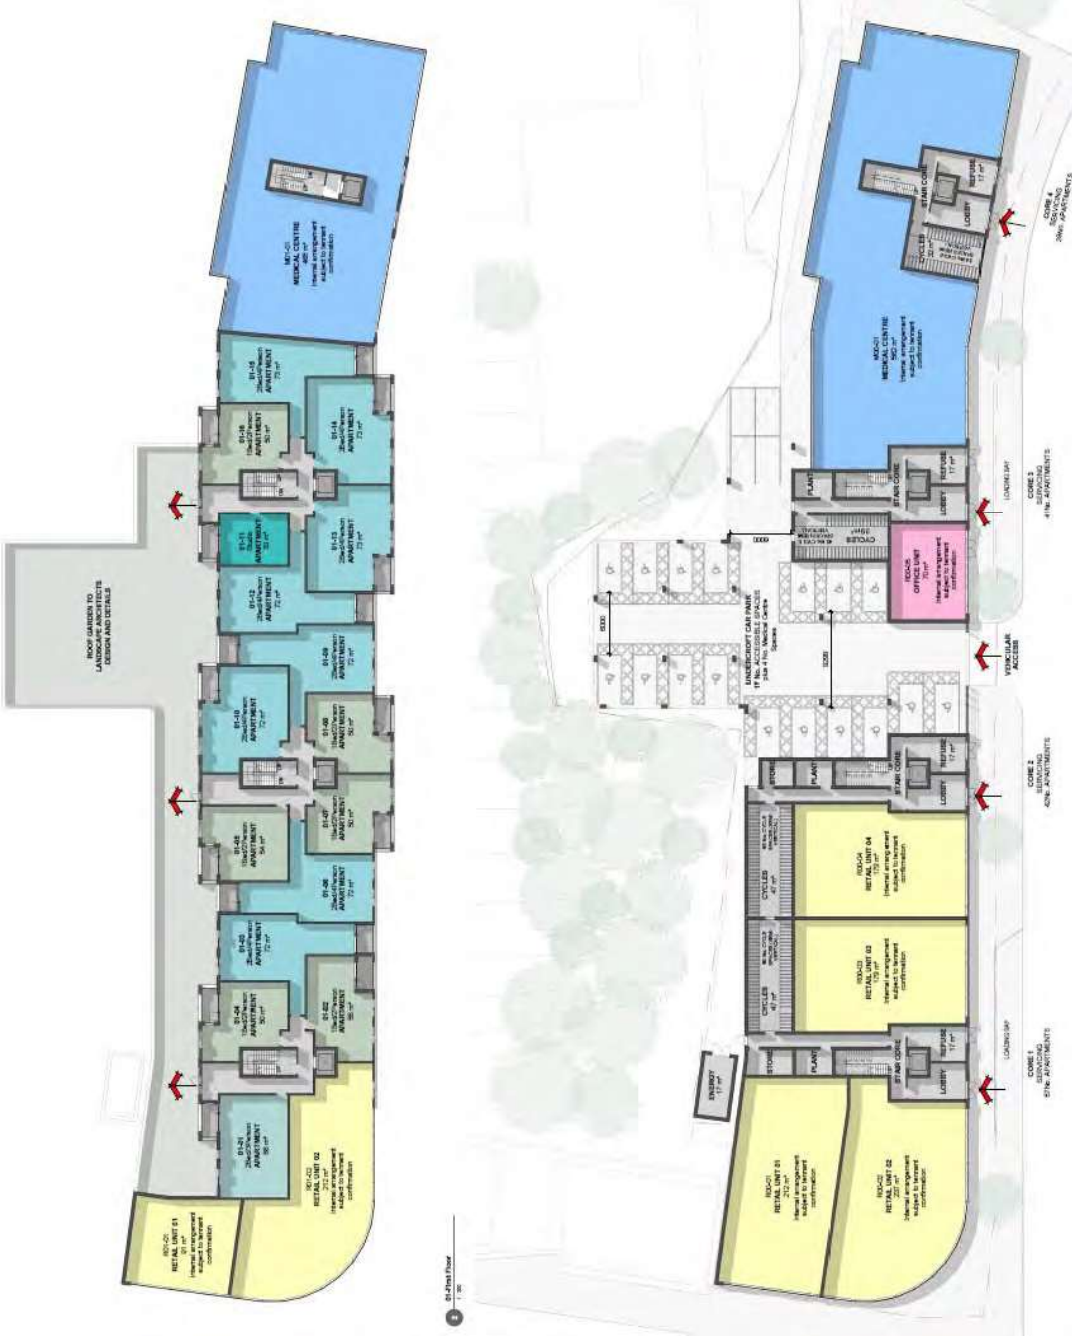
- 1.2.3 A 'Proposed Development Plan' for the whole site is shown on the CGL Drawing 'Figure 3', a copy of which is presented in Appendix E.
