# Heritage Statement regarding repairs to Pier and Wall at Southwood Lane.

19th September 2022  
Ref: SHERCO\_RP\_02

**Client:** Southwood House Estates Residents Company Limited (SHERCO)  
**Structural Engineer:** Malone Associates

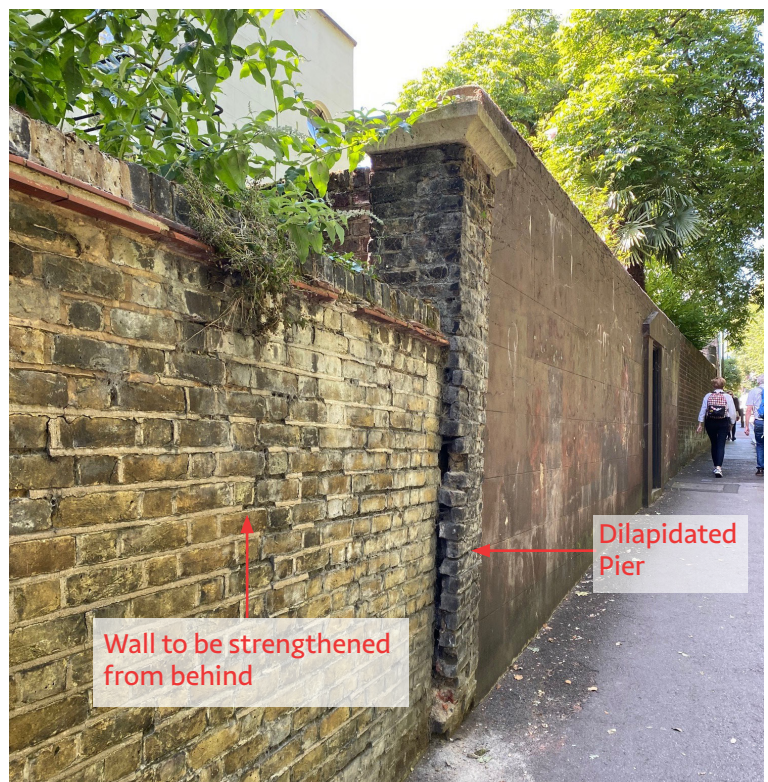
**Figure 2- Photograph of the condition of the current Pier and Wall**  
*Taken July 2022 showing the extent of deterioration.*

A peculiarity of the current pier and boundary wall are that they comprise two different types of brick, namely what appears to be a London Yellow stock for the boundary wall and a significantly weathered soft red for the brick pier as depicted in the photographs of figures 2 and 4.

The works comprise repairs of a dilapidated brick pier and strengthening of a brick wall retaining earth adjacent that reside next to Highstone House and common land owned by SHERCO near no. 86 Southwood Lane. It is intended to dismantle and rebuild the brick pier using existing bricks and use additional bricks from reclaim yards to match where required (thus restoring its current appearance). The wall strengthening will comprise the temporary excavation of the landscaped earth bank to allow for the addition of a concrete wall that will be tied into the existing brick wall and fully hidden with backfilled soil reinstating the existing earth bank on SHERCO's common land. This will hide the strengthening works meaning the traditional appearance of the wall is maintained. Repointing of both the pier and wall will also be carried out. Figures 1 & 2 show the principle arrangement of these elements and their condition. Please also refer to the Design & Access Statement (SHERCO\_RP\_01) for further details.

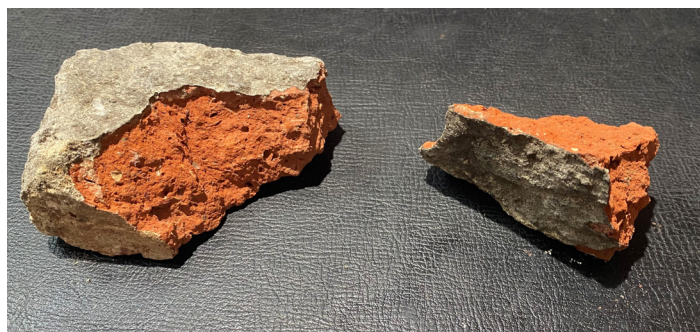
**Figure 4 – Samples of existing facing bricks from Pier**

*There is a very significant deposit of grey weathering on all exposed surfaces*

There is evidence to suggest that the pier and wall to be repaired have been an integral part of the Southwood Lane public highway setting for well over a century. This is also consistent with the imperial sizes used for the bricks and the considerable layer of weathering deposits found on two soft red brick samples which fell off the pier following strong weather (see figure 4).

Whilst the upper portion of the pier and facing bricks will need to be taken down to be repaired, the capping stone and all existing bricks will be reused where possible and replacement bricks will be sourced from a brick reclaim yard to match as closely as practicably possible the existing weathered bricks (this is further discussed in the design and access statement). In carrying out repair works in the above manner, the works will respect the scale and massing of the existing fabric and maintain the attractive view referred to for this area in the CA appraisal as forming an attractive view southwards towards the village.

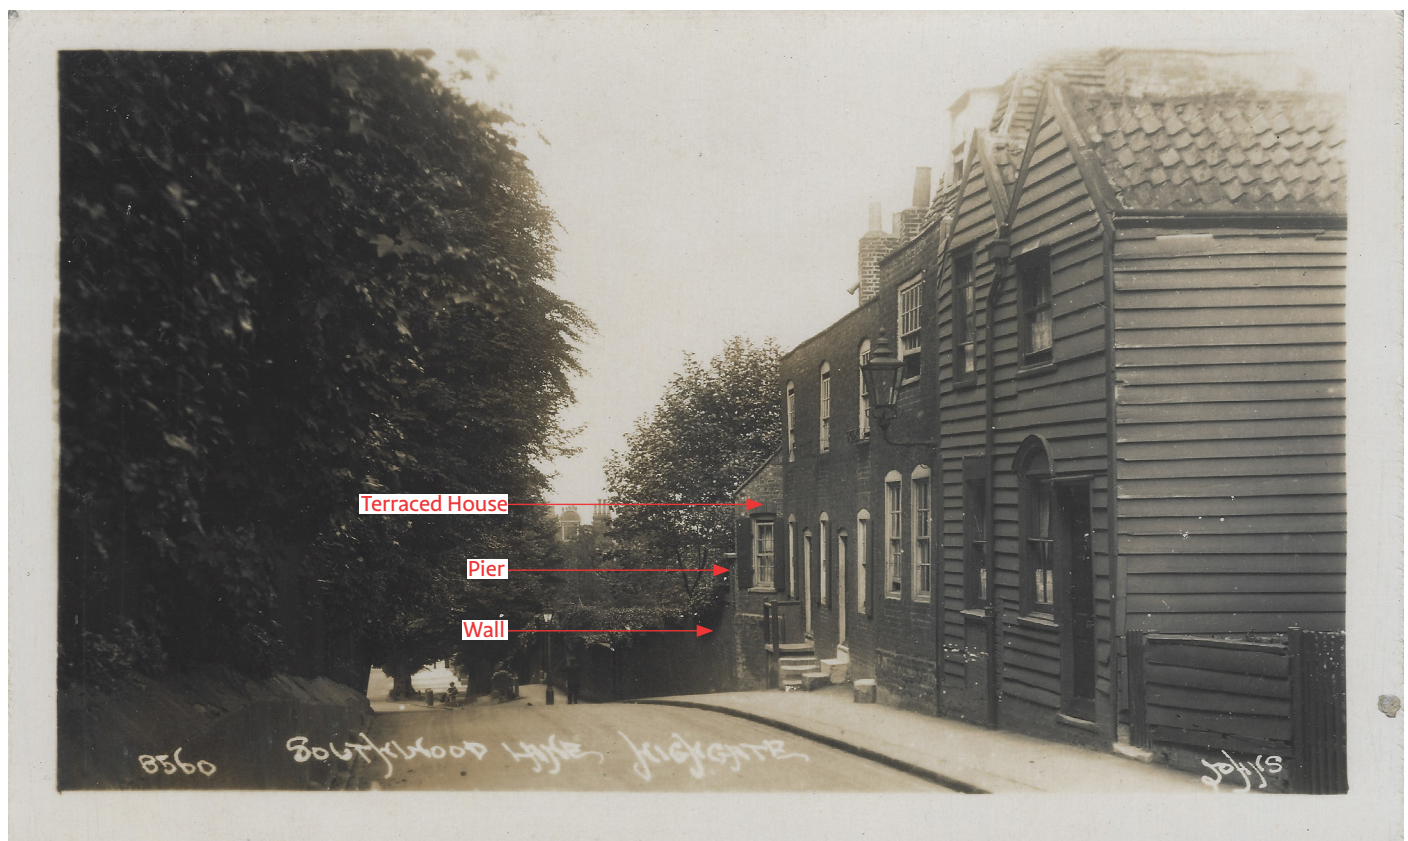
**Figure 6 – Antique Postcard Photograph, circa 1925, showing Pier and Wall at that time.**  
 (Photograph by R. J. Johns from Antique postcard Owned by SHERCO).

In Figure 6 it can be seen that the wall of the old terraced house that connects to the pier does so at a diagonal from the main wall which is also consistent on plan with a map surveyed in 1894 (Figure 7).

There is also strong evidence to suggest that the pier and wall are at least 128 years old through cross referencing of a vintage photograph of the Pier and wall taken circa 1925 (Figure 6) showing the character of the area and built assets of that time against a map surveyed in 1894 (figure 7) that represents the same buildings on plan shown in the photograph.

Aerial photography of the site taken in 1946 (Figure 10) shows the Pier and wall in existence at the time Highstone House was built which suggests that at some point between 1925 (Figure 6) and 1946 (Figures 10 & 11), the characterful brick and timber terraced houses were demolished to be replaced with a single dwelling house.

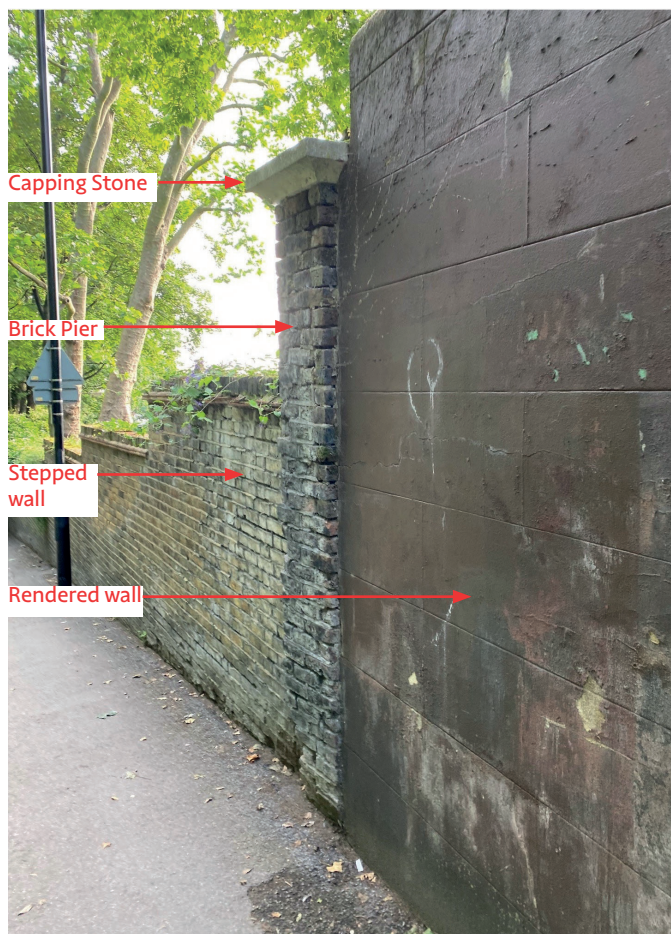
**Figure 8 – Photograph of Brick Pier and stepped wall (2022)**  
 Taken July 2022 (Photograph by SHERCO)

A photographic comparison of Figures 8 & 9 cross referenced to the map in figure 7 indicate the character of the stepped wall (to be strengthened), along with the brick pier (to be repaired) and its characteristic capping stone providing strong evidence of its existence in 1894.

Whilst not conclusive by this photo alone, it is likely that the existing wall of Highstone House (shown rendered brown in Figure 8) may have been built around that time as a wall also appears on plan in an ordinance survey map of 1950 (Figure 12).

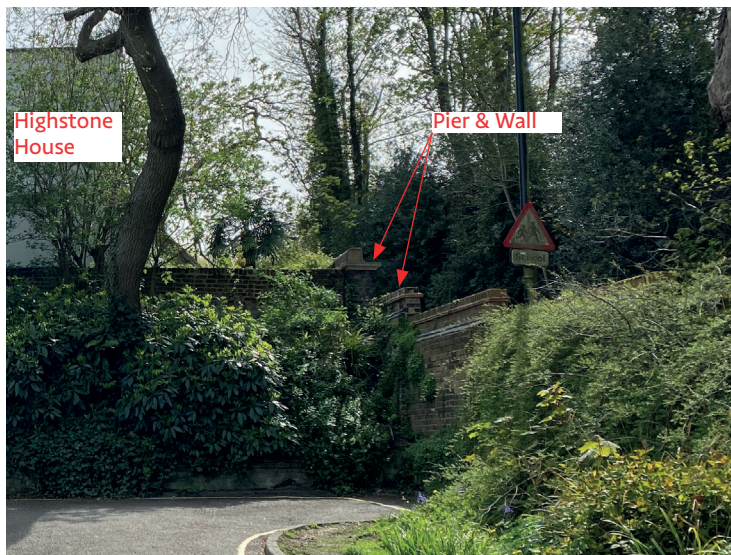
**Figure 13 – View from Southwood Lane Cul-de-sac Road Looking South**  
July 2022

Given the above and also the fact that the adjoining party wall between Highstone house and Common land owned by SHERCO (Figures 3, 13 & 14) is similar in height to the Brick Pier, it is SHERCO's opinion that these assets should be repaired and restored without altering their existing height or proportion. All structural strengthening works will also be concealed as noted in the design and access statement and illustrated in figure 15 below.
