**From:** Brendan  
**Sent:** 12 July 2022 14:53  
**To:** 'Andrew Ardill'  
**Subject:** RE: Pillar on Southwood Lane

Condition photos of Pier at  
Southwood Lane  
Taken 8th July 2022

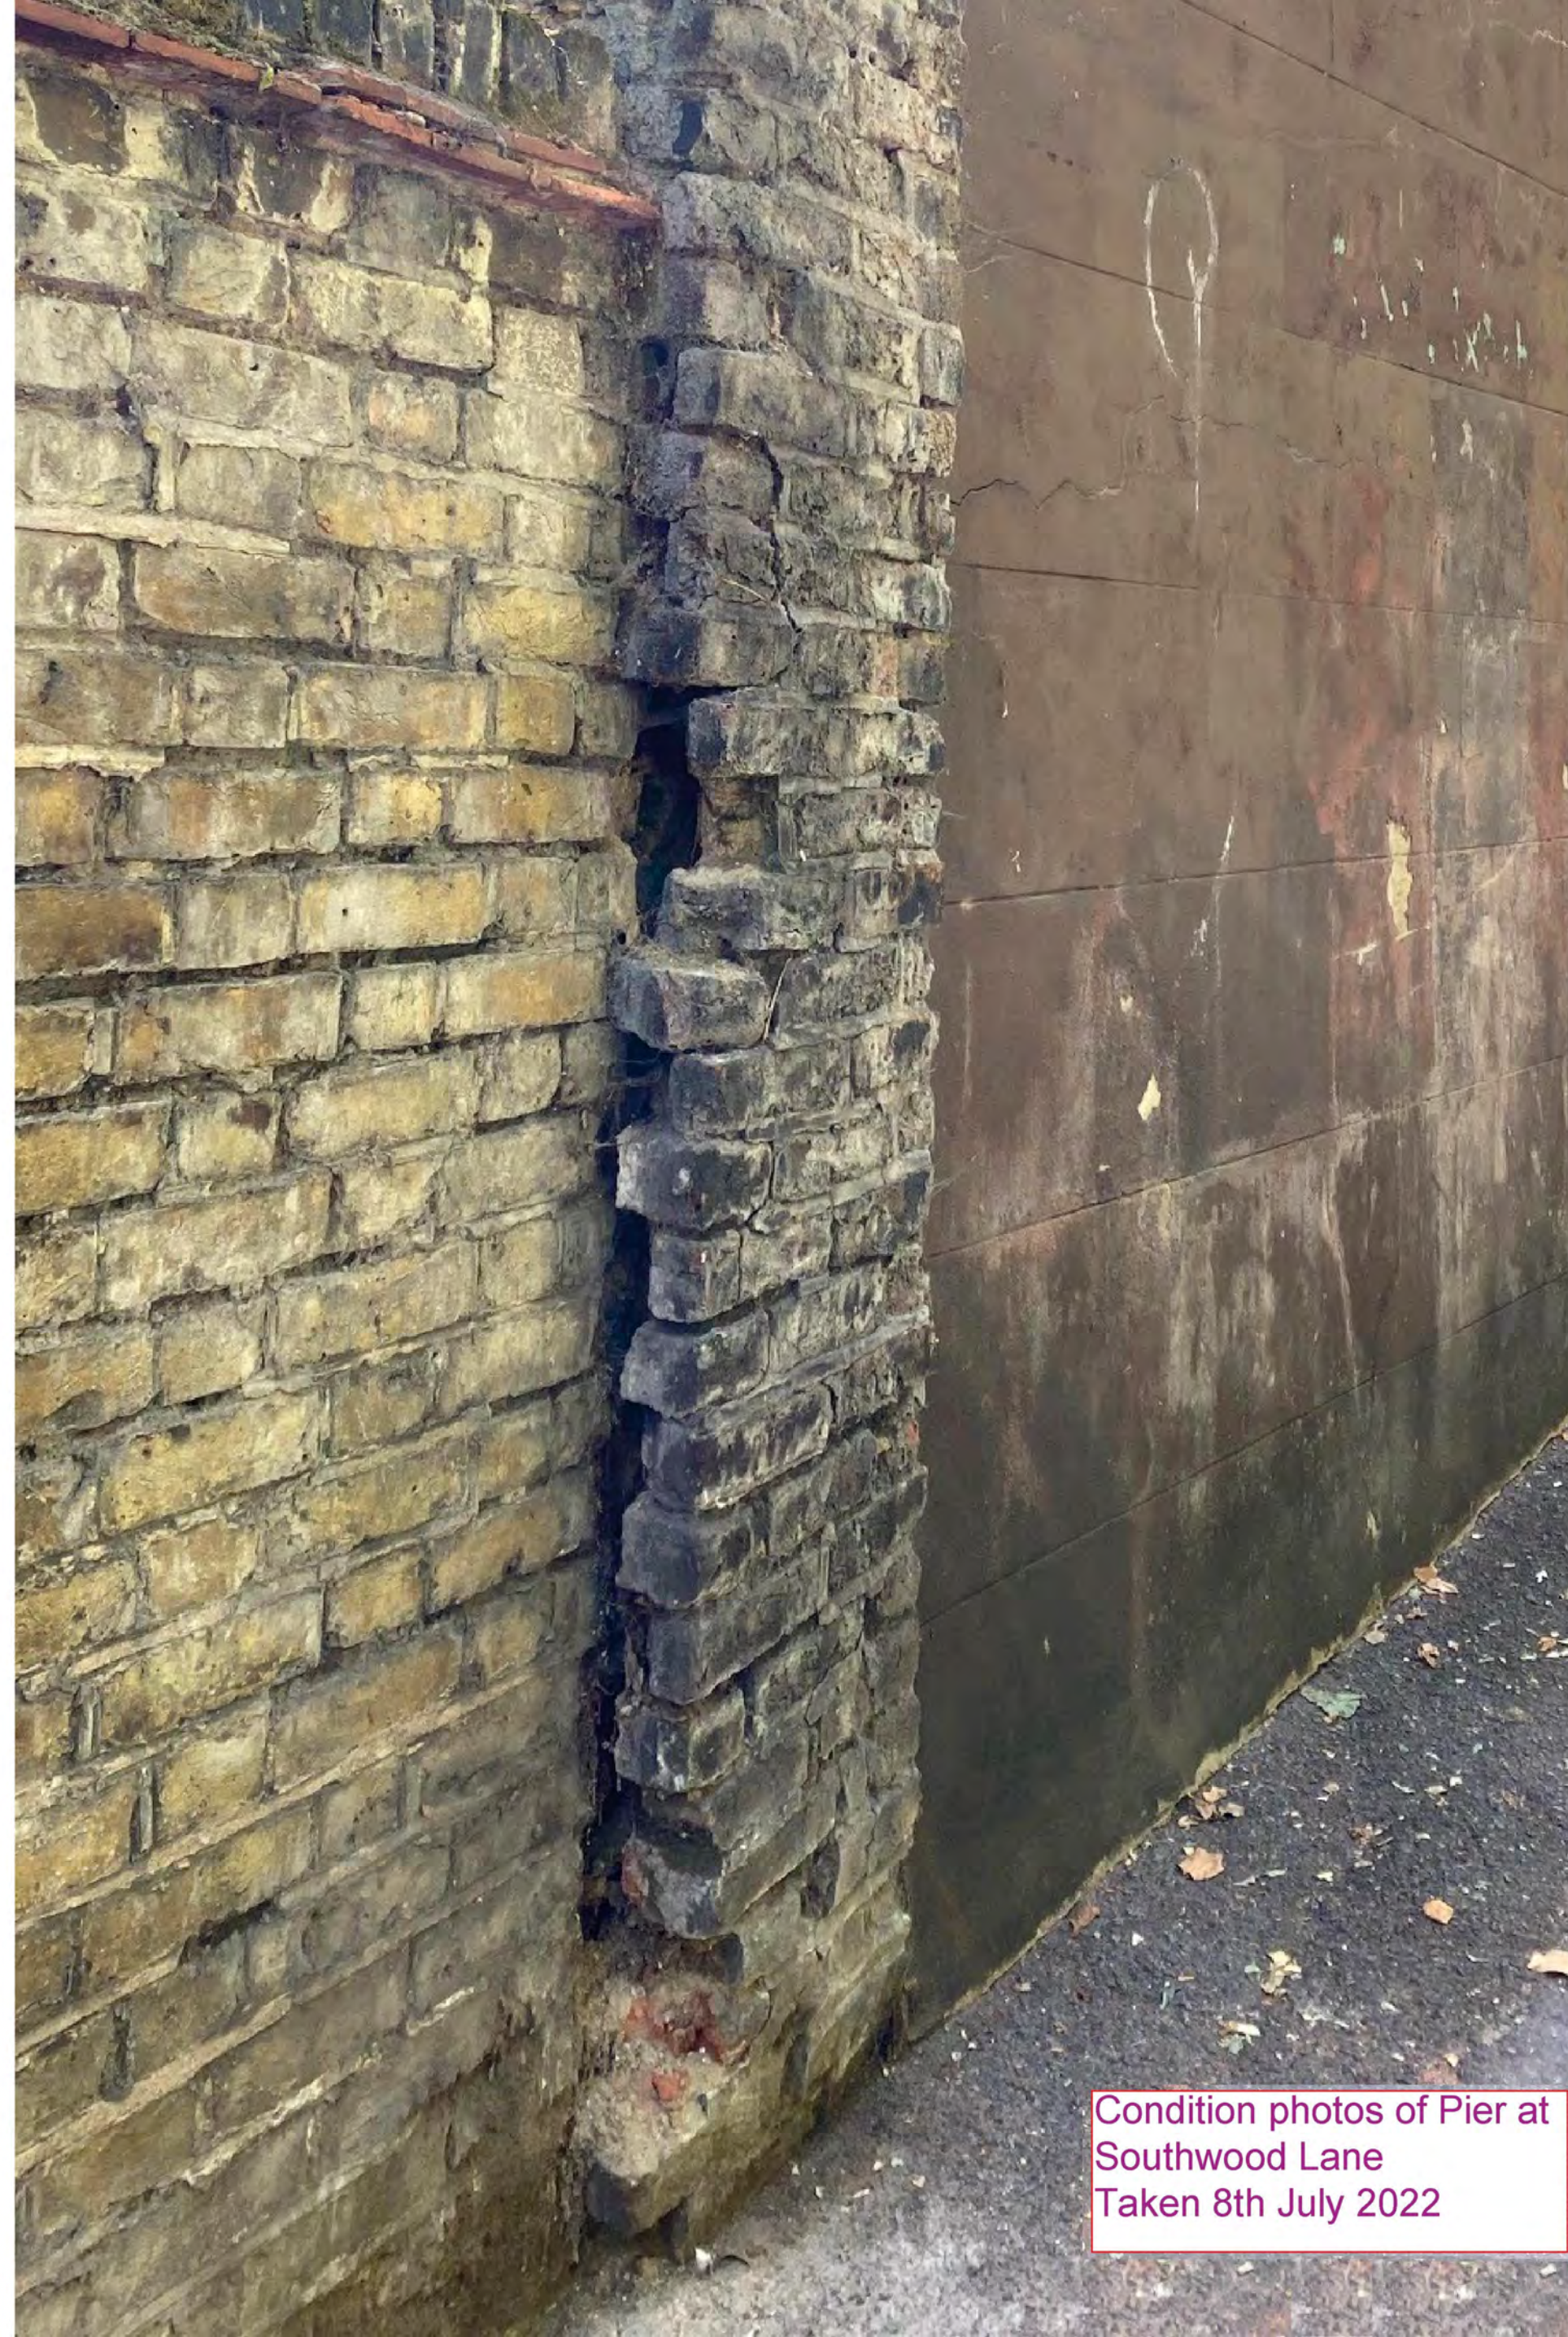
Having made a careful comparison of the various photographs of the pier from each of these inspections, I cannot discern any significant change in the condition of the pier over the last year. As the open joints continue to be exposed to the weather some further washing out of the loose mortar can be expected, but the greatest difference between the appearance of the pier now and before my inspection is that the accumulated spiders webs which were in the open joints prior to my inspection are no longer there, as I removed these to facilitate my examination of the pier.

The fact that the open joints are now more visible will result in a change in perception, which in turn may be responsible for the concerns raised.

I do not consider that there is a need to carry out emergency repairs, but I recommend that you continue with the appointment of a contractor with all possible haste and have the repairs carried out as soon as the current difficulties of getting a builder on site permit.
