# GROUND INVESTIGATION REPORT AND BASEMENT IMPACT ASSESSMENT

Nice Place  
Compton Avenue  
London N6 4LH

Client: WT Capital Group Limited

J22272

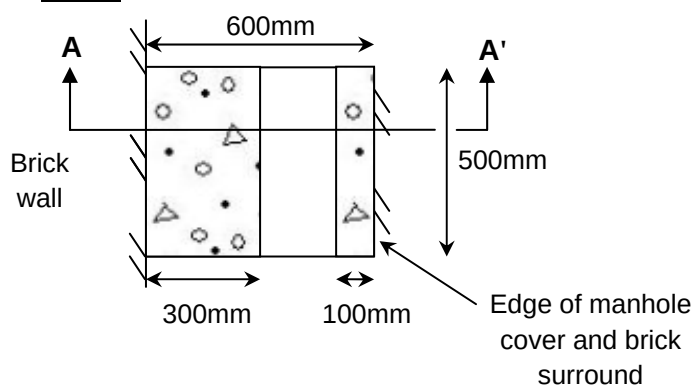
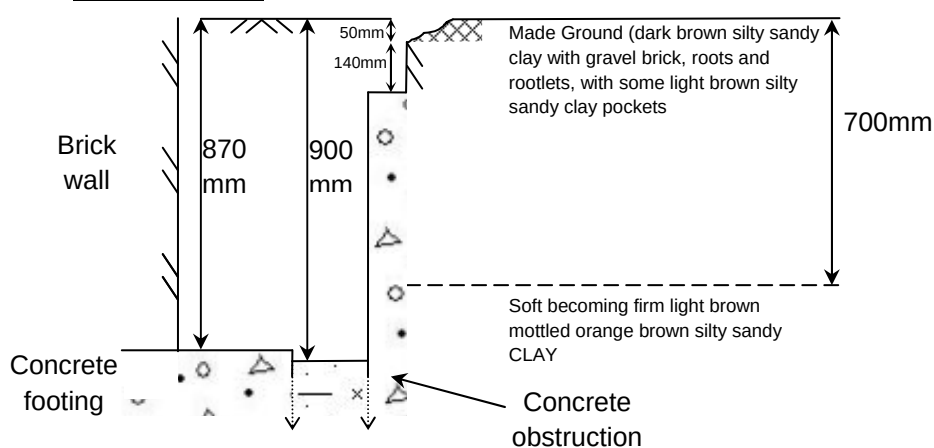
### SECTION A-A

Depth of foundation not proved due to a concrete obstruction

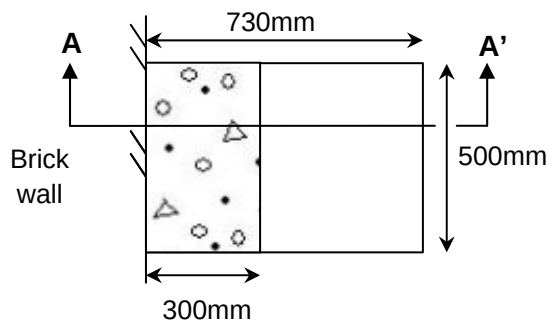
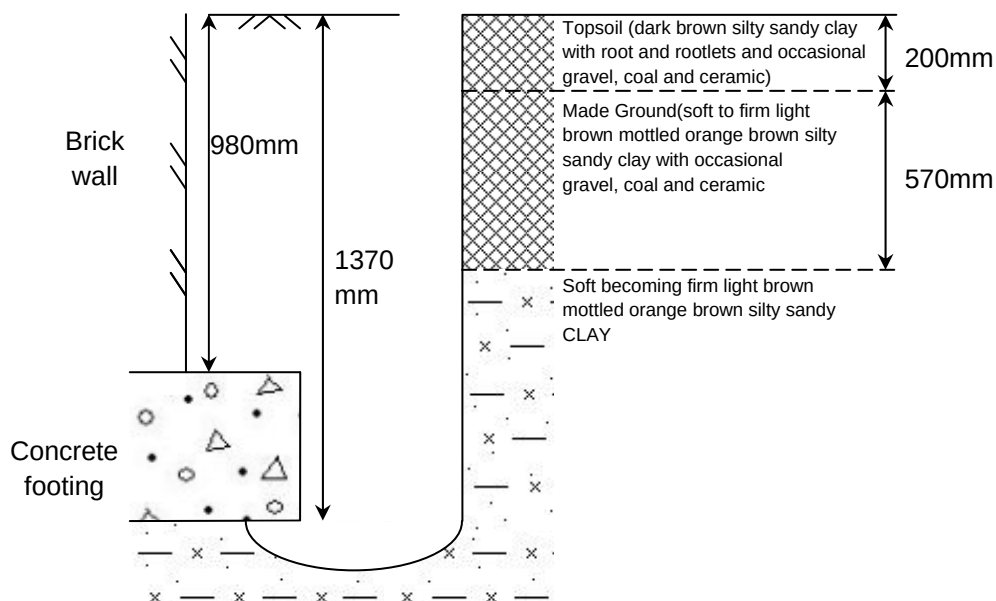
### SECTION A-A

- (1) No standing water encountered
- (2) No collapse during excavation
- (3) No services encountered

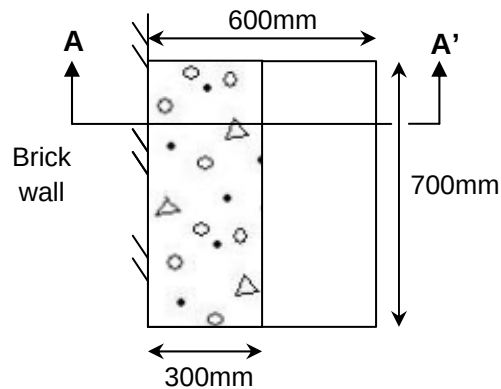
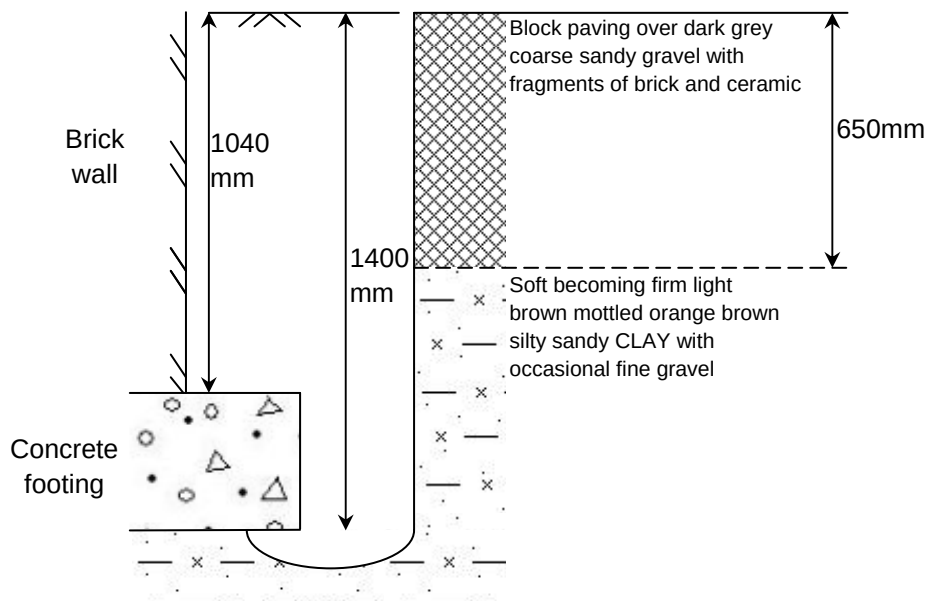
### SECTION A-A

- (1) No standing water encountered
- (2) No collapse during excavation
- (3) No services encountered

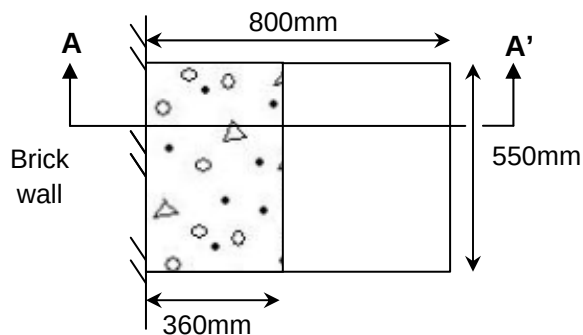
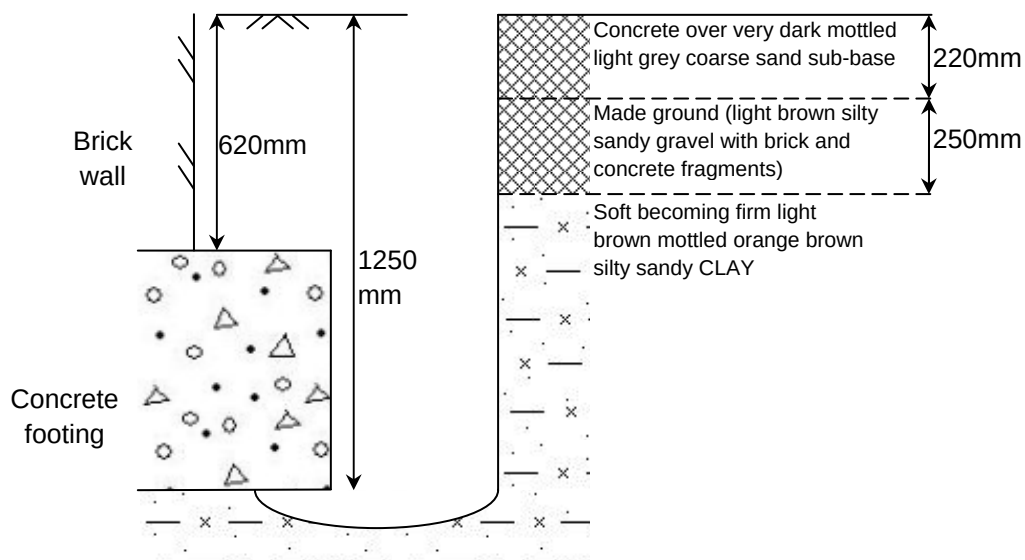
### SECTION A-A

- (1) No standing water encountered
- (2) Partial collapse during excavation
- (3) No services encountered

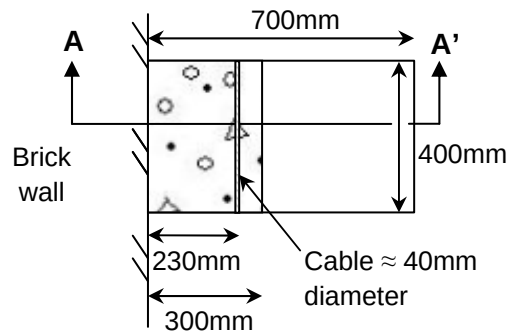
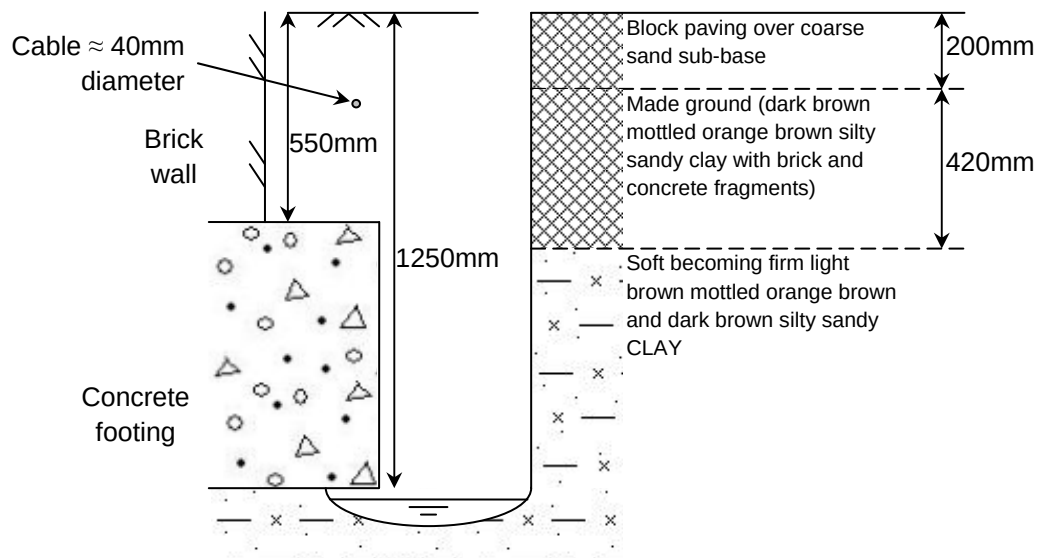
### SECTION A-A

- (1) Standing water at 1.28m below GL
- (2) Partial collapse of excavation overnight
- (3) 40mm diameter cable encountered

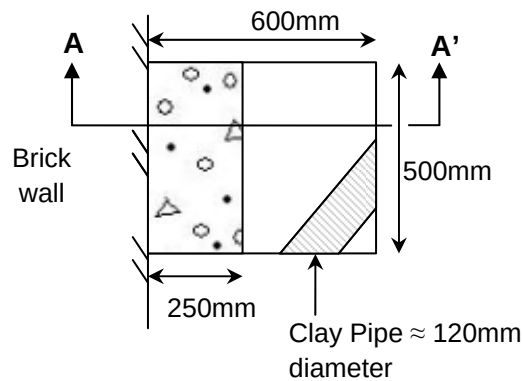
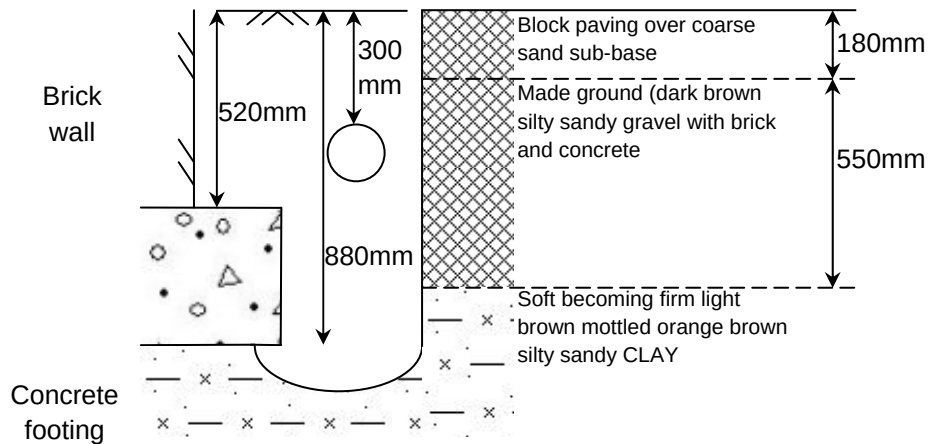
### SECTION A-A

- (1) Moisture encountered at base (no standing water)
- (2) Partial collapse of excavation overnight
- (3) 120mm diameter clay pipe encountered

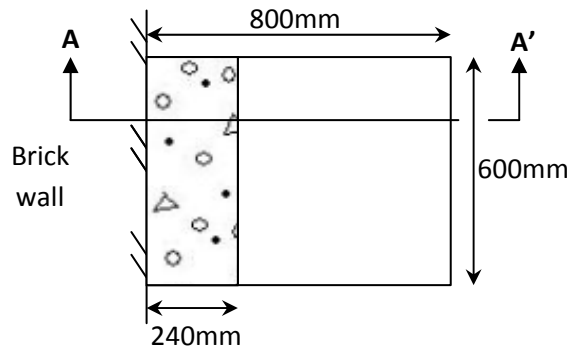
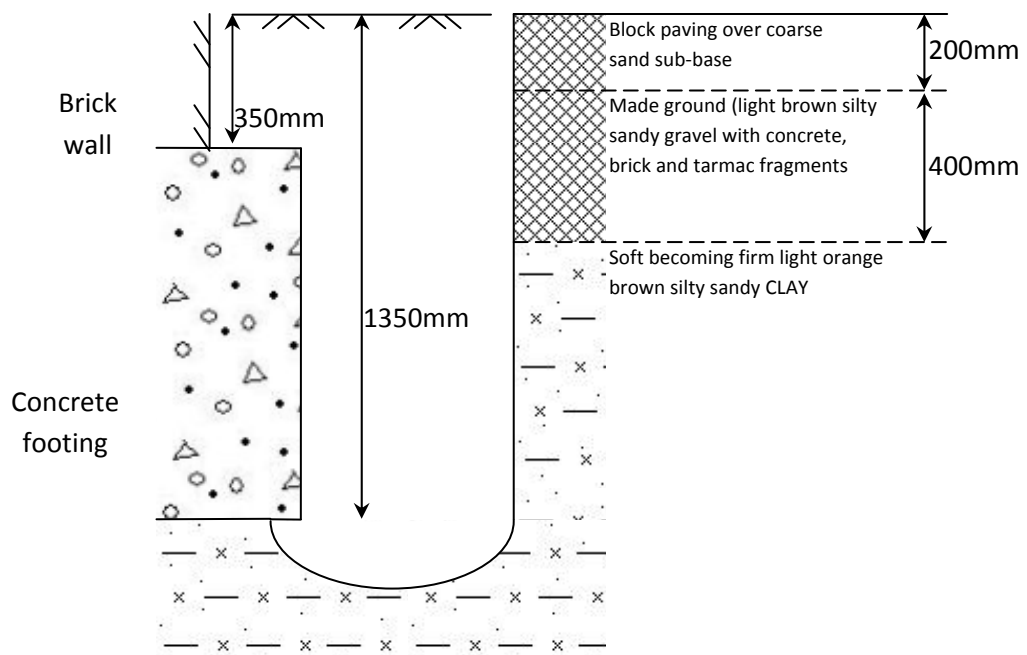
### SECTION A-A

- (1) No standing water encountered
- (2) Sides of excavation remained stable during excavation
- (3) No services encountered

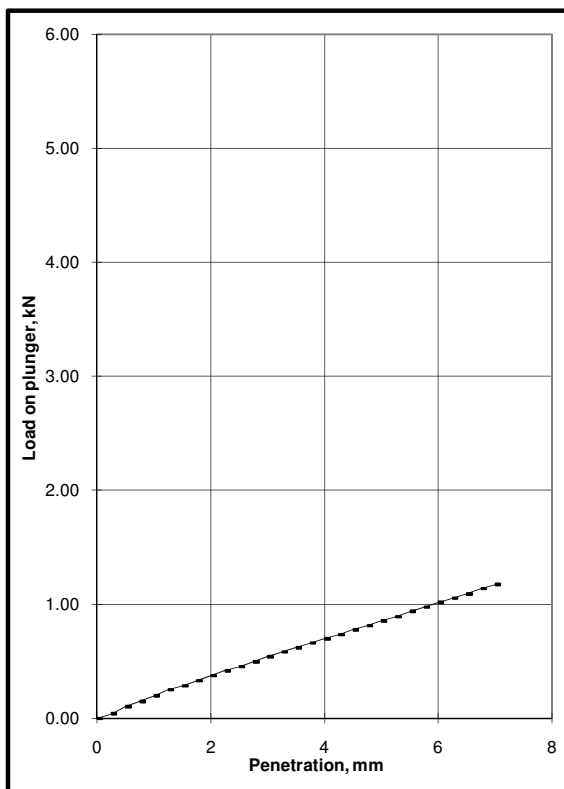
Force - penetration curve

| CBR % |
|---|
| 4.3 |

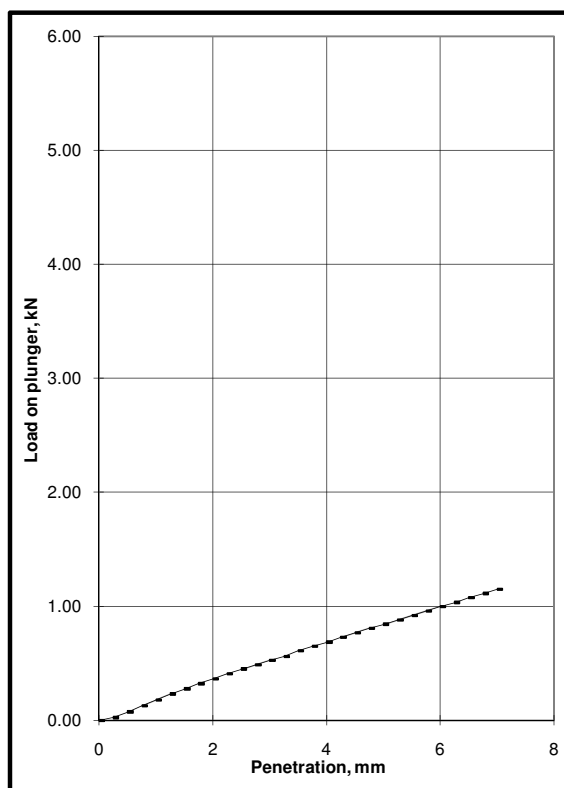
Force - penetration curve

| CBR % |
|---|
| 4.2 |

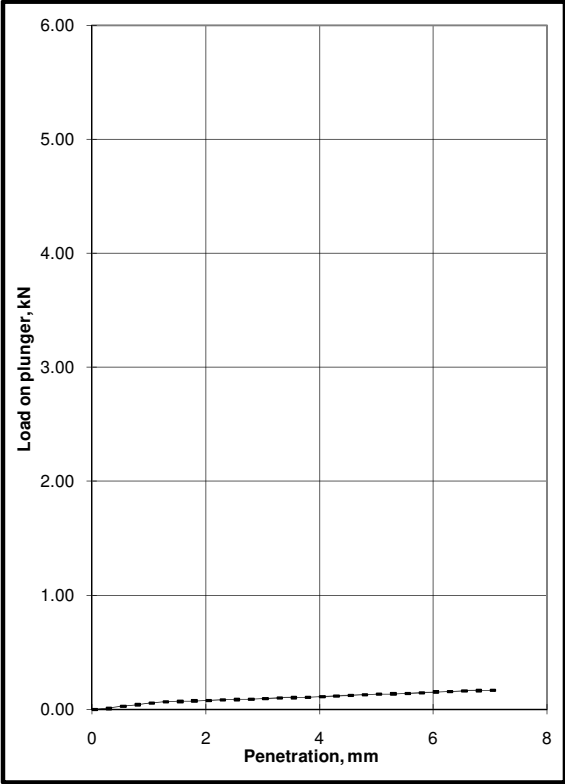
Force - penetration curve

| CBR % |
|---|
| 0.7 |

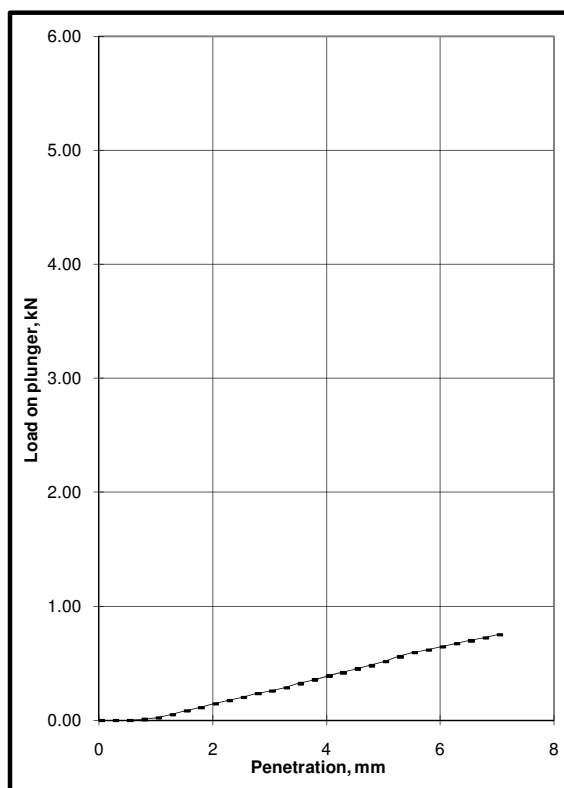
Force - penetration curve

| CBR % |
|---|
| 2.6 |

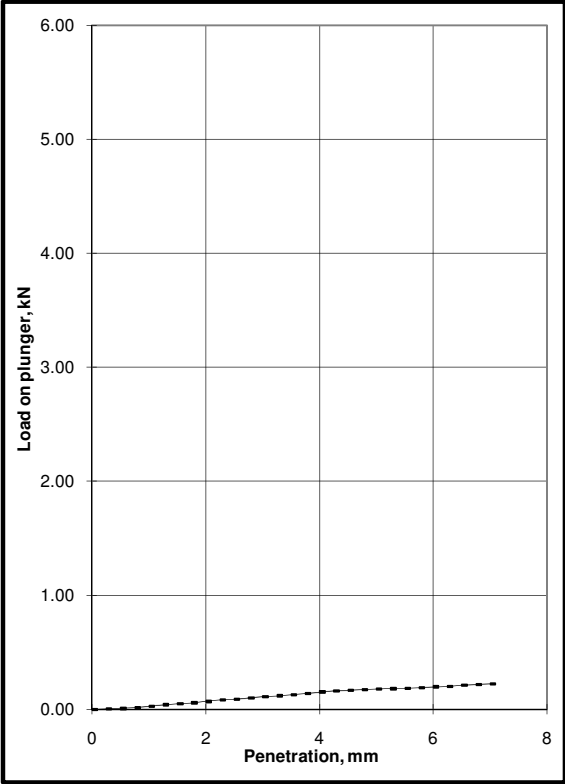
</div> <div style="margin-top: 20px; text-align: center;"><table border="1"><tr><td>CBR %</td></tr><tr><td>0.9</td></tr></table></div> |                                                                                                                                                                                                                                            |                                      | CBR % | 0.9 |
| CBR % | | | | |
| 0.9 | | | | |
| 17/08/2011 | <div style="background-color: #cccccc; text-align: center; padding: 2px;"><b>Determination of the in-situ California Bearing Ratio (CBR)</b></div> <div style="text-align: center; padding: 5px;">BS 1377 : Part 9 : Clause 4 : 1990</div> | Approved<br><br>Initials :<br>Date : | | |

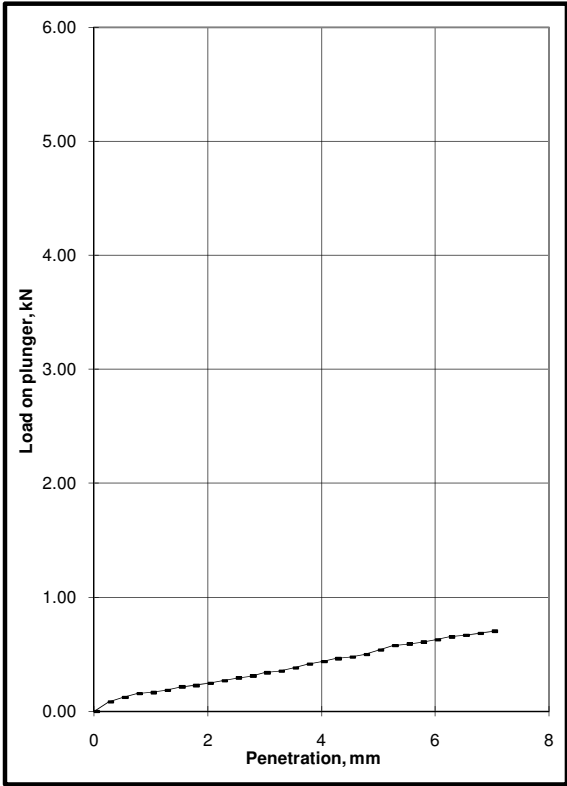
| <b>Client:</b> GEA<br><br><b>Site:</b> Nice Place<br><br><b>Location Ref:</b> CBR6 | <b>Depth (m):</b> 0.40 | <b>Report No:</b> GGB010719<br><br><b>Report date:</b> GGB010811<br><br><b>Test date:</b> GGB010719 | | | | | | | | | |
|---|---|---|---|---|---|---|--|--|---|---|--|
| <p><u>Force - penetration curve</u></p> <table border="1" style="margin: 10px auto; width: 150px; text-align: center;"> <tr> <th>CBR %</th> </tr> <tr> <td>2.7</td> </tr> </table> | | | CBR % | 2.7 | | | | | | | |
