# GROUND INVESTIGATION REPORT AND BASEMENT IMPACT ASSESSMENT

Nice Place  
Compton Avenue  
London N6 4LH

J11150B

March 2020

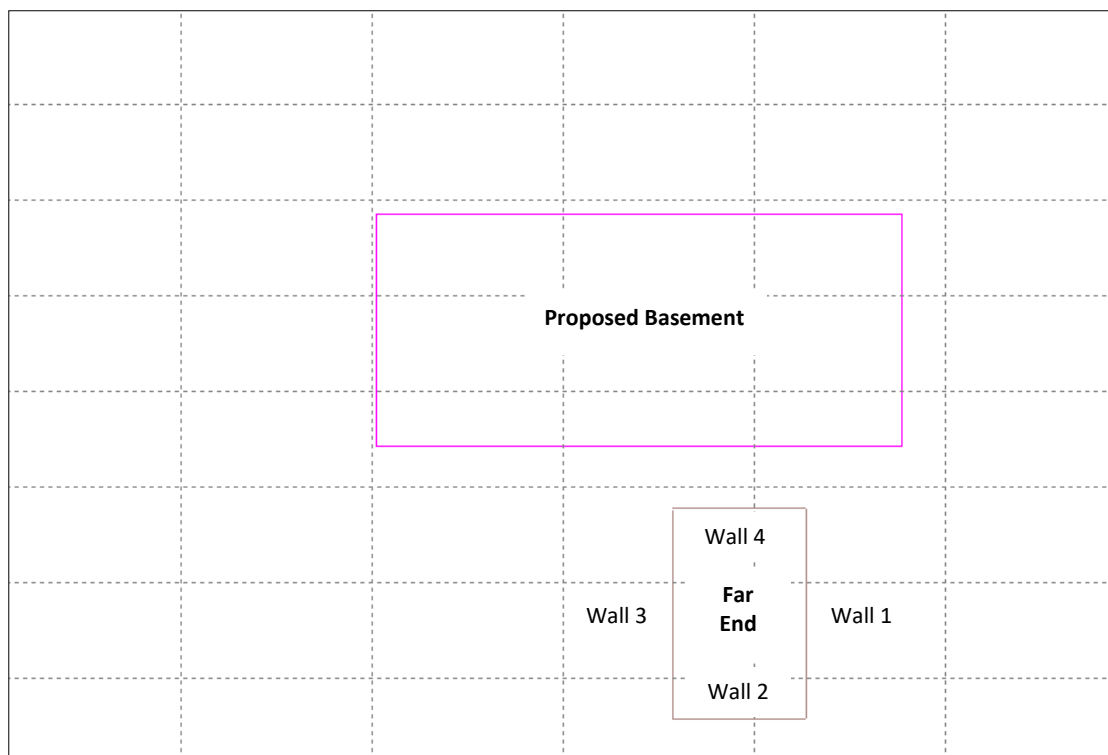
The sensitive structures outlined above have been modelled as lines in the analysis and are the lines along which the damage assessment has been undertaken. The location of each of the buildings is detailed on the plan below.

Reference to planning drawings for the most recent redevelopment of Far End found on the planning portal, the site immediately to the south of the site, shows the property to have a single level basement and the excavation to have been supported by contiguous bored pile walls. The basement has been assumed to extend to a standard depth of 3.50 m below ground level. It is not been possible to ascertain the foundation detail of the building and it has

therefore been assumed for the purposes of this assessment that it is supported by strip foundations beneath each wall extending to a depth of 0.50 m below basement level. However, this is highly conservative as the piled wall will have remained in place and will limit the scale of the movement experienced by the foundations. A standard storey height of 3.50 m has been assumed for the building, and it is known to be a two storey property with a basement level. As a result, the wall heights for the building have been calculated to be a total of 11 m.

The combined movements resulting from both retaining wall installation and basement excavation calculated using the X-Disp modelling software have been used to carry out an assessment of the likely damage to adjacent properties. All structures were predicted as sustaining damage Category 0 (Negligible). On this basis, the damage that would inevitably occur as a result of basement construction would fall within the acceptable limits. The detailed tabular output can be seen in the Appendix.

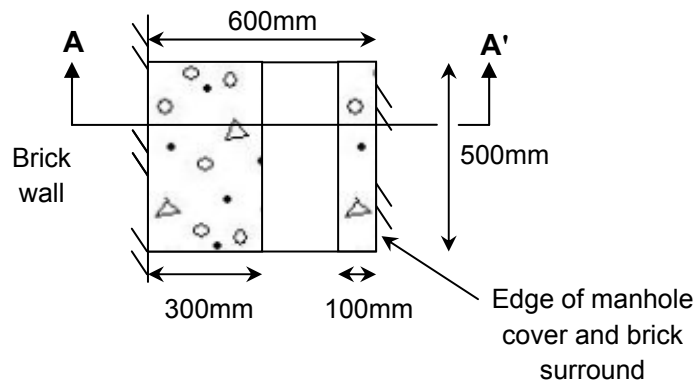
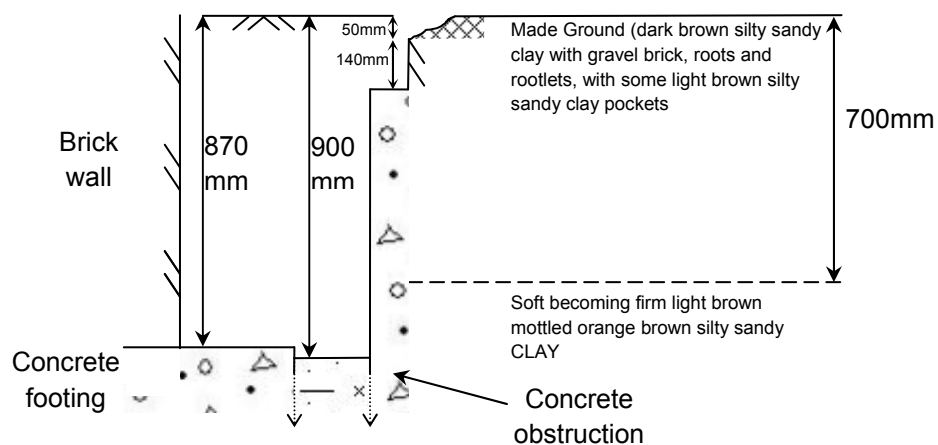
### PLAN

Depth of foundation not proved due to a concrete obstruction

A series of seven manually excavated trial pits has shown the existing buildings to be supported on relatively shallow spread foundations comprising concrete footings, bearing within the firm clay of the Claygate Member at depths of between 0.88 m (102.53 m OD) and 1.40 m (102.82 m OD). Logs and photographs are included within the appendix.

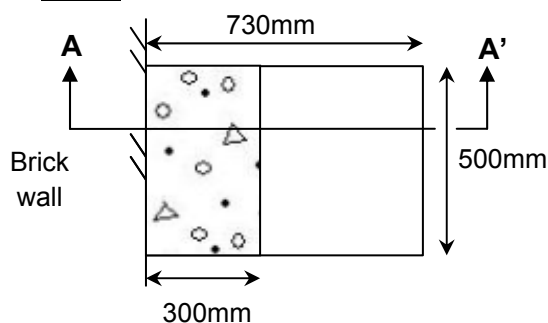
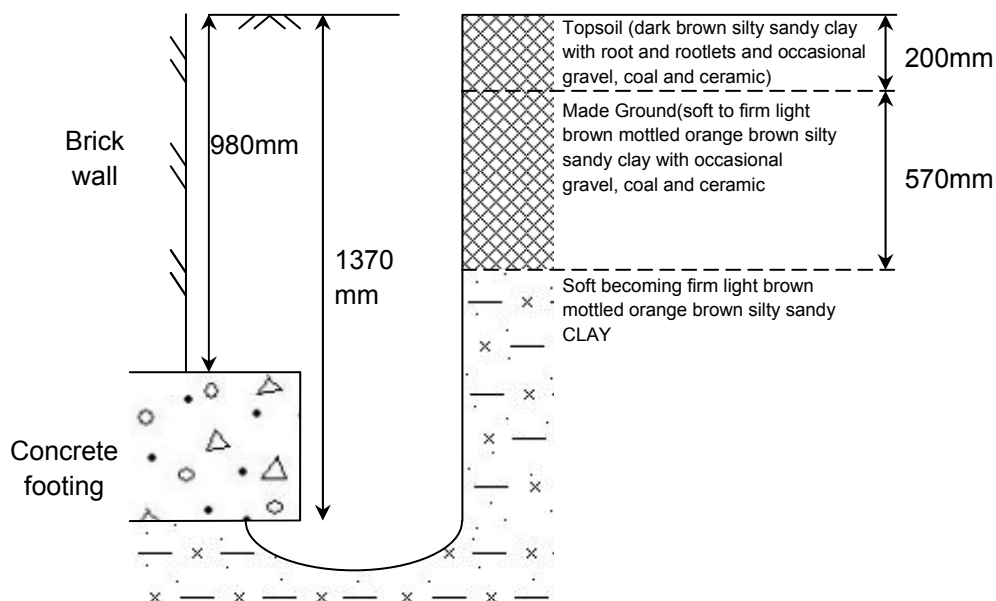
### PLAN

- (1) No standing water encountered
- (2) No collapse during excavation
- (3) No services encountered

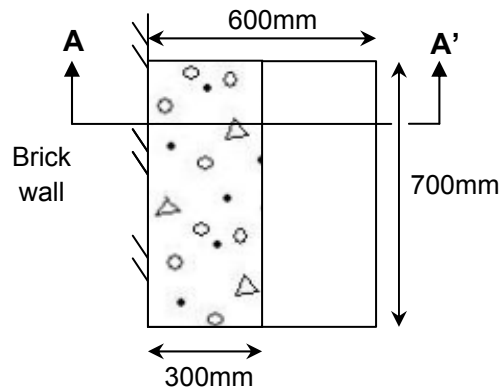
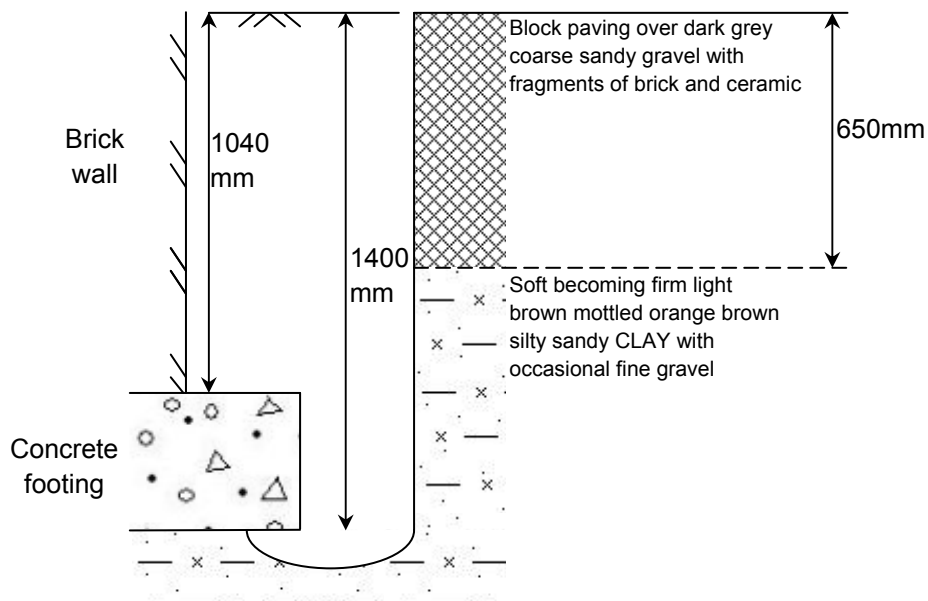
### PLAN

- (1) No standing water encountered
- (2) No collapse during excavation
- (3) No services encountered

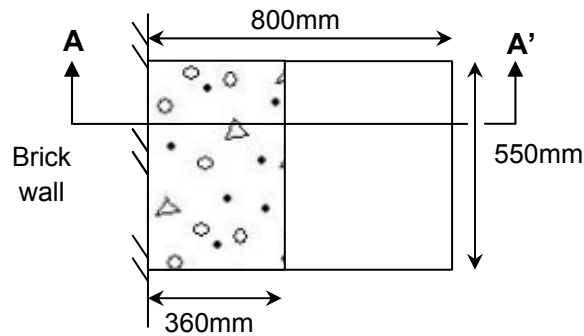
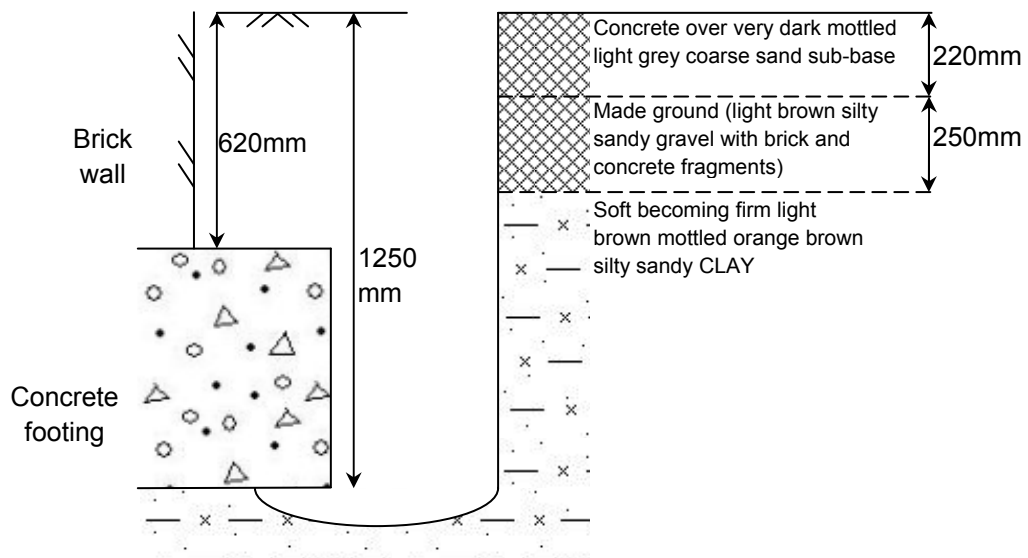
### PLAN

- (1) No standing water encountered
- (2) Partial collapse during excavation
- (3) No services encountered

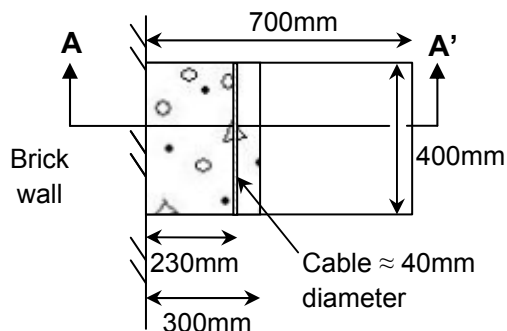
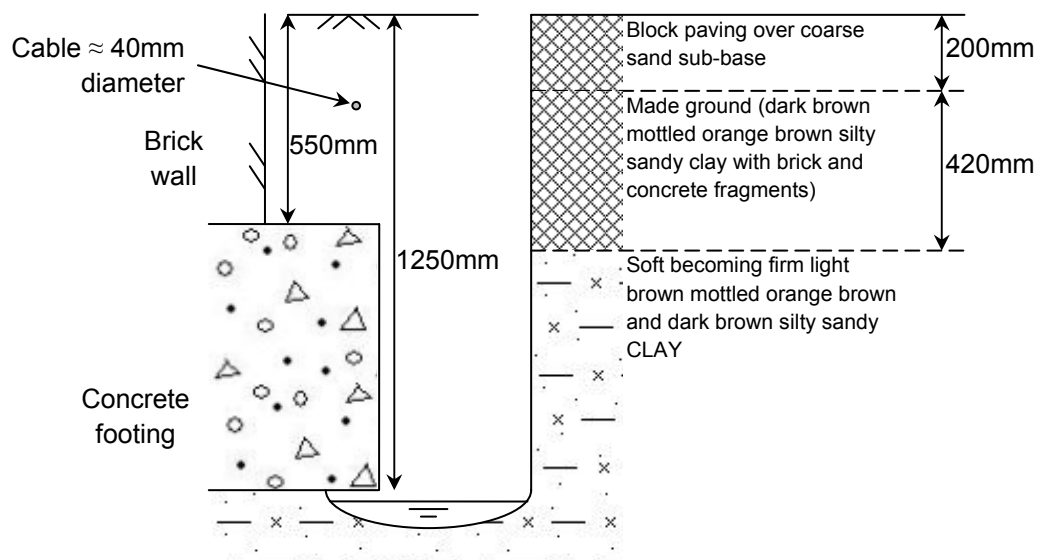
### PLAN

- (1) Standing water at 1.28m below GL
- (2) Partial collapse of excavation overnight
- (3) 40mm diameter cable encountered

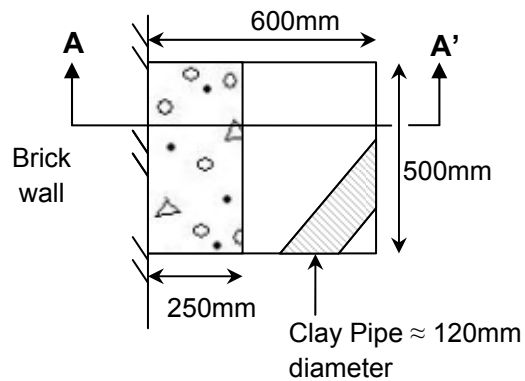
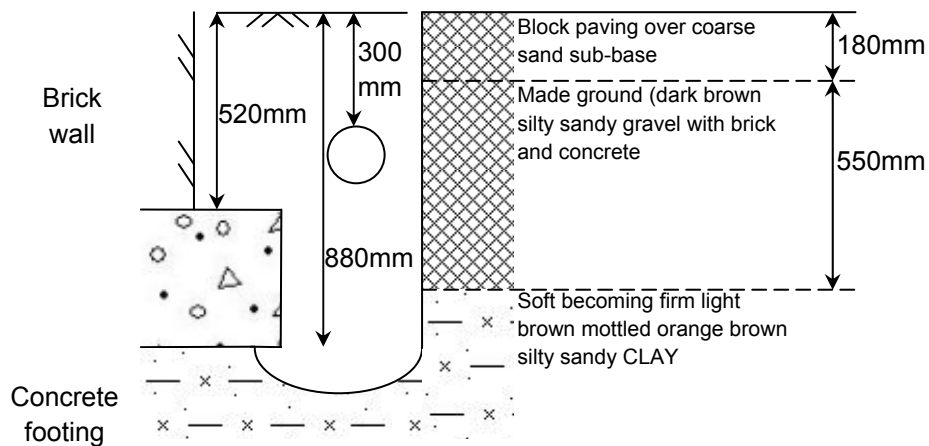
### PLAN

- (1) Moisture encountered at base (no standing water)
- (2) Partial collapse of excavation overnight
- (3) 120mm diameter clay pipe encountered

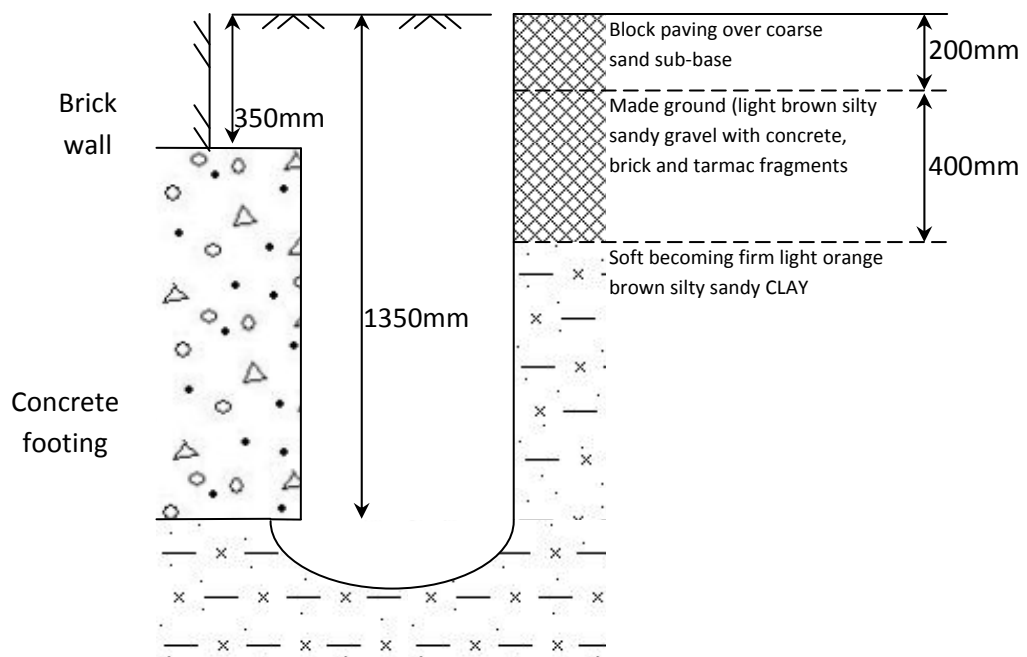
### PLAN

- (1) No standing water encountered
- (2) Sides of excavation remained stable during excavation
- (3) No services encountered

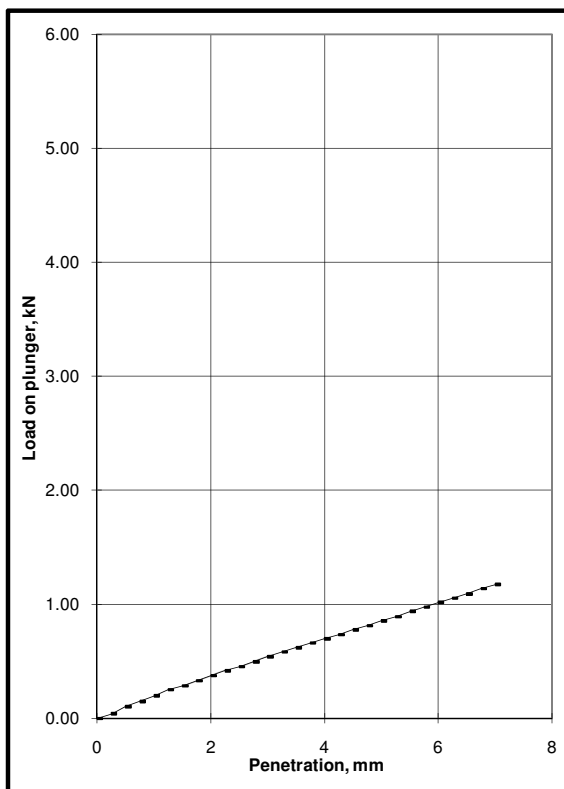
Force - penetration curve

| CBR % |
|---|
| 4.3 |

Formation level for the proposed roads and hardstandings is likely to be within the Claygate Member and on the basis of the insitu testing and published data, new roads and pavements should be designed on the basis of a California Bearing Ratio (CBR) of 2% to 3%. The results of the geotechnical testing indicate that the shallow soils should not be considered to be frost susceptible.

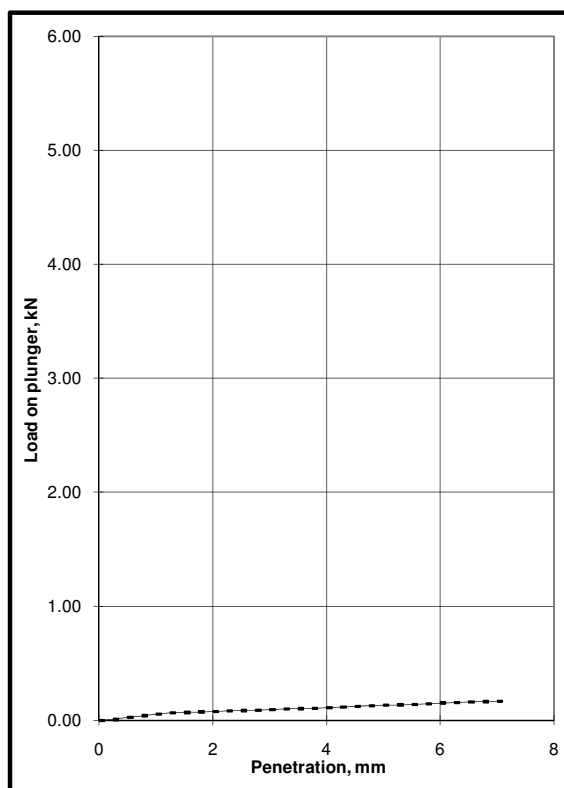
Force - penetration curve

| CBR % |
|---|
| 0.7 |

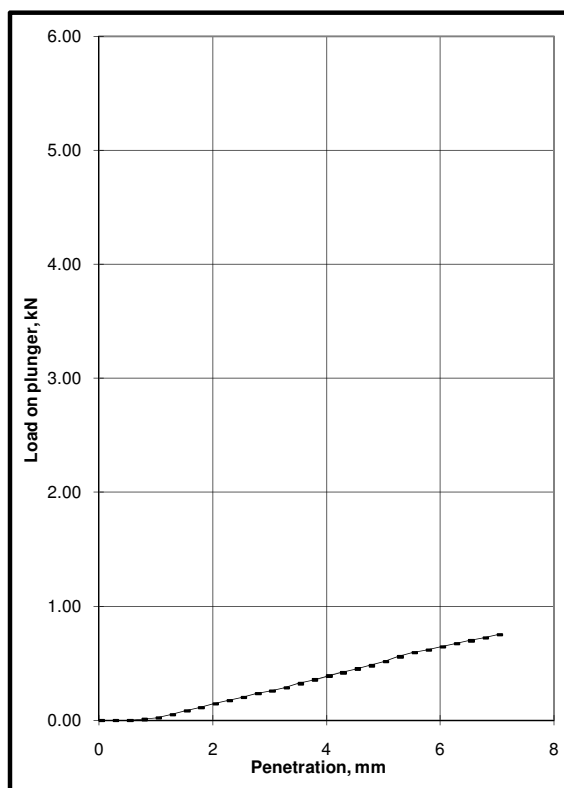
Force - penetration curve

| CBR % |
|---|
| 2.6 |

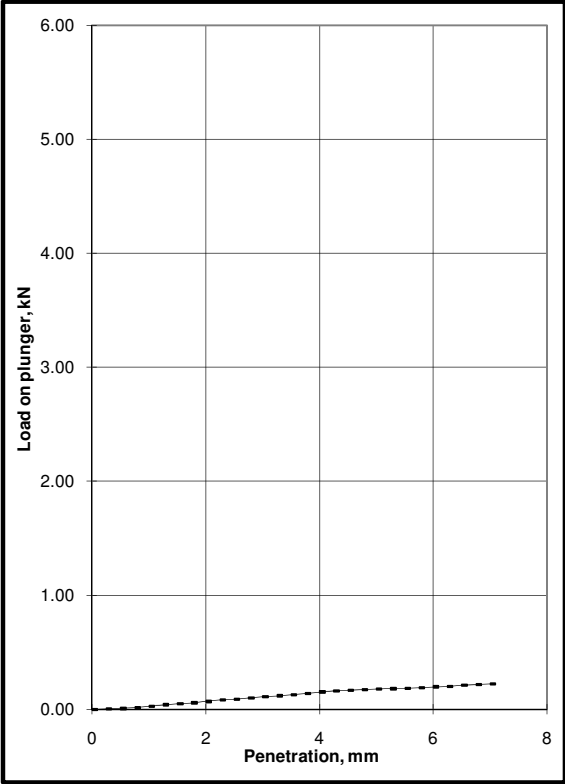
Force - penetration curve

| CBR % |
|---|
| 0.9 |

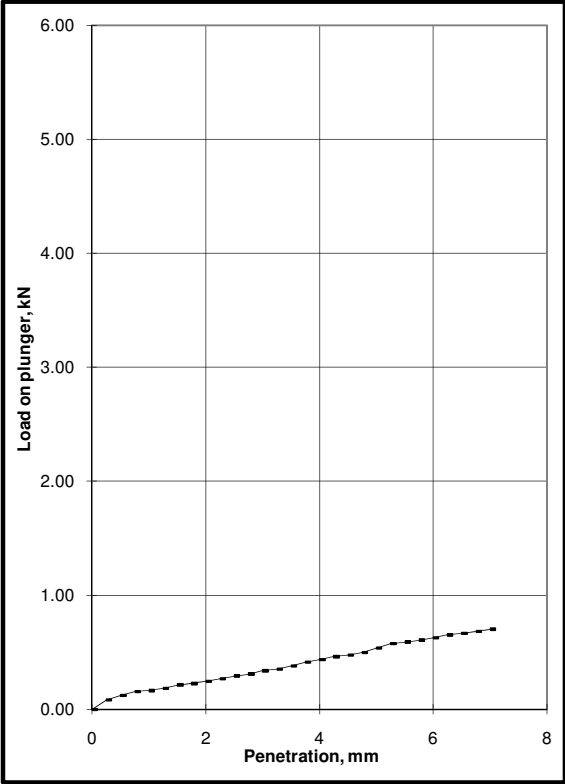
Force - penetration curve

| CBR % |
|---|
| 2.7 |
