# Ground Investigation Report

167 Hermitage Road, Harringay, London N4 1LZ

On behalf of Topfling

| Report Reference: GWPR4712/GIR/June 2022 V1.01 | | | Status: Final |

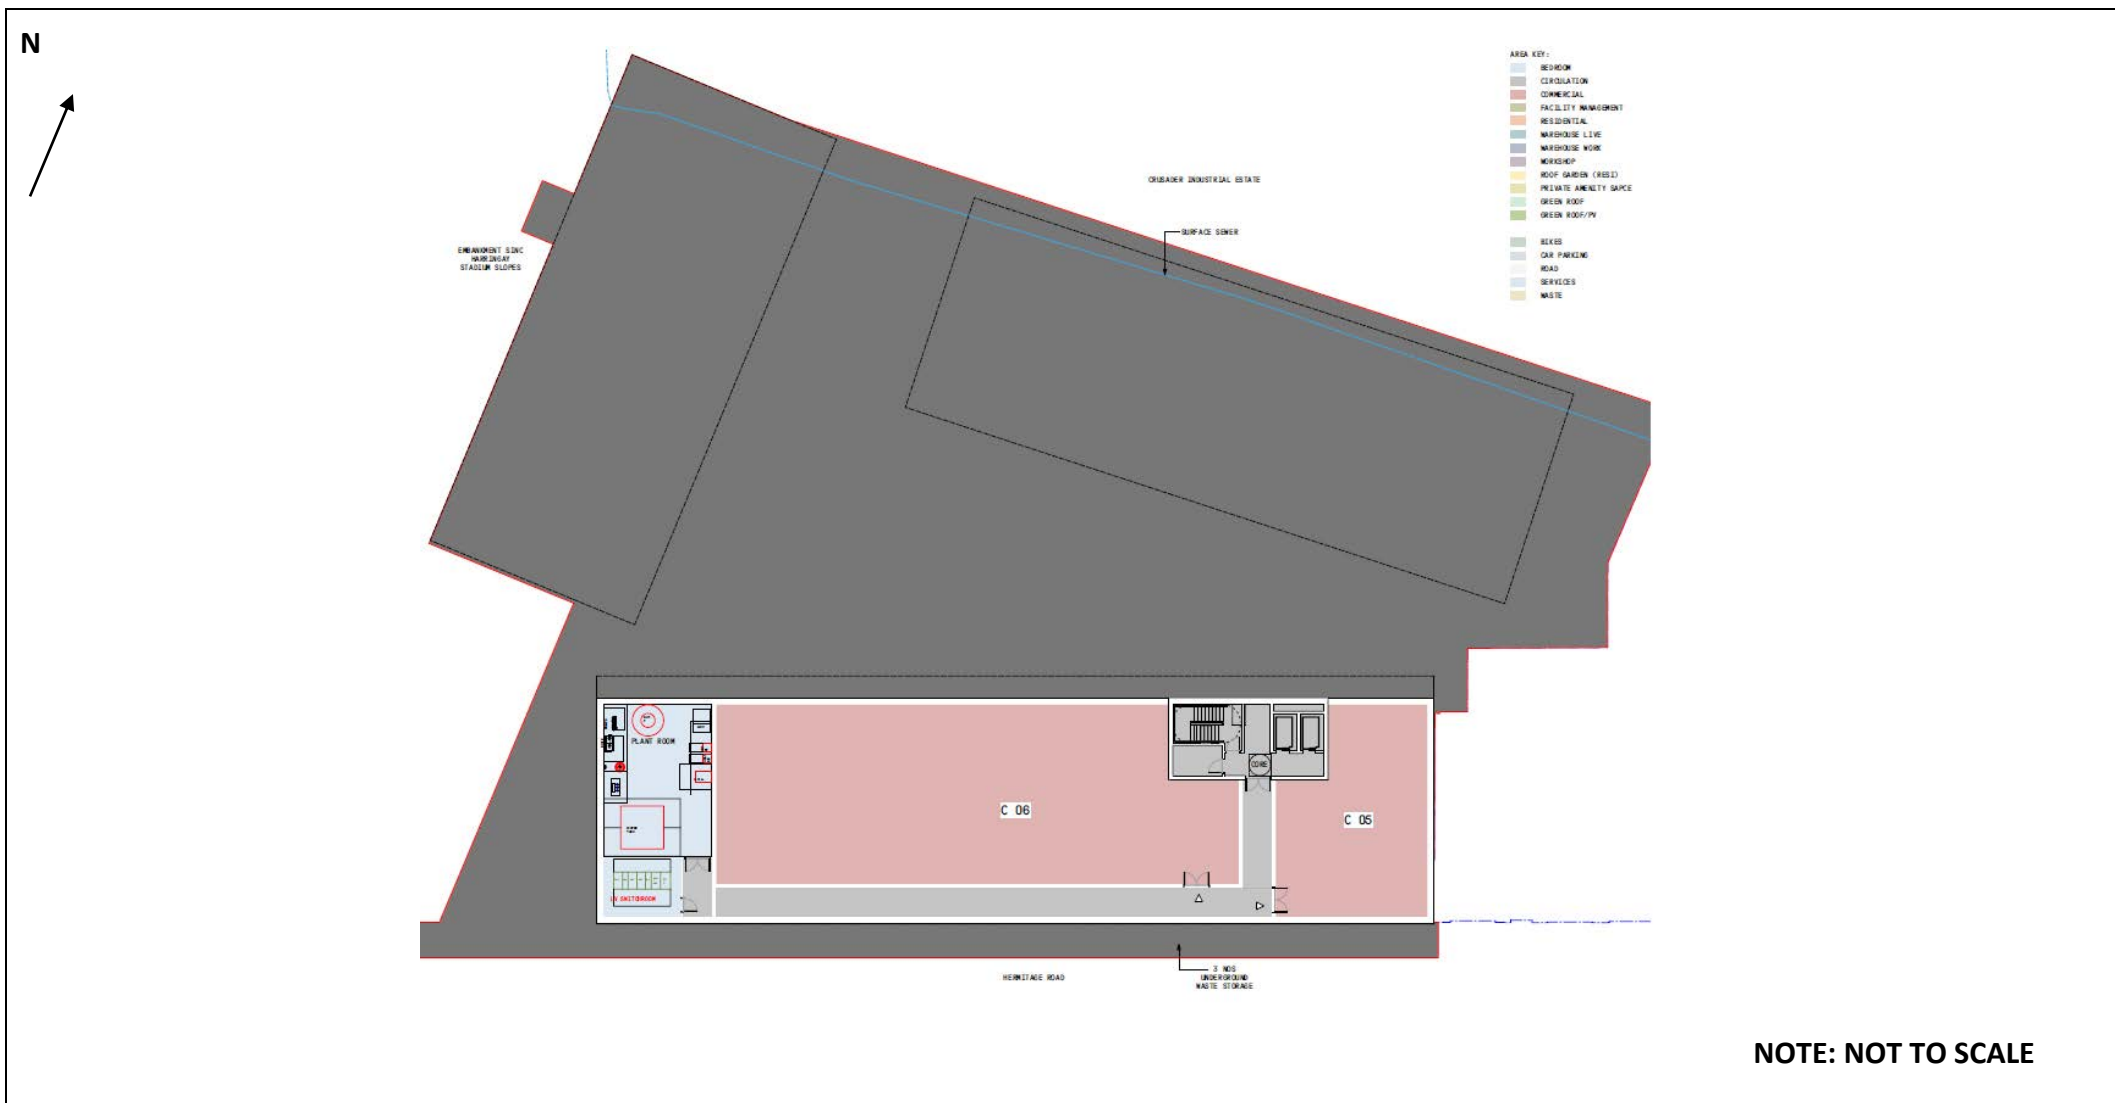
Figure 1

The site comprised a ~3,800m<sup>2</sup> rectangular-shaped plot of land, orientated in a north-east to south-west direction, along the north-western side of Hermitage Road. The site was located in the southern portion of the borough of Haringey, North London. The national grid reference for the centre of the site was approximately TQ 32344 88096. A site location plan is given within Figure 1.

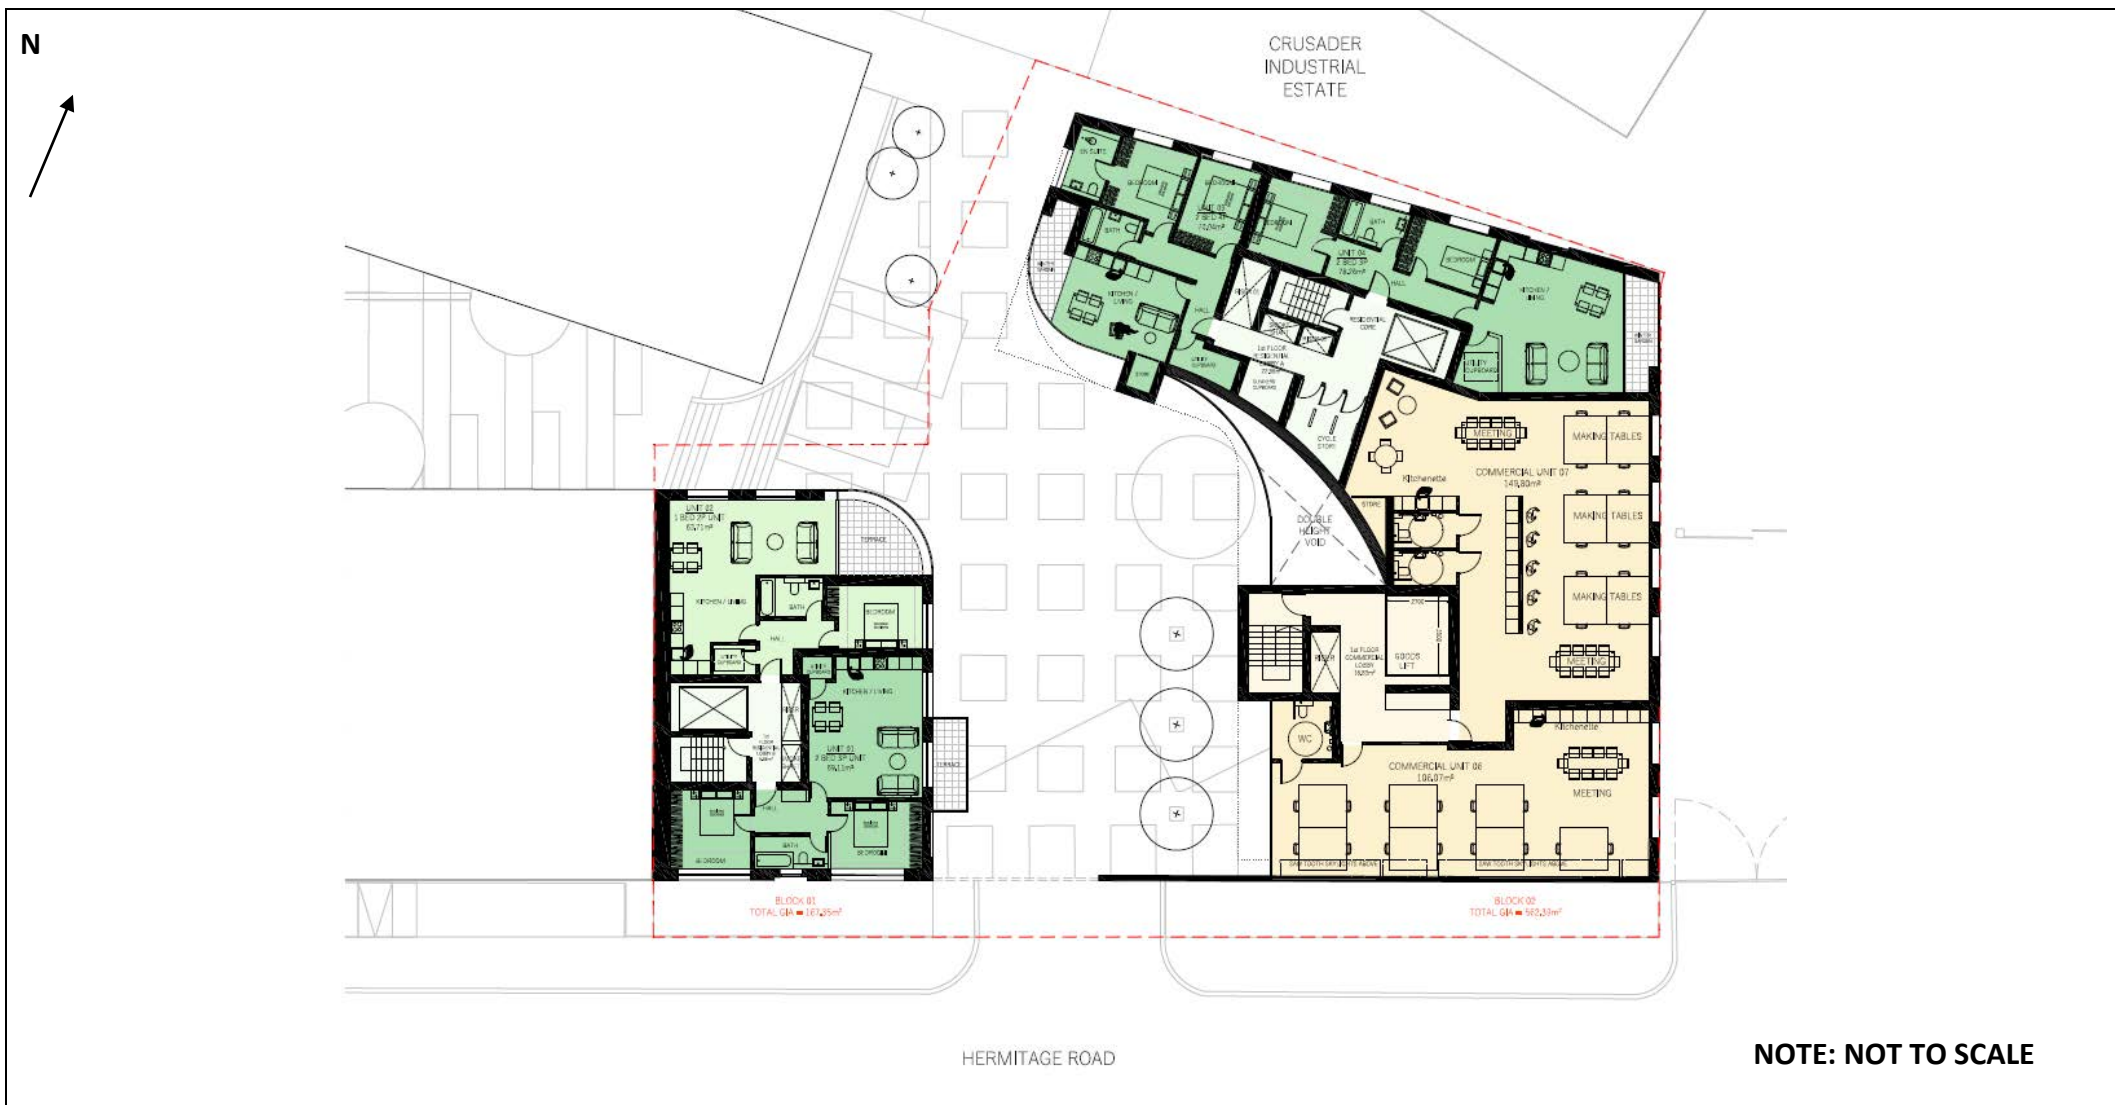
Figure 11

The approximate location of the trial hole locations can be seen within Figure 11.

For details of the composition of the soils encountered at particular points, reference must be made to the individual trial hole logs within Appendix D of this report. A trial hole location plan can also be viewed within Figure 11.

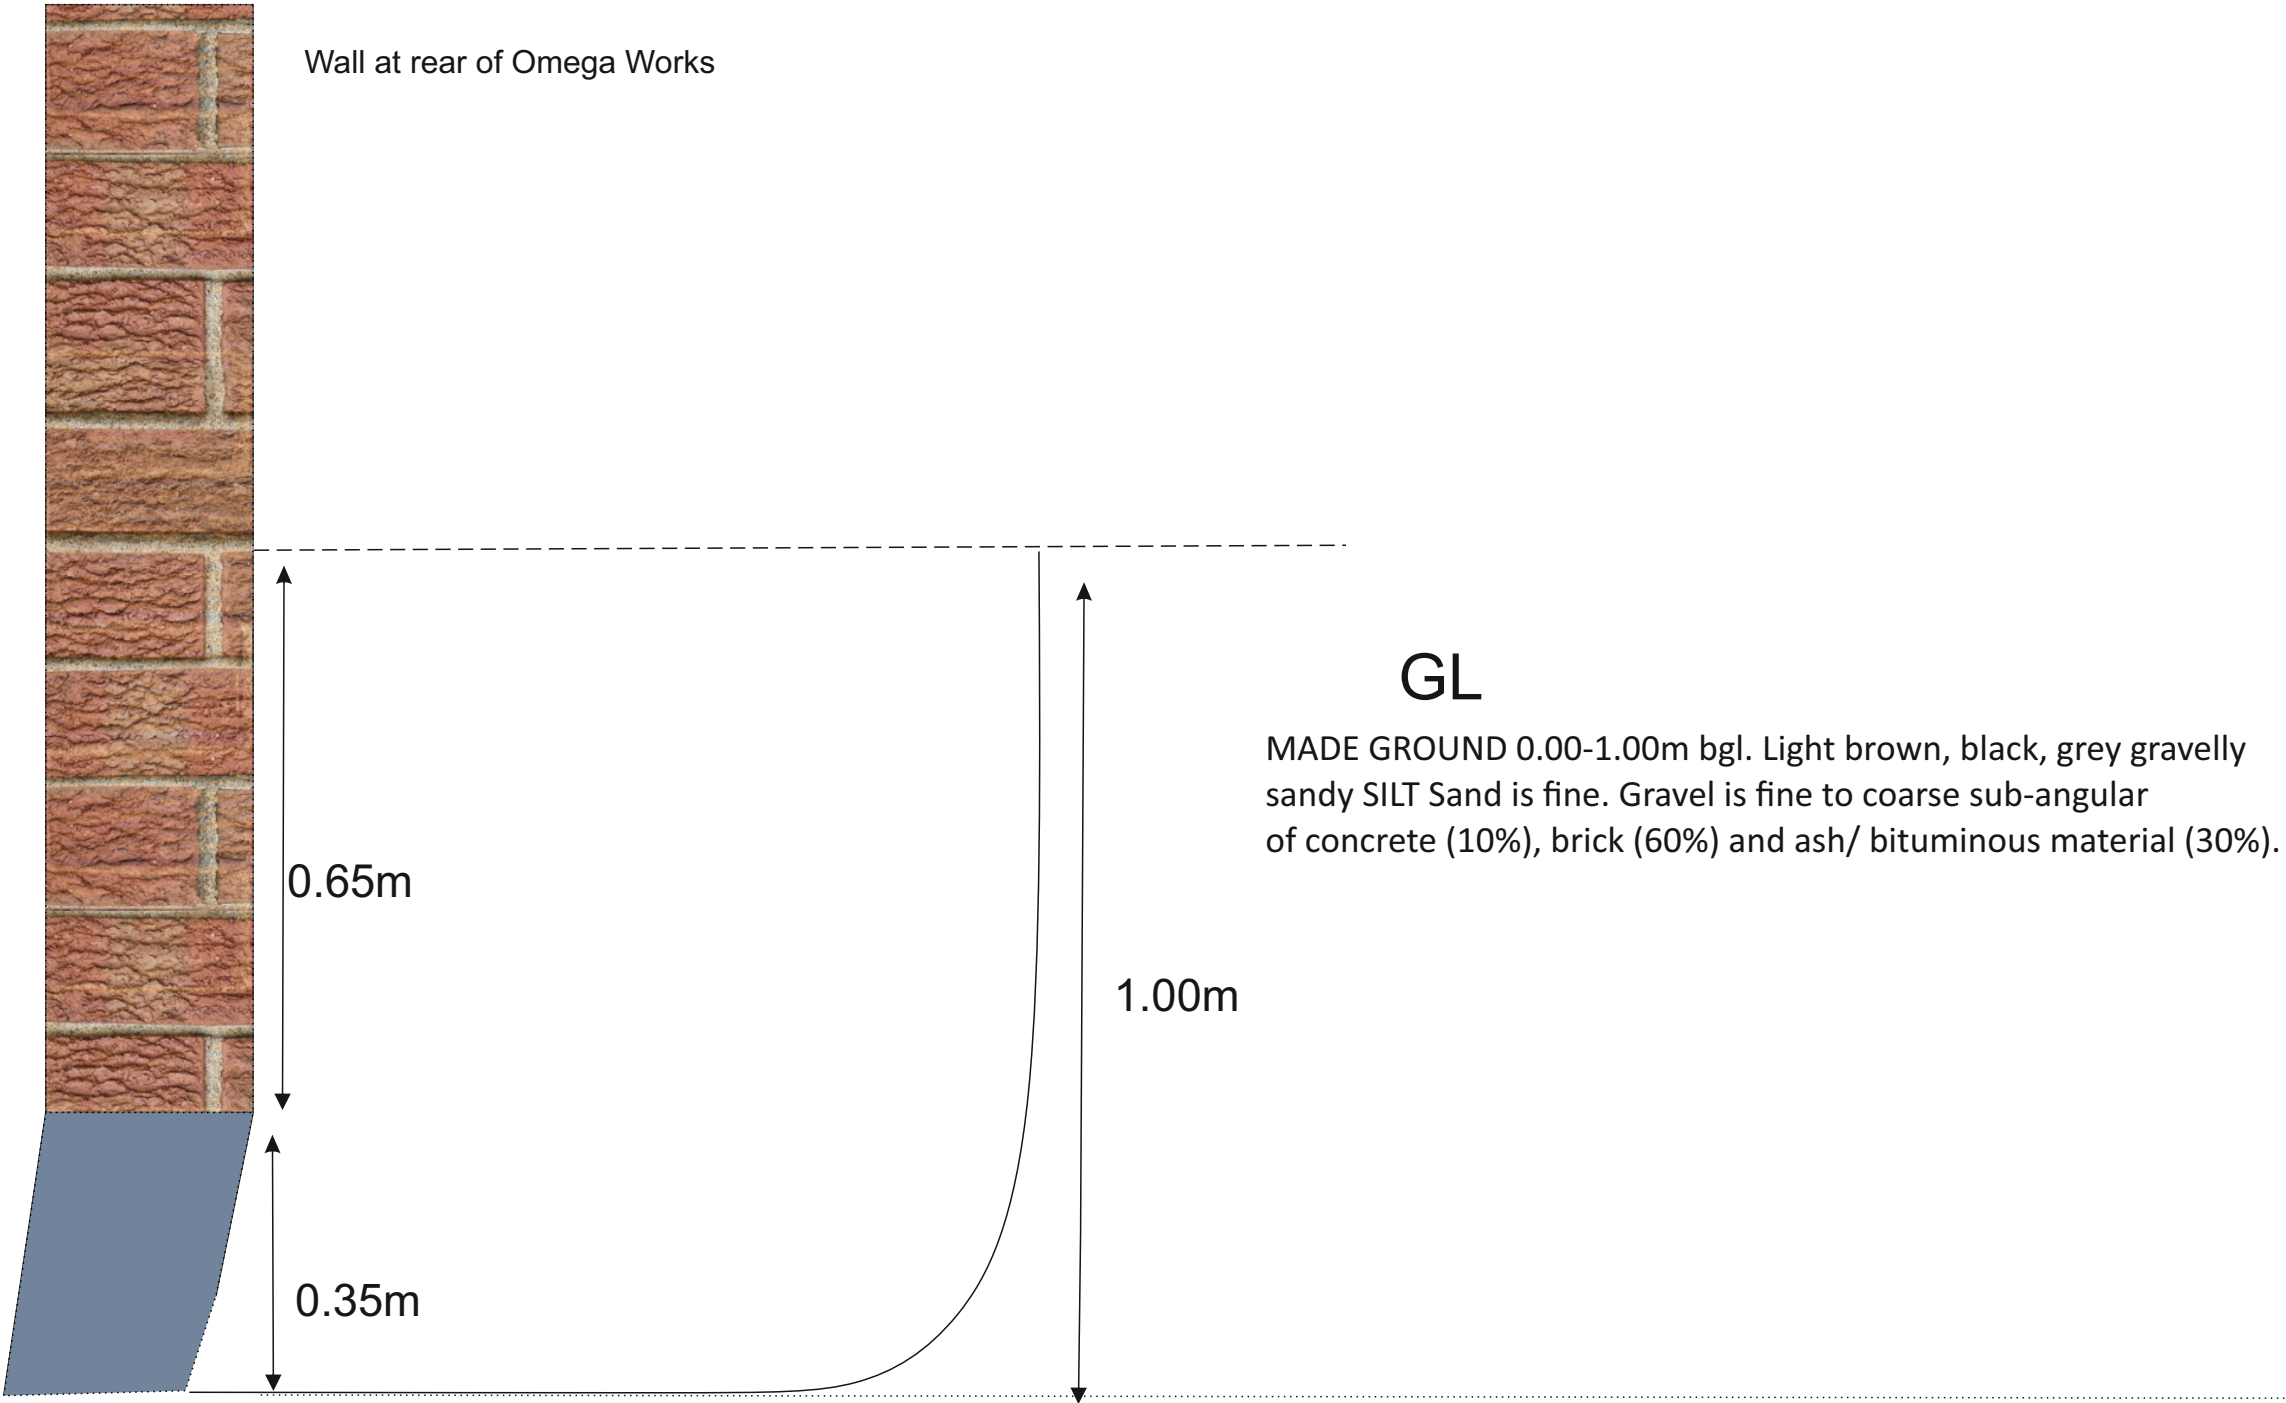
| DRAWING NUMBER<br>GWPR4712 - Figure 20 | DATE<br>June 2022 |

TP 2

- Concrete
- Brick Wall
- 0.10m Distance in Metres

The hand excavation of 8No. Foundation Exposures (TP/FE1 – TP/FE8) was undertaken across the site. A tabulated summary showing the depth and width of each foundation can be viewed below, as well as the bearing stratum. Diagrams of each foundation exposure can be viewed within Figures 20 – 27.

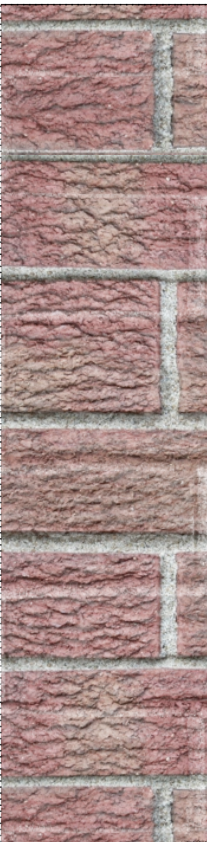
DRAWING TITLE  
Foundation Exposure TP 3

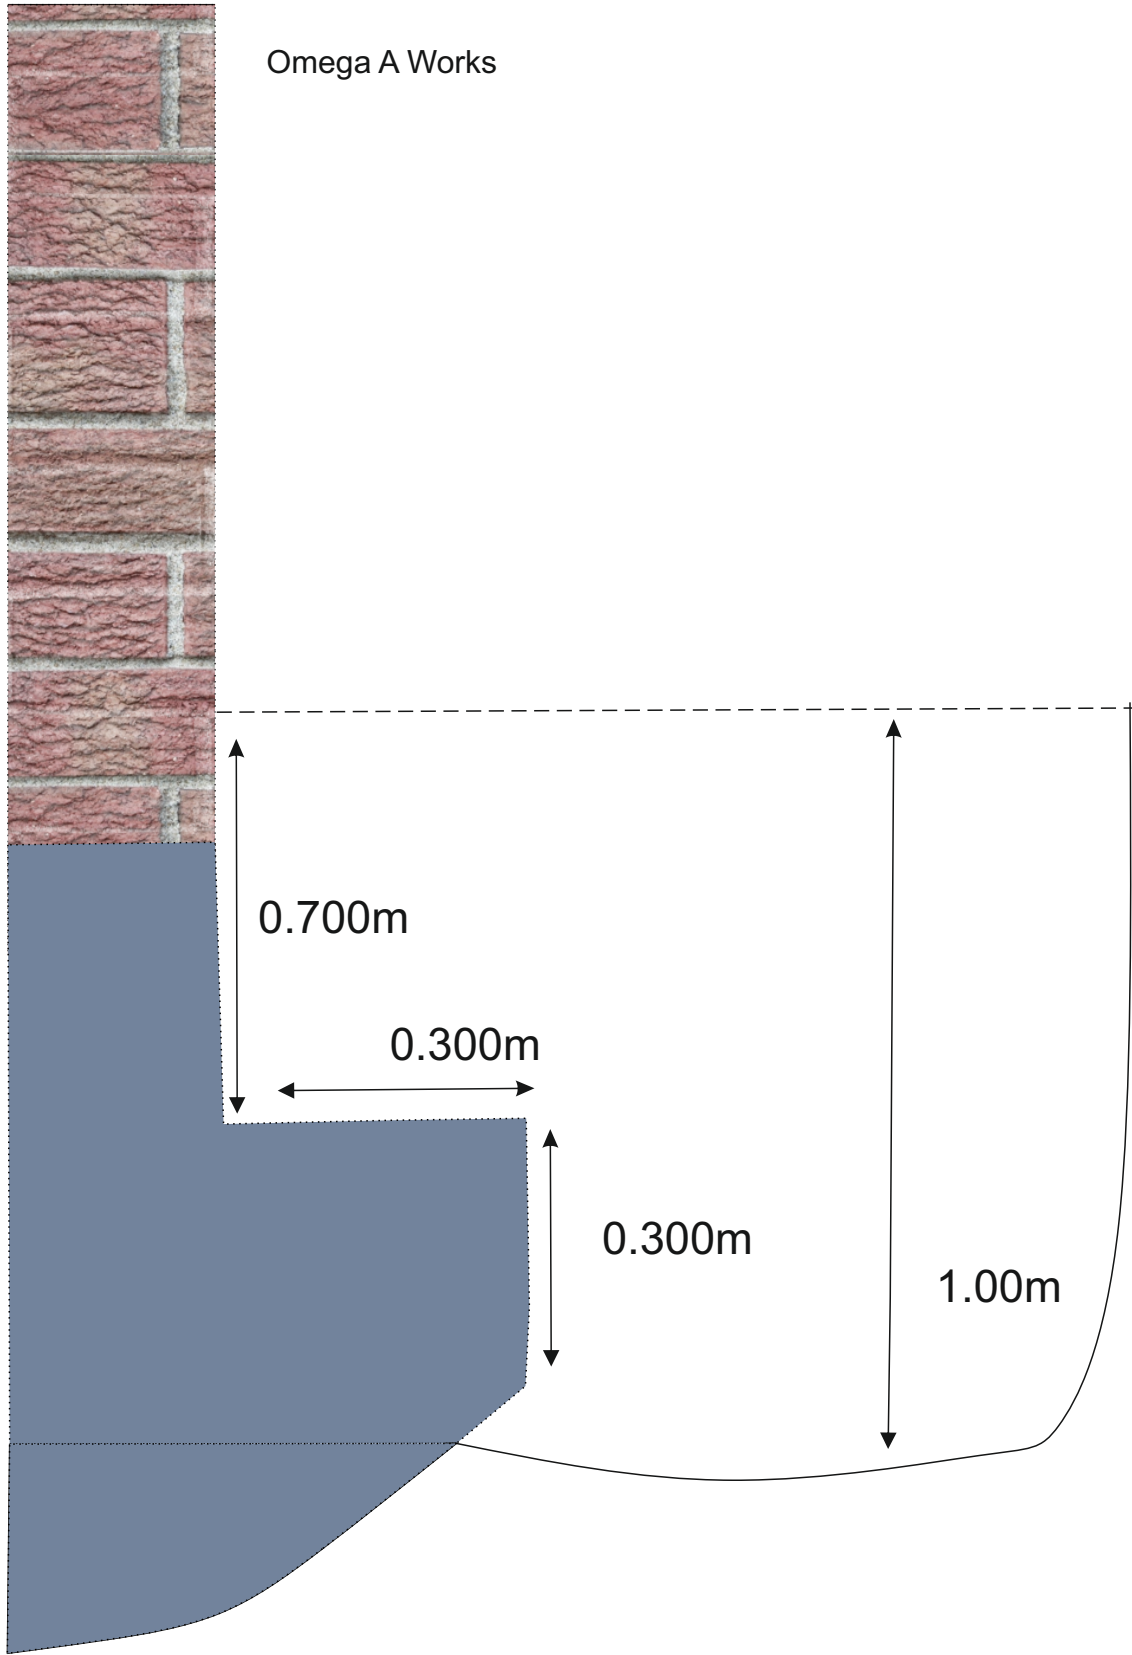
| DRAWING NUMBER<br>GWPR4712 - Figure 23 | DATE<br>October 2022 |

TP 6

MADE GROUND 0.00-0.50m bgl. Black, brown grey gravelly sandy SILT. Sand is fine. Gravel is fine to medium sub-angular of flint (50%), concrete (10%), brick (10%) and ash (30%).

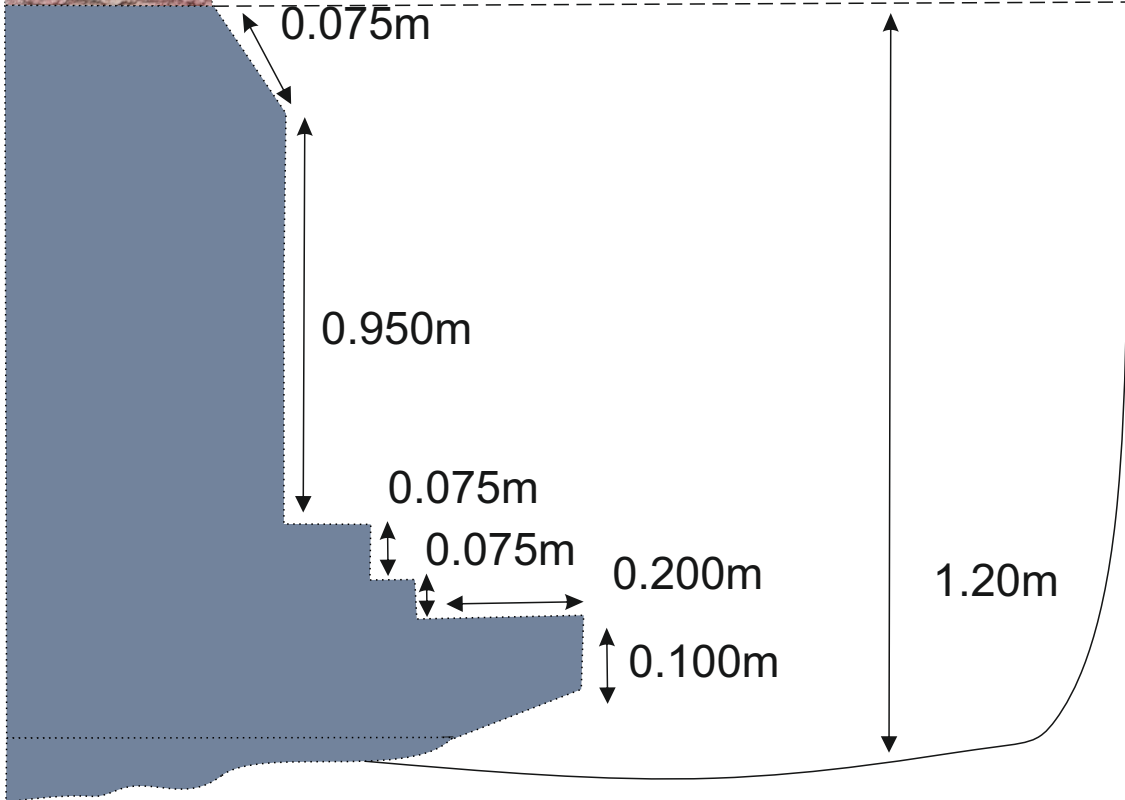
| DRAWING NUMBER<br>GWPR4712 - Figure 24 | DATE<br>October 2022 |

TP 7

MADE GROUND 0.00-0.80m bgl: Black, grey gravelly sandy SILT. Sand is fine. Gravel is fine to coarse sub-angular of brick (20%) flint (40%) and ash (40%).

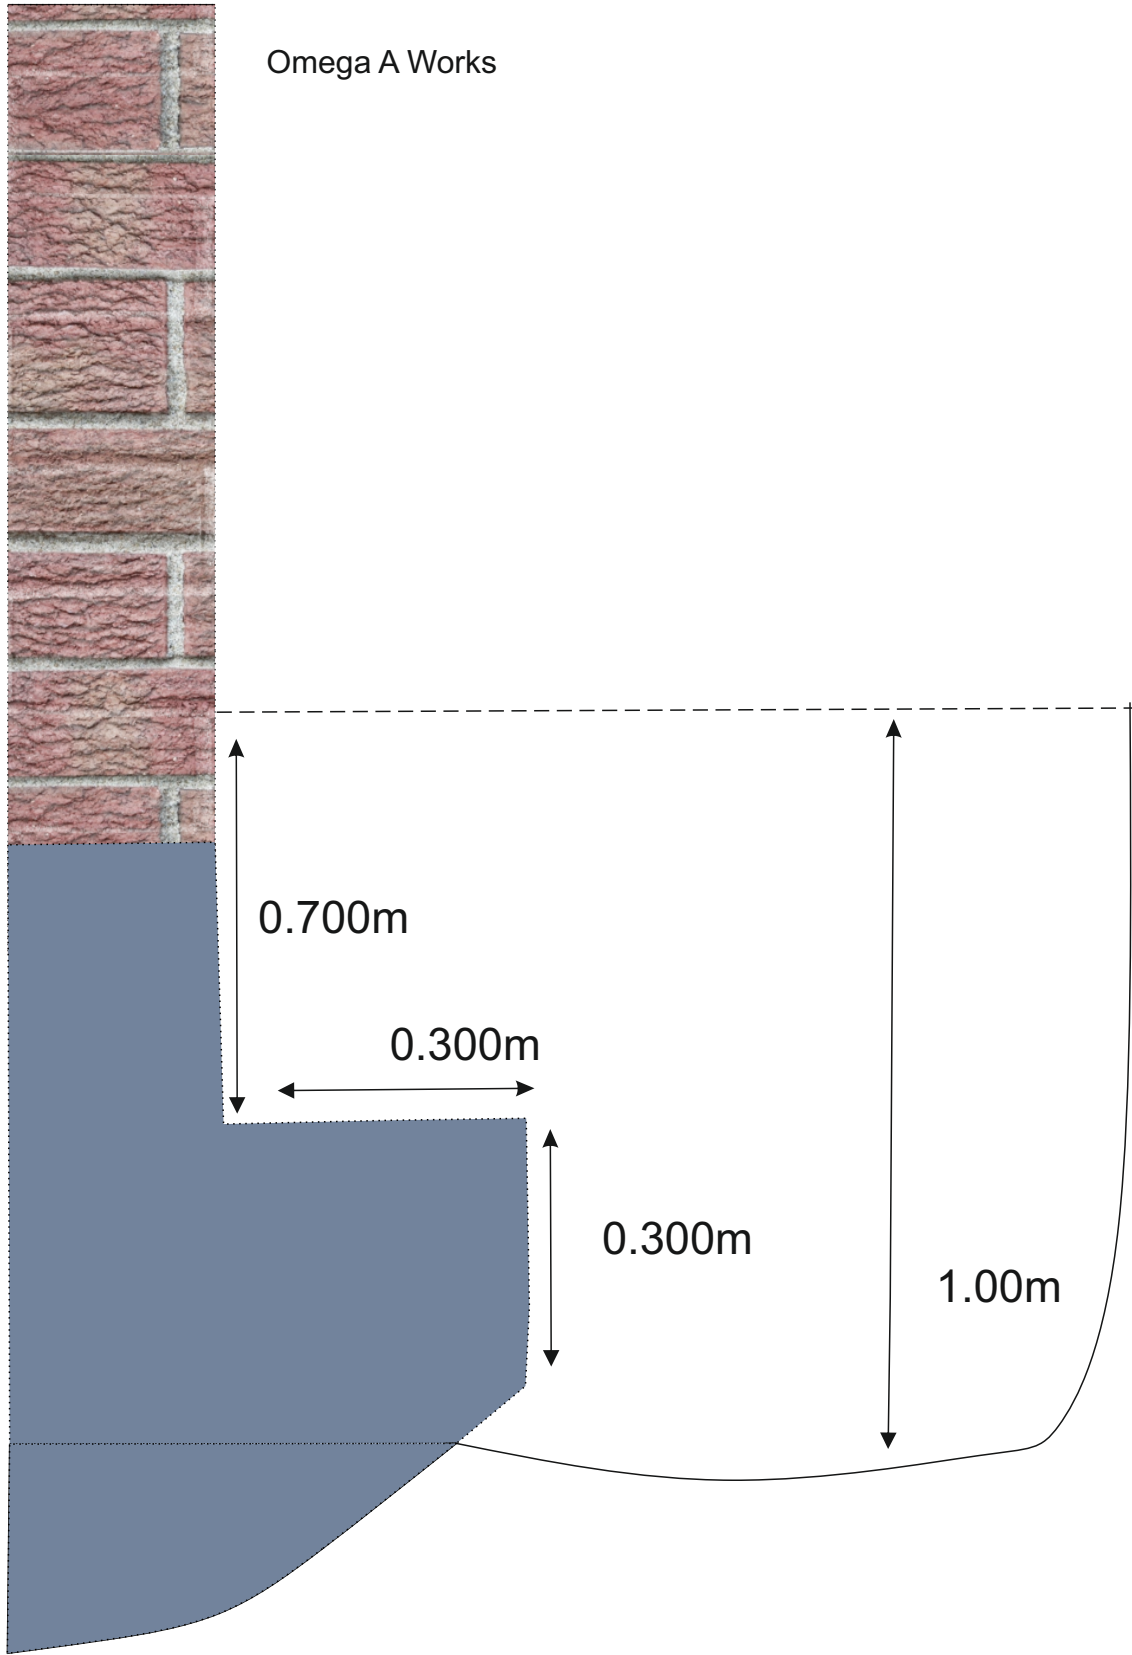
| DRAWING NUMBER<br>GWPR4712 - Figure 25 | DATE<br>October 2022 |

TP 8

MADE GROUND 0.00-0.50m bgl. Black, brown grey gravelly sandy SILT. Sand is fine. Gravel is fine to medium sub-angular of flint (50%), concrete (10%), brick (10%) and ash (30%).

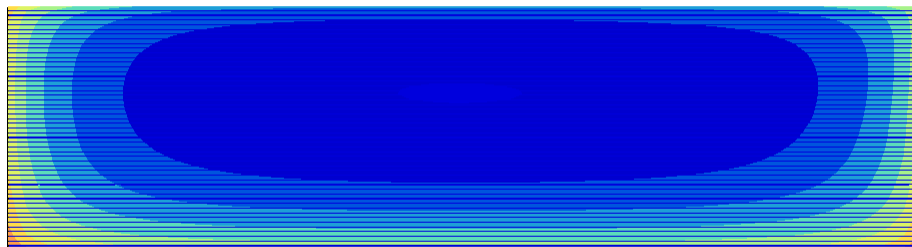
## Model 1

■ -92.15 kN/m<sup>2</sup>  
 ■ -90.00 kN/m<sup>2</sup>

■ -22.00 : -20.00 mm  
 ■ -20.00 : -18.00 mm  
 ■ -18.00 : -16.00 mm  
 ■ -16.00 : -14.00 mm  
 ■ -14.00 : -12.00 mm  
 ■ -12.00 : -10.00 mm  
 ■ -10.00 : -8.000 mm  
 ■ -8.000 : -6.000 mm  
 ■ -6.000 : -4.000 mm

Analyses of vertical ground movements, using the Mindlin analysis method within Pdisp software, was undertaken to assess the potential movements resulting from changes of net vertical pressure changes. Geotechnical parameters noted in the previous section of this report were used for the model. A rigid boundary at depth was considered at 42.50m bgl, for calculation purposes. The inputs and outputs of this analysis can be viewed within Appendix F.
