# NOS. 808-810/812 HIGH ROAD

## SECTION FOUR: DESIGN RESPONSE

DESIGN & ACCESS STATEMENT

### 4.1 PROTECTING THE EXISTING FABRIC

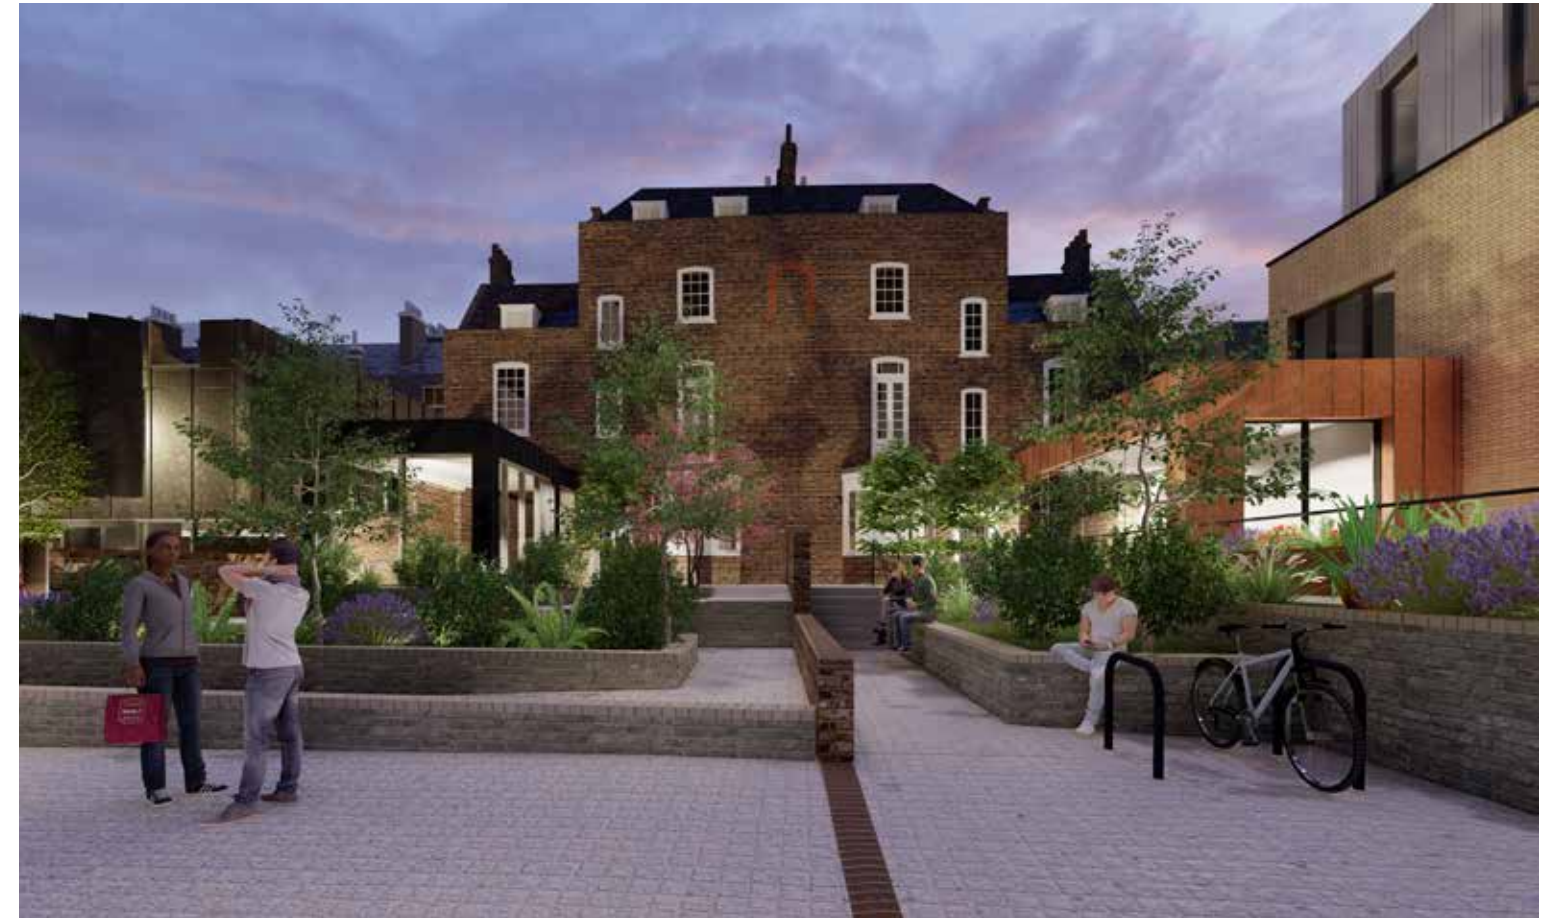
**FIGURE 23.** Proposed rear extensions accomodating cafe and gallery uses

- Uses which are likely to have more of an impact on the interiors accommodated within new build elements. For example, the gallery and cafe spaces which have a public use.
- Close consideration given to where necessary interventions are proposed in response to the siting of the most significant existing internal features.
- For example, in No. 810/12, at first floor, the WC layout has been carefully considered such that it does not conflict with possibly the most significant 18th Century surviving wallpaper sample.
- The siting of the lift is another example of this approach.

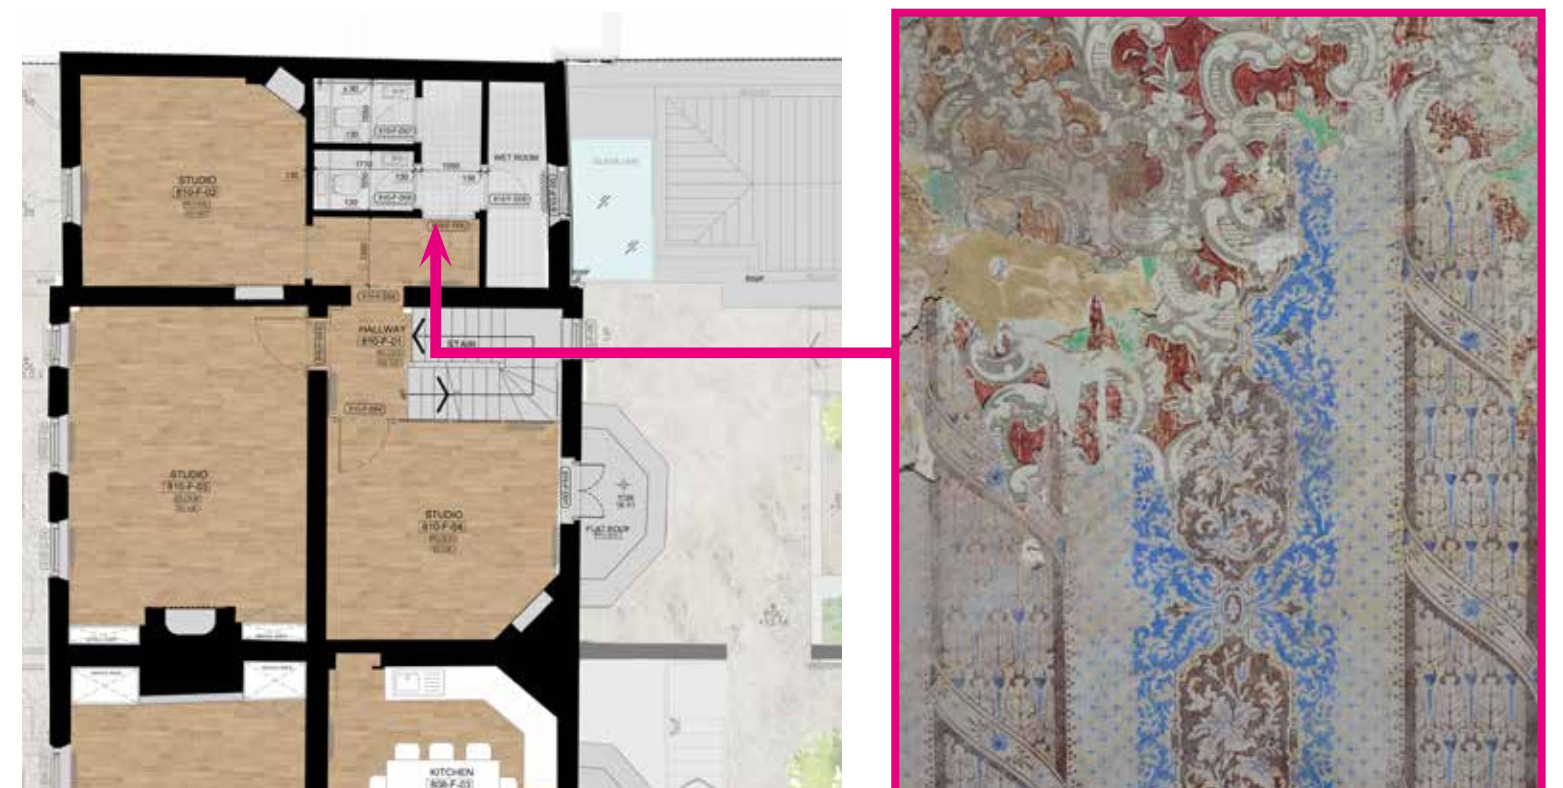
**FIGURE 24.** Key plan showing location of 18th Century wallpaper

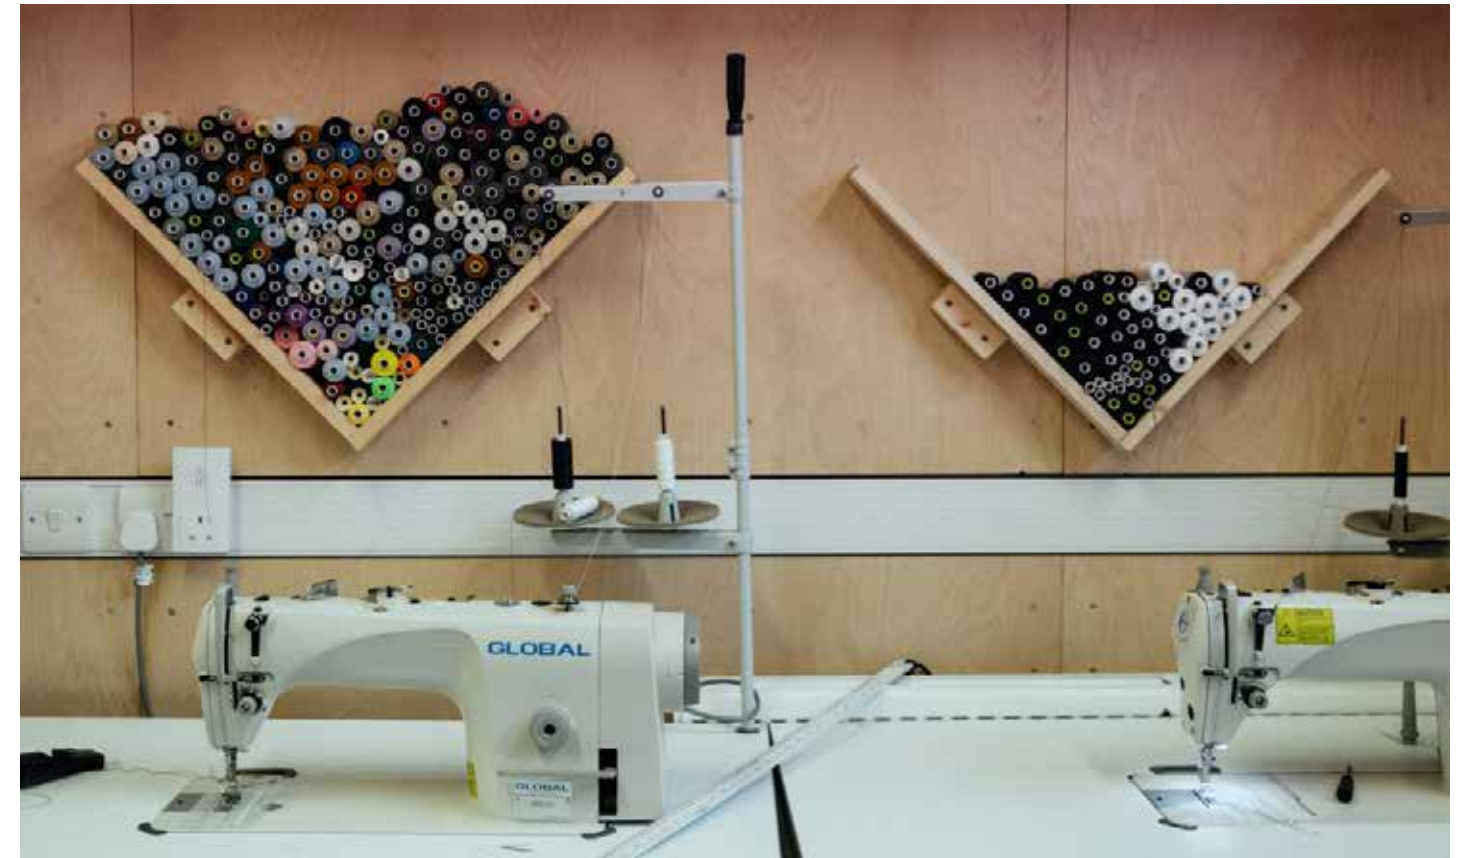
**FIGURE 25.** Existing ply linings in Hoxton

- Following the precedent set at their existing premises, the proposals see plywood linings set off the existing fabric to provide flexible pin up space.

- This also creates a very important 'group aesthetic'.
- These linings would in turn protect the existing fabric.
- They are set in from the historic room envelope, both in plan and elevation, such that existing features are still visible.

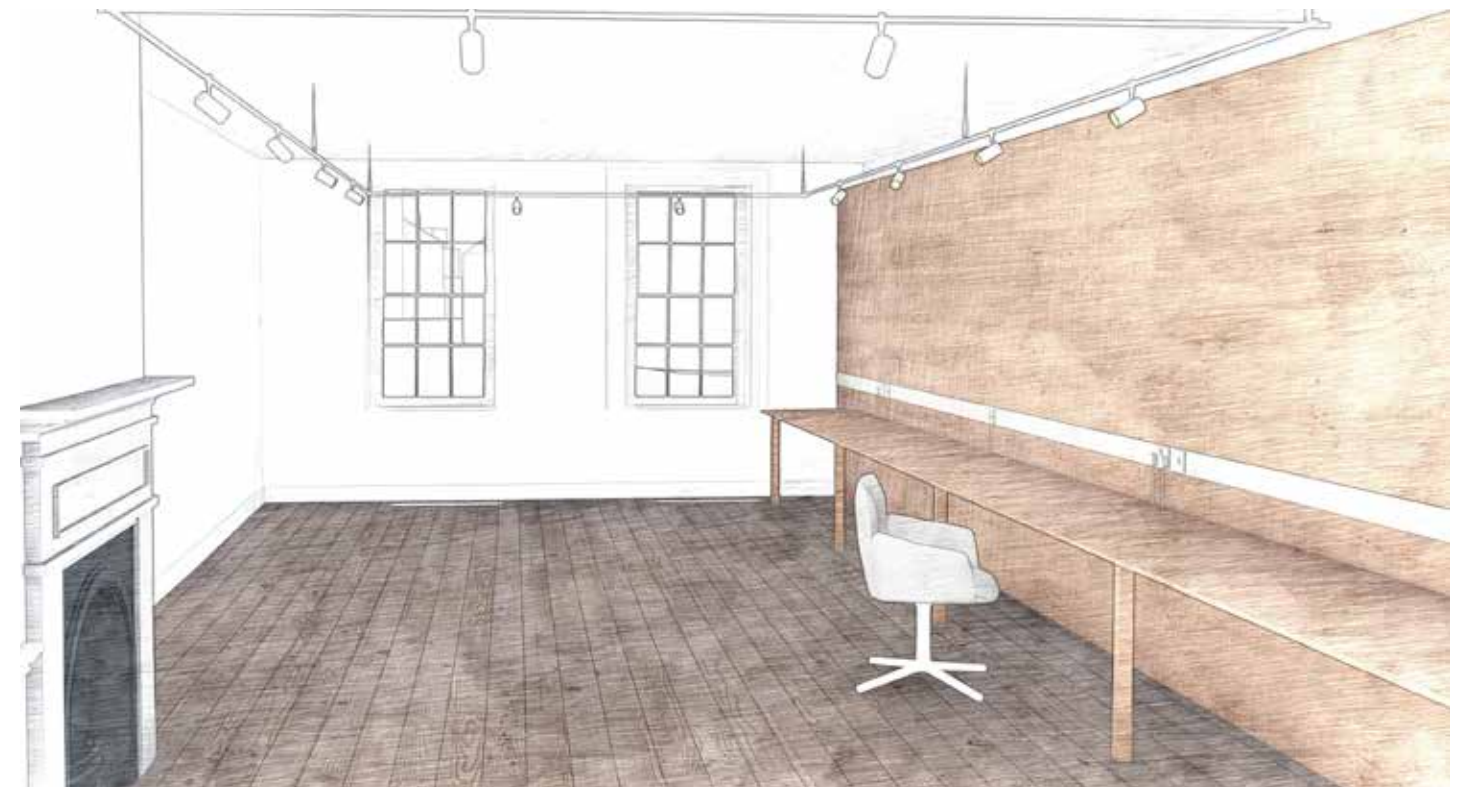
**FIGURE 26.** Proposed visuals for ply linings in studios

- Their scope is limited such that they would not impact all elevations within a space.
- These are being tested at Sarabande's interim accommodation a few doors down on the Terrace – please refer to the detailed drawing on the following page:
