**ASHLEY HOUSE & CANNON FACTORY, ASHLEY  
ROAD SOUTH, TOTTENHAM HALE, LONDON**

**FACTUAL AND INTERPRETATIVE REPORT ON  
GROUND INVESTIGATION**

**Report No D8061-18**

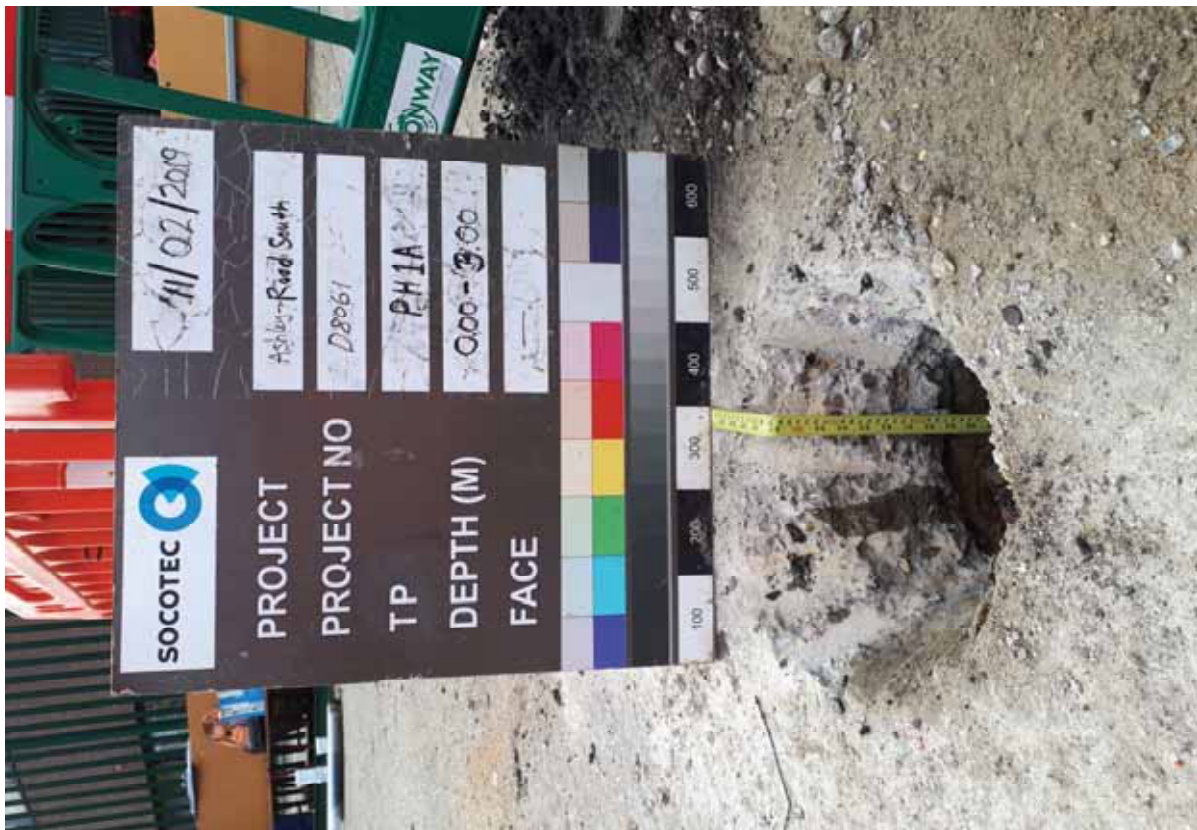
generally angular to rounded, fine to coarse of brick, concrete and siliceous material. A strong hydrocarbon odour was noted in the Made Ground below 0.65 m in PH1A (ie the north-west corner of the Ashley House site).

PH1A Pit 0.00m - 3.00m

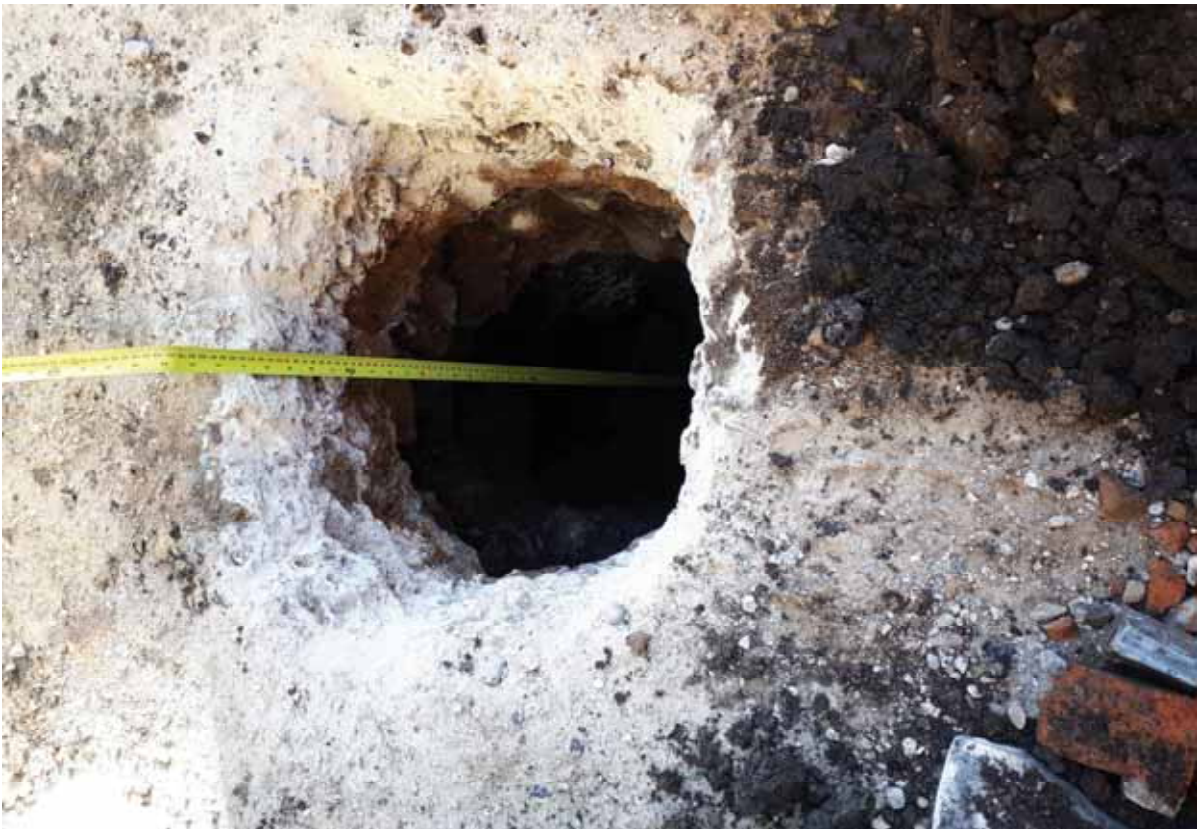
The Enfield Silt Member typically consists of very soft to soft, orangish/yellowish brown, locally fissured, slightly sandy gravelly clay, with occasional pockets of amorphous peat. A moderate organic odour was noted in this material in PH2. The gravel fraction of the material is typically angular to rounded, fine to coarse of siliceous material (flint).

PH2 Inspection Pit 0.00m - 1.20m
