Wood Green Underground Station shop front detail A  
 © Savills November 2022

wood arm underground station shopfront detail B.

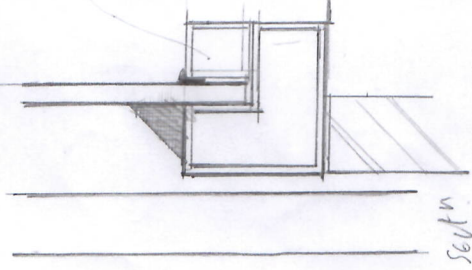
Section through shopfront  
(replacement in S.A.A.)  
@ 1:2

blind track

S.A.A. shopfront

door frame with  
(original) bronze  
cladding.

hardwood door casted  
externally in bronze  
in place @ 1:2

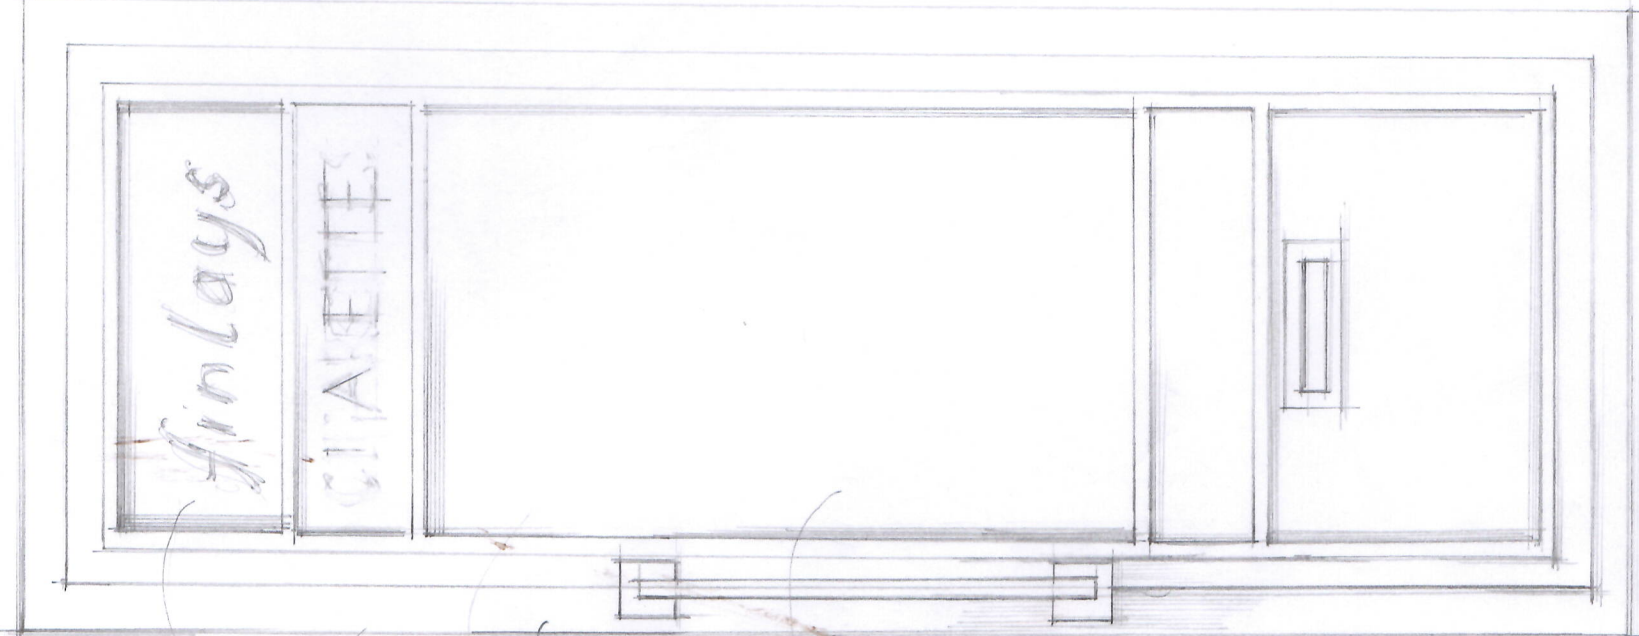
External elevation to shopfront @ 1:10

Remove overpanel  
boarding

clean & repolish  
hardwood

Repair damaged  
door in hardwood  
to match

Introduce  
applied drop  
draught  
excluder

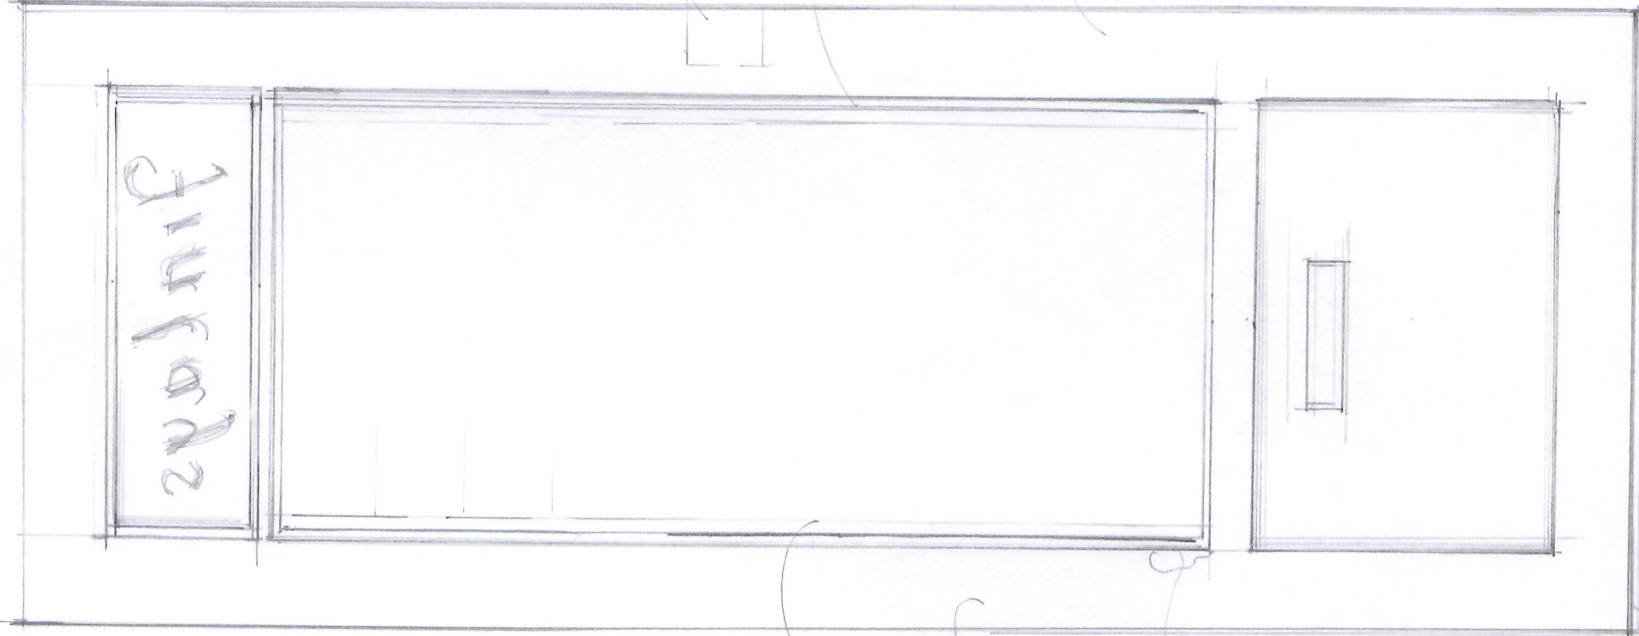
Internal elevation to shopfront @ 1:10

shopfront

Repair where former lockcase  
damaged frame  
Renew glass with  
new hardwood bearing

roller shutter  
S.A.A. shopfront.
