## **Annex D: Site Investigation Report**

- 'Factual Ground Investigation Report', ref.no. FACT/12942, Chelmer Global Ltd, November 2022

# Factual Report

| <b>Site</b> | Braemar Avenue Baptist Church<br>London<br>N22 7BY |

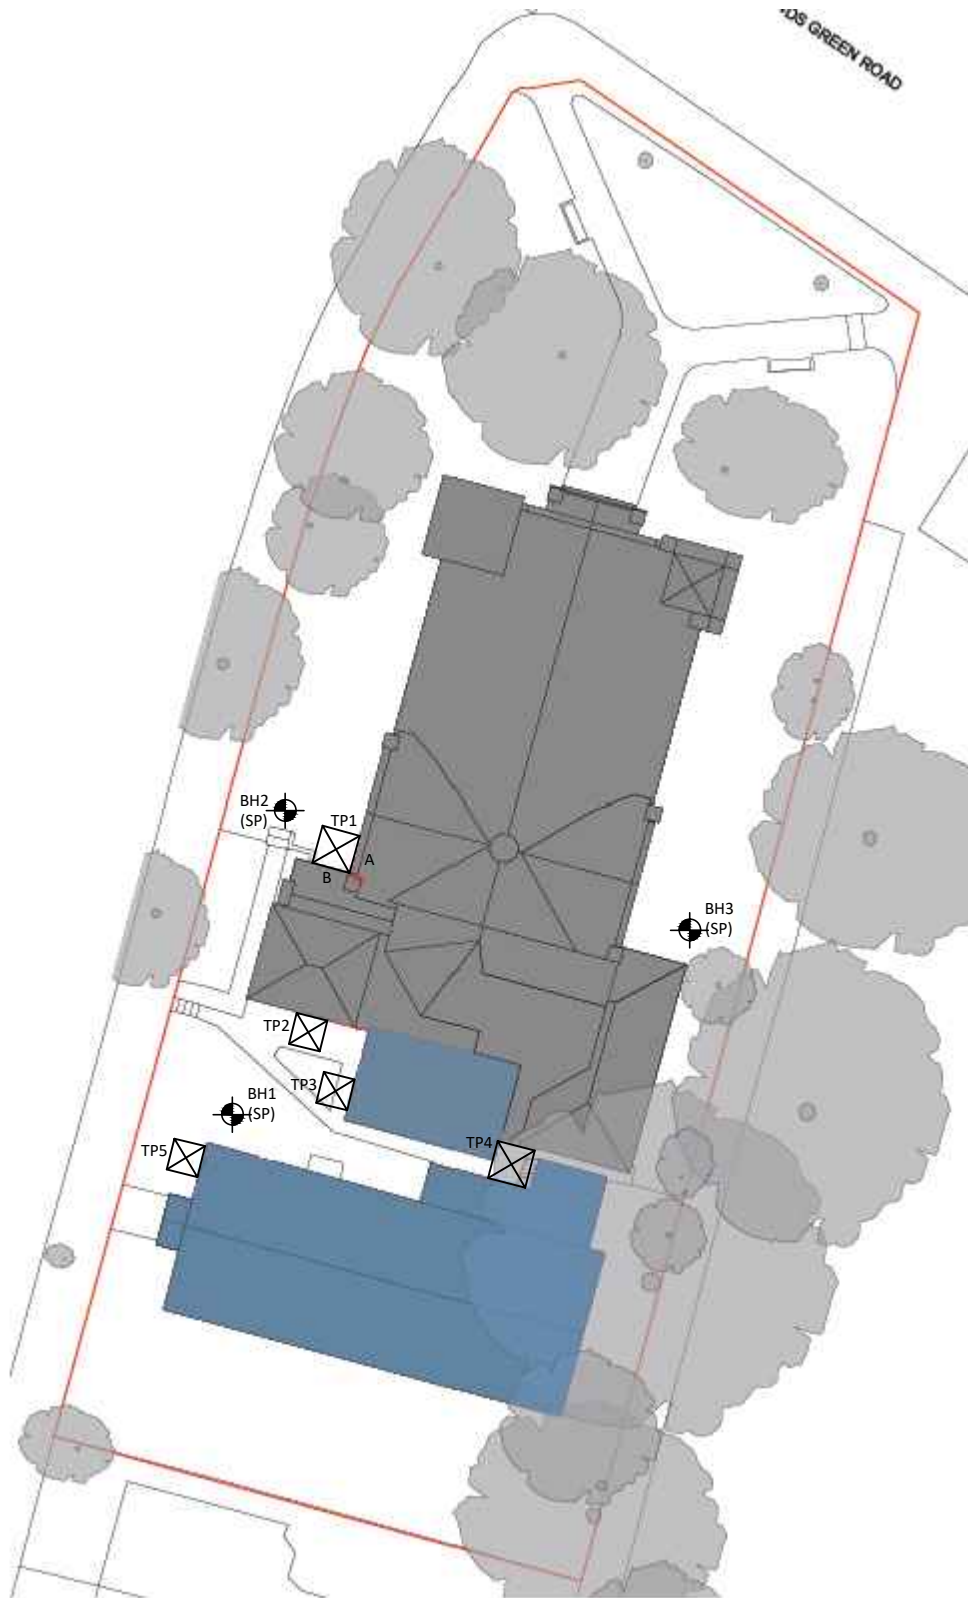
## Sketch Site Plan

**Remarks:** No access for trial pit 2 and 3 in proposed positions- TP2 and 3 relocated.  
On site tree identification for guidance only. Not authenticated.  
All dimension in metres unless stated otherwise.

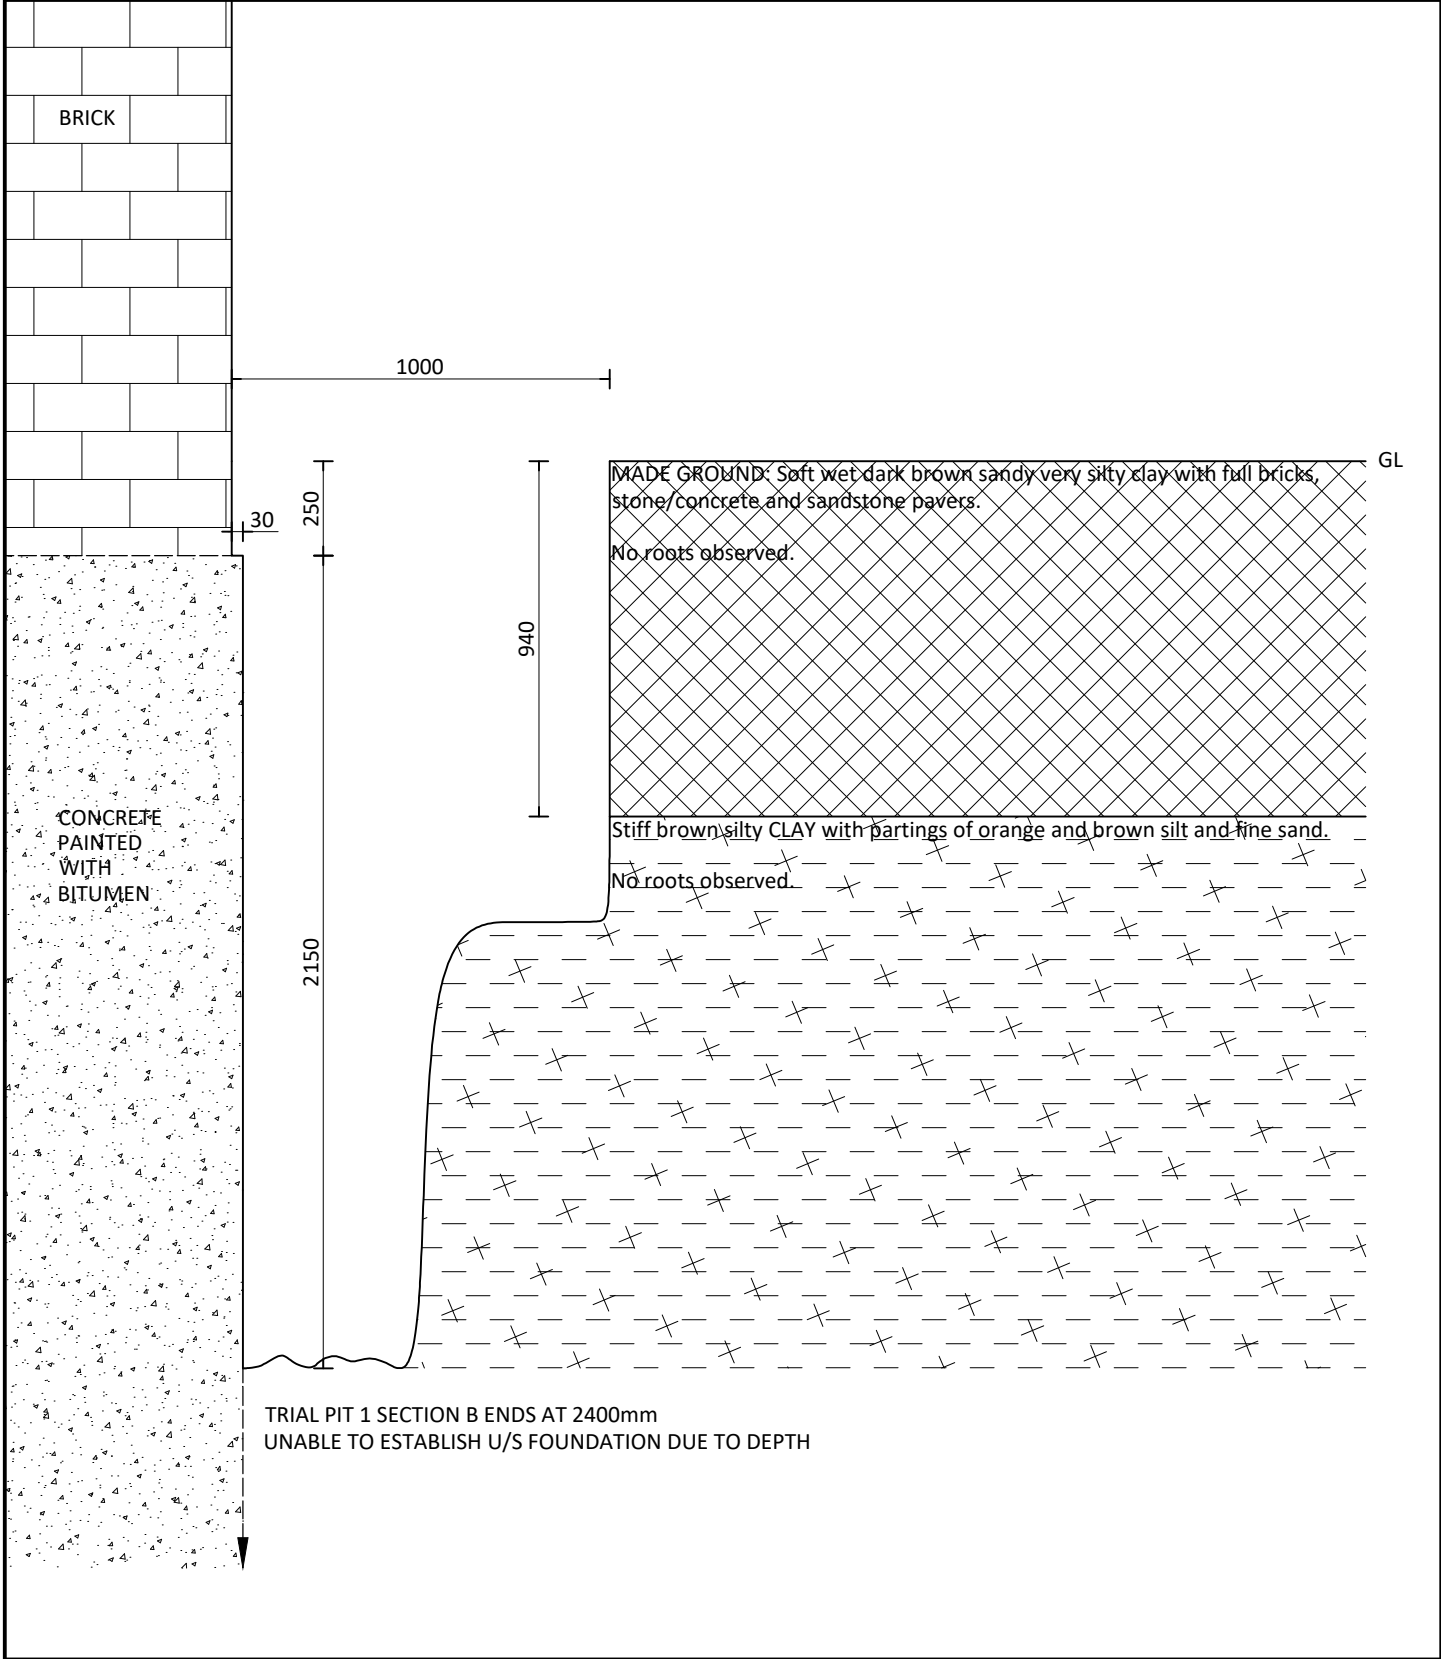
| Hand augured down face of concrete to attempt to find u/s foundation. | ND No Data |
