# **GEO-ENVIRONMENTAL & GEOTECHNICAL ASSESSMENT (GROUND INVESTIGATION) REPORT**

Partridge Way  
Wood Green  
N22 8DT

**Report Title:** Geo-environmental & Geotechnical Assessment Ground Investigation Report for Partridge Way, Wood Green, N22 8DT

**Job No:** P2794J2049/TE

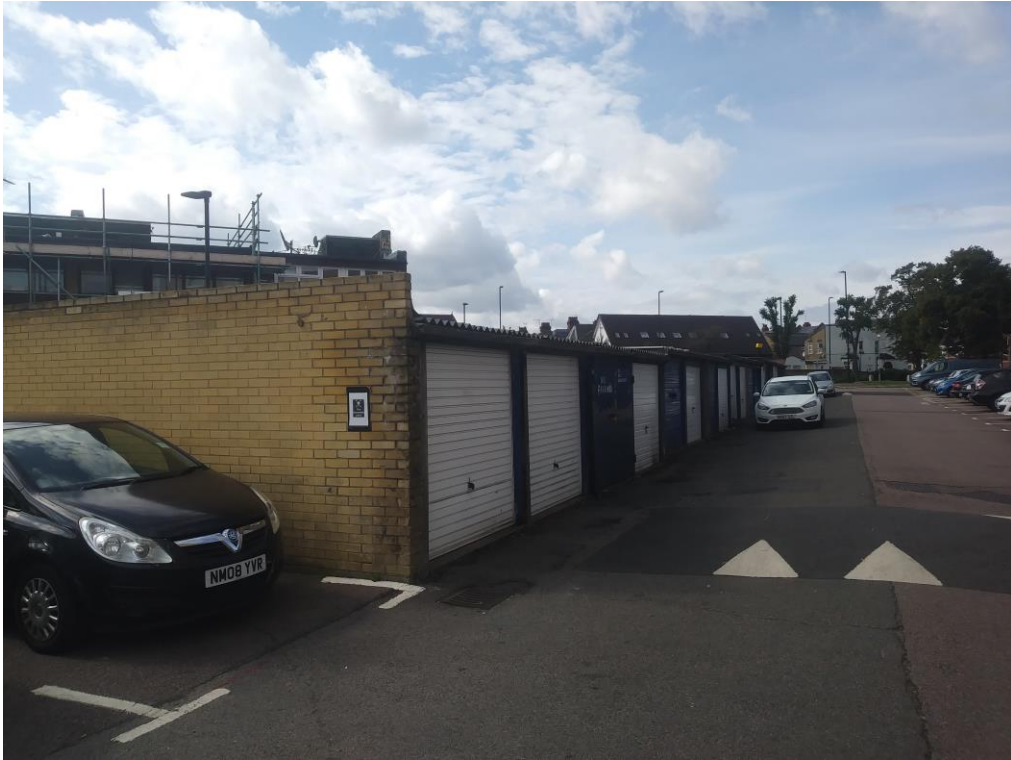
| <b>Photo 1:</b> The site, as viewed east from Partridge Way. | | <b>Photo 2:</b> The site, as viewed west from Partridge Way | |

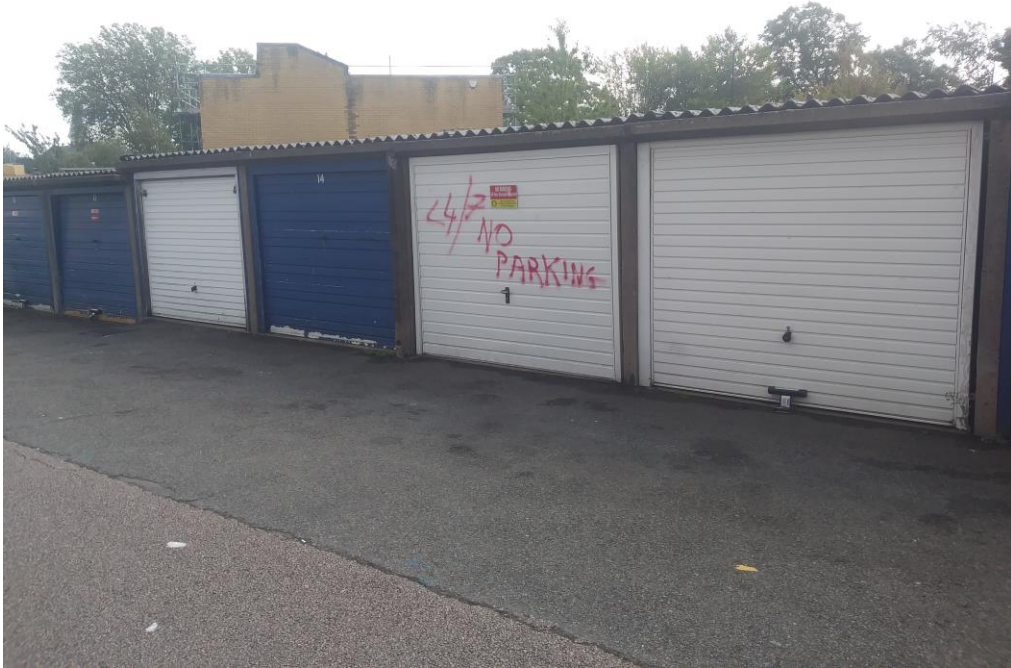
| <b>Photo 3:</b> Domestic lock-up garages onsite, viewed south form Partridge Way. | | <b>Photo 4:</b> Paved area in the south of the site, viewed east. | |

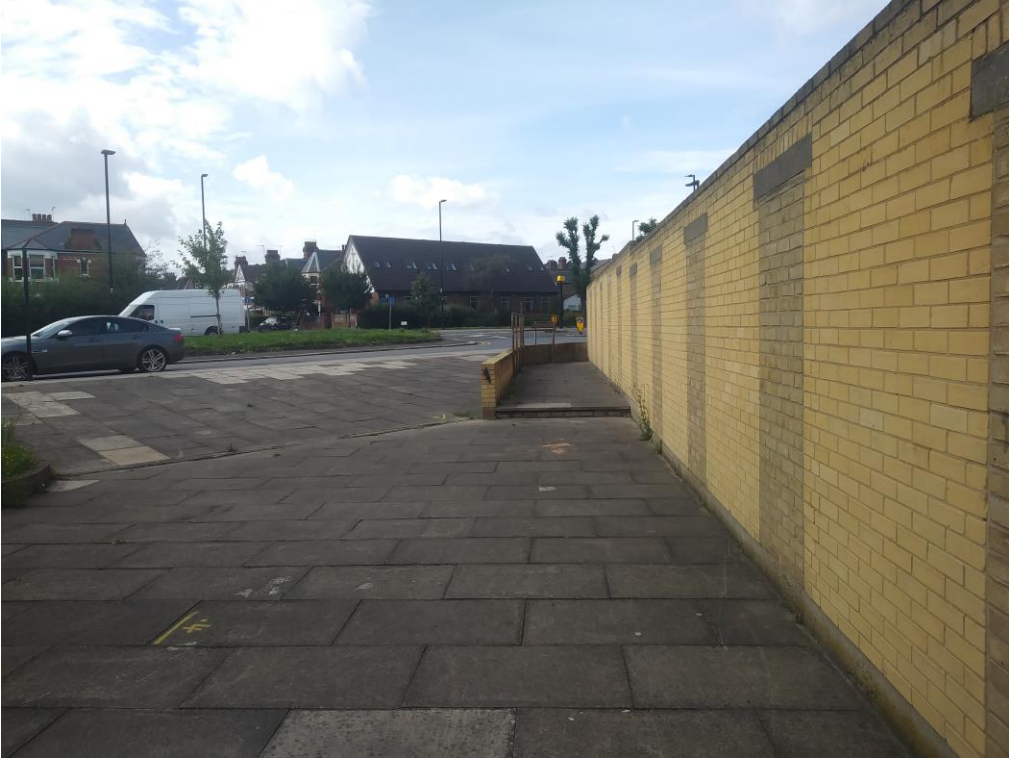
| <b>Photo 5:</b> Paved area in the south of the site, viewed west. | | <b>Photo 6:</b> Manhole adjacent to the south of garage block. | |

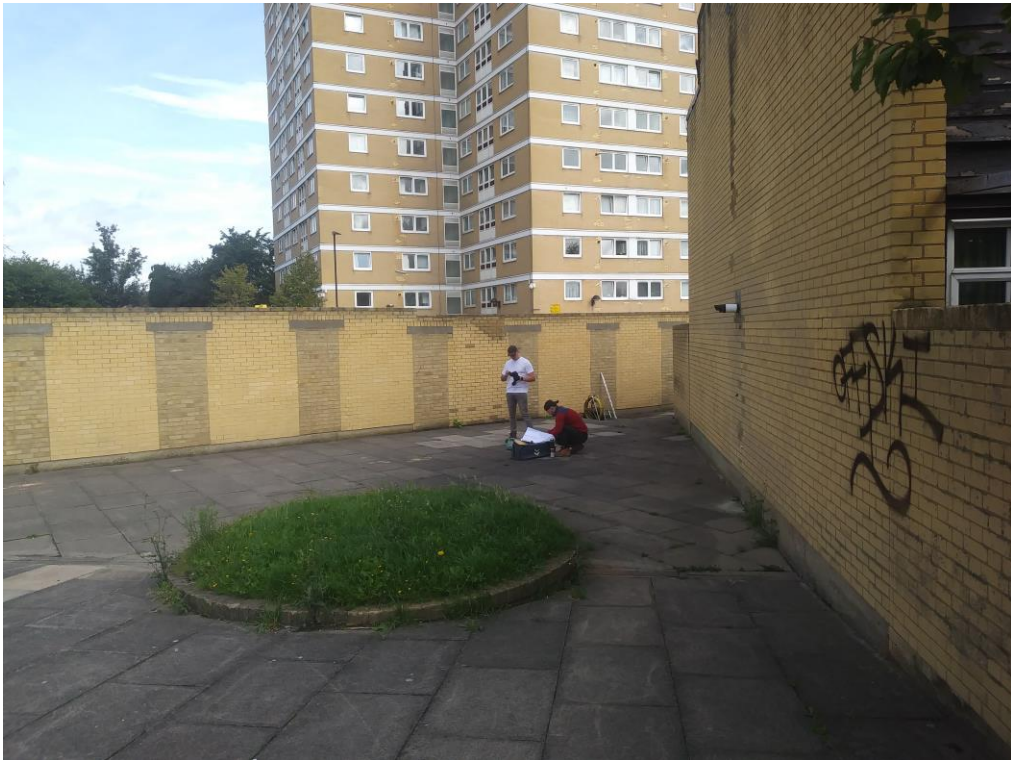
| <b>Photo 7:</b> Island of turf in south of site, viewed north. | | <b>Photo 8:</b> Trinity Road, adjacent to the south of site, viewed southeast. | |
