| Stockpile Validation Inspection Form | | | |
| Site:<br>Clarendon Road Phase 3 | | Job No:<br>6075 | |
| Company: | Keltbray Remediation | | |

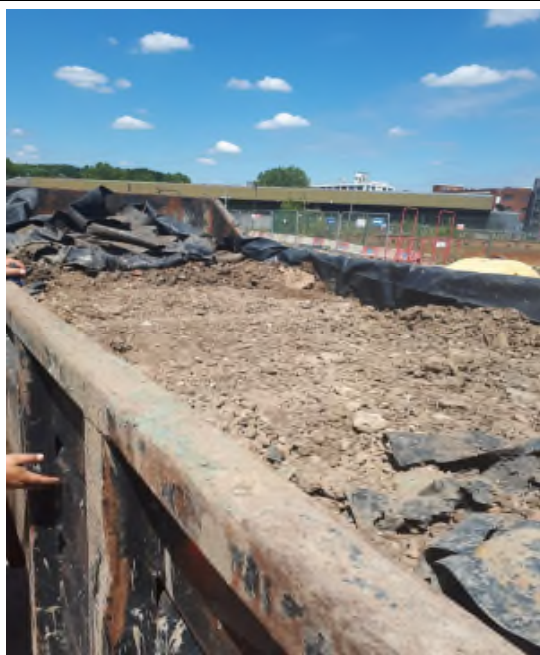
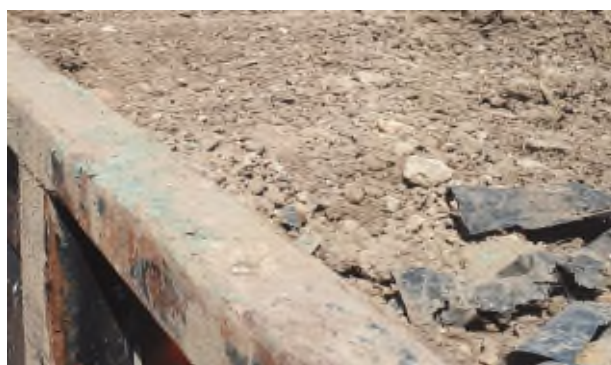
| Stockpile Validation Inspection Form | | | |
|---|---|---|---|
| Stockpile ID: | SP-Knotweed | | |

| Stockpile Validation Inspection Form | | | |
|---|---|---|---|
| General Description of Material:<br>topsoil and made ground removed during knotweed excavation/removal. | | | |
| Visual Evidence of potential contaminants e.g. oily residues, asbestos, etc.:<br>No visual or olfactory signs of contamination | | | |
| VOC PID analysis (ppm):<br>0 | | | |
| Comments:<br>Topsoil from the knotweed excavation as supervised by specialist. Stored in lined skip for disposal. | | | |

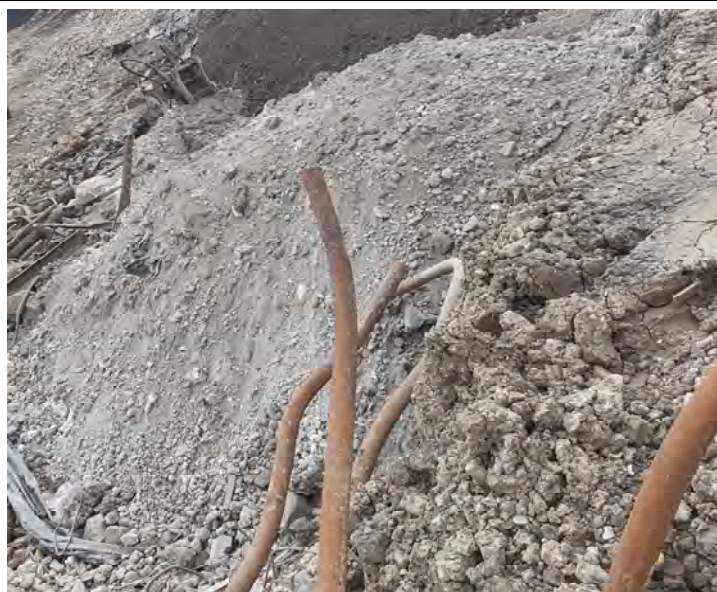
| Stockpile Validation Inspection Form | | | |
|---|---|---|---|
| Stockpile ID: | SP-sludge | | |

| Stockpile Validation Inspection Form | | | |
|---|---|---|---|
| Dried and turned black sludge and brick screened from trench hotpot in J. | | | |
| 854 | | | |

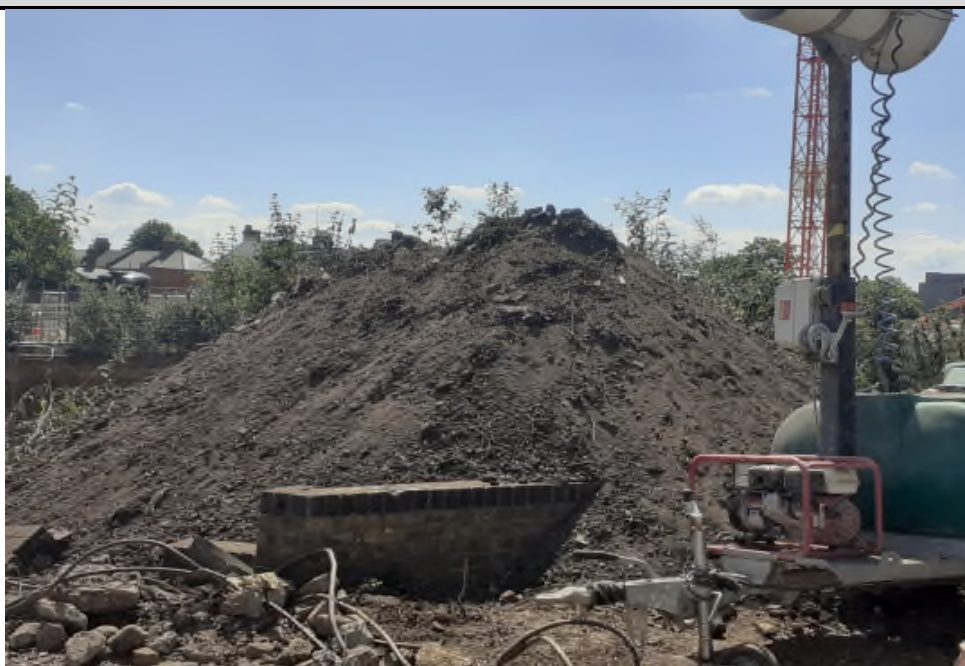
| <b>Stockpile ID:</b> | SP1 | | |

| Light brown gravelly made ground with flint gravels and broken brick and concrete fragments.<br>Screened and stockpiled adjacent to GH3. End destination TBC | | | |
| No visual or olfactory signs of contamination | | | |
| combined SP1, SP2, SP3 from previous works adjacent to the marketing suite. | | | |

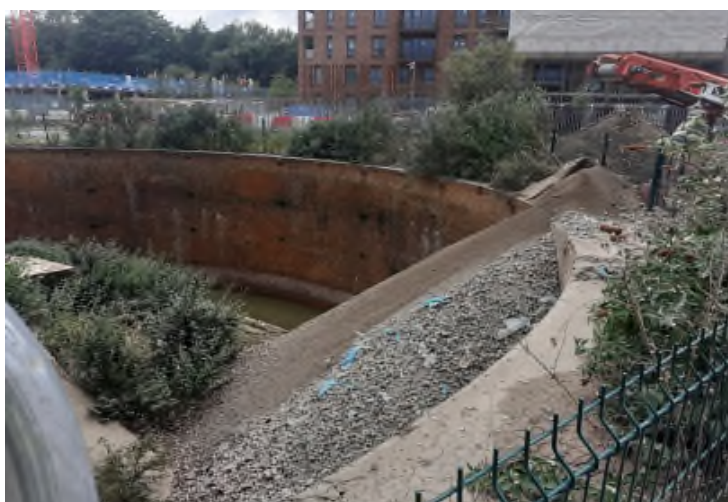
| <b>Stockpile ID:</b> | SP004 | | |

| Type 1 site won material from car park excavation | | | |
| No visual or olfactory signs of contamination | | | |

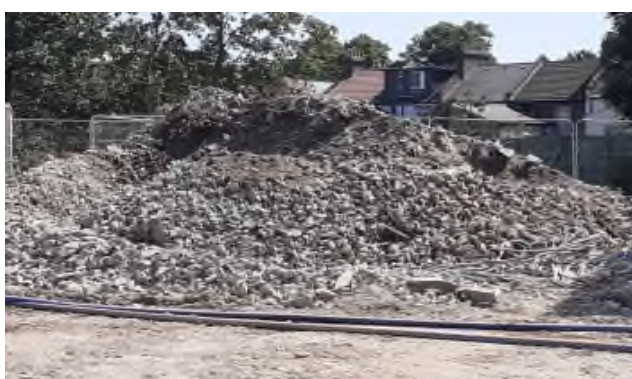
| <b>Stockpile ID:</b> | SP005 | | |

| <b>General Description of Material:</b><br>Crushed and screened concrete | | | |
| <b>Visual Evidence of potential contaminants e.g. oily residues, asbestos, etc.:</b><br>No visual or olfactory signs of contamination | | | |

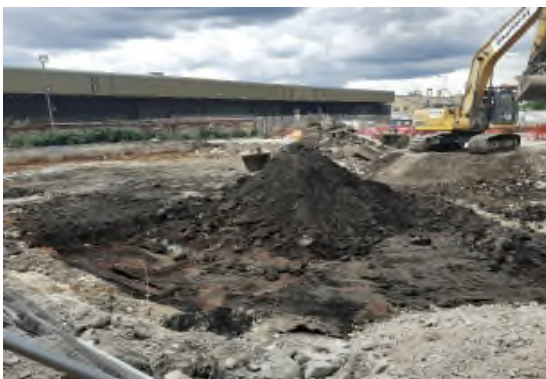
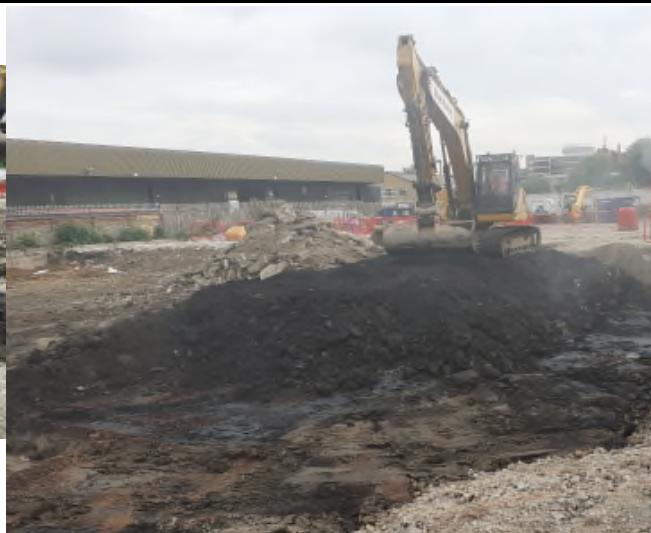
| <b>Stockpile ID:</b> | SP006 | | |

| Ashy sandy gravelly made ground. Gravells of flint, slag, brick and concrete. | | | |
| Black in colour with moderate burnt and gas works odour. | | | |
| 10.7 | | | |

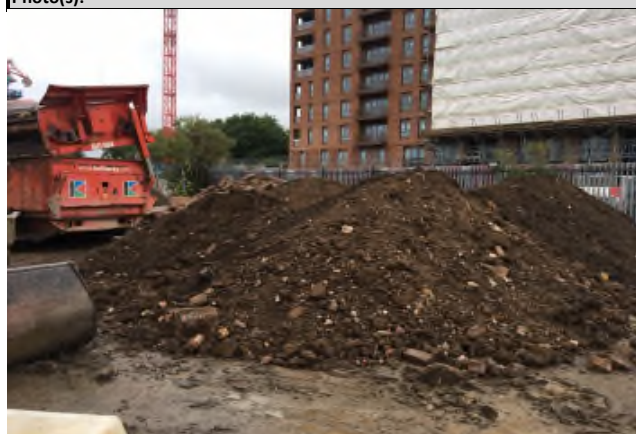
| <b>Stockpile ID:</b> | SP-pocket park | | |

| <b>General Description of Material:</b><br>screened fill material consisting of sandy Type 1, brick fragments, flint gravels. | | | |
| <b>Visual Evidence of potential contaminants e.g. oily residues, asbestos, etc.:</b><br>No visual or olfactory signs of contamination | | | |

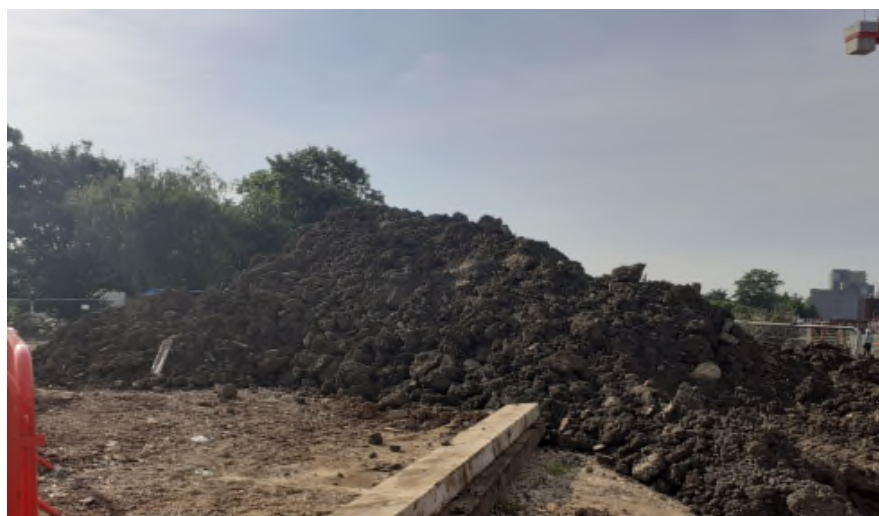
| <b>Stockpile ID:</b> | SP008 | | |

| <b>General Description of Material:</b><br>Clay scrape from Car Park excavation to FL. | | | |
| <b>Visual Evidence of potential contaminants e.g. oily residues, asbestos, etc.:</b><br>Slight gas works odour | | | |

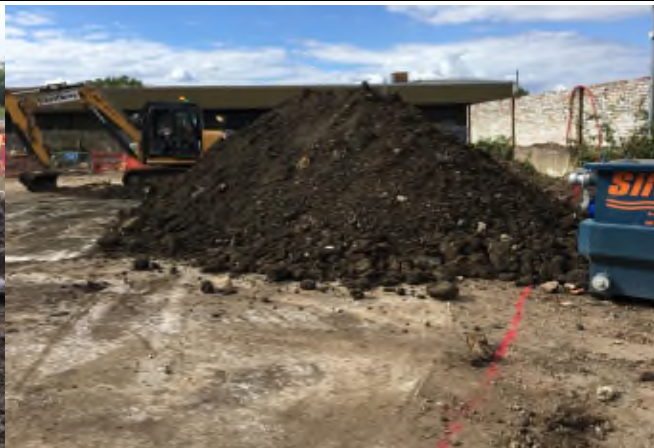
| <b>Stockpile ID:</b> | SP009 | | |

| Crushed and screened ashy made ground from the pocket park. Consisting of sandy ashy gravelly made ground. Gravells of flint, brick fragments and concrete. | | | |
| No odour, visual black ashy made ground with some tarmac. | | | |
| 0.3 | | | |

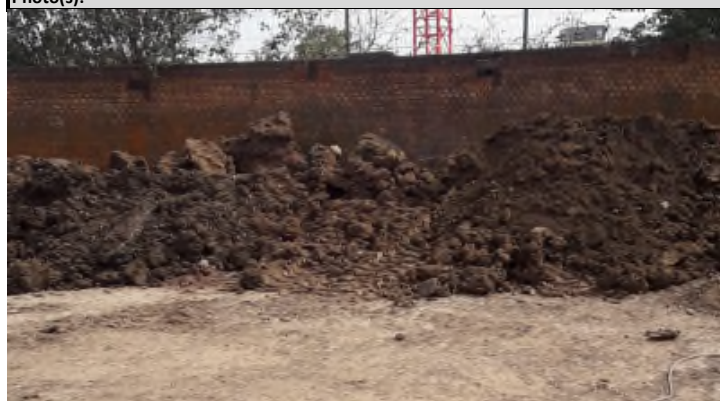
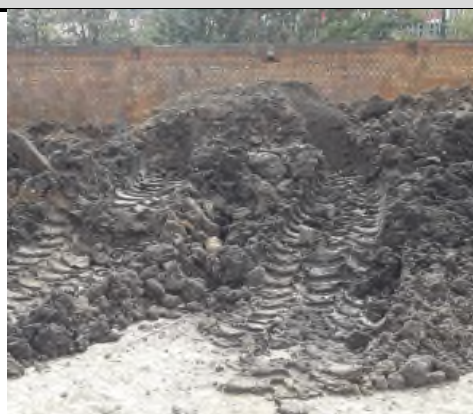
| <b>Stockpile ID:</b> | SP011 | | |

| Soft brown natural CLAY from 0.5-3mbgl Q/R/S 13-11. | | | |
| No visual or olfactory evidence of contamination. | | | |
| clean brown clay 0.5-3mbgl | | | |

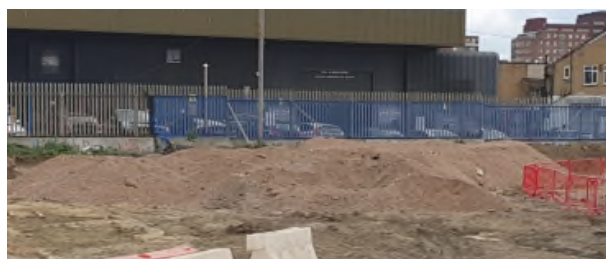
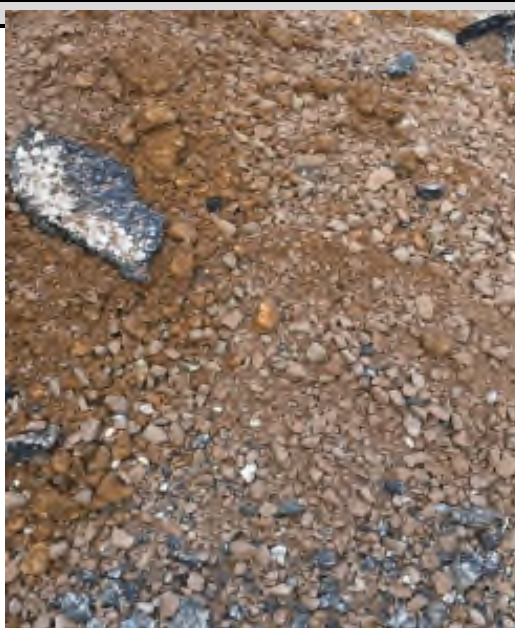
| <b>Comments:</b><br>No evidence of contamination olfactory or visual. | | | |

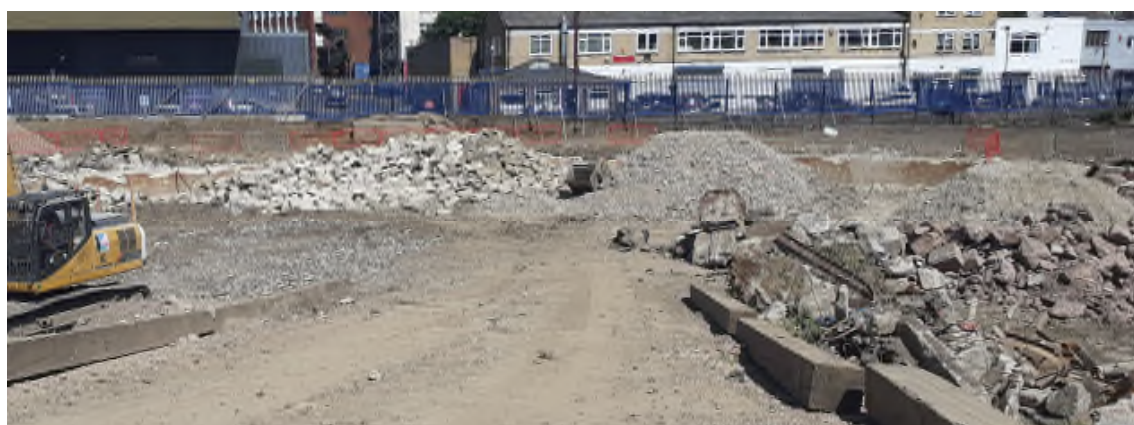
| <b>Comments:</b><br>No evidence of contamination olfactory or visual. | | | |

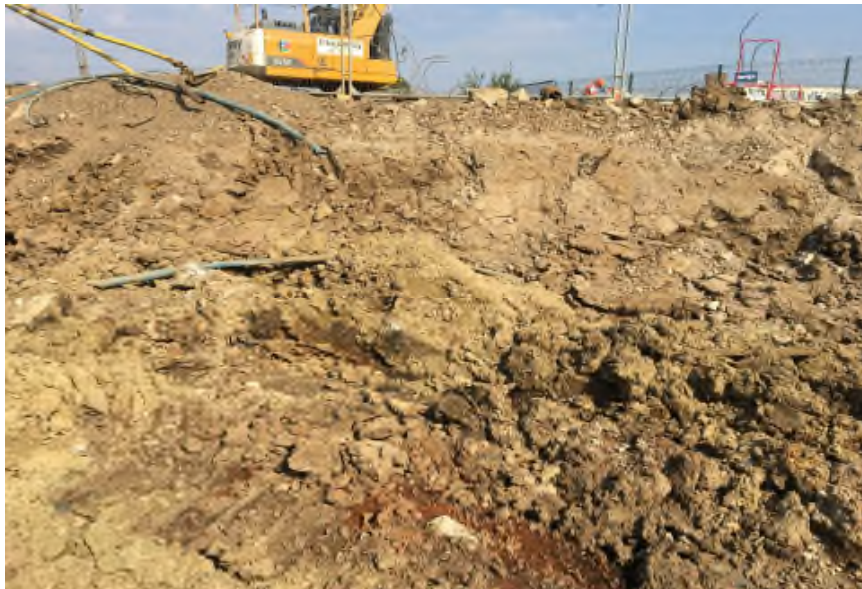
| <b>Comments:</b><br>stockpiled and rolled into GH1 | | | |

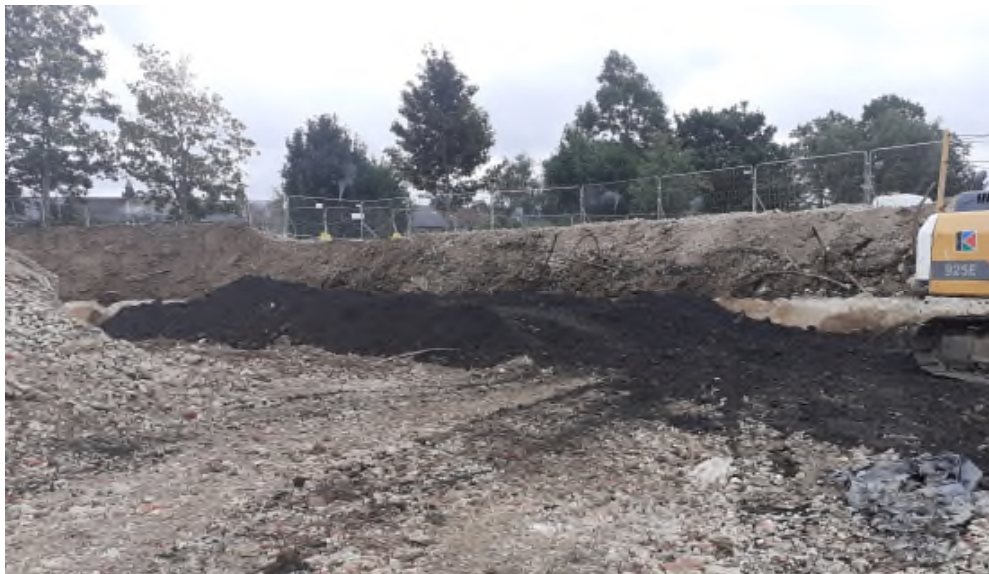
| <b>General Description of Material:</b><br>Black stained gravelly clay from J/K/L10 and 11. | | | |
