# GEOSHIELD Verification Report

## VERIFICATION ITEM ONE

LOCATION/GRID LINE: Block D1 - Core - Lower

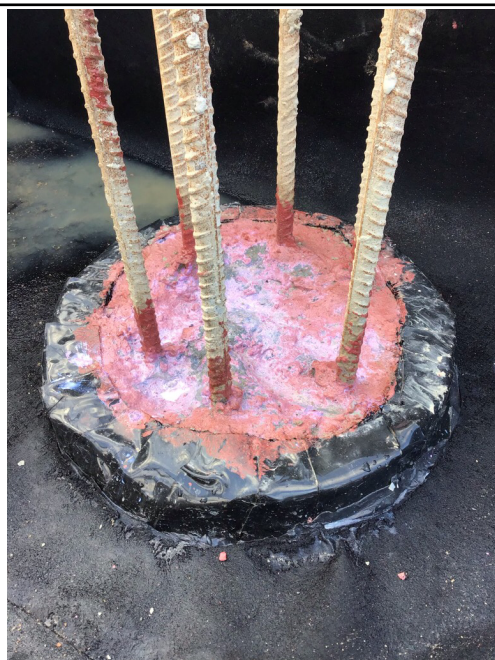
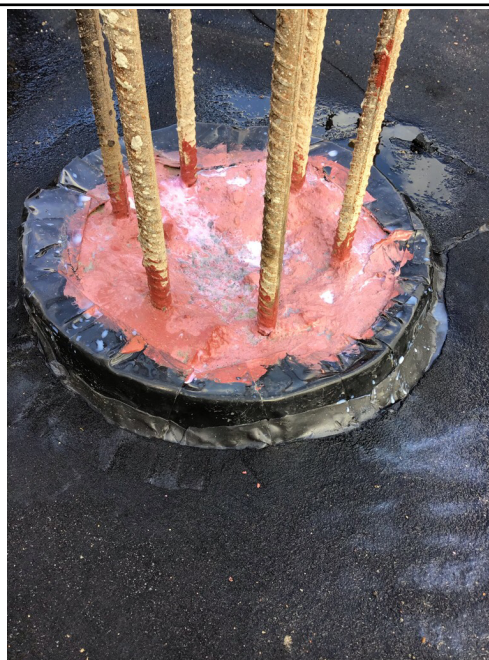
NOTES: Pudlo Liquid gas barrier has been applied to the pile heads

and a good coverage has been achieved. Double sided tape has then been installed

around all pipe heads to seal Pudlo GP Ultra+ Gas Barrier to the pile heads. Pick and

probe tests carried out to ensure continuous seal was created.

Overview photos of sealed and completed pile heads with double sided tape applied.

To manufacturers specification.

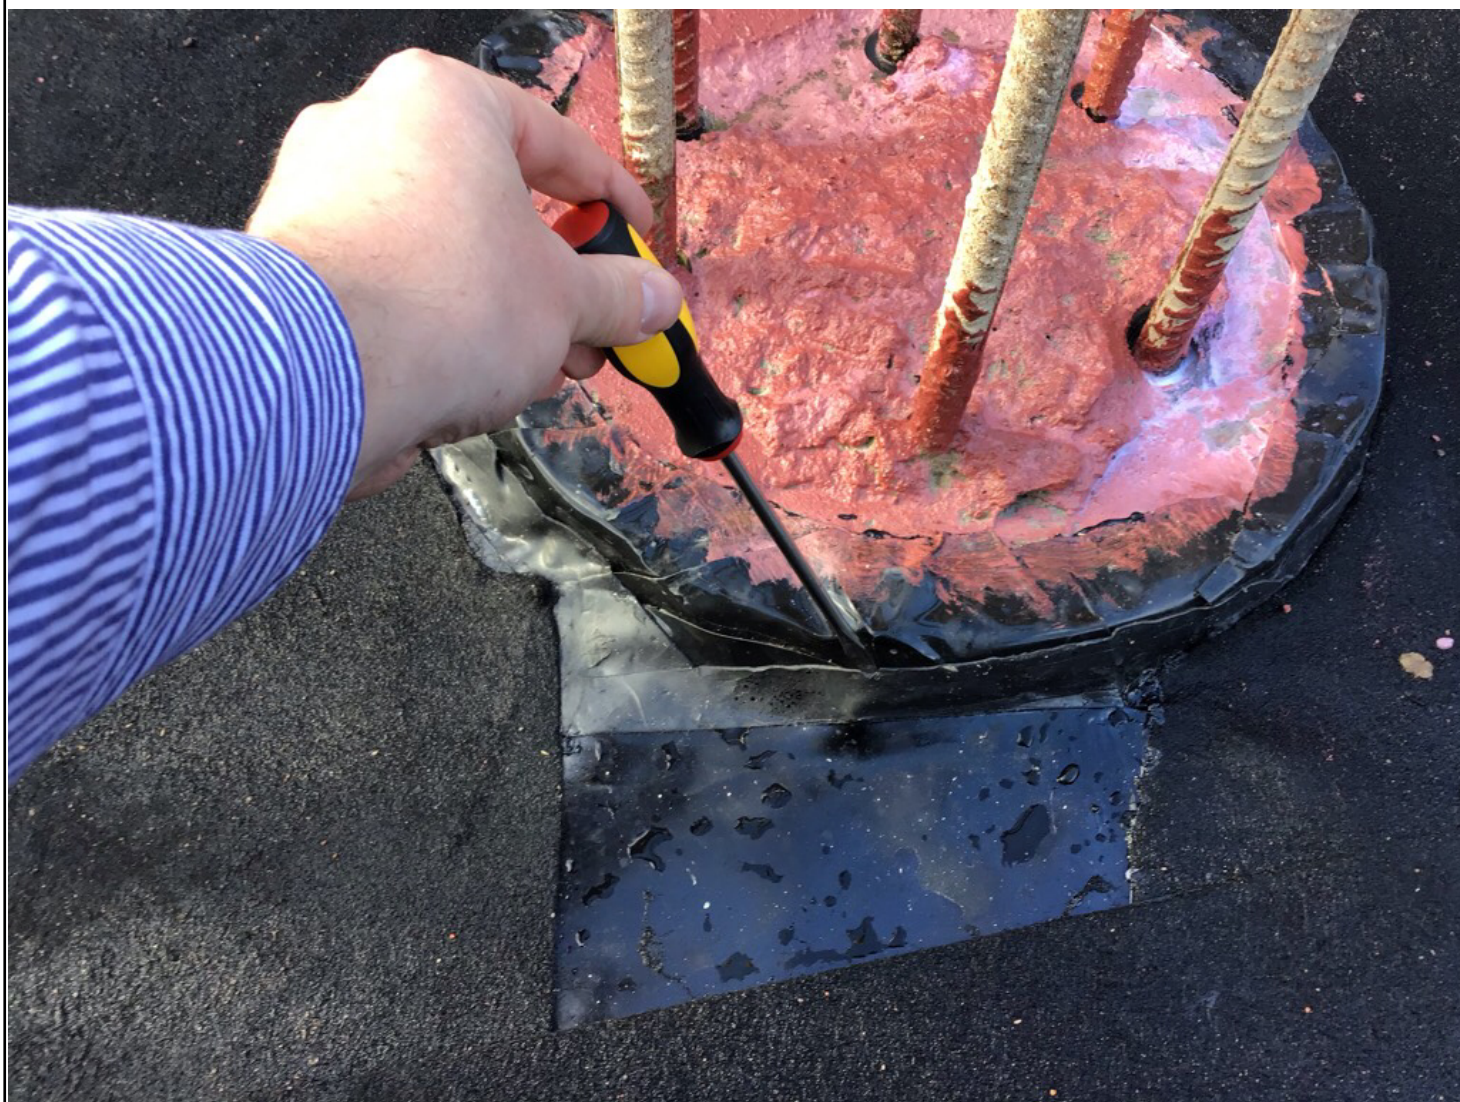
Above photo) pick and probe tests were carried out on all sealed and completed pile heads to ensure a continuous seal had been created.

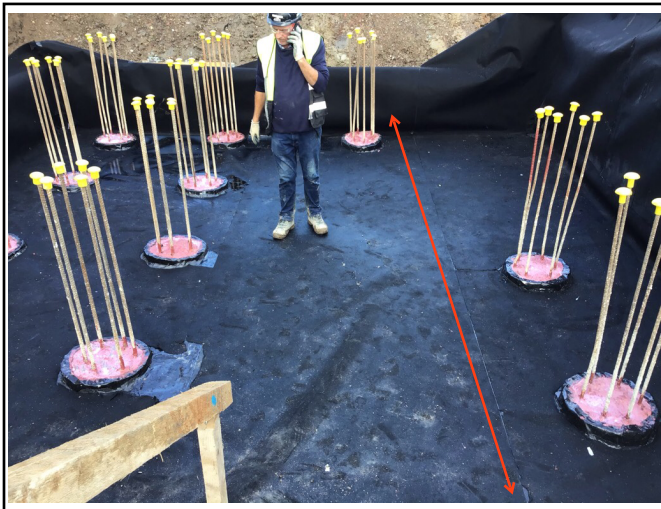
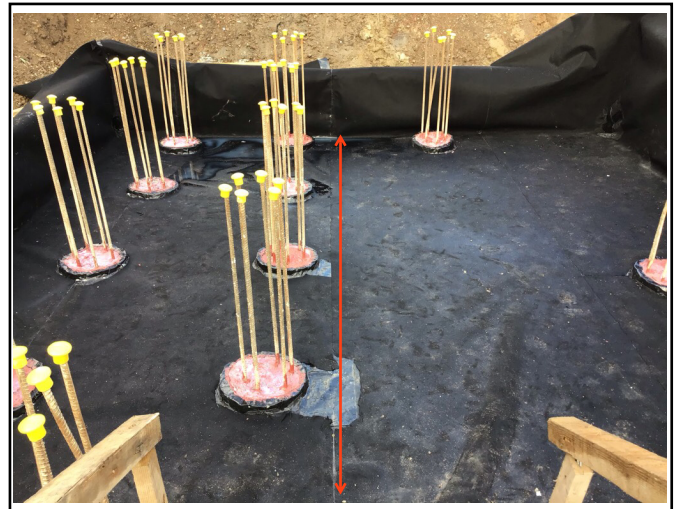
NOTES: Sealed Lap Joints

Pudlo GP Ultra+ Gas Barrier has been installed across the verified area and overlaps has been created. They have been sealed using a leister to manufacturers specification.

The above photos show overviews of the verified area, and the red arrows shows the welded lap joints. All laps have been sealed to a high standard and to manufacturers specification.
