# GEOSHIELD

## Verification Report

GCL - Clarendon Road PHASE 3

AREA SURVEYED: Block D2 - Core.

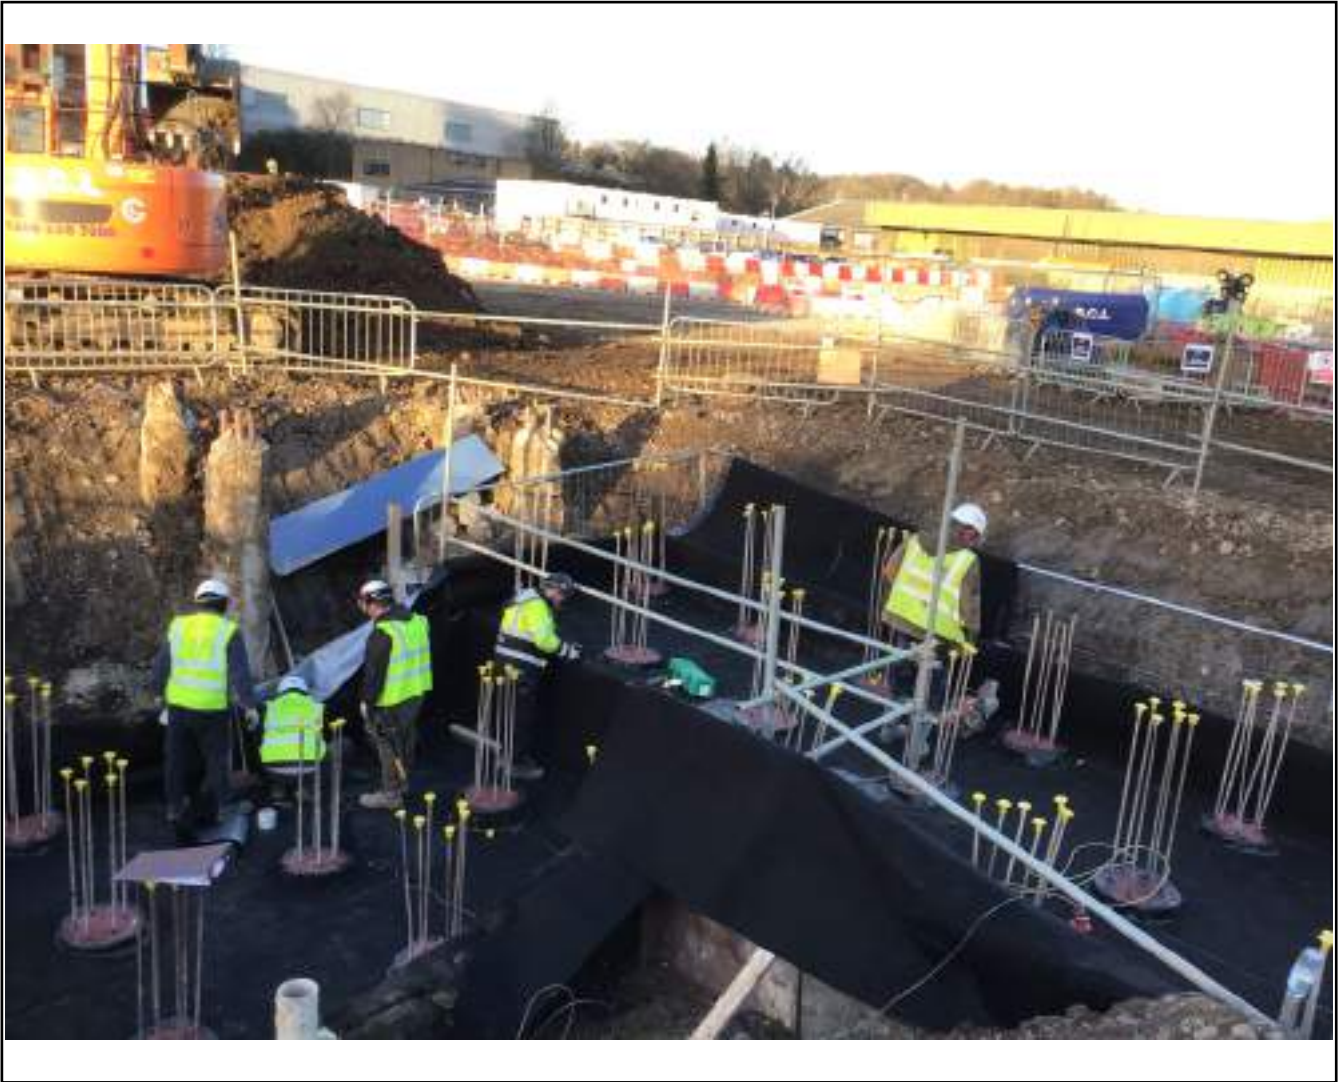
## OVERVIEW PHOTOGRAPHS

The photograph above shows an overview of the completed installation of the

Pudlo GP Ultra+ Gas Barrier to D2 Core.

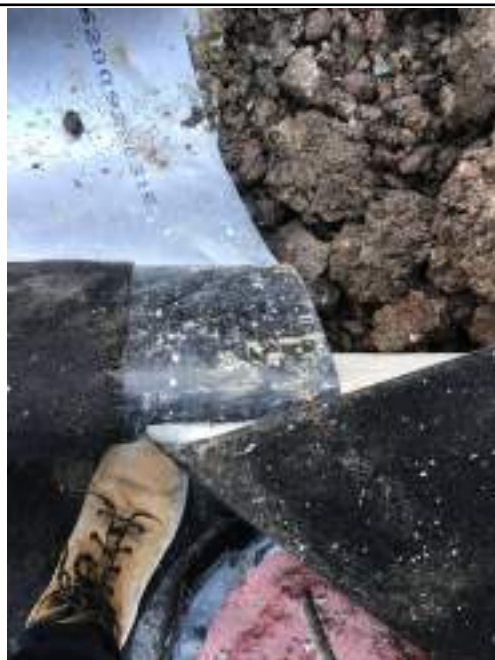
## VERIFICATION ITEM ONE

NOTES: Installation of the Pudlo GP Ultra+ Gas Barrier to core base.

The first photograph below shows the installers have lapped the membrane using the preformed no fleeced lap. The installers have then used a hot air leister and roller to achieve a consistent 40mm weld.

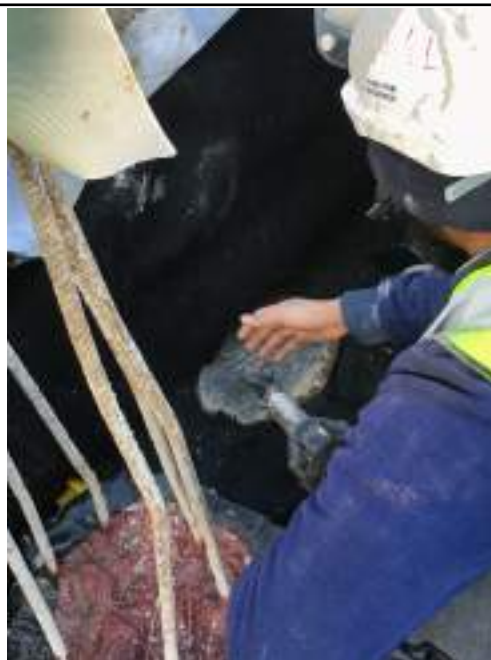
The second photograph above shows the installers using the hot air leister to dry an area of the membrane before carrying out remediations.

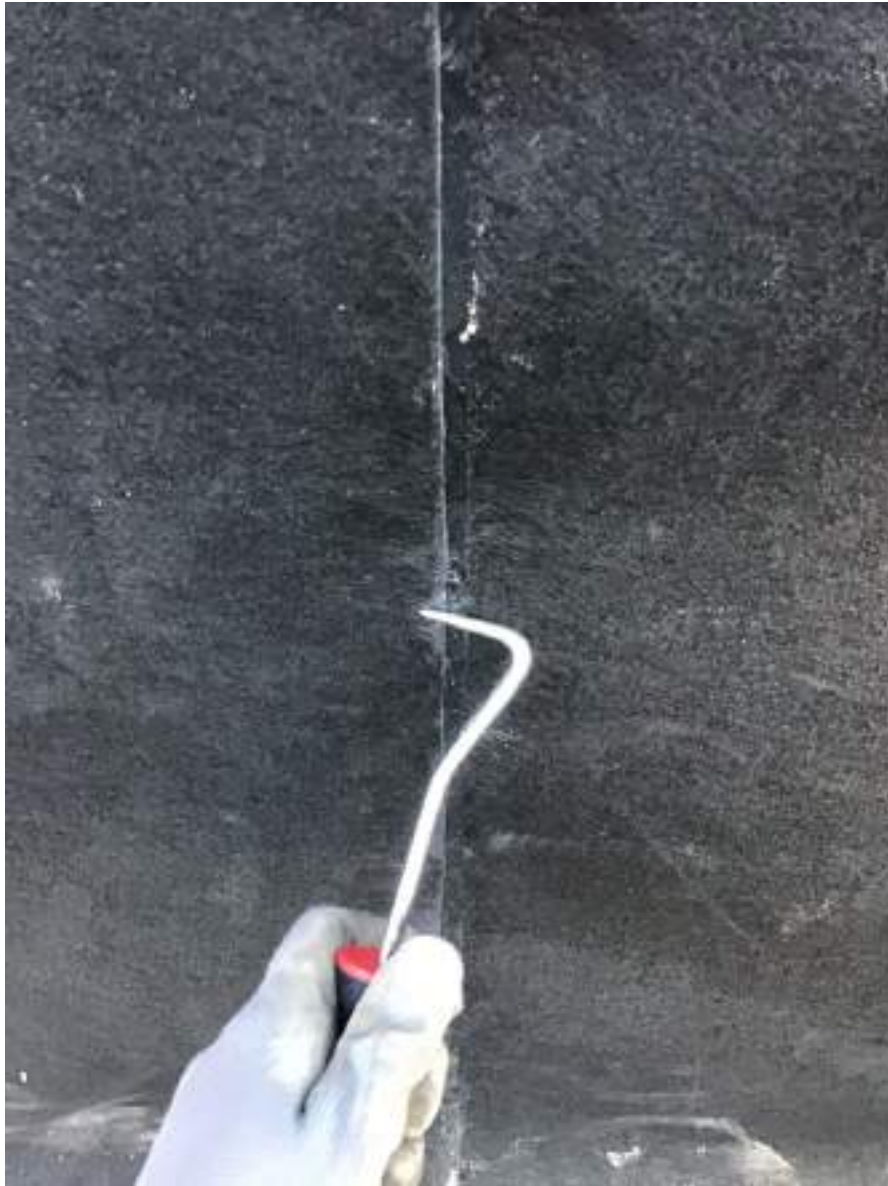
## VERIFICATION ITEM ONE

The photograph above shows a pick and probe test carried out to a welded lap of the Pudlo GP Ultra+ Gas Barrier which has been installed to the base of D2 Core. The installers have achieved a strong weld and no faults or defects were identified.

Verified in accordance with CIRIA 735.

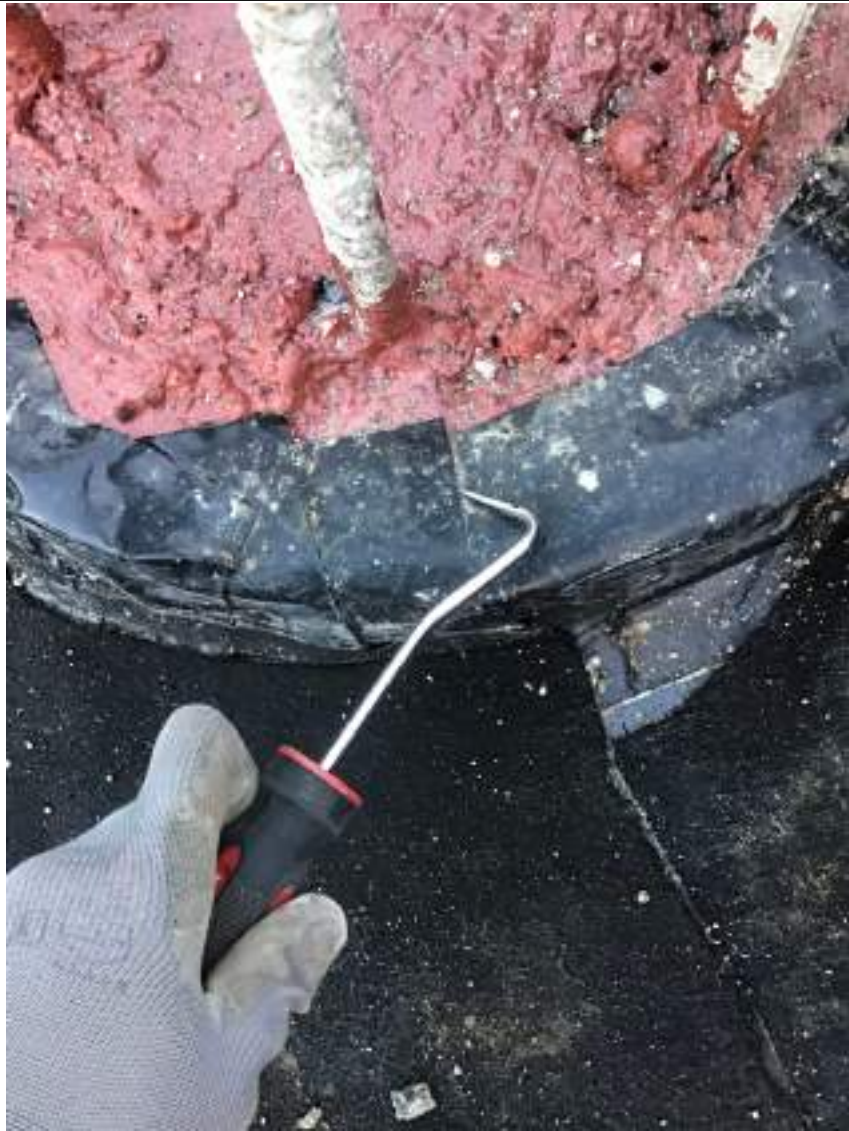
## VERIFICATION ITEM TWO

The photograph above shows a pick and probe test carried out to a sealed pile cap which was verified during this visit. The installers have achieved a strong seal and no gaps were present.

Verified in accordance with CIRIA 735.

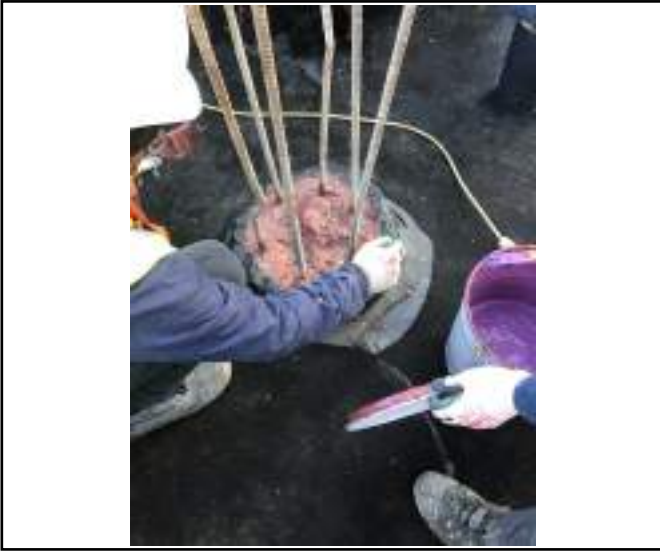
Installers applying the Pudlo Liquid

GB.

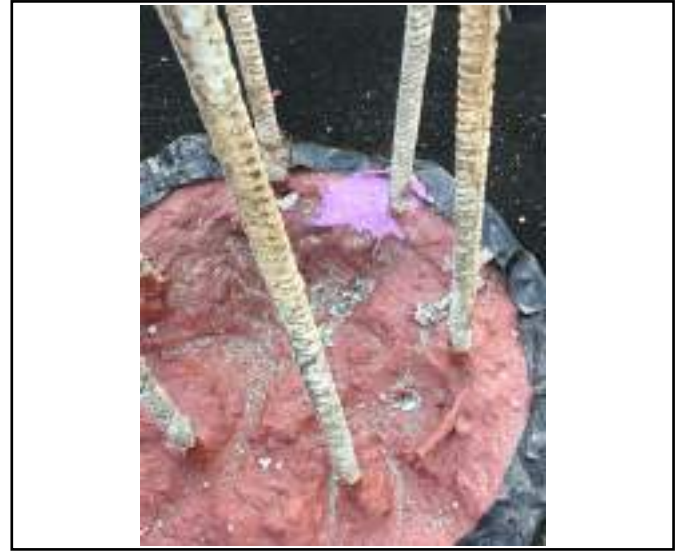
Installers have touched up chip in the

cap using Pudlo Liquid GB.

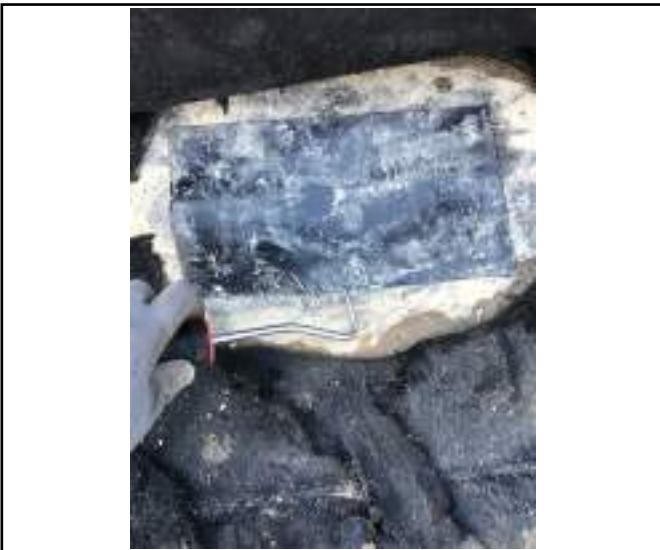
Pick and probe test carried out to a

patched fault identified during this visit.

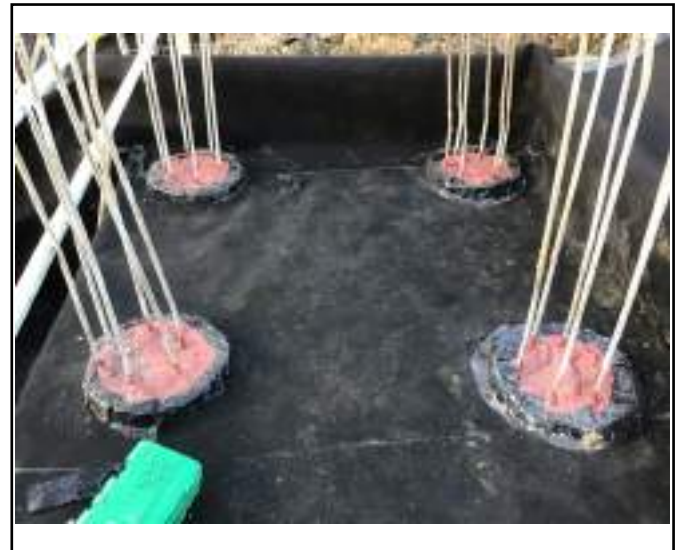
Additional sealed pile caps.
