Our ref: RS/9894/ES

**Phase 3, Clarendon Road Site, Wood Green: Report of Japanese knotweed excavation works carried out to date**

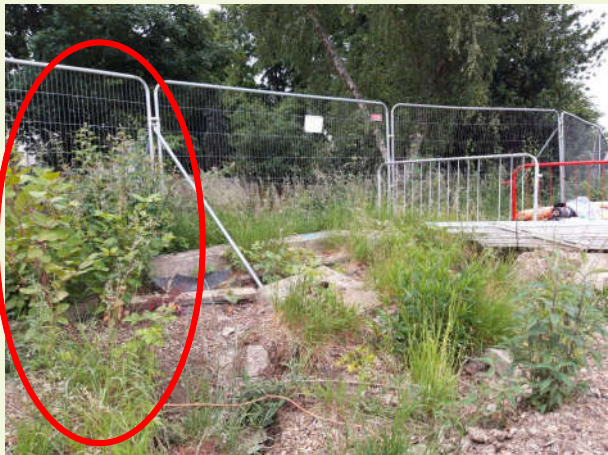
| Photo No. | Photograph |
|---|---|
| <p><b>1.</b></p> <p>View of the Japanese knotweed area before the excavation, part of the onsite Japanese knotweed growth is circled in red.</p> | |

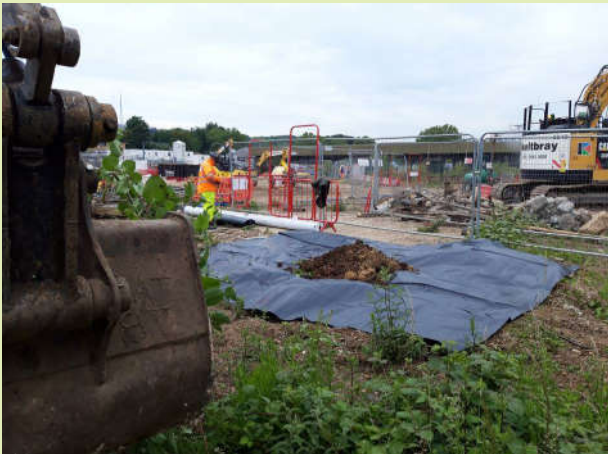
| Photo No. | Photograph |
|---|---|
| <p><b>2.</b></p> <p>Stockpiled area was located immediately adjacent to the excavation area and covered with Visqueen sheets.</p> | |

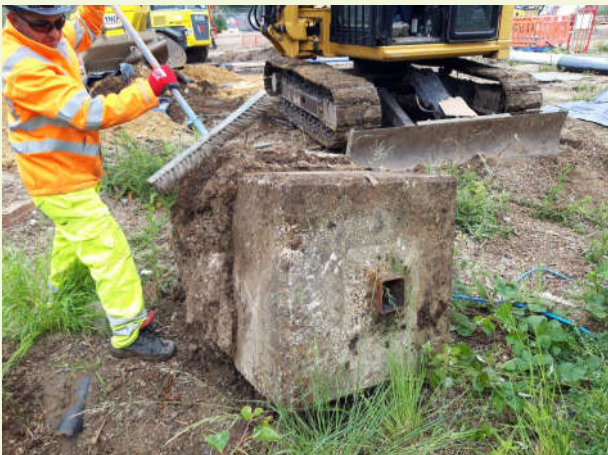
| Photo No. | Photograph |
|---|---|
| <p><b>3.</b></p> <p>Big block of concrete were extracted, inspected, cleaned and stockpiled separately.</p> | |

- Due to the large amount of concrete blocks in the excavation area, they were thoroughly inspected by Phlorum staff, cleaned and moved to a separate pile.

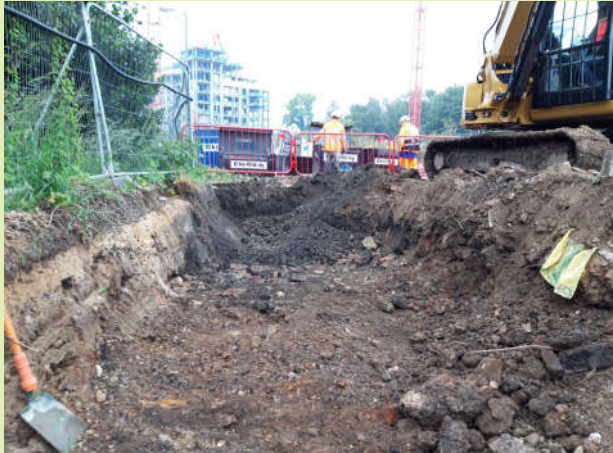
| Photo No. | Photograph |
|---|---|
| <p>4.</p> <p>View of the excavation.</p> | |

- Constant inspection of the excavation for Japanese knotweed rhizomes in order to advise Keltbray on the size and shape of the excavation. The final excavated area measured 15m by 4m.

- The whole excavation had a maximum depth of 1.3m; however in one area the knotweed rhizomes were followed and removed up to 2m in depth.
- Since some knotweed growth was observed off-site a permeable root-barrier membrane was installed along the side and the bottom of the excavation to block any future growth to migrate back onsite.

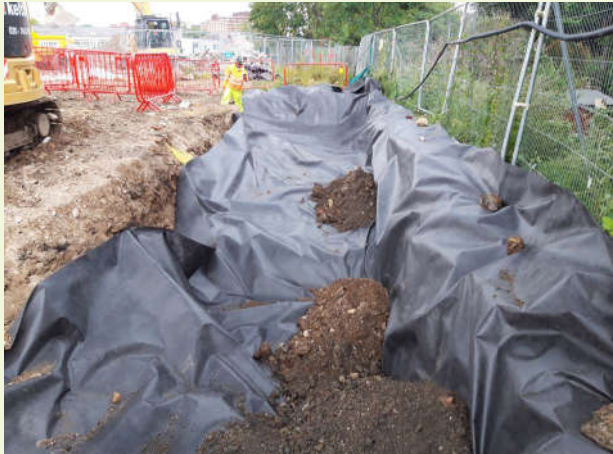
| Photo No. | Photograph |
|---|---|
| <p>5.</p> <p>View of the excavated area with the permeable root-barrier membrane laid down.</p> | |

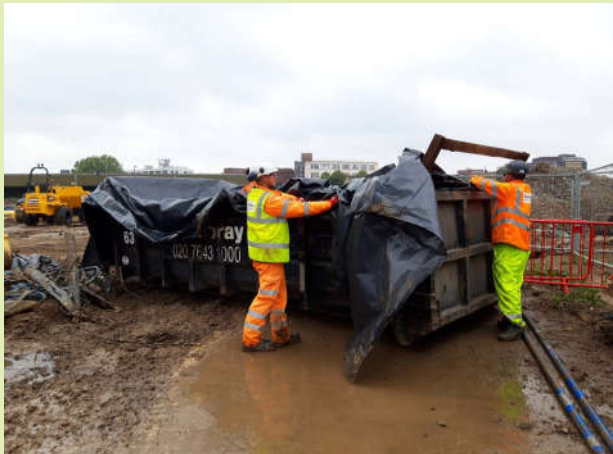
| Photo No. | Photograph |
|---|---|
| <p>6.</p> <p>The 16 tonnes skip linen with Visqueen sheet before being loaded with soil contaminated with Japanese knotweed.</p> | |

- The haulage and landfill of the excavated material was managed by Keltbray.
- The arisings contaminated with Japanese knotweed were stockpiled first, and then moved into a 16 tonnes skip, which was first lined with Visqueen sheets.

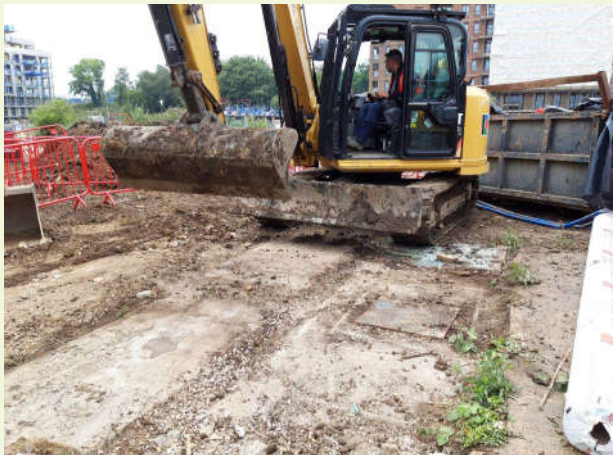
| Photo No. | Photograph |
|---|---|
| <p><b>7.</b></p> <p>Stockpile area scraped at the end of the works.</p> | |

- Once all the soils and Visqueen sheets had been loaded onto the skip a surface scrape of the stockpile area was carried out.
- The excavation and the stockpile areas were inspected for Japanese knotweed rhizomes and plants. None were found.

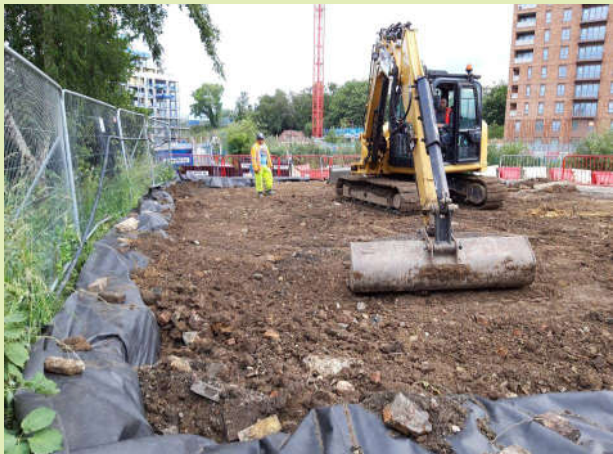
| Photo No. | Photograph |
|---|---|
| <p><b>8.</b></p> <p>Excavated area backfilled on top of the membrane with soil free of Japanese knotweed.</p> | |

- After the installation of the membrane the excavation area was backfilled with soil deemed free from Japanese knotweed by Phlorum member of staff.
- The excavation area was always fenced with guard rails, only providing access for the excavator.

We recommend that the herbicide monitoring programme for the site continues until there has been two years of no regrowth.
