| Stockpile Validation Inspection Form | | | |
| Site:<br>Clarendon Road Phase 3 | | Job No:<br>6075 | |
| Company: | Keltbray Remediation | | |

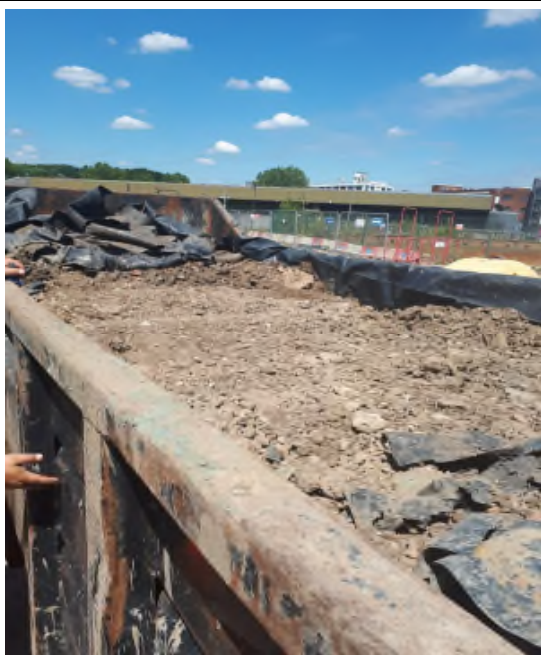
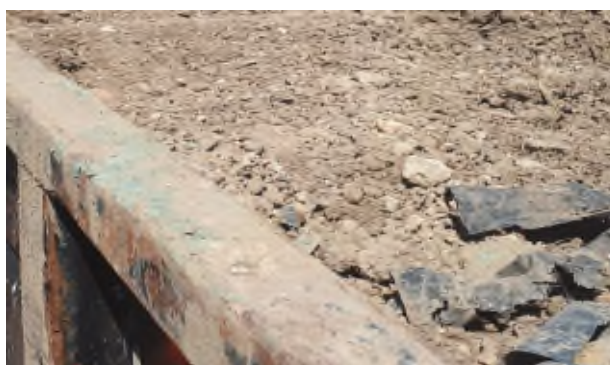
| Stockpile Validation Inspection Form | | | |
|---|---|---|---|
| Stockpile ID: | SP-Knotweed | | |

| Stockpile Validation Inspection Form | | | |
|---|---|---|---|
| General Description of Material:<br>topsoil and made ground removed during knotweed excavation/removal. | | | |
| Visual Evidence of potential contaminants e.g. oily residues, asbestos, etc.:<br>No visual or olfactory signs of contamination | | | |
| VOC PID analysis (ppm):<br>0 | | | |
| Comments:<br>Topsoil from the knotweed excavation as supervised by specialist. Stored in lined skip for disposal. | | | |

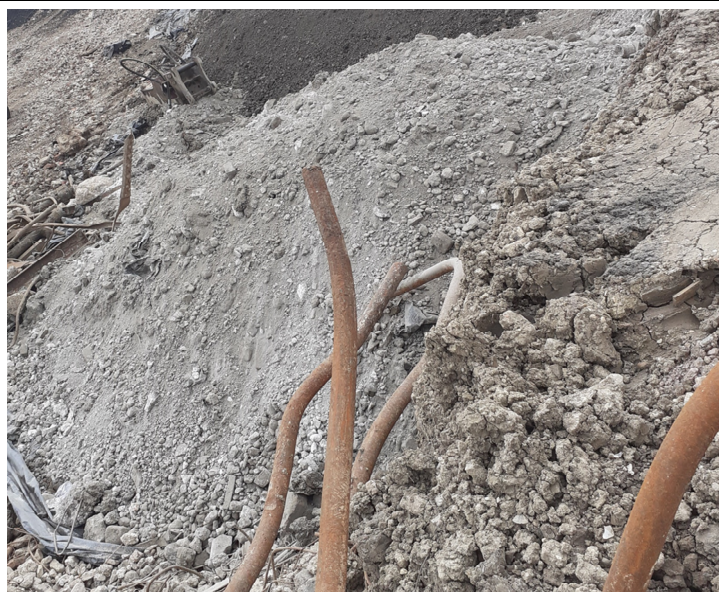
| Stockpile Validation Inspection Form | | | |
|---|---|---|---|
| Stockpile ID: | SP-sludge | | |

| Stockpile Validation Inspection Form | | | |
|---|---|---|---|
| Dried and turned black sludge and brick screened from trench hotpot in J. | | | |
| 854 | | | |

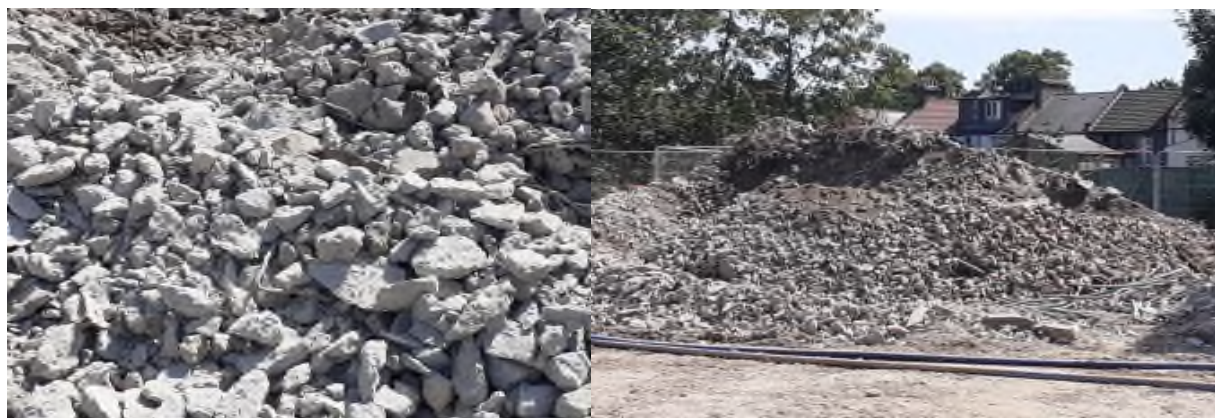
| <b>Stockpile ID:</b> | SP0 | | |

| <b>General Description of Material:</b><br>Crushed concrete and brick fines. | | | |
| <b>Visual Evidence of potential contaminants e.g. oily residues, asbestos, etc.:</b><br>No visual or olfactory signs of contamination | | | |
| <b>Comments:</b><br>Crushed concrete and fines from central wall and concrete slab- used in temporary ramp into GH3 and between high and low level | | | |

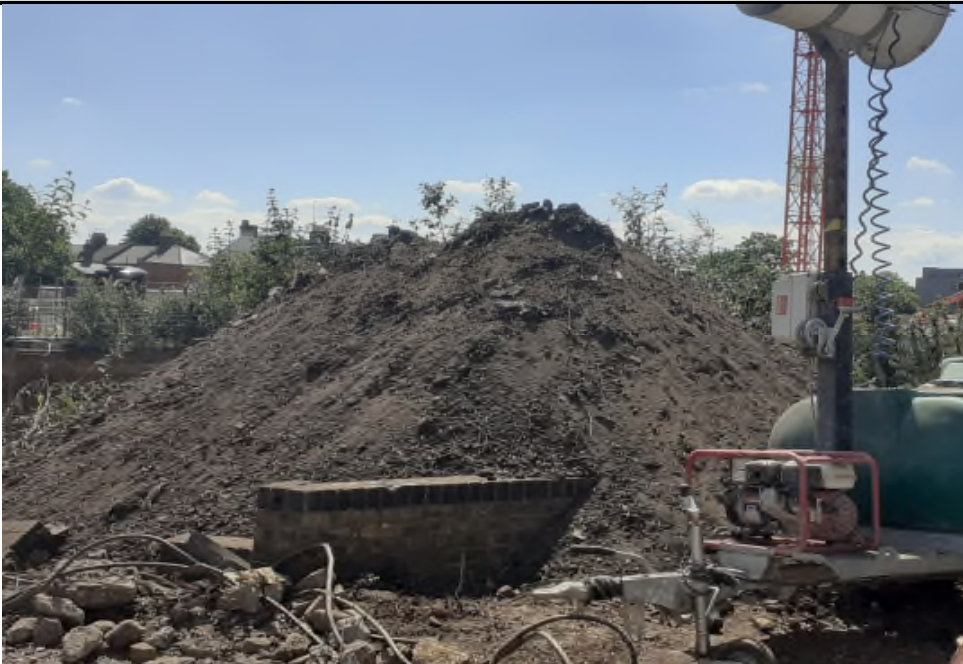
| <b>Stockpile ID:</b> | SP1 | | |

| Light brown gravelly made ground with flint gravels and broken brick and concrete fragments.<br>Screened and stockpiled adjacent to GH3. End destination TBC | | | |
| No visual or olfactory signs of contamination | | | |
| combined SP1, SP2, SP3 from previous works adjacent to the marketing suite. | | | |

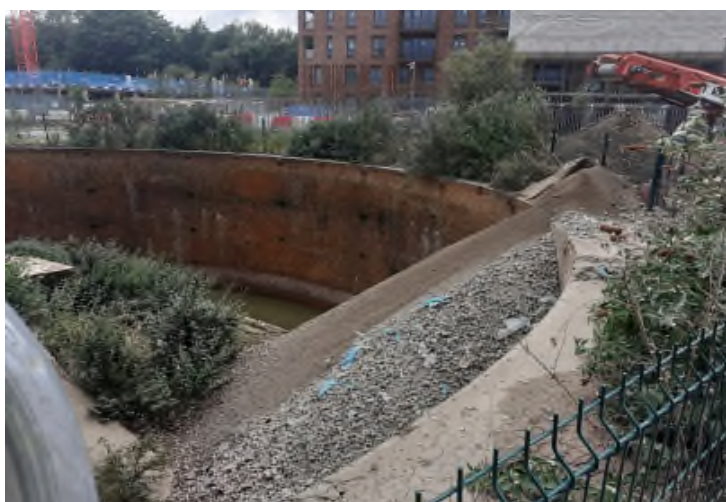
| <b>Stockpile ID:</b> | SP004 | | |

| Type 1 site won material from car park excavation | | | |
| No visual or olfactory signs of contamination | | | |

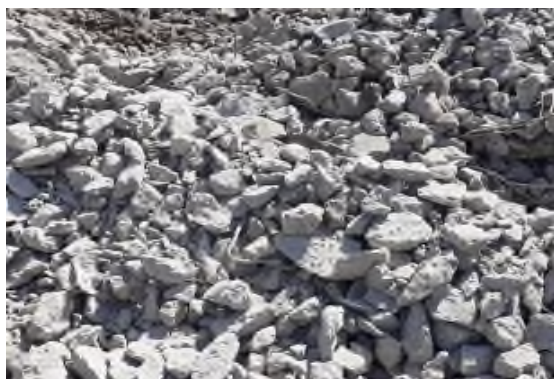
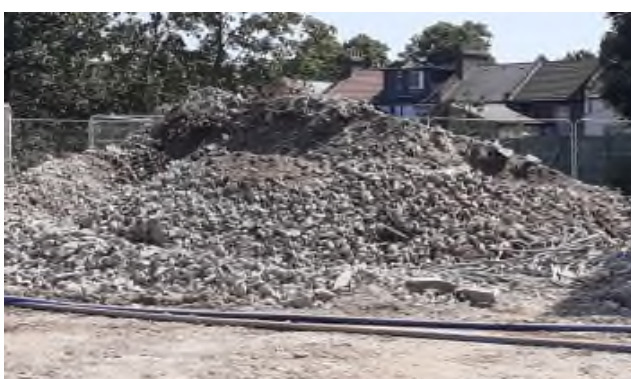
| <b>Stockpile ID:</b> | SP005 | | |

| <b>General Description of Material:</b><br>Crushed and screened concrete | | | |
| <b>Visual Evidence of potential contaminants e.g. oily residues, asbestos, etc.:</b><br>No visual or olfactory signs of contamination | | | |

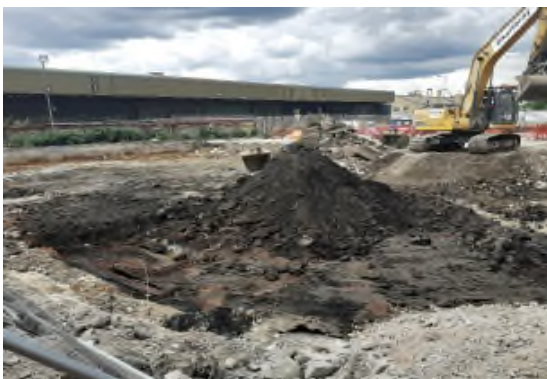
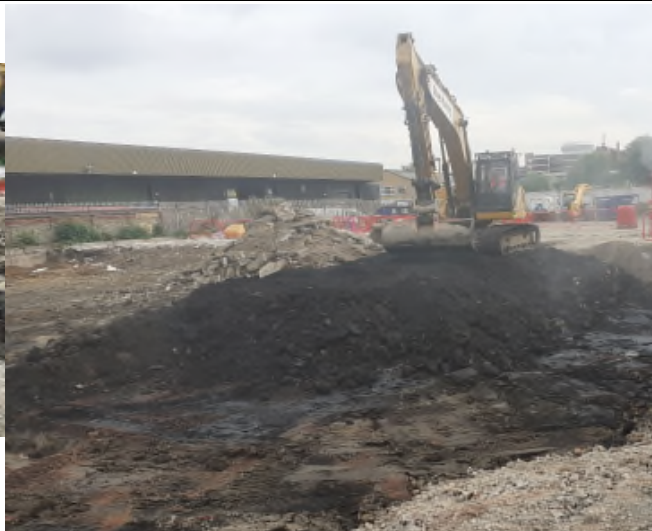
| <b>Stockpile ID:</b> | SP006 | | |

| Ashy sandy gravelly made ground. Gravells of flint, slag, brick and concrete. | | | |
| Black in colour with moderate burnt and gas works odour. | | | |
| 10.7 | | | |

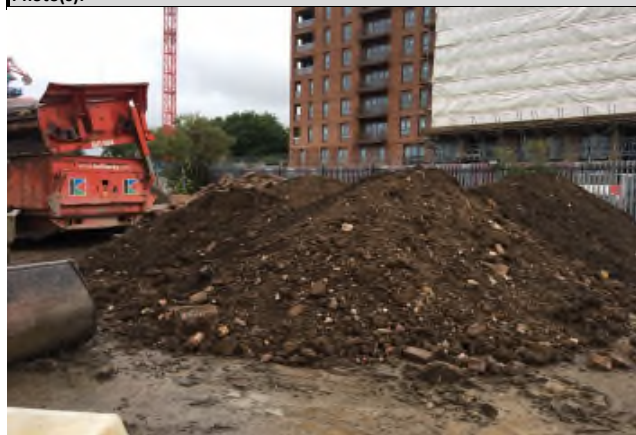
| <b>Stockpile ID:</b> | SP-pocket park | | |

| <b>General Description of Material:</b><br>screened fill material consisting of sandy Type 1, brick fragments, flint gravels. | | | |
| <b>Visual Evidence of potential contaminants e.g. oily residues, asbestos, etc.:</b><br>No visual or olfactory signs of contamination | | | |

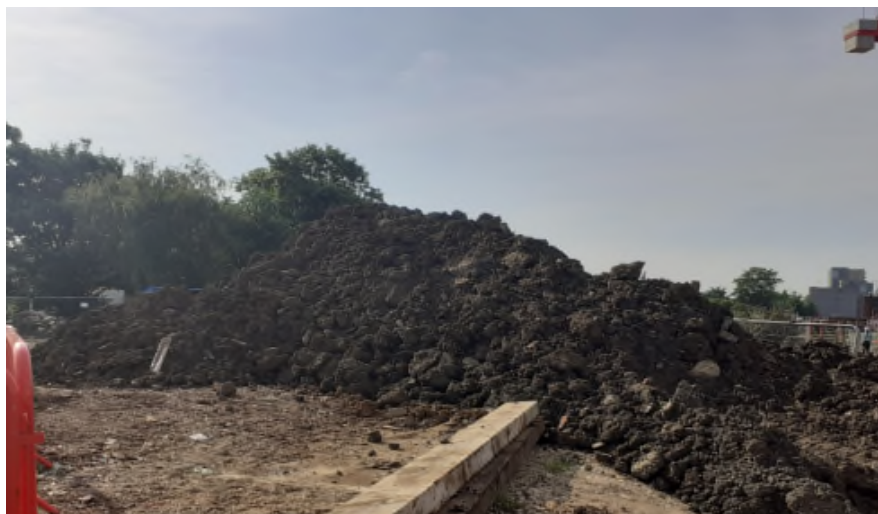
| <b>Stockpile ID:</b> | SP008 | | |

| Clay scrape from Car Park excavation to FL. | | | |
| Slight gas works odour | | | |

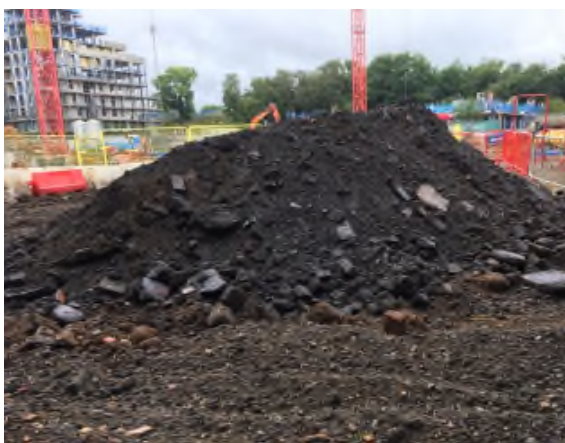
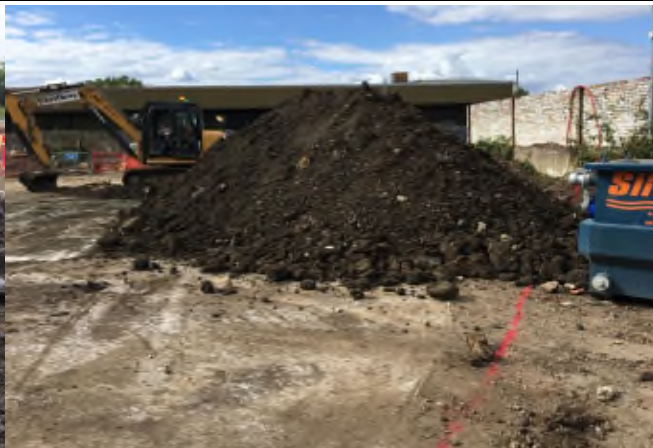
| <b>Stockpile ID:</b> | SP009 | | |

| Crushed and screened ashy made ground from the pocket park. Consisting of sandy ashy gravelly made ground. Gravells of flint, brick fragments and concrete. | | | |
| No odour, visual black ashy made ground with some tarmac. | | | |
| 0.3 | | | |

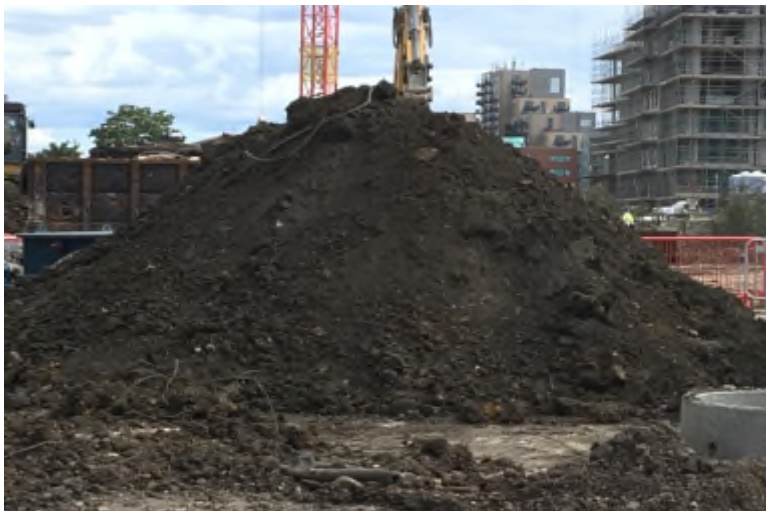
| <b>Stockpile ID:</b> | SP010 | | |

| <b>General Description of Material:</b><br>Brown slightly gravelly topsoil from top 0-0.0m Q/R/S 13-11. | | | |
| <b>Visual Evidence of potential contaminants e.g. oily residues, asbestos, etc.:</b><br>No visual or olfactory evidence of contamination. | | | |
| <b>Comments:</b><br>brown organic, sandy, gravelly topsoil 0.0-0.5m | | | |

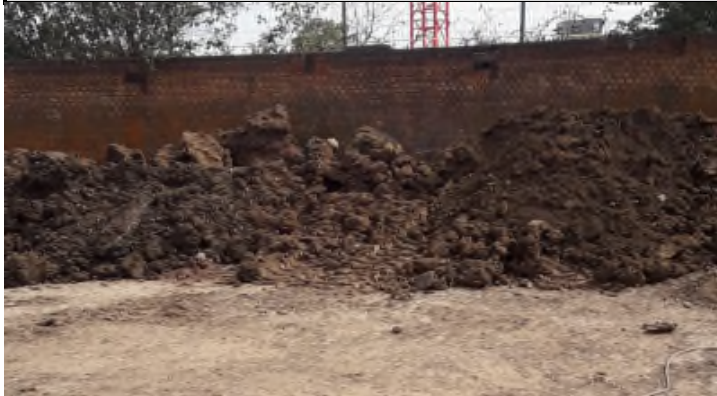
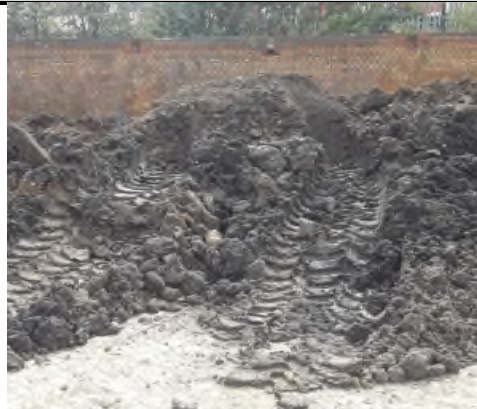
| <b>Stockpile ID:</b> | SP011 | | |

| Soft brown natural CLAY from 0.5-3mbgl Q/R/S 13-11. | | | |
| No visual or olfactory evidence of contamination. | | | |
| clean brown clay 0.5-3mbgl | | | |

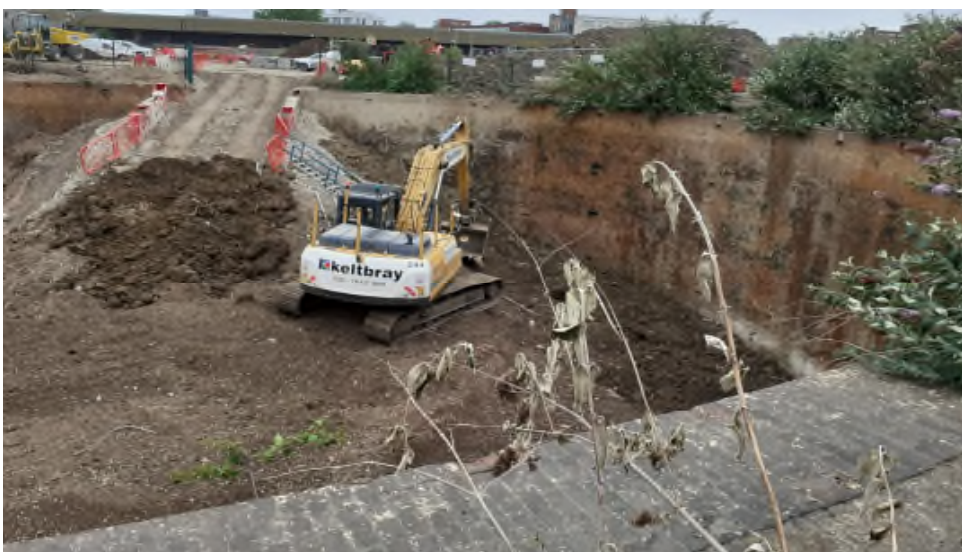
| <b>Stockpile ID:</b> | SP012 | | |

| <b>General Description of Material:</b><br>mottled black /brown reworked clay | | | |
| <b>Visual Evidence of potential contaminants e.g. oily residues, asbestos, etc.:</b><br>No visual or olfactory evidence of contamination. | | | |

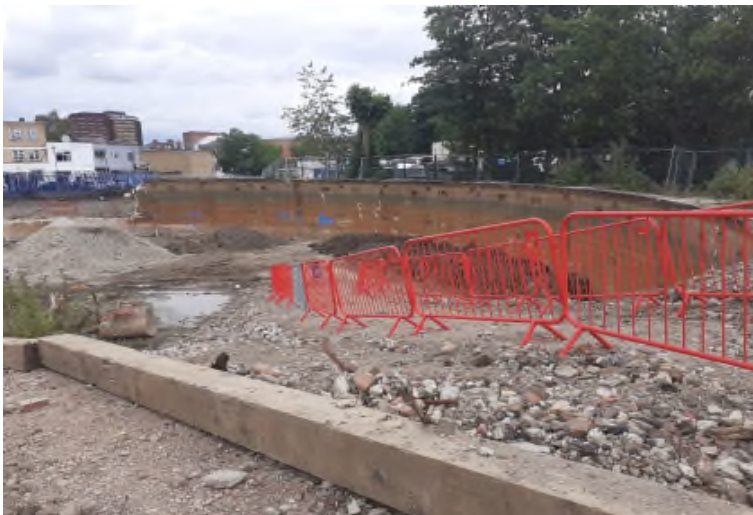
| <b>Stockpile ID:</b> | SP014 | | |

| <b>General Description of Material:</b><br>Crushed concrete combined with SP022 | | | |
| <b>Comments:</b><br>Crushed hardcore (concrete and brick) | | | |

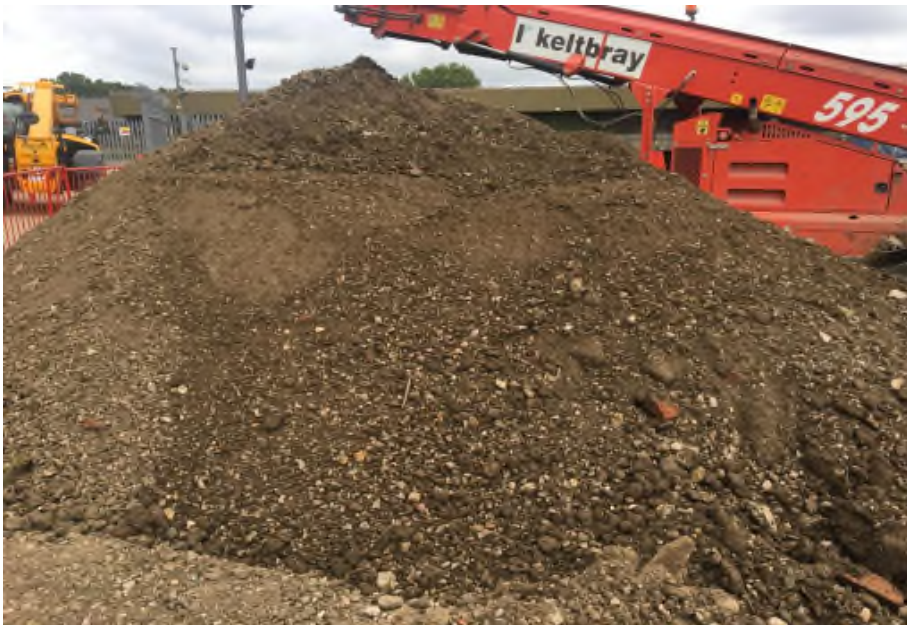
| <b>Photo(s):</b> | | | |

| <b>Stockpile ID:</b> | SP016 | | |
| <b>General Description of Material:</b><br>type 1 gravelly fill material with clay pockets and whole bricks | | | |
| <b>Visual Evidence of potential contaminants e.g. oily residues, asbestos, etc.:</b><br>N/A | | | |
| <b>VOC PID analysis (ppm):</b><br>0 | | | |

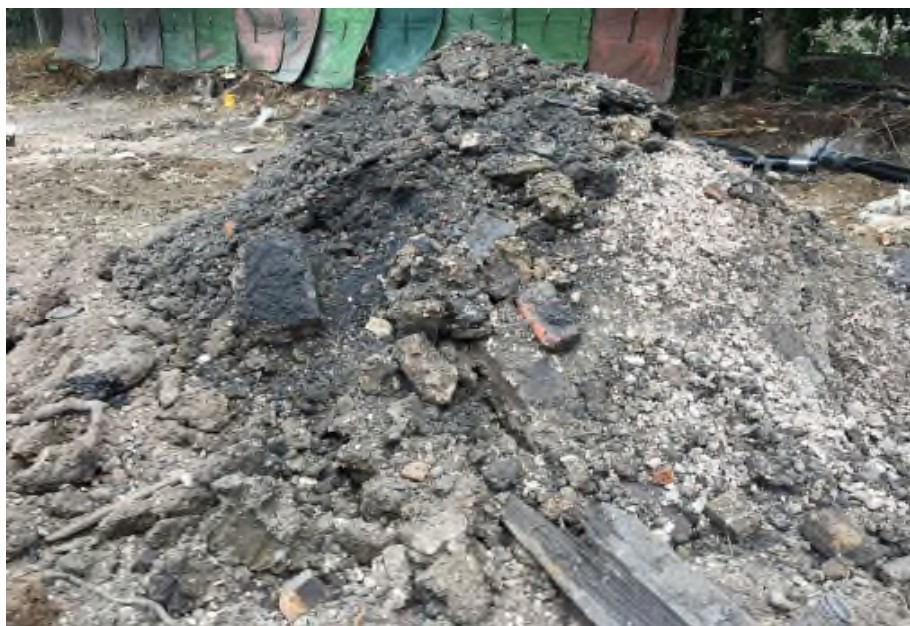
| <b>Photo(s):</b> | | | |

| <b>Stockpile ID:</b> | SP017 | | |
| <b>General Description of Material:</b><br>ashy black gravelly MG from hotspot excavation in Q/-2 | | | |
| <b>VOC PID analysis (ppm):</b><br>0 | | | |

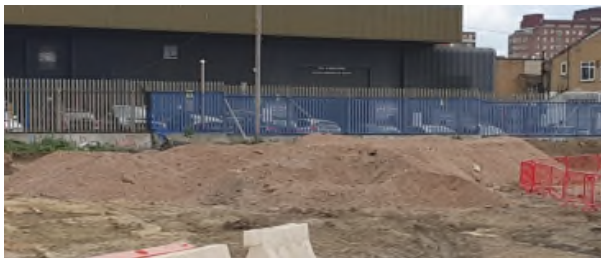
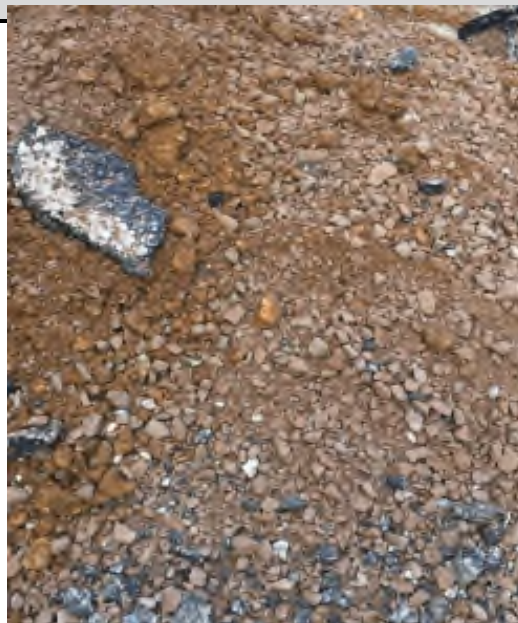
| <b>Comments:</b><br>No evidence of contamination olfactory or visual. | | | |

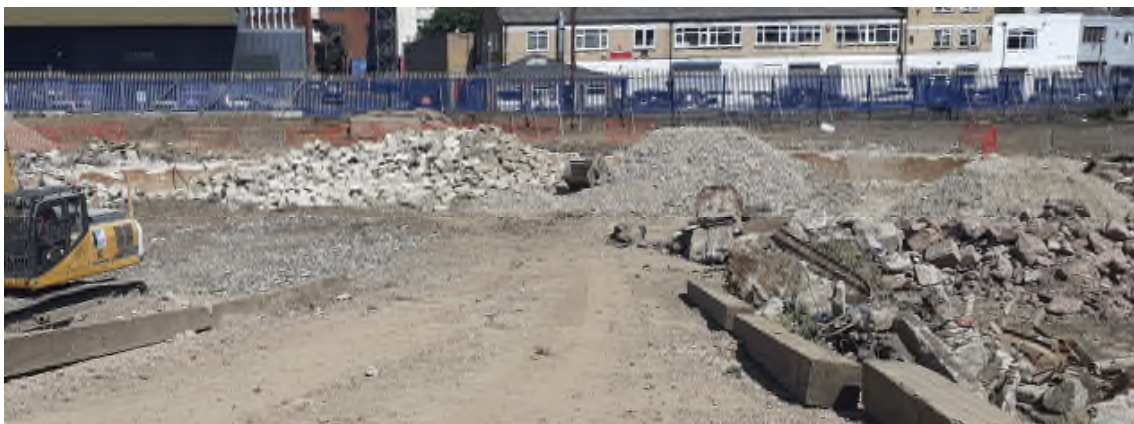
| <b>Comments:</b><br>No evidence of contamination olfactory or visual. | | | |

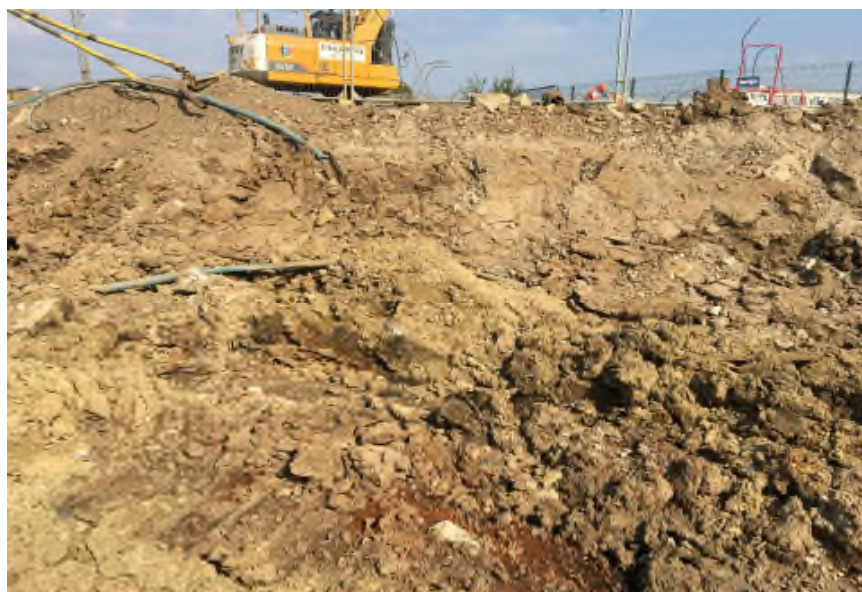
| <b>Comments:</b><br>stockpiled and rolled into GH1 | | | |

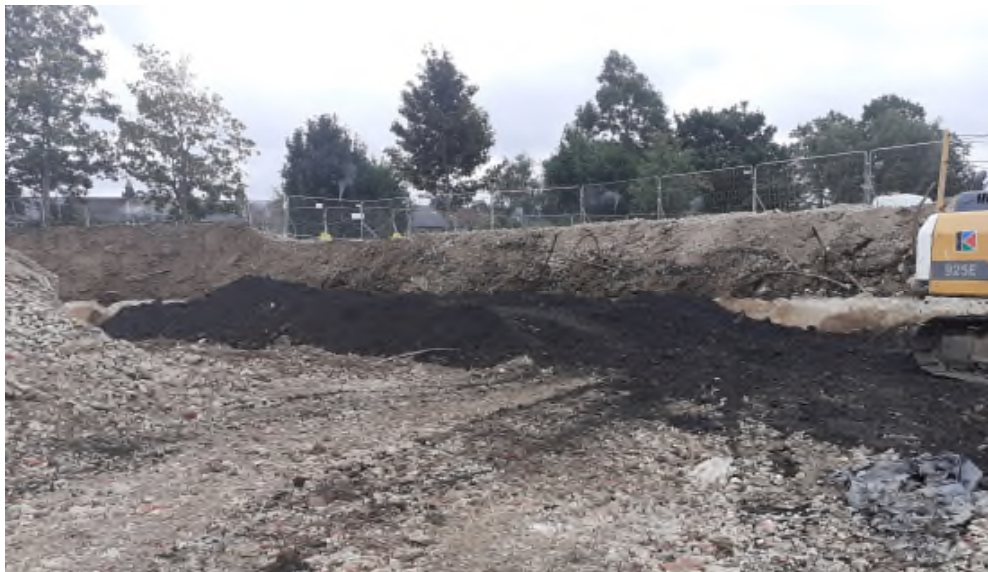
| <b>General Description of Material:</b><br>Black stained gravelly clay from J/K/L10 and 11. | | | |
