## Phase I Desk Study

423-435 Lordship Lane, Wood Green, London N22 5DH

On behalf of Ivorystone Investments Limited

| Report Reference: GWPR5273/DS/March 2023 | | | Status: Final |

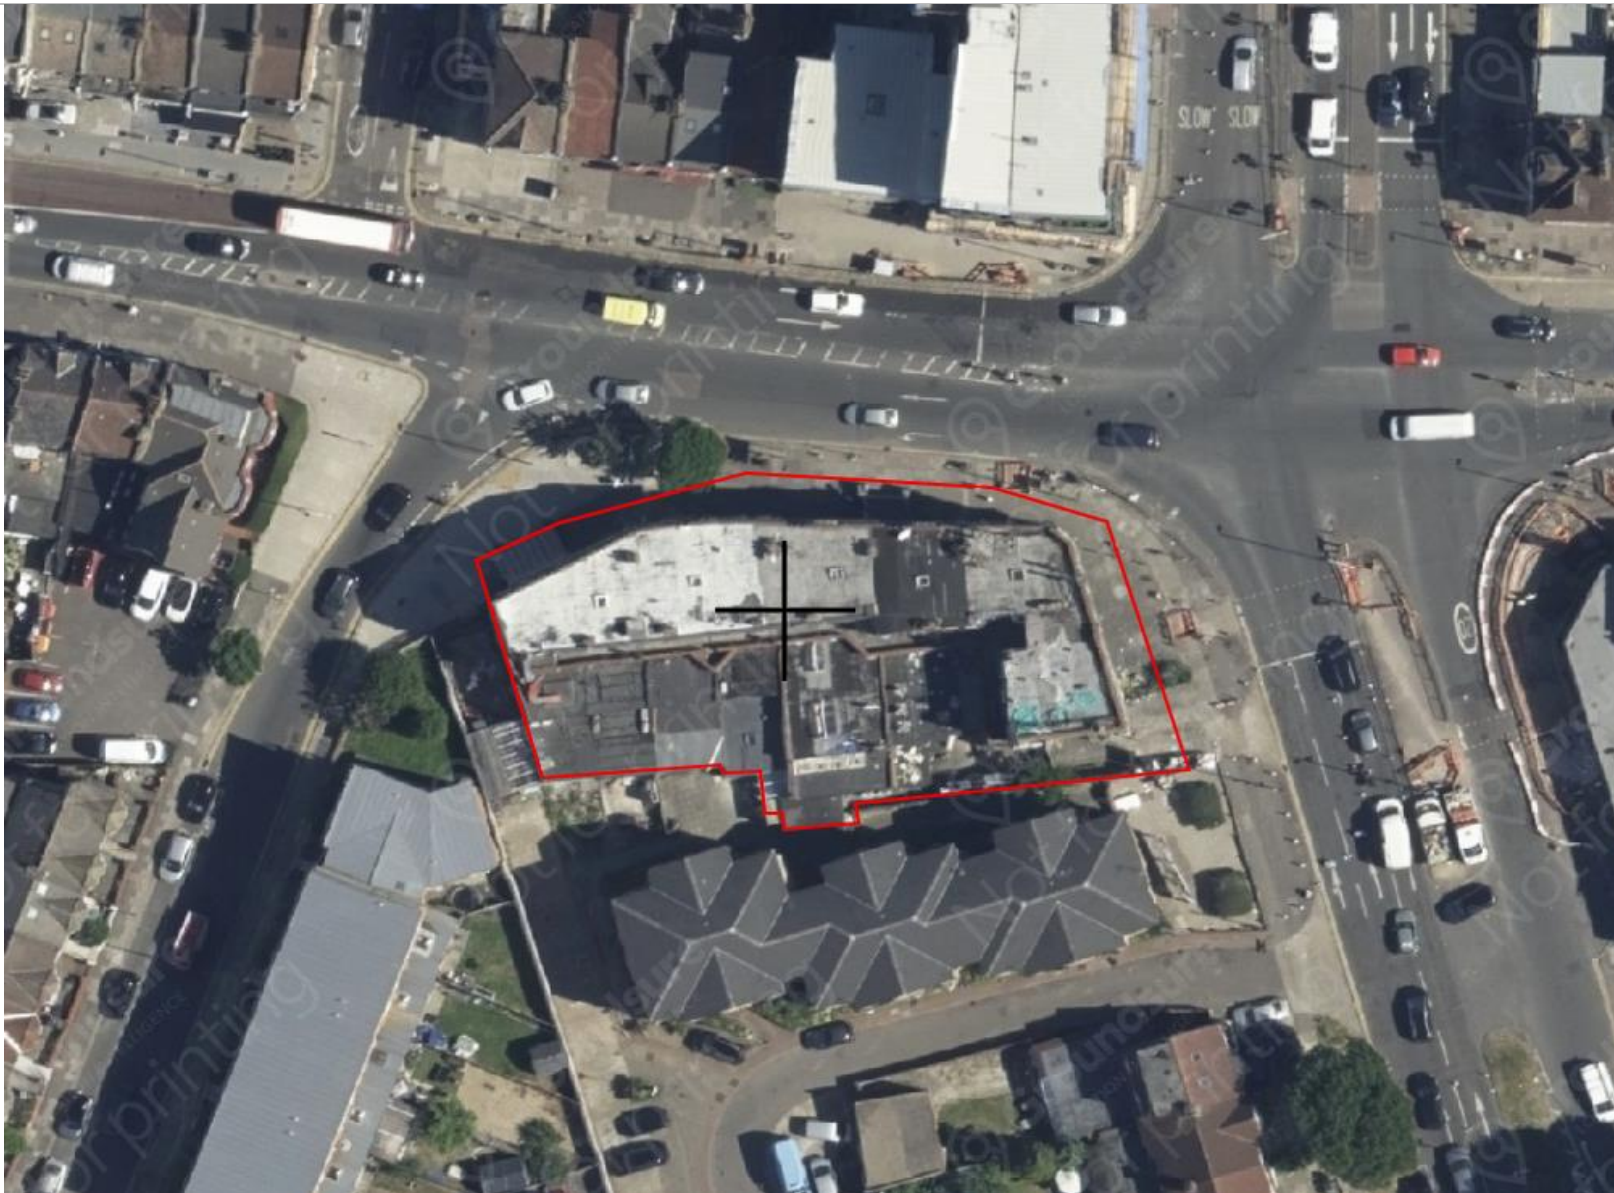
Figure 3 – Aerial View of the Site

Site Boundary

A description of the site, as noted during the recent site photographs from February 2023 and Assessment of Google satellite imagery and 'street view' photography dated March 2022, is tabulated below. Photographs can be seen in Appendix C. An Aerial image of the site can be seen in Figure 3.
