## Bruce Castle Museum

Heritage Statement to Accompany LBC application for the Repair of Lime Plaster in Secondary Rooms

BUTLER  
HEGARTY  
ARCHITECTS

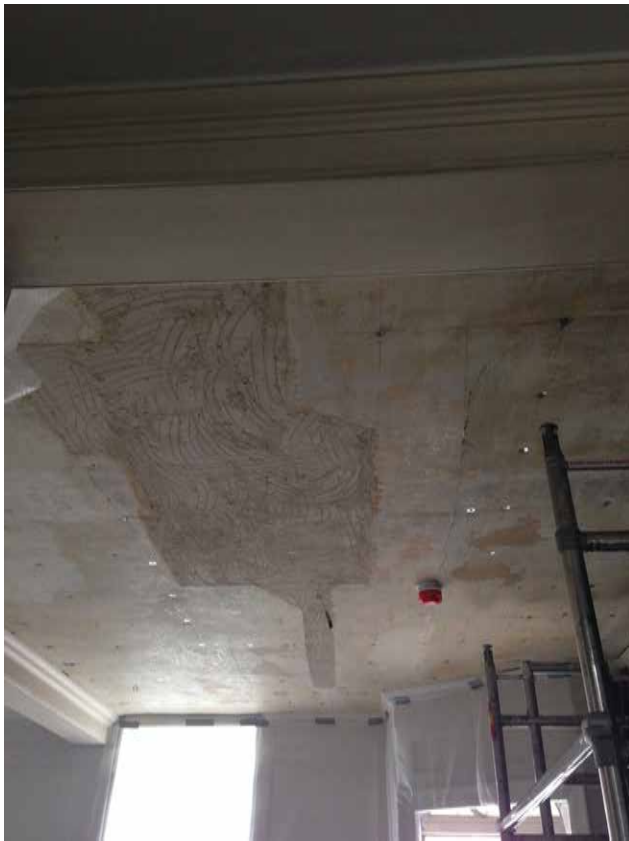
Photo 1 Ceiling area generally with a patch repair

Below we have included a set of photos of a ceiling repaired in a similar way. The ceiling was a high status room in a grade 2\* building and repairs

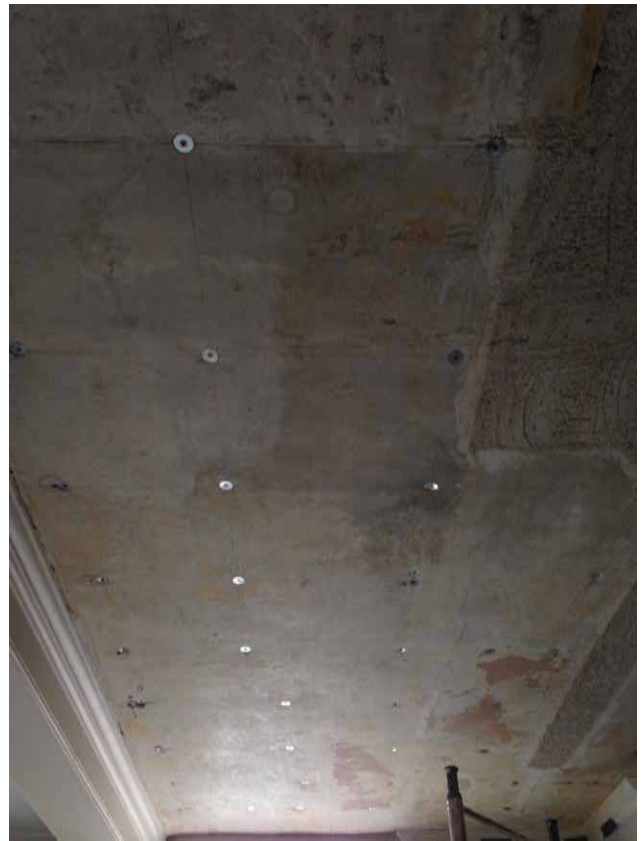
Photo 2 Ceiling secured with screws and washers

To reduce the amount of historic plaster to be removed and the risk of plaster loss, we propose stabilizing the areas by installing screws with penny washers inserted into the plaster and lathing through to the floor joists to hold areas of friable plaster in place. These screws will be installed at approximately 450mm centre grid to the area similar to those shown on photo 1, 2 and 3 below. This will stabilize the plaster and stop further collapse or disengagement from the lathing. Small patches of loose plaster within the area where the plaster key has completely broken and failed, will be removed, laths retained where sound, re-fixed to joists if required or replaced with riven Chestnut lathing to match existing. The lime plaster will be reinstated in area of repair in three coat lime plaster work.

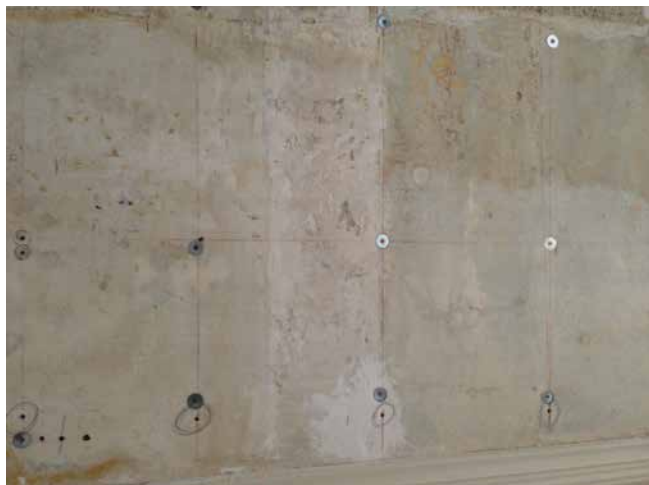
Photo 3 Grid of Screw and Washer fixing  
securing existing lime plaster ceiling

The stabilization process includes installing screws with penny washers inserted into the plaster and lathing ceiling to penetrate through to the floor joists, holding areas of friable plaster in place. The washers and screws will be recessed into the plaster surface. The screws will be installed at approximately 450mm centre grids to the area. The aim will be to stabilize the plaster and stop further disengagement from the lathing and possible collapse. Small patches of loose plaster within the area where the plaster key has completely broken and failed will be removed, laths retained and re-fixed if necessary, and lime plaster repaired in three-coat lime plasterwork.

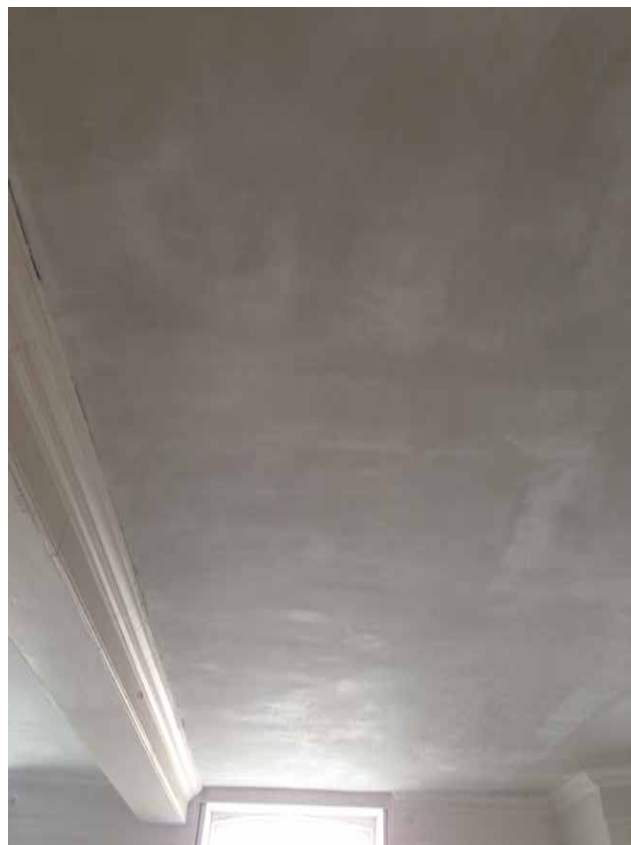
Photo 4 Completed repaired ceiling  
with skim coat finish made good
