# Site Investigation Report

88222.3.TSI

Auger were commissioned by Sedgwick to undertake a site investigation within the area of concern (AOC) at the property.

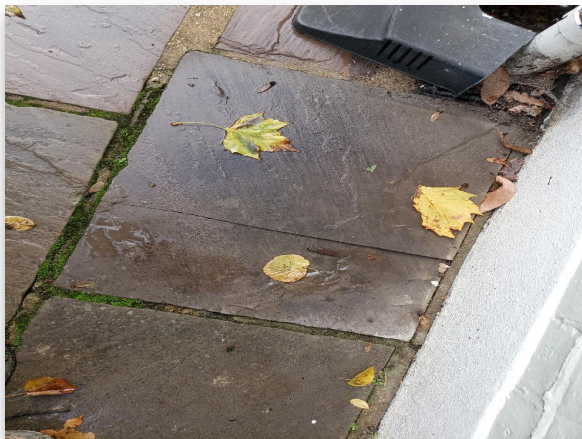
Fig 1.1: Trial Hole 1 Location

TH1 was able to reach the required depth in the proposed location and reveal the footing. Soil and root samples were taken.
