# LEVEL MONITORING

## for Subsidence Management Services

**2 Elms Avenue, Muswell Hill, London, N10 2JP**

| Our Ref: | M18000 |

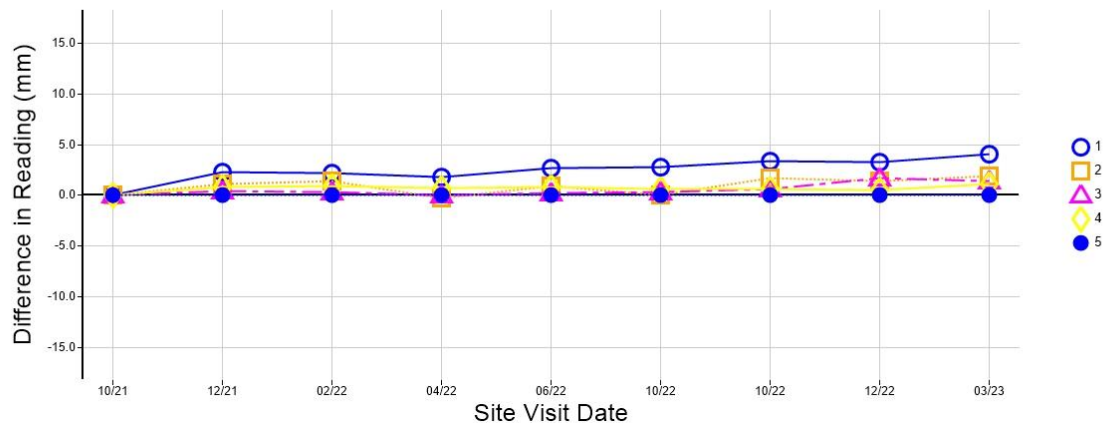
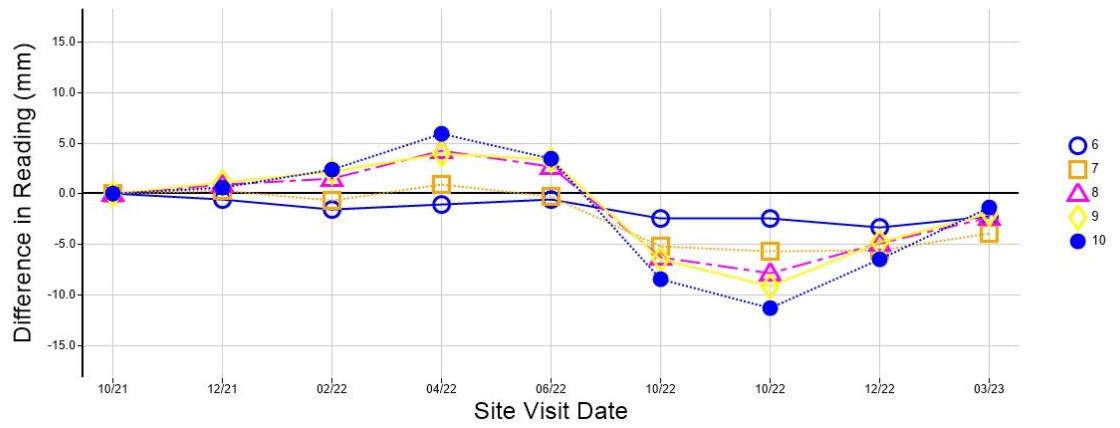
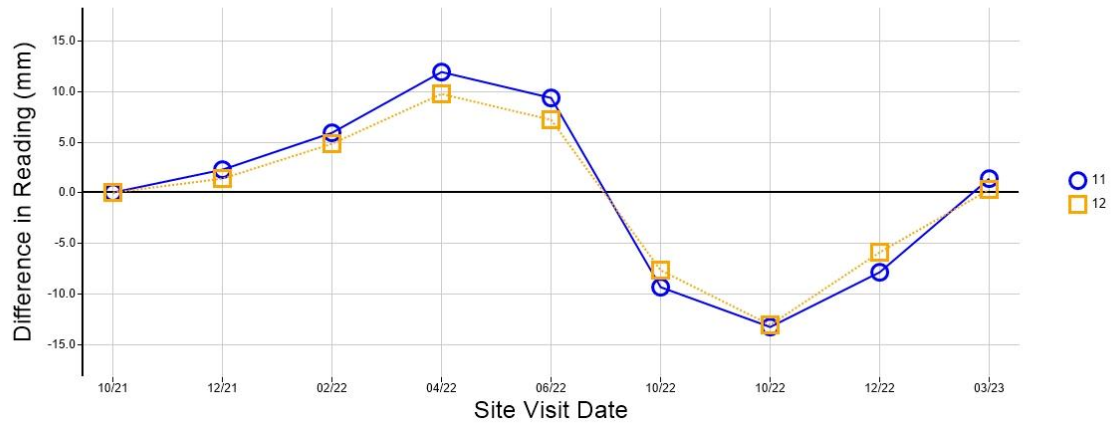
## Level Monitoring Difference Graphs

The following graphs display the progressive movement that each Level Monitoring Station recorded at each separate site visit date to give an overall look at how much the property is moving.

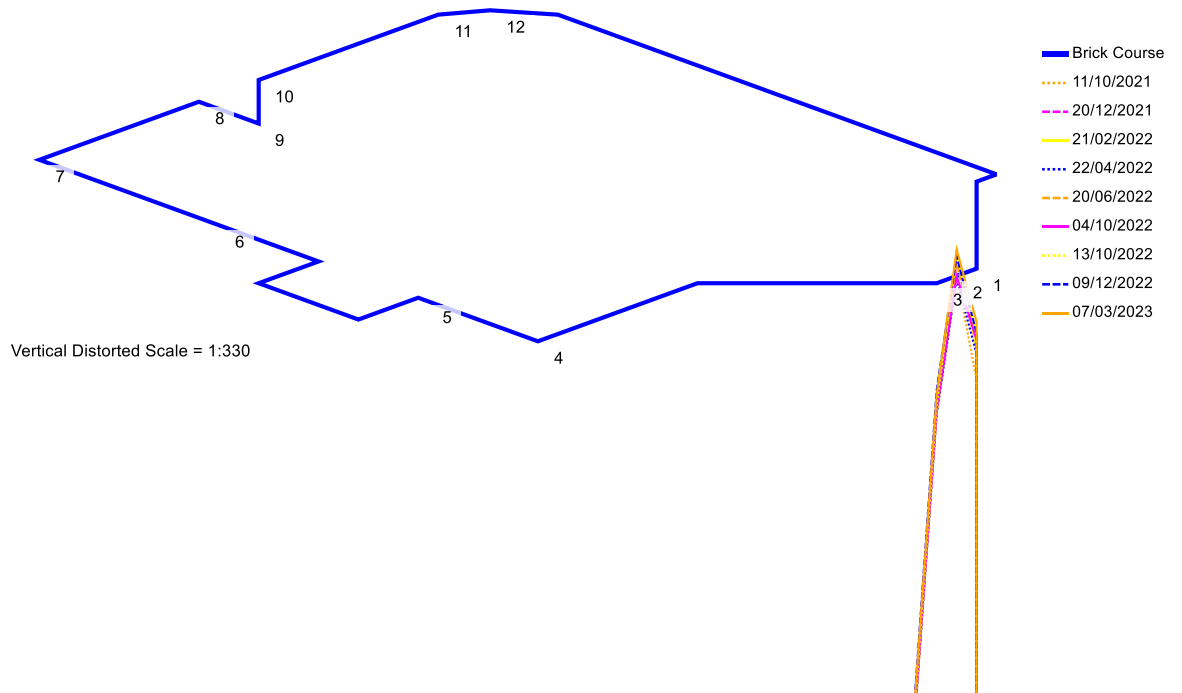
## Level Monitoring Displacement Map

The following image shows an isometric representation of the movement of the property, based on the Level Monitoring Stations that were installed.

FRONT

Datum is relative to point 5. It has an assumed value of 10.0000m. There is no suitable remote datum available. If this is not suitable, a deep datum is recommended.

Points 1, 2 & 3 on front bay. Points 9 - 12 on bay to rear.
