## Planning Application – Supporting Documents

**Job ref.** 115222-100/43/GBM/AJC

**Subject** Land and Buildings Beneath Station, White Hart Lane, London N17 8HH

### Conditions 3-4 of Planning Application

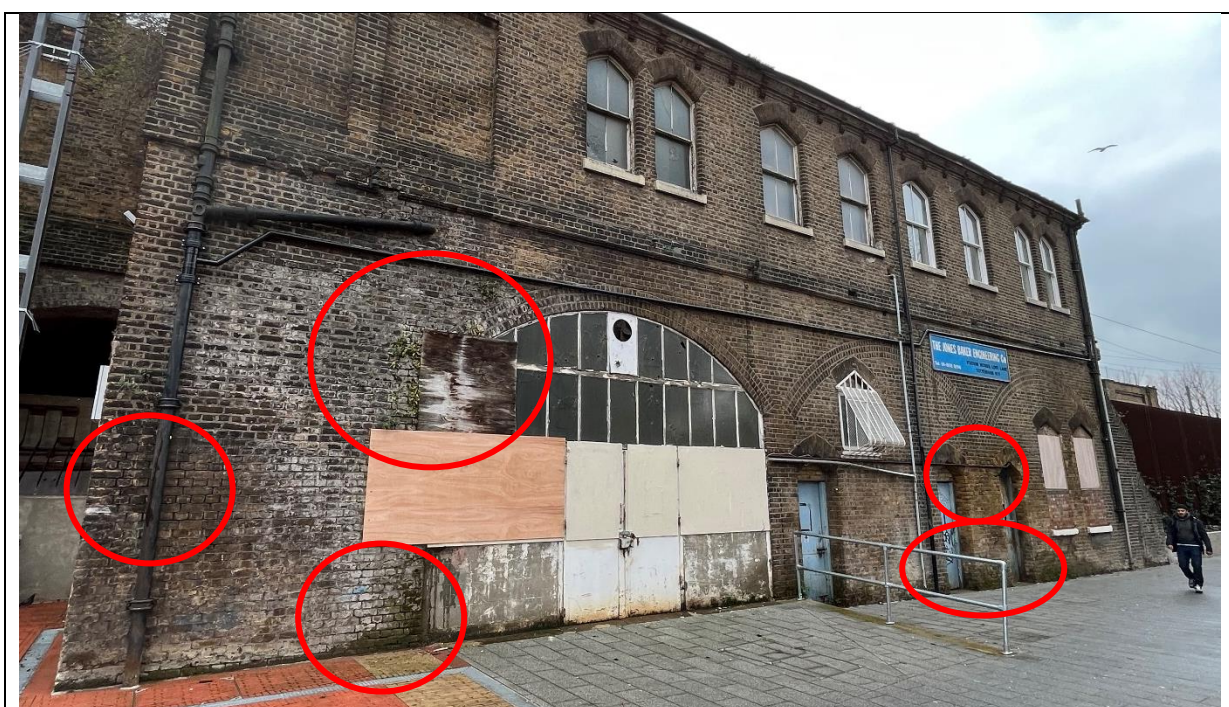
Photo showing front elevation of building. Areas of brickwork to be replaced and/or repointed are circled for clarity. Vegetation removal is also required to the left hand side of arch 1, located within large the red circle. Further details of these areas are covered in the table below. The brickwork will be cleaned to remove efflorescence and return the natural colour of the existing brickwork. This will ensure the new bricks will more closely match the existing.

The bricks and mortar have been colour matched and sourced to match the original installations as closely as possible. The old mortar shall be carefully raked out and replaced in areas that are badly eroded, to prevent water ingress in future. The repointed sections of brickwork shall be closely matched with the existing mortar joints to ensure the profile and colour is similar to the local aesthetic.

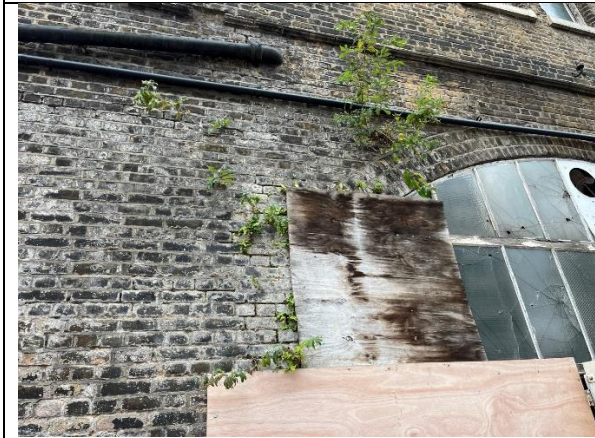
The vegetation to the elevations shall be removed. Vegetation largely consists of small buddleia and weeds growing within mortar joints.

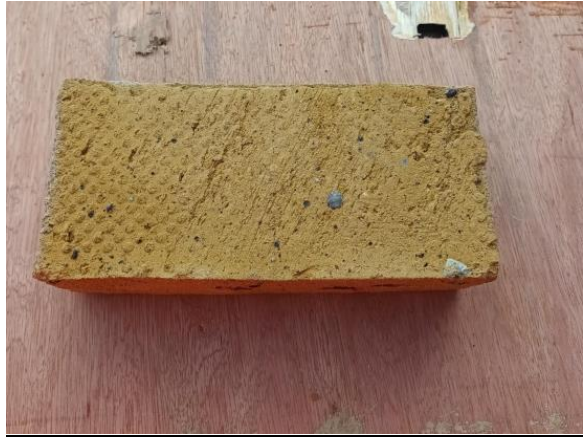
| Proposed London Stock brick – bed face | Proposed London Stock brick – header profile |

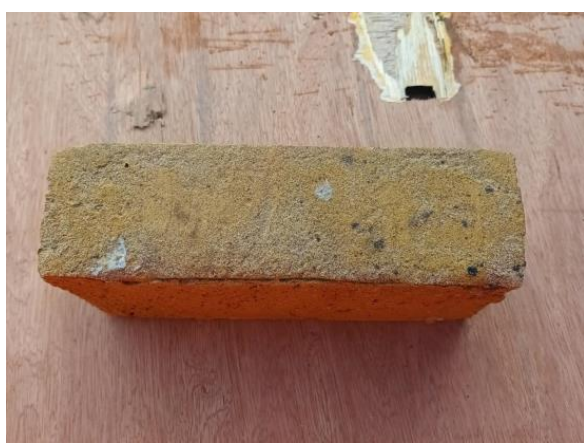
| Proposed London Stock brick – side profile | Proposed London Stock brick – frog profile |
