**QA****Haringey Civic Centre –Bat Survey Report**

- 1.1 Greengage Environmental Ltd was commissioned by Hawkins/Brown Architects to undertake a bat survey of a site known as Haringey Civic Centre, within the administrative boundary of the London Borough of Haringey.

- 1.2 This document is a report of this survey and has been produced to support a planning submission for the site which seeks the refurbishment of the existing building on site as well as to build a new residential area.

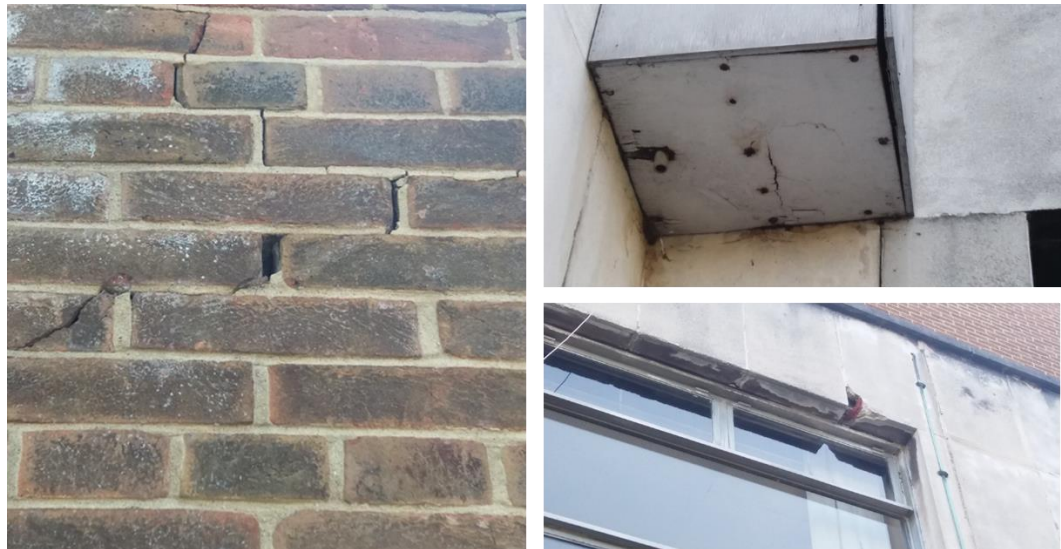
**Figure 2.1 Example of roosting features on building 1.**

- 2.11 During the initial ecological site visit, undertaken on the 10<sup>th</sup> August 2020, a visual assessment of the buildings and trees to identify their suitability to support roosting bats was undertaken.
- 2.12 The potential access points, roost locations, foraging areas and commuting routes were identified during this inspection.
- 2.13 During the inspection the main building on site (Building 1) was found to be in generally good condition although there were signs of wear particularly around the brickwork. The features of interest on the buildings include gaps under the fascia boards, missing mortar, damaged brickwork and lifted lead flashing.
- 2.14 These features were deemed suitable to support low numbers of common crevice dwelling species such as common pipistrelle.

- 2.15 The site's urban location, isolation from suitable foraging habitat and exposure to regular noise and light disturbance, reduced the suitability of these roosting features.
- 2.16 Therefore, overall Building 1 was given **Low** bat roosting potential.

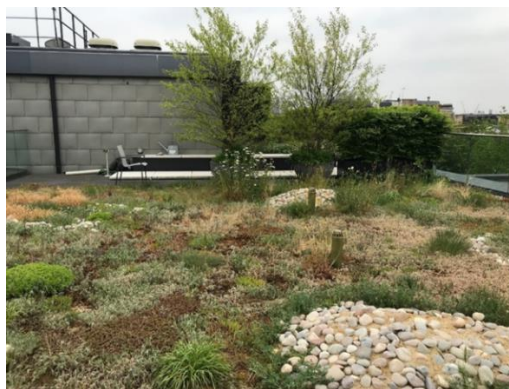
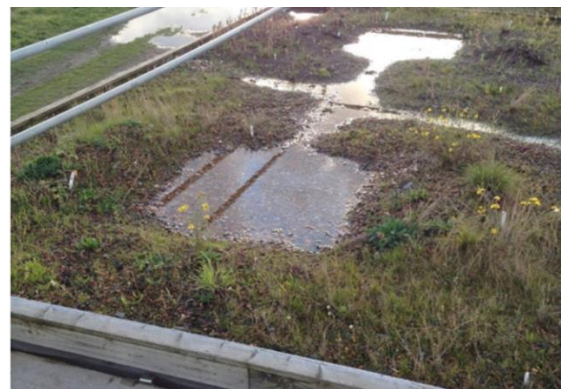
**Figure 5.1 Left: Sandy piles covered in stones on biodiverse roof Right: Ephemeral wetlands on a biodiverse roof.**

- 5.10 Roof enhancements should also be used on the green roof where possible, these should include rope coils, sandy piles and log piles which all enhance the habitat for invertebrate species, thus improving foraging habitat for bats.

- 5.7 Green roofs should be implemented due to their valuable contribution towards habitat provision for local wildlife, green connectivity across the landscape
- 5.8 Green roofs should take the form of substrate-based biodiverse roofs. Which utilise multiple substrate types including:
  - Typical biodiverse substrate designed for extensive living roofs, composed of recycled crushed brick, expanded clay shale and recycled organic content (for example Bauder's Biodiverse Substrate<sup>4</sup>);

- Caledonia cobbles of roughly 40-120mm size mixed with the biodiverse roof substrate; and
  - Water collection trays for ephemeral wetland planting. These should be lined with a suitable aquatic compost and cobbles.
