### **Haringey Civic Centre – Pre-cast sample Petrographic Analysis**

# Haringey Civic Centre – Cast Stone Petrographic Analysis

**Results of Mortar Analysis for Sample:** Pre-Cast Stone from Haringey Civic Centre, North London.

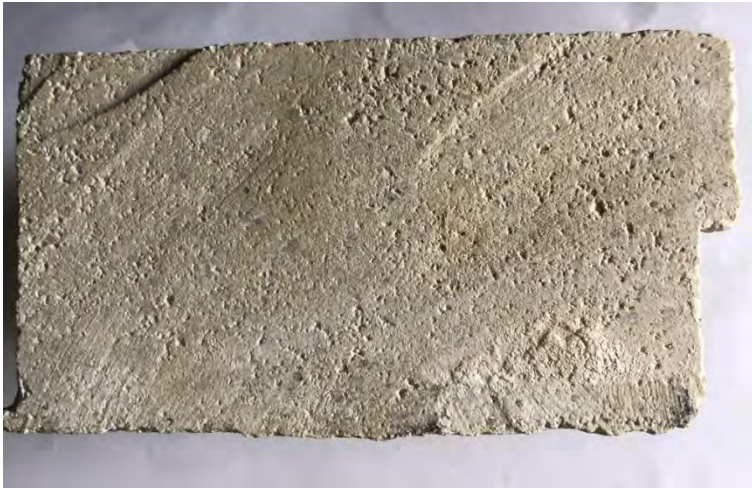
**Observations:** A hard (5.5 - 6 Mohs), off-white coloured, fine - medium grained cast mortar containing fine angular quartz and feldspar grains, small shiny platelets of mica and very occasional small black magnetite:

Cut side elevation of Pre-Cast Stone (length 12cm)

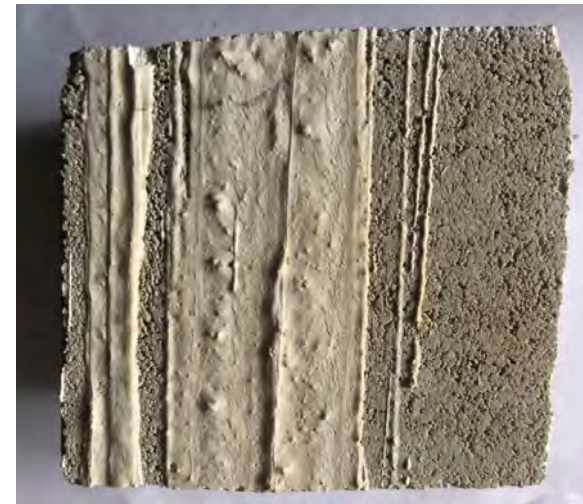
Top painted and weathered surface of the Stone

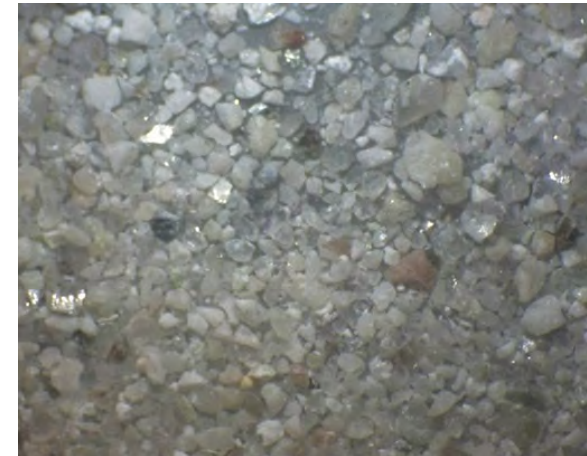
Aggregate mag. x 10

Is a white - off-white coloured, quite well graded, sharp, fine to medium grained siliceous material with the characteristics of a crushed white granite, composed mainly of whitish-grey orthoclase (some pinkish-white), milky-white and clear quartz grains together with a smaller amount of shiny mica platelets (mostly clear muscovite).

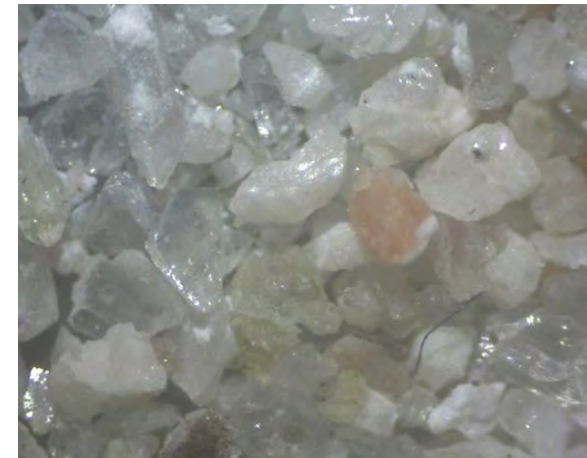
Aggregate mag. x 60. Note pinkish-white orthoclase feldspar and platelets of clear muscovite mica.

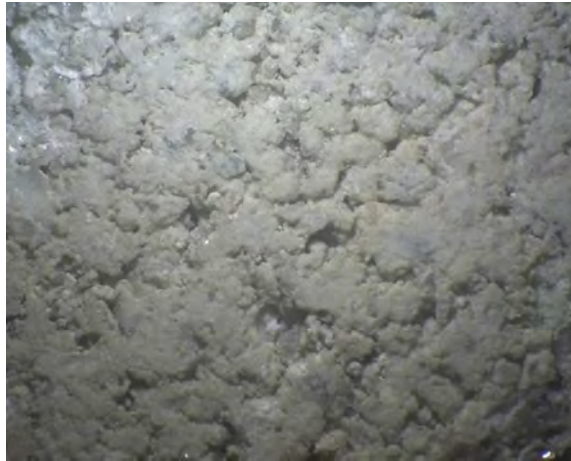
Top surface of Pre-cast stone, mag. x 60.

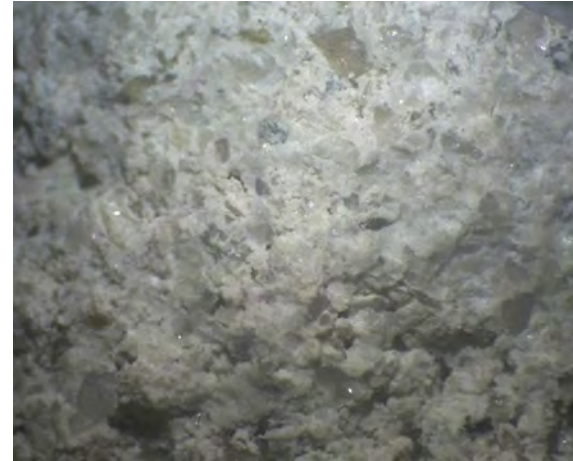
Surface of cast stone core, mag x 10.

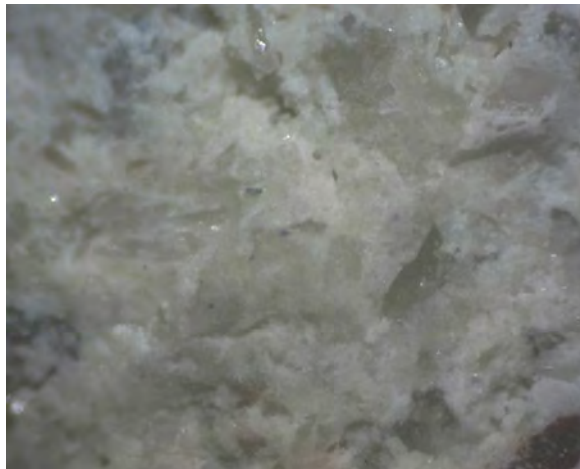
Core surface mag. x 60.

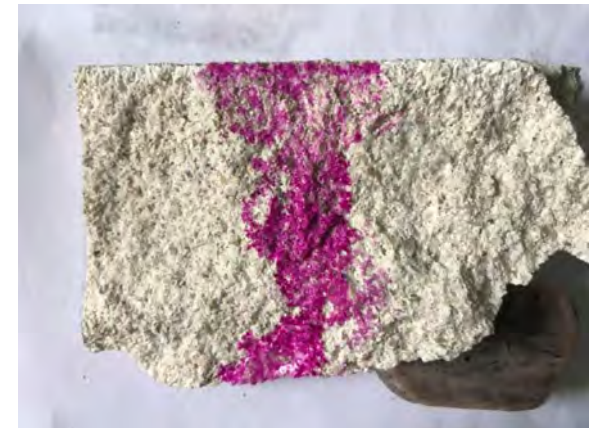
**TOP:** Section of 'stone' with Phenolphthalein, mag. x 10.

**BOTTOM:** whole core section with phenolphthalein (purple-red colour indicates alkaline non carbonated lime  $\text{Ca}(\text{OH})_2$ )

Phenolphthalein turns from clear to purple-red in contact with alkaline surfaces. The photomicrographs indicate that there is uncarbonated lime [ $\text{Ca}(\text{OH})_2$  Portlandite] mainly from hydrated cement compounds (alite and belite), plus some uncarbonated 'free lime' from the original cement clinker.

This can be deduced from the value of pH12 for the cast stone surfaces (which should be about pH8 after full carbonation), indicating significantly more lime present within the cast stone matrix than if it were fully cured. However, the top surface of the cast stone is mostly carbonated down to depth of about 1mm (no red colouration of the surface was seen with phenolphthalein).

Analysis results give **4.4% active lime** in the binder (indicating it is **95.6% carbonated**). There is generally about 2.5% free lime  $\text{Ca}(\text{OH})_2$  in white cement clinker, so much of the uncarbonated lime must be attributable to hydrated but uncarbonated alite and belite, despite any free lime from the clinker.

It is quite likely that the uncarbonated nature of the cast stone is the main cause of any deficiencies in its performance because it will not be as strong or as dense as it might be if fully cured/carbonated (its compressive strength is around **16MPa** when it should be perhaps around 30MPa).

Due to the inherent deficiencies, it is not recommended to carry out mortar repairs to pre-cast cladding as the substrate is prone to failure resulting in loss of adhesion, de-bonding and detachment of material.

It is Recommend investigating alternative cladding for replacement of all existing pre-cast to de-risk the facades and provide a long-term economic solution with added benefit of the potential to include insulating properties.
