***10 Ellington Road, Muswell Hill, London,  
N10 3DG***

***GEOTECHNICAL GROUND INVESTIGATION REPORT***

*Project No. 1896-22*

**REPORT ON GEOTECHNICAL GROUND INVESTIGATION  
AT 10 ELLINGTON ROAD, MUSWELL HILL, LONDON, N10 3DG**

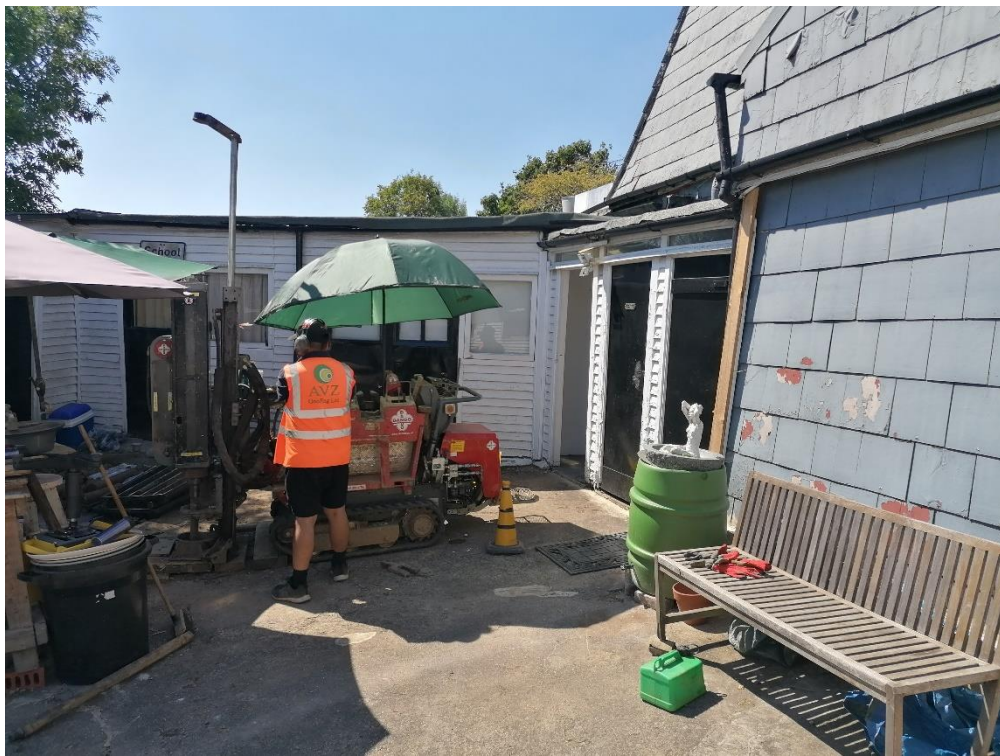
| <b>Photo<br/>No.1</b> | <b>Figure 6</b> | | | | |

| <b>Description:</b><br>Terrier Rig Performing<br>Drilling at the location | | | | | |

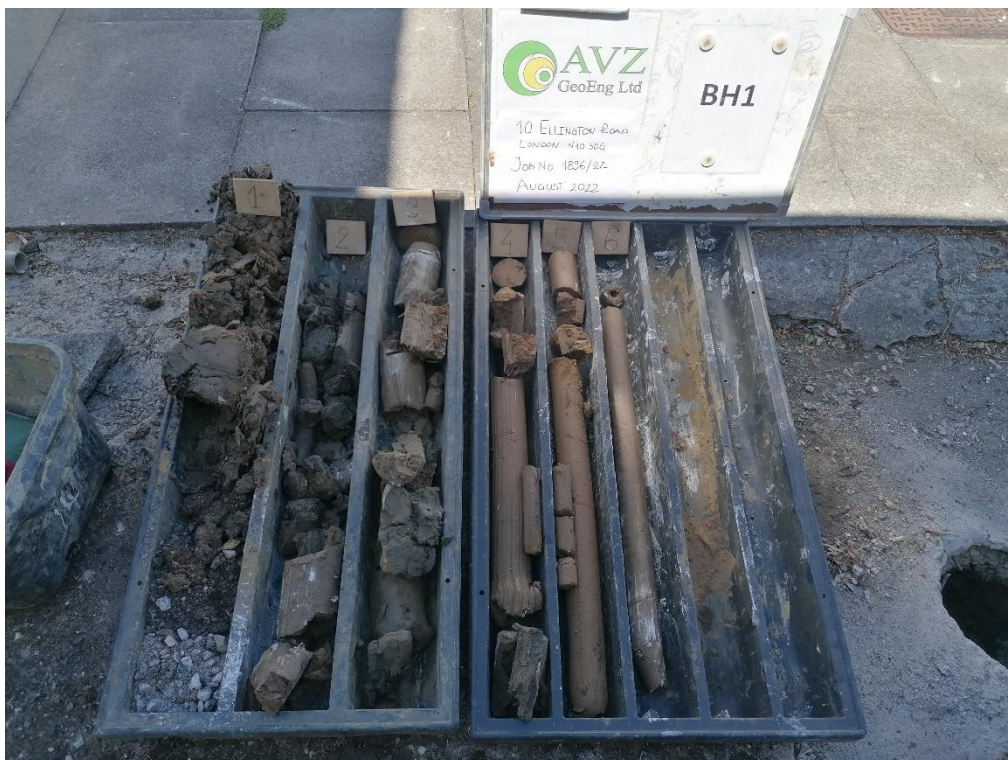
| <b>Photo<br/>No.2</b> | <b>Figure 6</b> | | | | |

| <b>Description:</b><br>Core Recovered<br>From BH1 | | | | | |

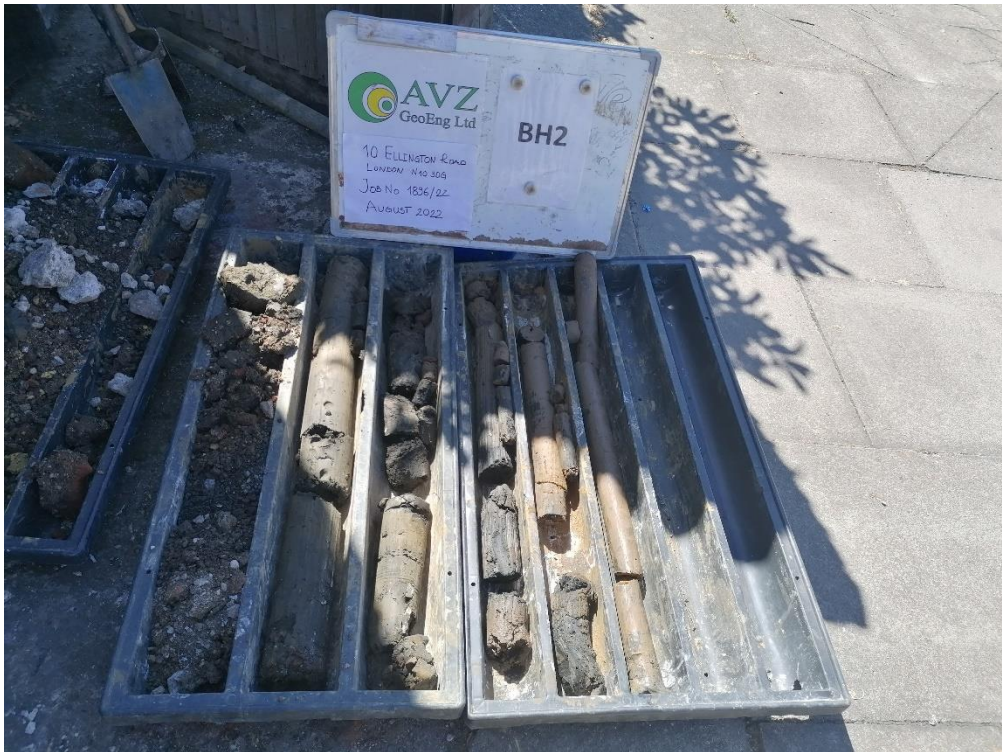
| Photo<br>No.3 | Figure 6 | |

| Description:<br>Core Recovered<br>From BH2 | | |

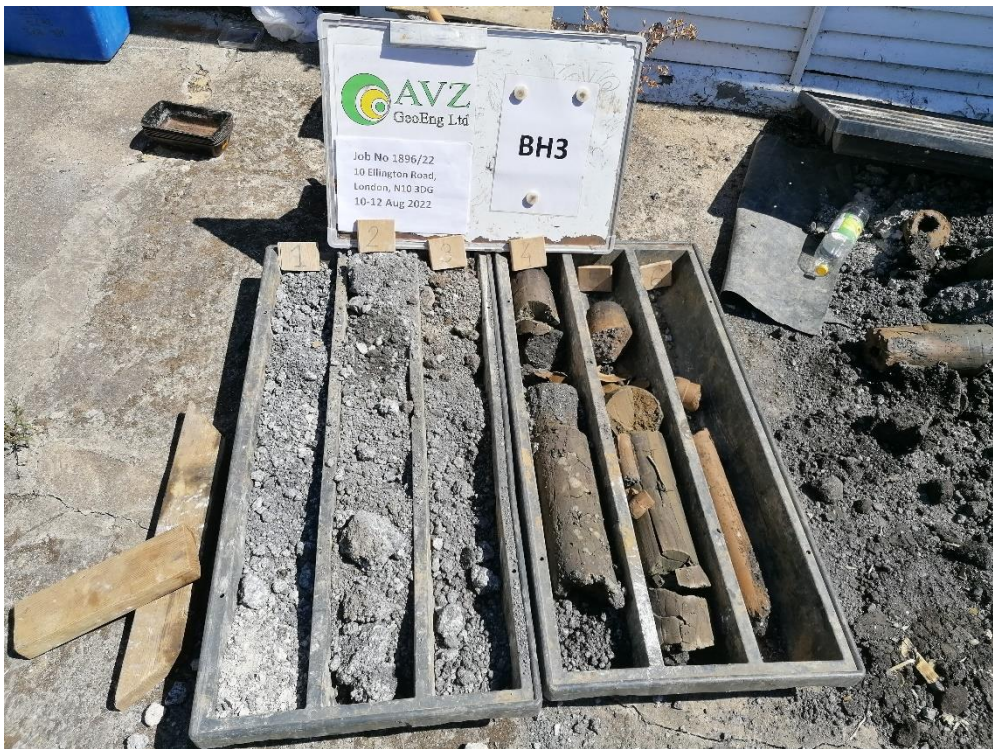
| Photo<br>No.4 | Figure 6 | |

| Description:<br>Core Recovered<br>From BH3 | | |

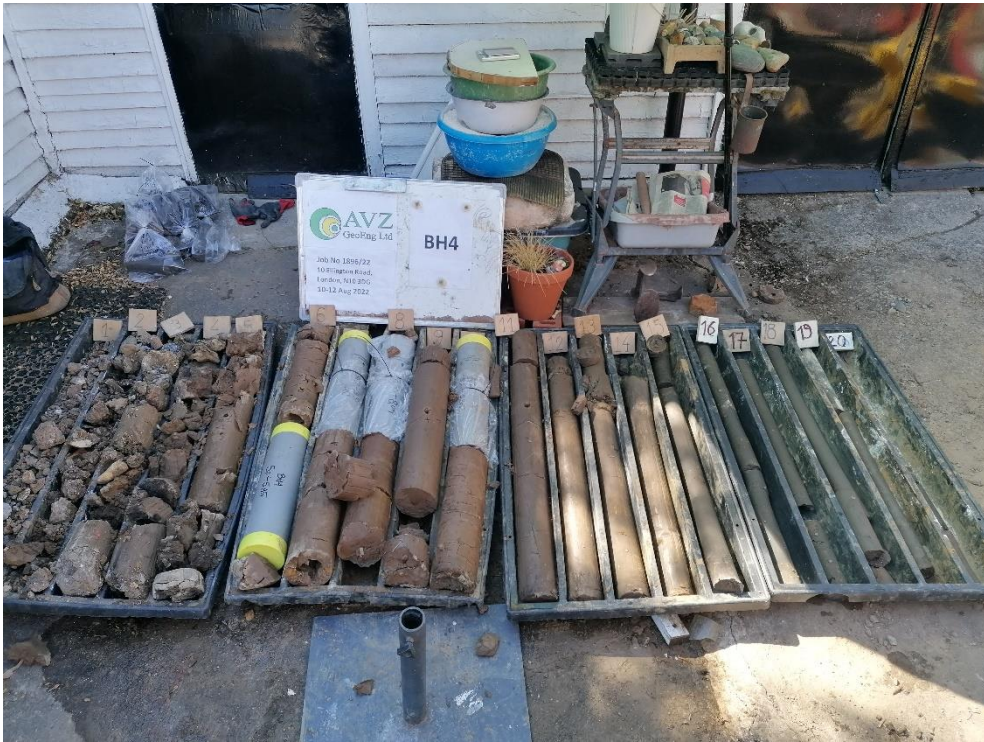
| Photo<br>No.5 | Figure 6 | |

| Description:<br>Core Recovered<br>From BH4 | | |
