**PHASE 1 ENVIRONMENTAL REPORT**  
**of a site at**  
**10 ELLINGTON ROAD, MUSWELL HILL, N10 3DG**  
**for**  
**AVZGEOENG LTD**

**Project No 2367**  
**Report ref: 2367-P1E-1**  
**Issued: 26 September 2022**  
**Revision:**

Mr Boban Zarkovski of AVZGeoEng Ltd. requested a phase 1 environmental desk top study for a site at 10 Ellington Road, Muswell Hill, N10 3DG.

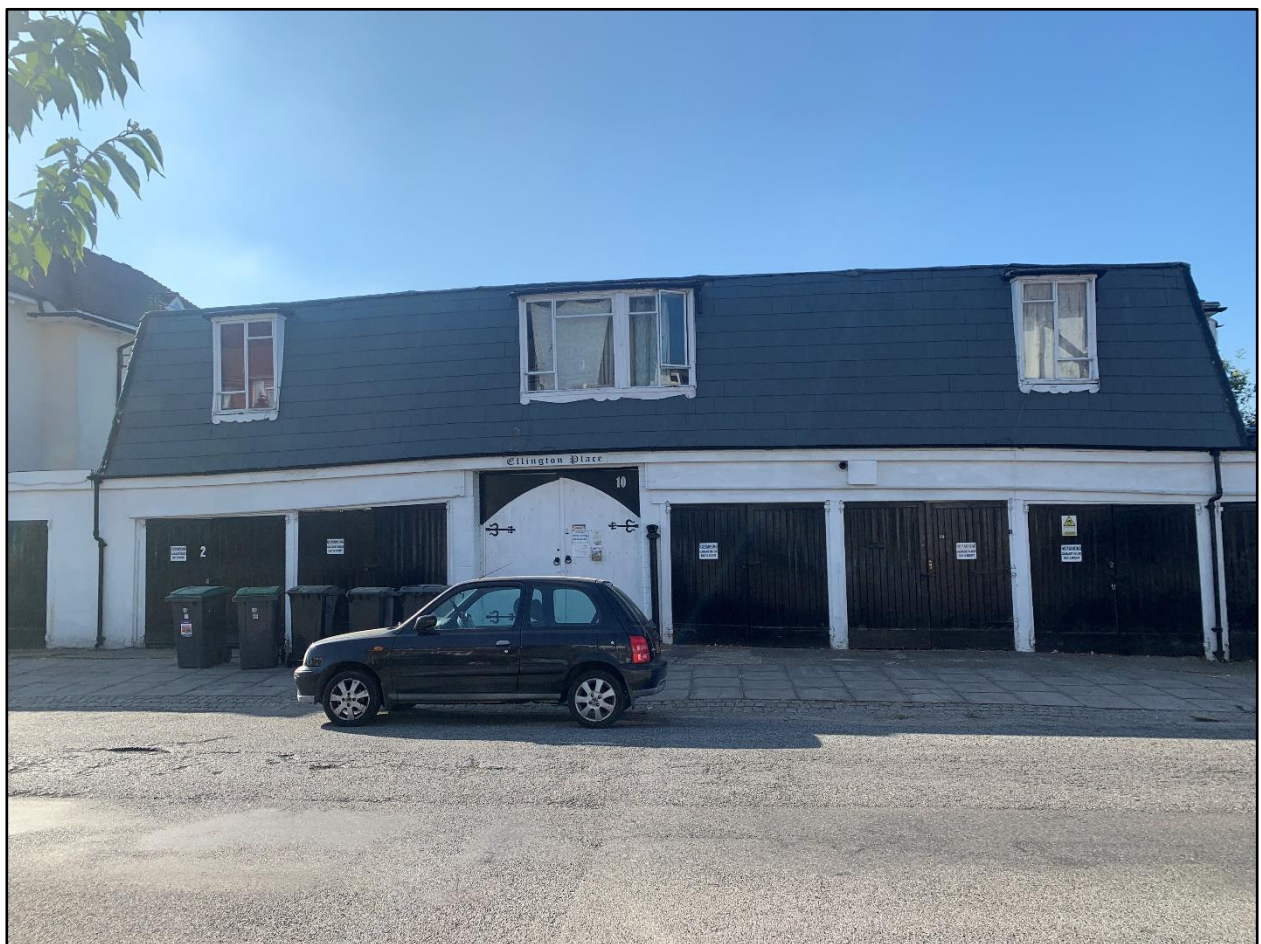
**Photograph 1: View of the site from Ellington Road**

The property is located along the northern site boundary. Adjacent to the northern side of the building, several drainage grates and a inspection chamber covers were identified.

The remainder of the site is a concrete surfaced courtyard. Adjacent to the southern side of the property, several downpipes and drainage grates were identified.

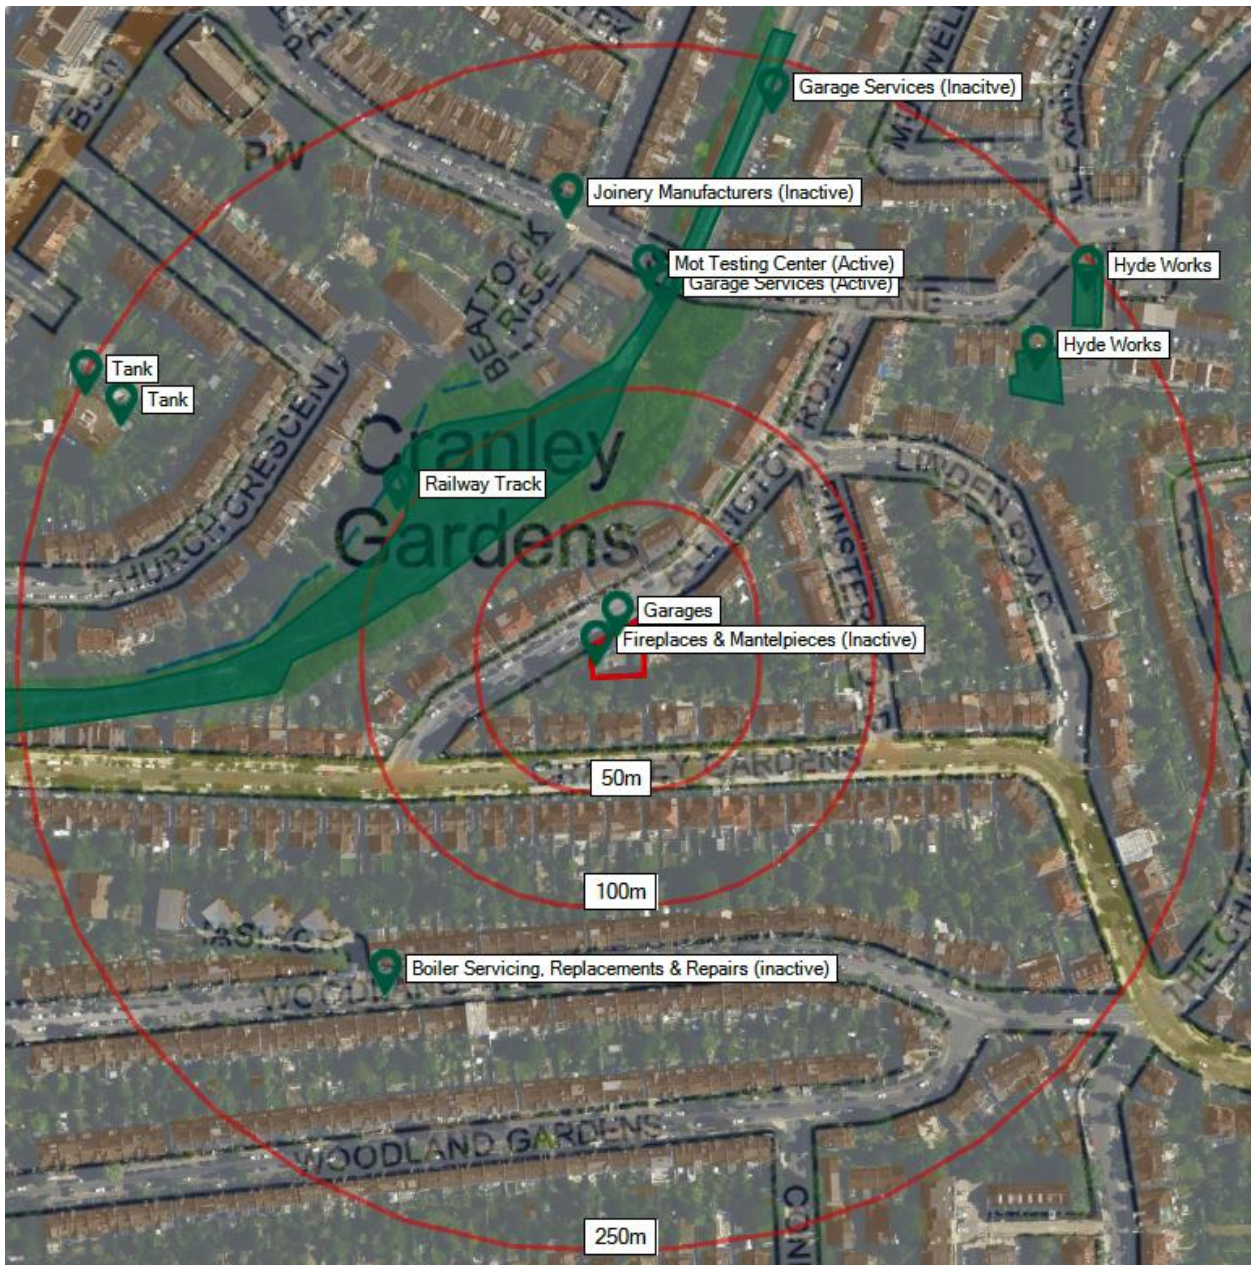
**Figure 2: Potential sources of contamination within 250m of the site**

Potentially contaminating commercial activities have been identified in the vicinity. The general topography falls to the east. This is assumed to be the general direction of the hydraulic gradient, therefore sources to the west and within the near vicinity are considered to have the most potential to impact the site.

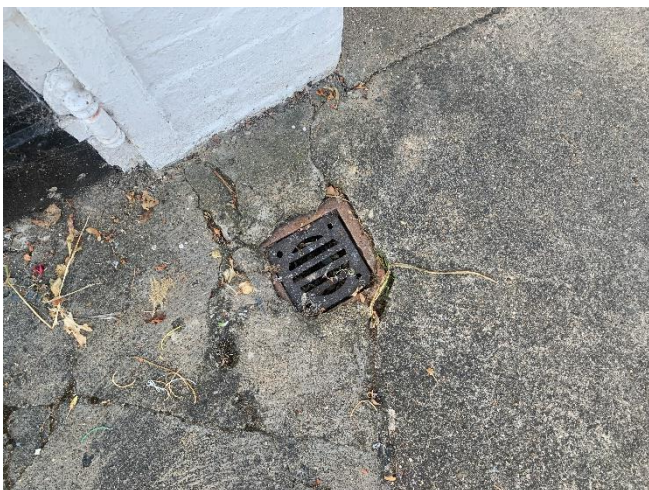
Drainage grate located adjacent to front gate.

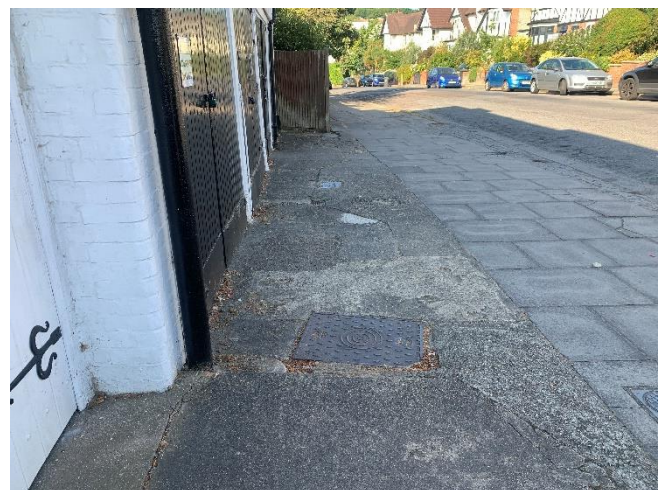
Manhole cover and drainage grates located along the northern site boundary.

**12.3** If it is proposed to make use of the existing drainage system, or any existing connections to the mains sewers. A CCTV survey should be considered in order to determine both the general condition and suitability for the proposed use.

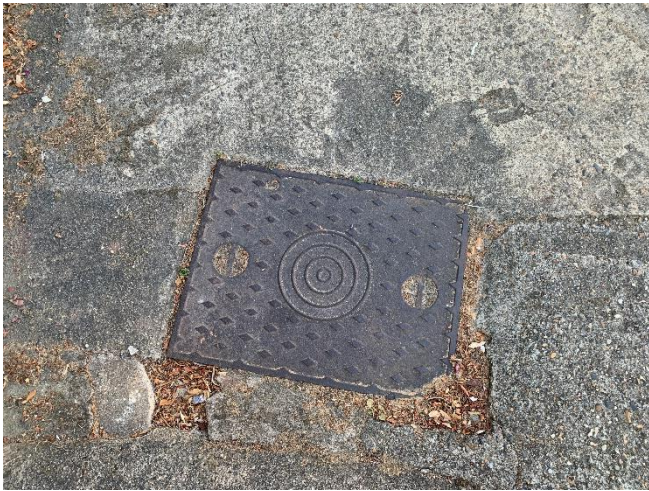
Manhole cover.

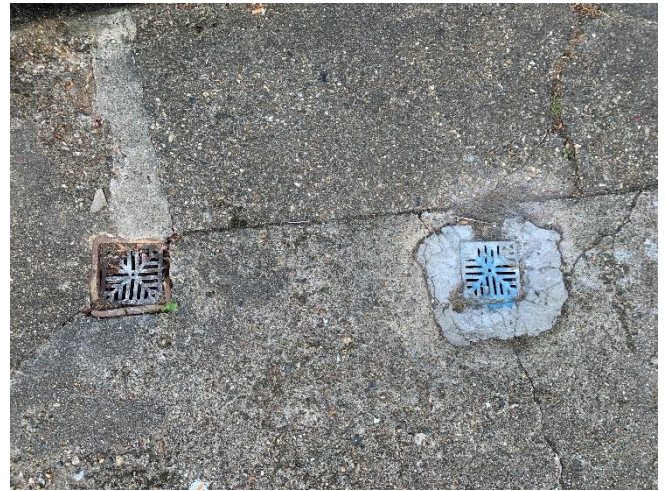
Drainage grates.

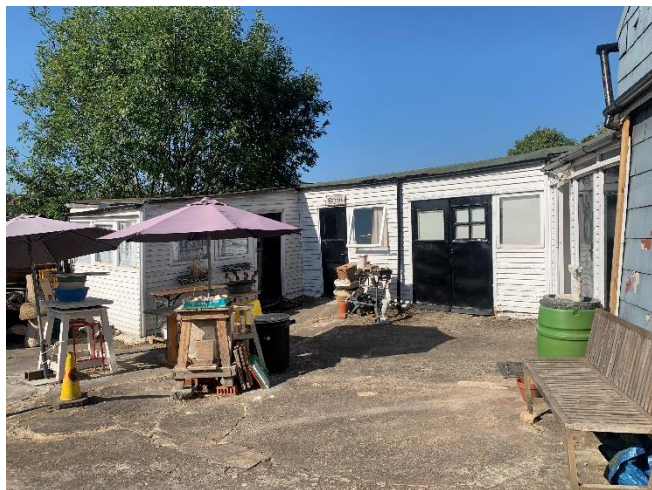
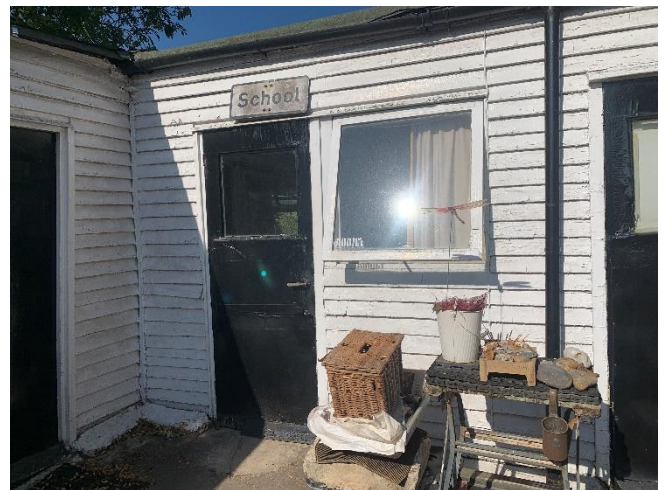
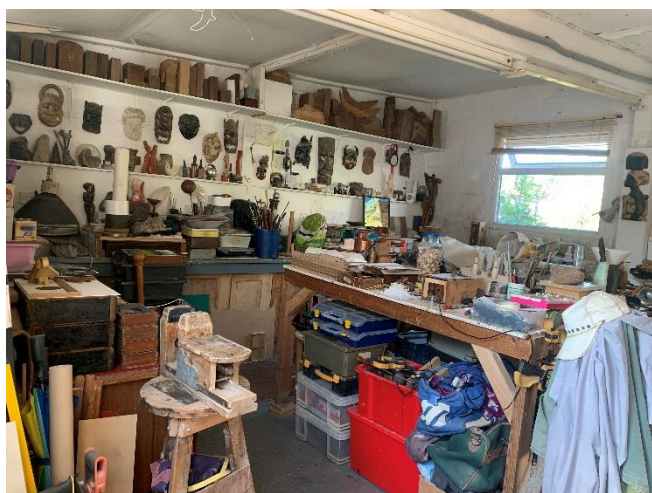
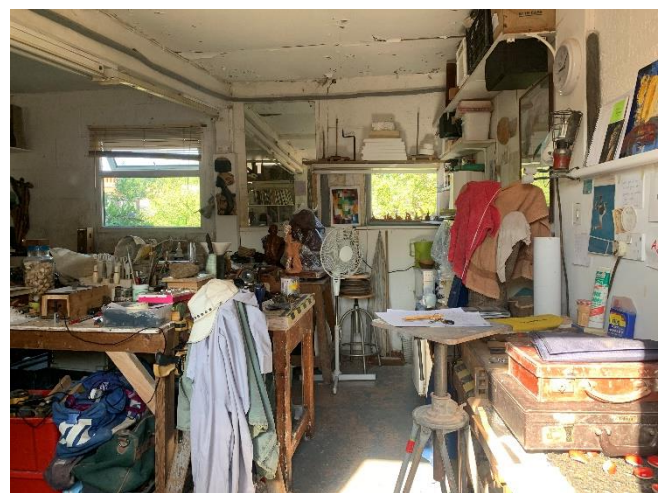
At the time of the site visit the timber outbuildings were being used as workshops. The use of the workshops included, a soap producer, an art workshop, a carpenter's workshop and a health and beauty spa.

Typical views of the timber workshops located along the western site boundary.

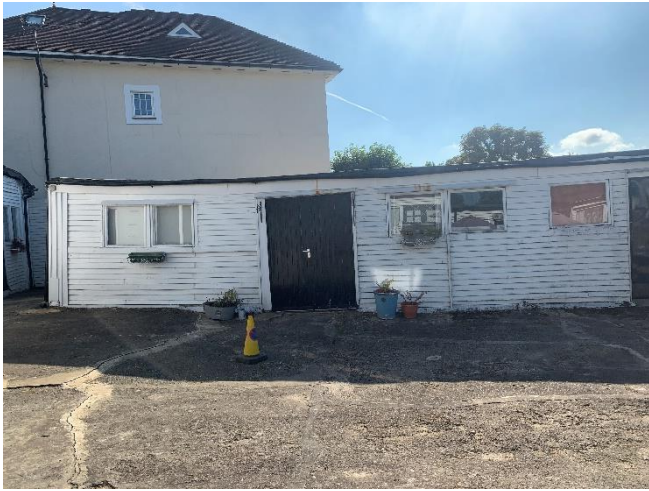
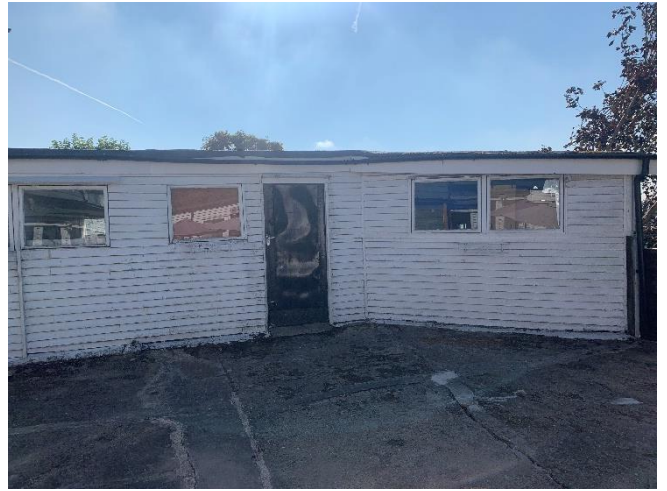
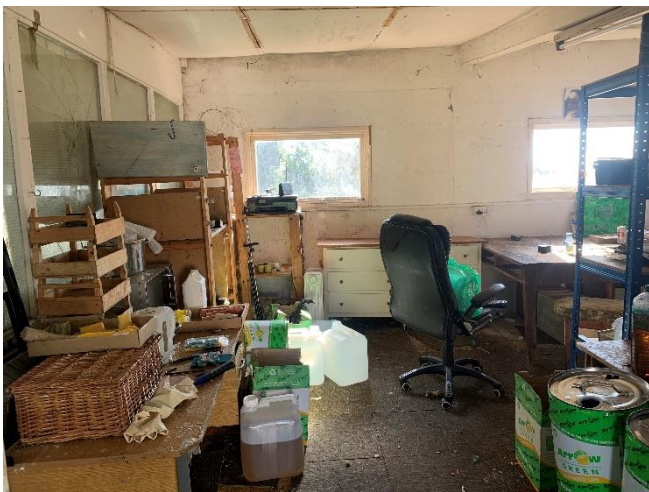
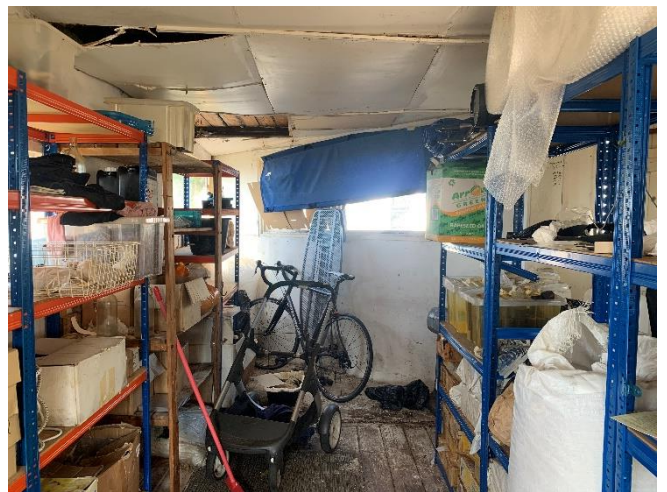
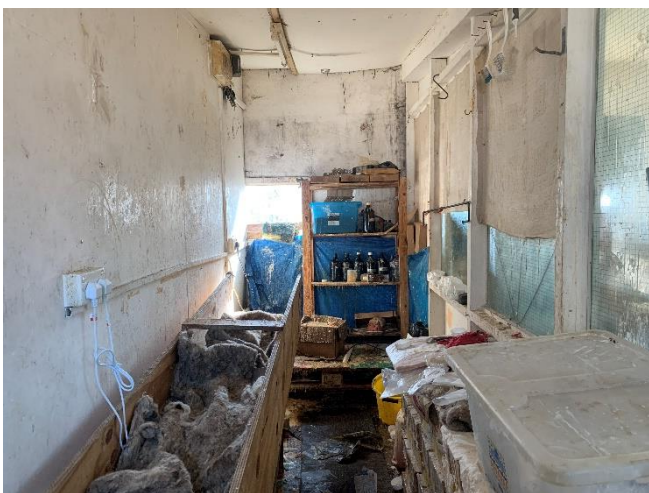
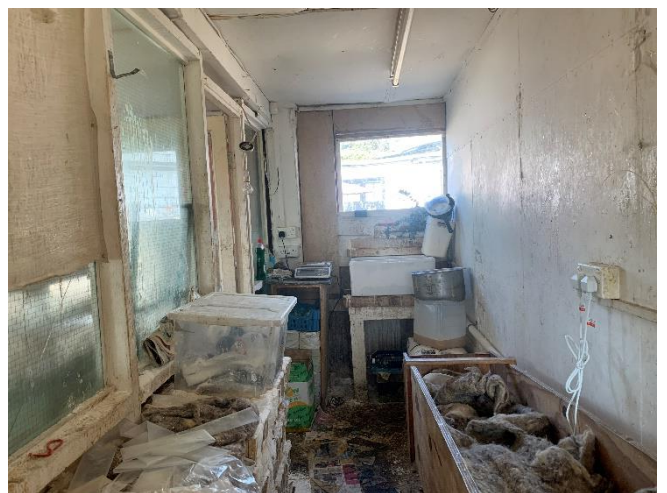
Typical views of the workshops located along the eastern site boundary

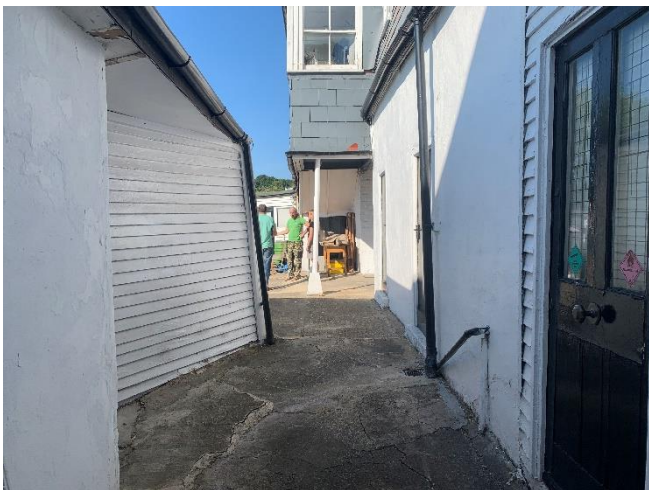
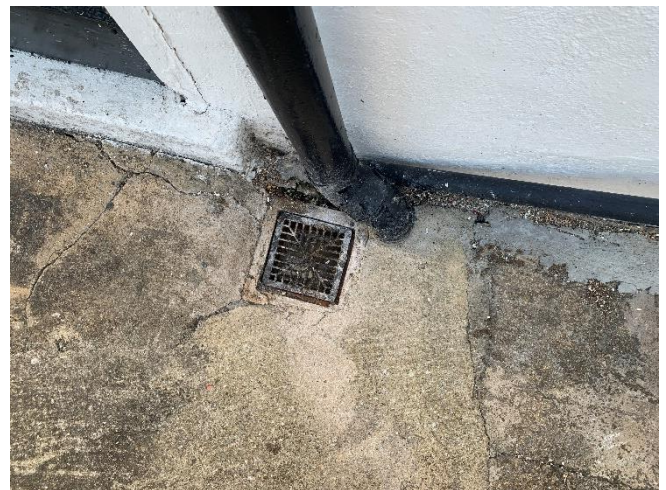
W facing view of the courtyard, with downpipes and drainage grates shown in the background.

Down pipe and drainage grate.

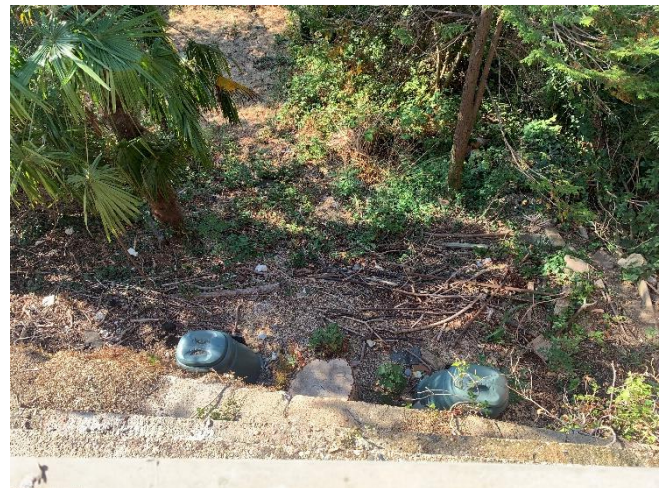
The western and southern site boundaries are marked by the private gardens of the neighbouring properties as well as a decrease in elevation by an estimated 8m.

View of the estimated 8m drop adjacent to the southern side boundary.
