Client: London Borough of Haringey Drawing Title: D1 AMS - Drainage

Site: Ashley Road Depot, Park View Road, London, N17 9AZ

Scale: 1:500 (A1) Checked By: NH Drawing No: 9775-D1-AMS Rev: -

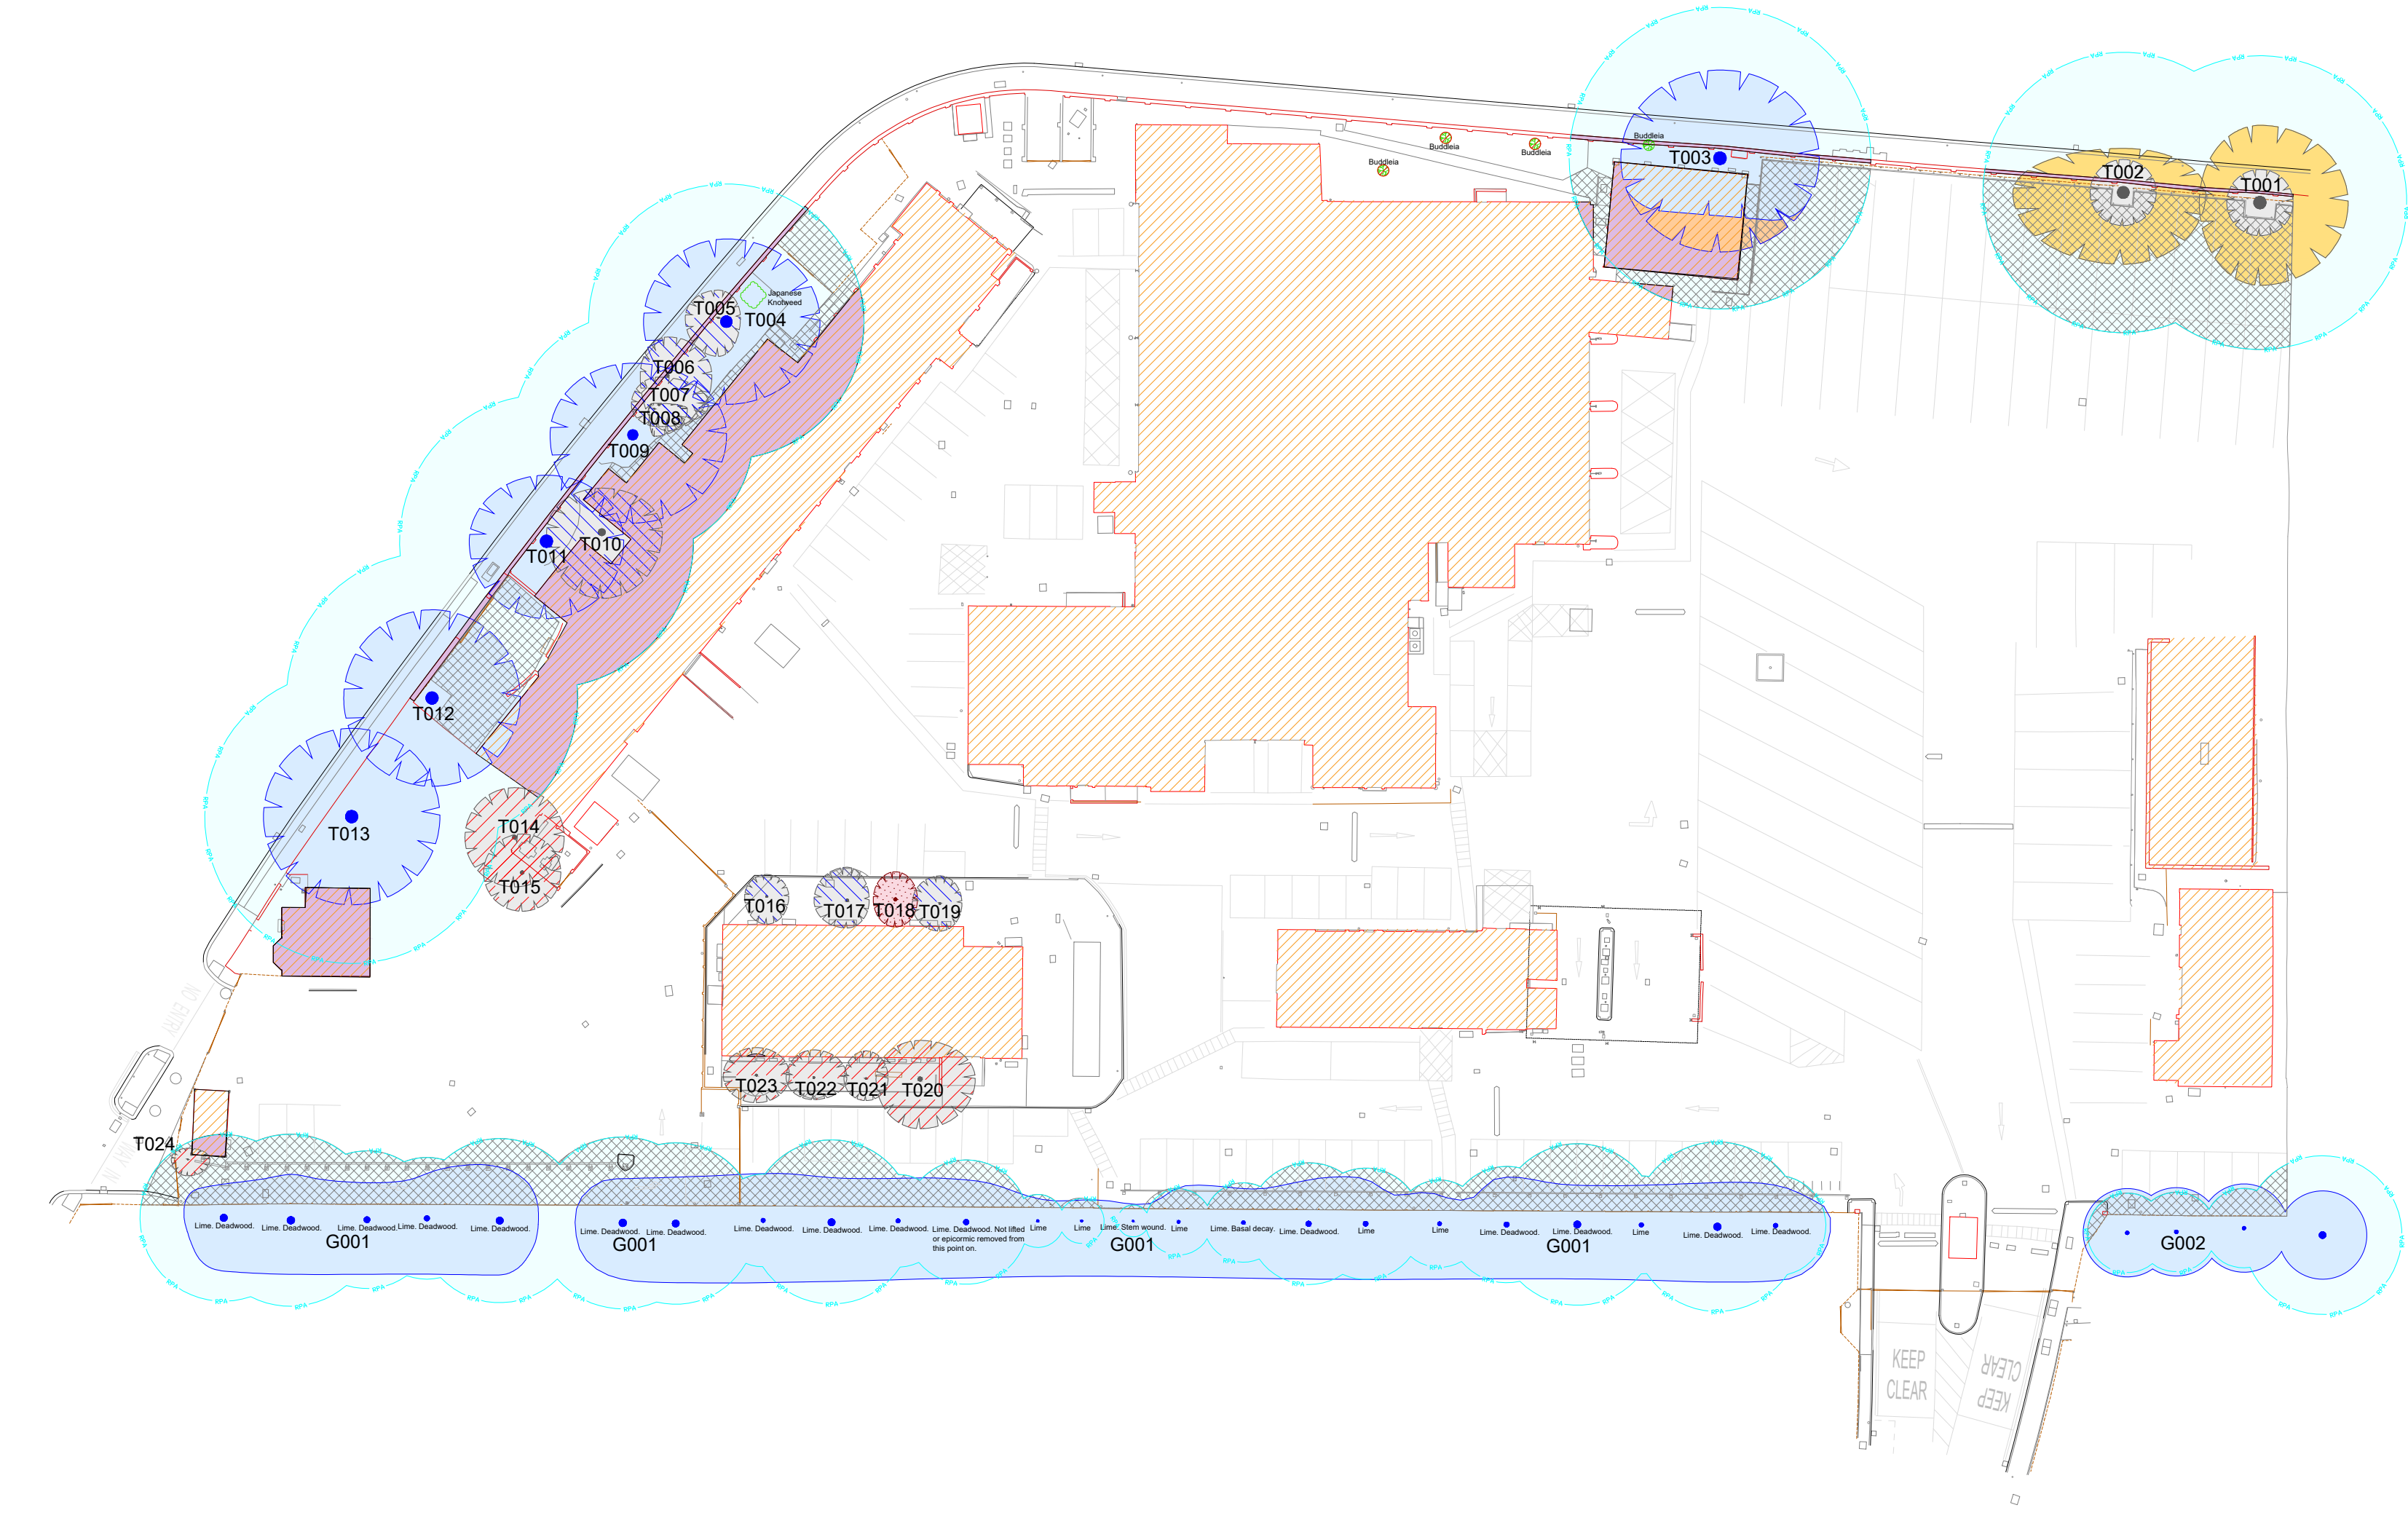
Existing Site Plan

The position, condition, and dimensions of the trees are based on a site survey undertaken on 09/07/21  
"The original of this drawing was produced in colour - a monochrome copy should not be relied upon"

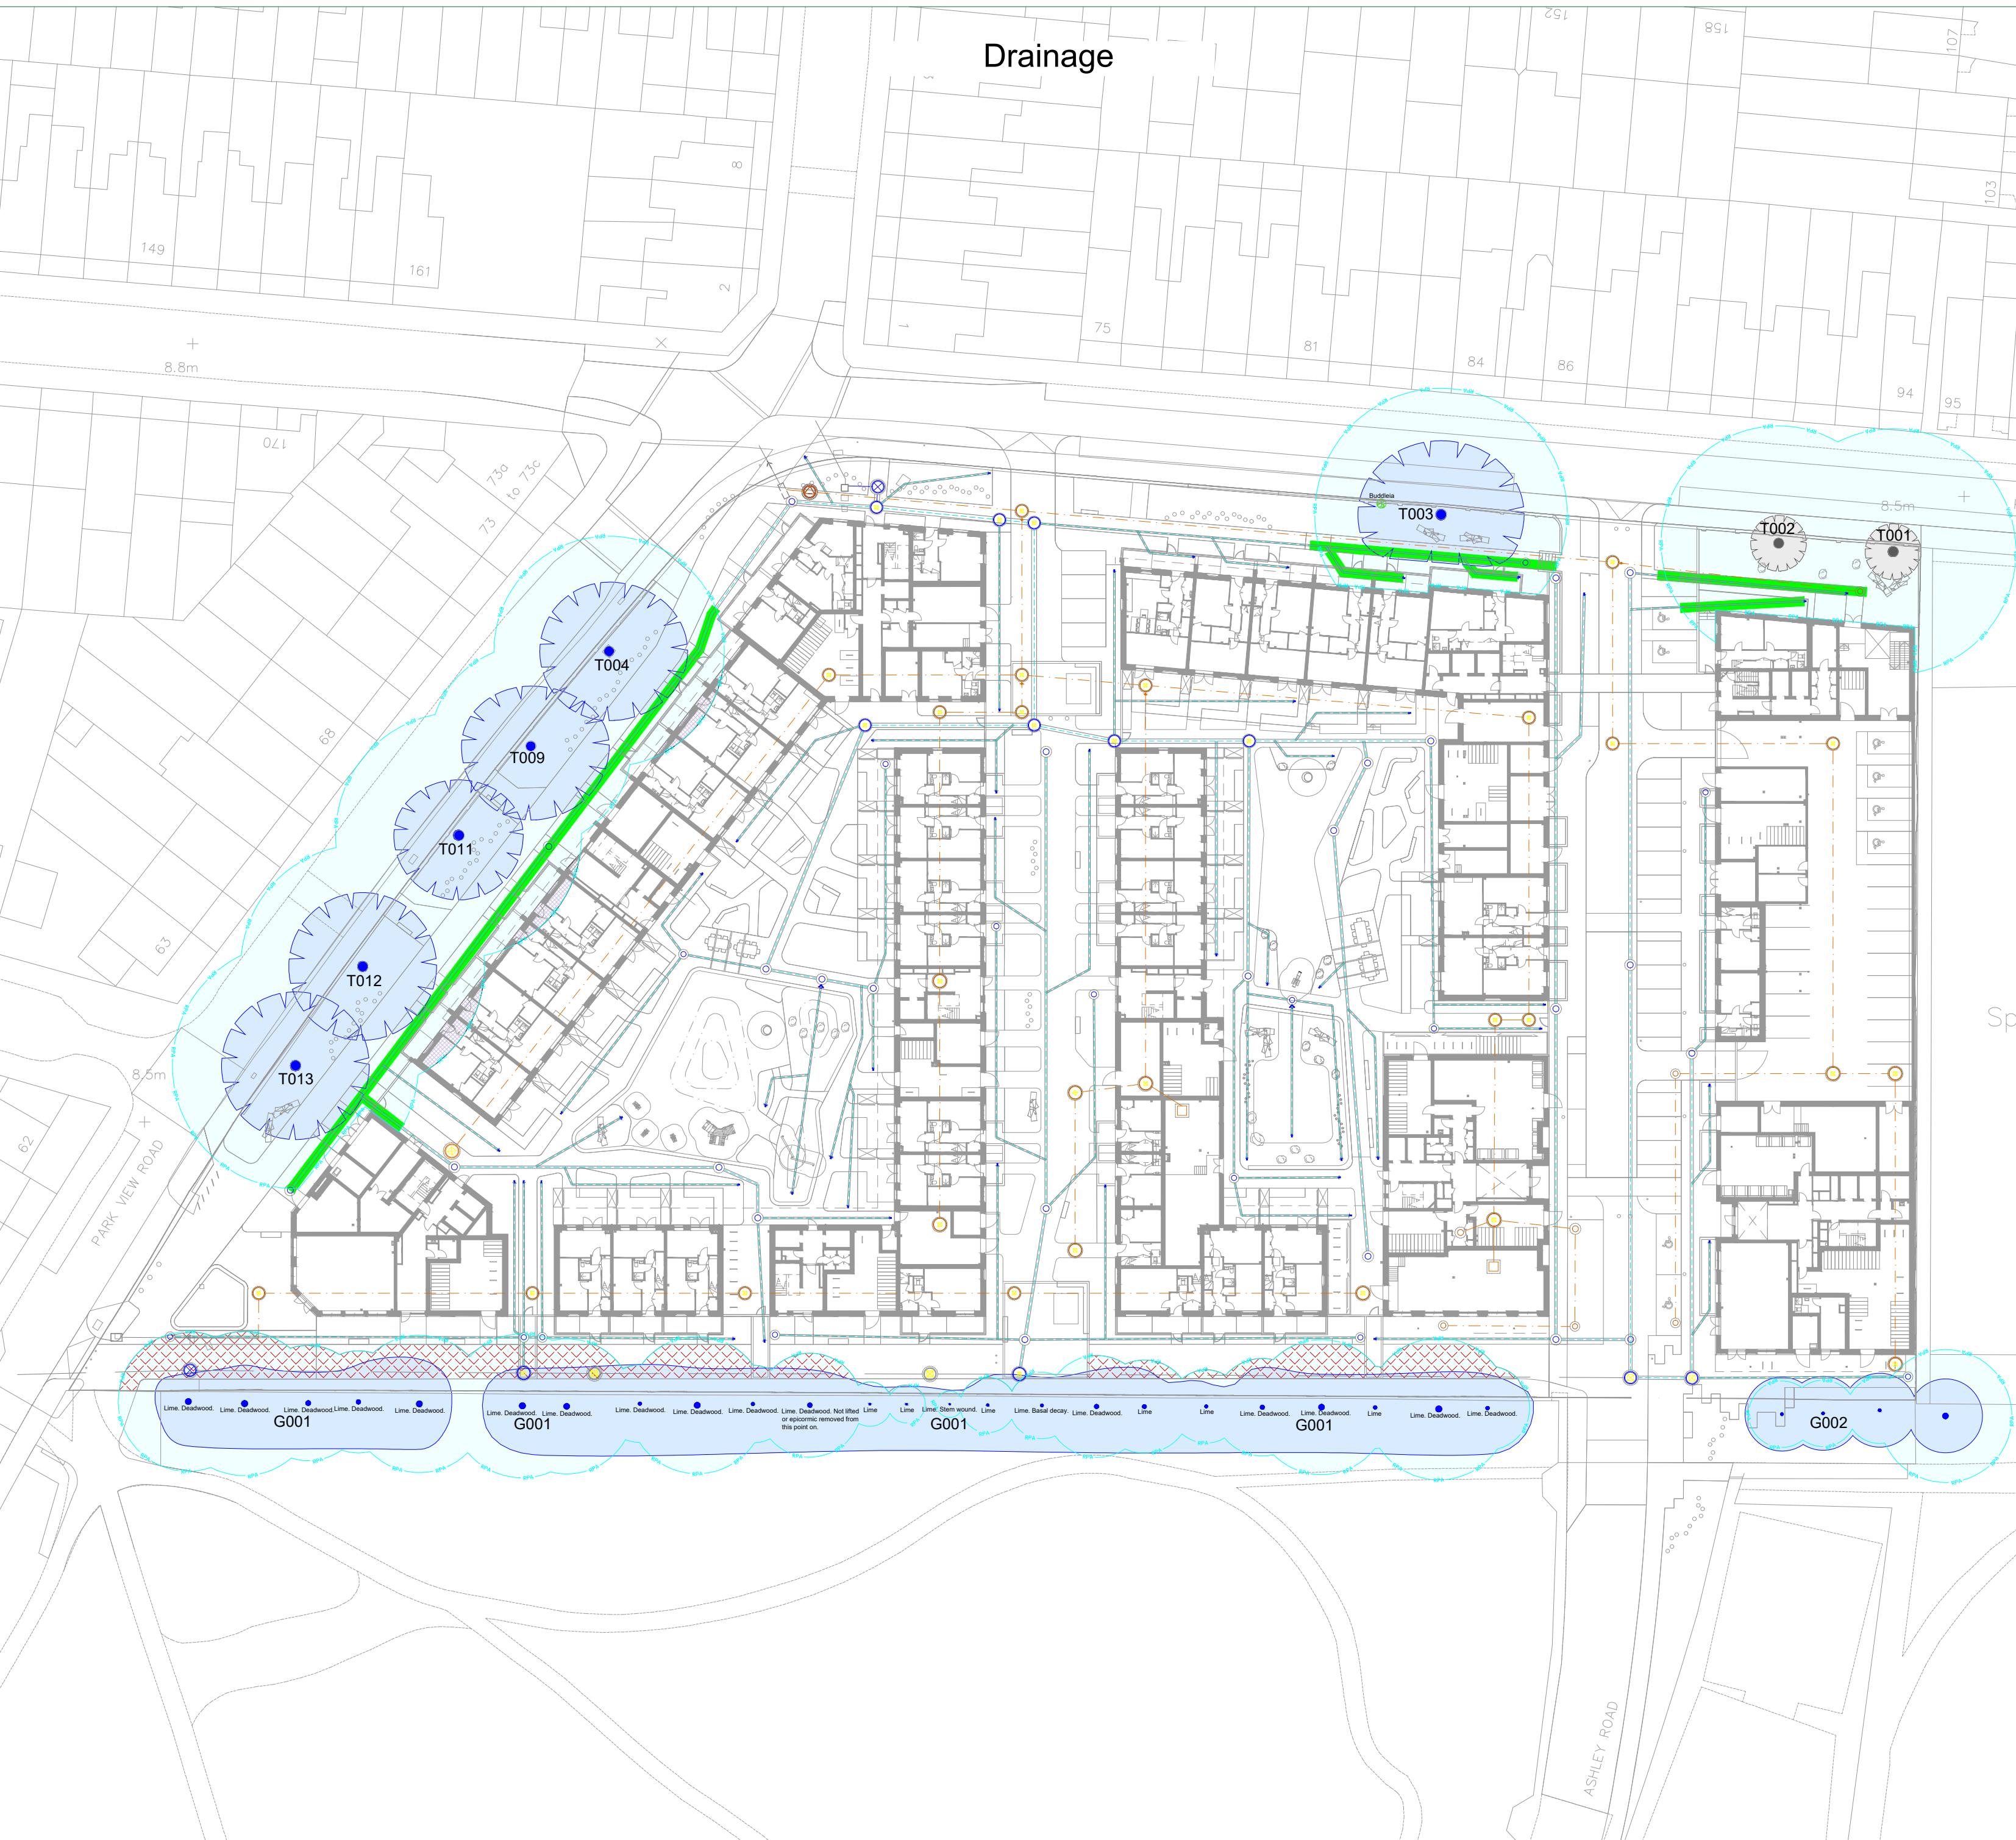
10/02/2023 CM Based on Civic Engineers Proposed below ground Drainage drawing no:1832-CIV-XX-XX-XX-D-C-30001/30002/30003/30011/30012  
Rev: Date: By: Revision:
