# **Ashley House & Cannon Factory, Ashley Road South, Tottenham Hale, London**

## **Remediation Strategy**

May 2023

**Client Name:** Notting Hill Genesis  
**Document Reference:** WIE16248-100-S-1-2-1-RMS  
**Project Number:** WIE16248

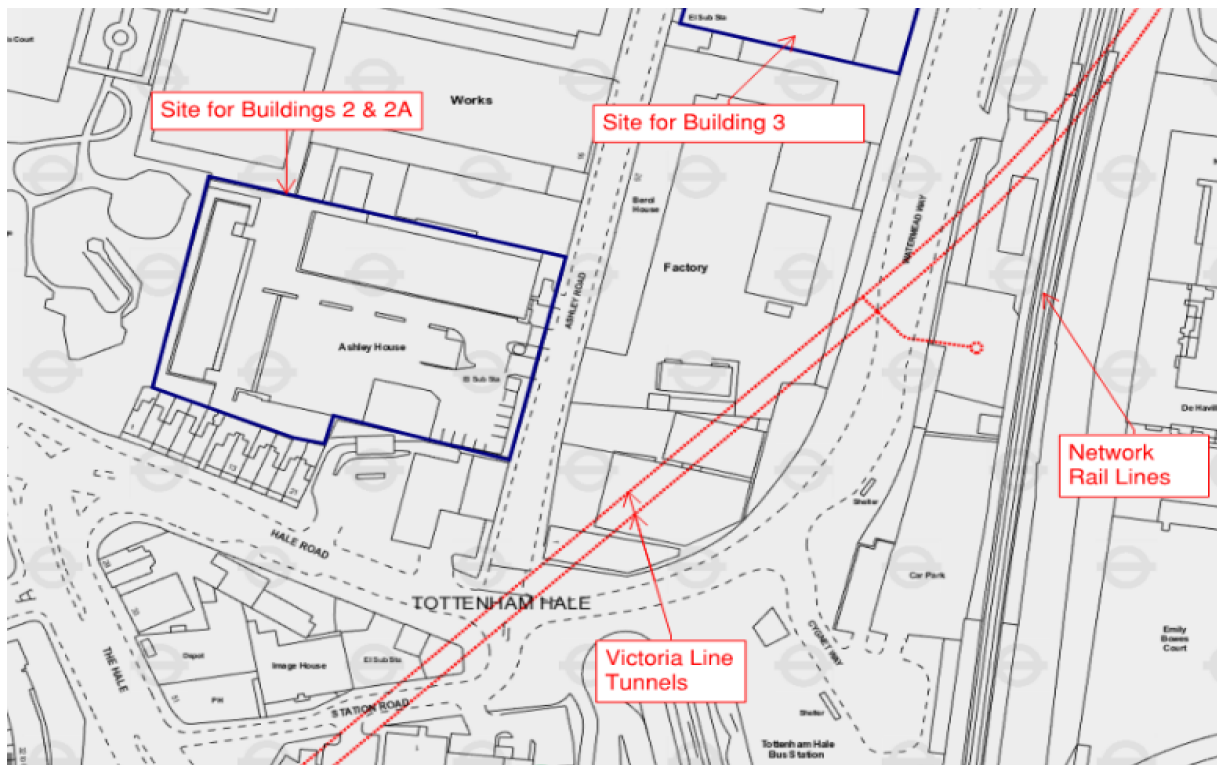
Figure 1: Location of Victoria Line

Development constraints identified include existing Thames Water Sewers on both the Ashley House and Cannon Factory Site, and the Victoria Line (below ground rail line) close to both land parcels (Figure 1).

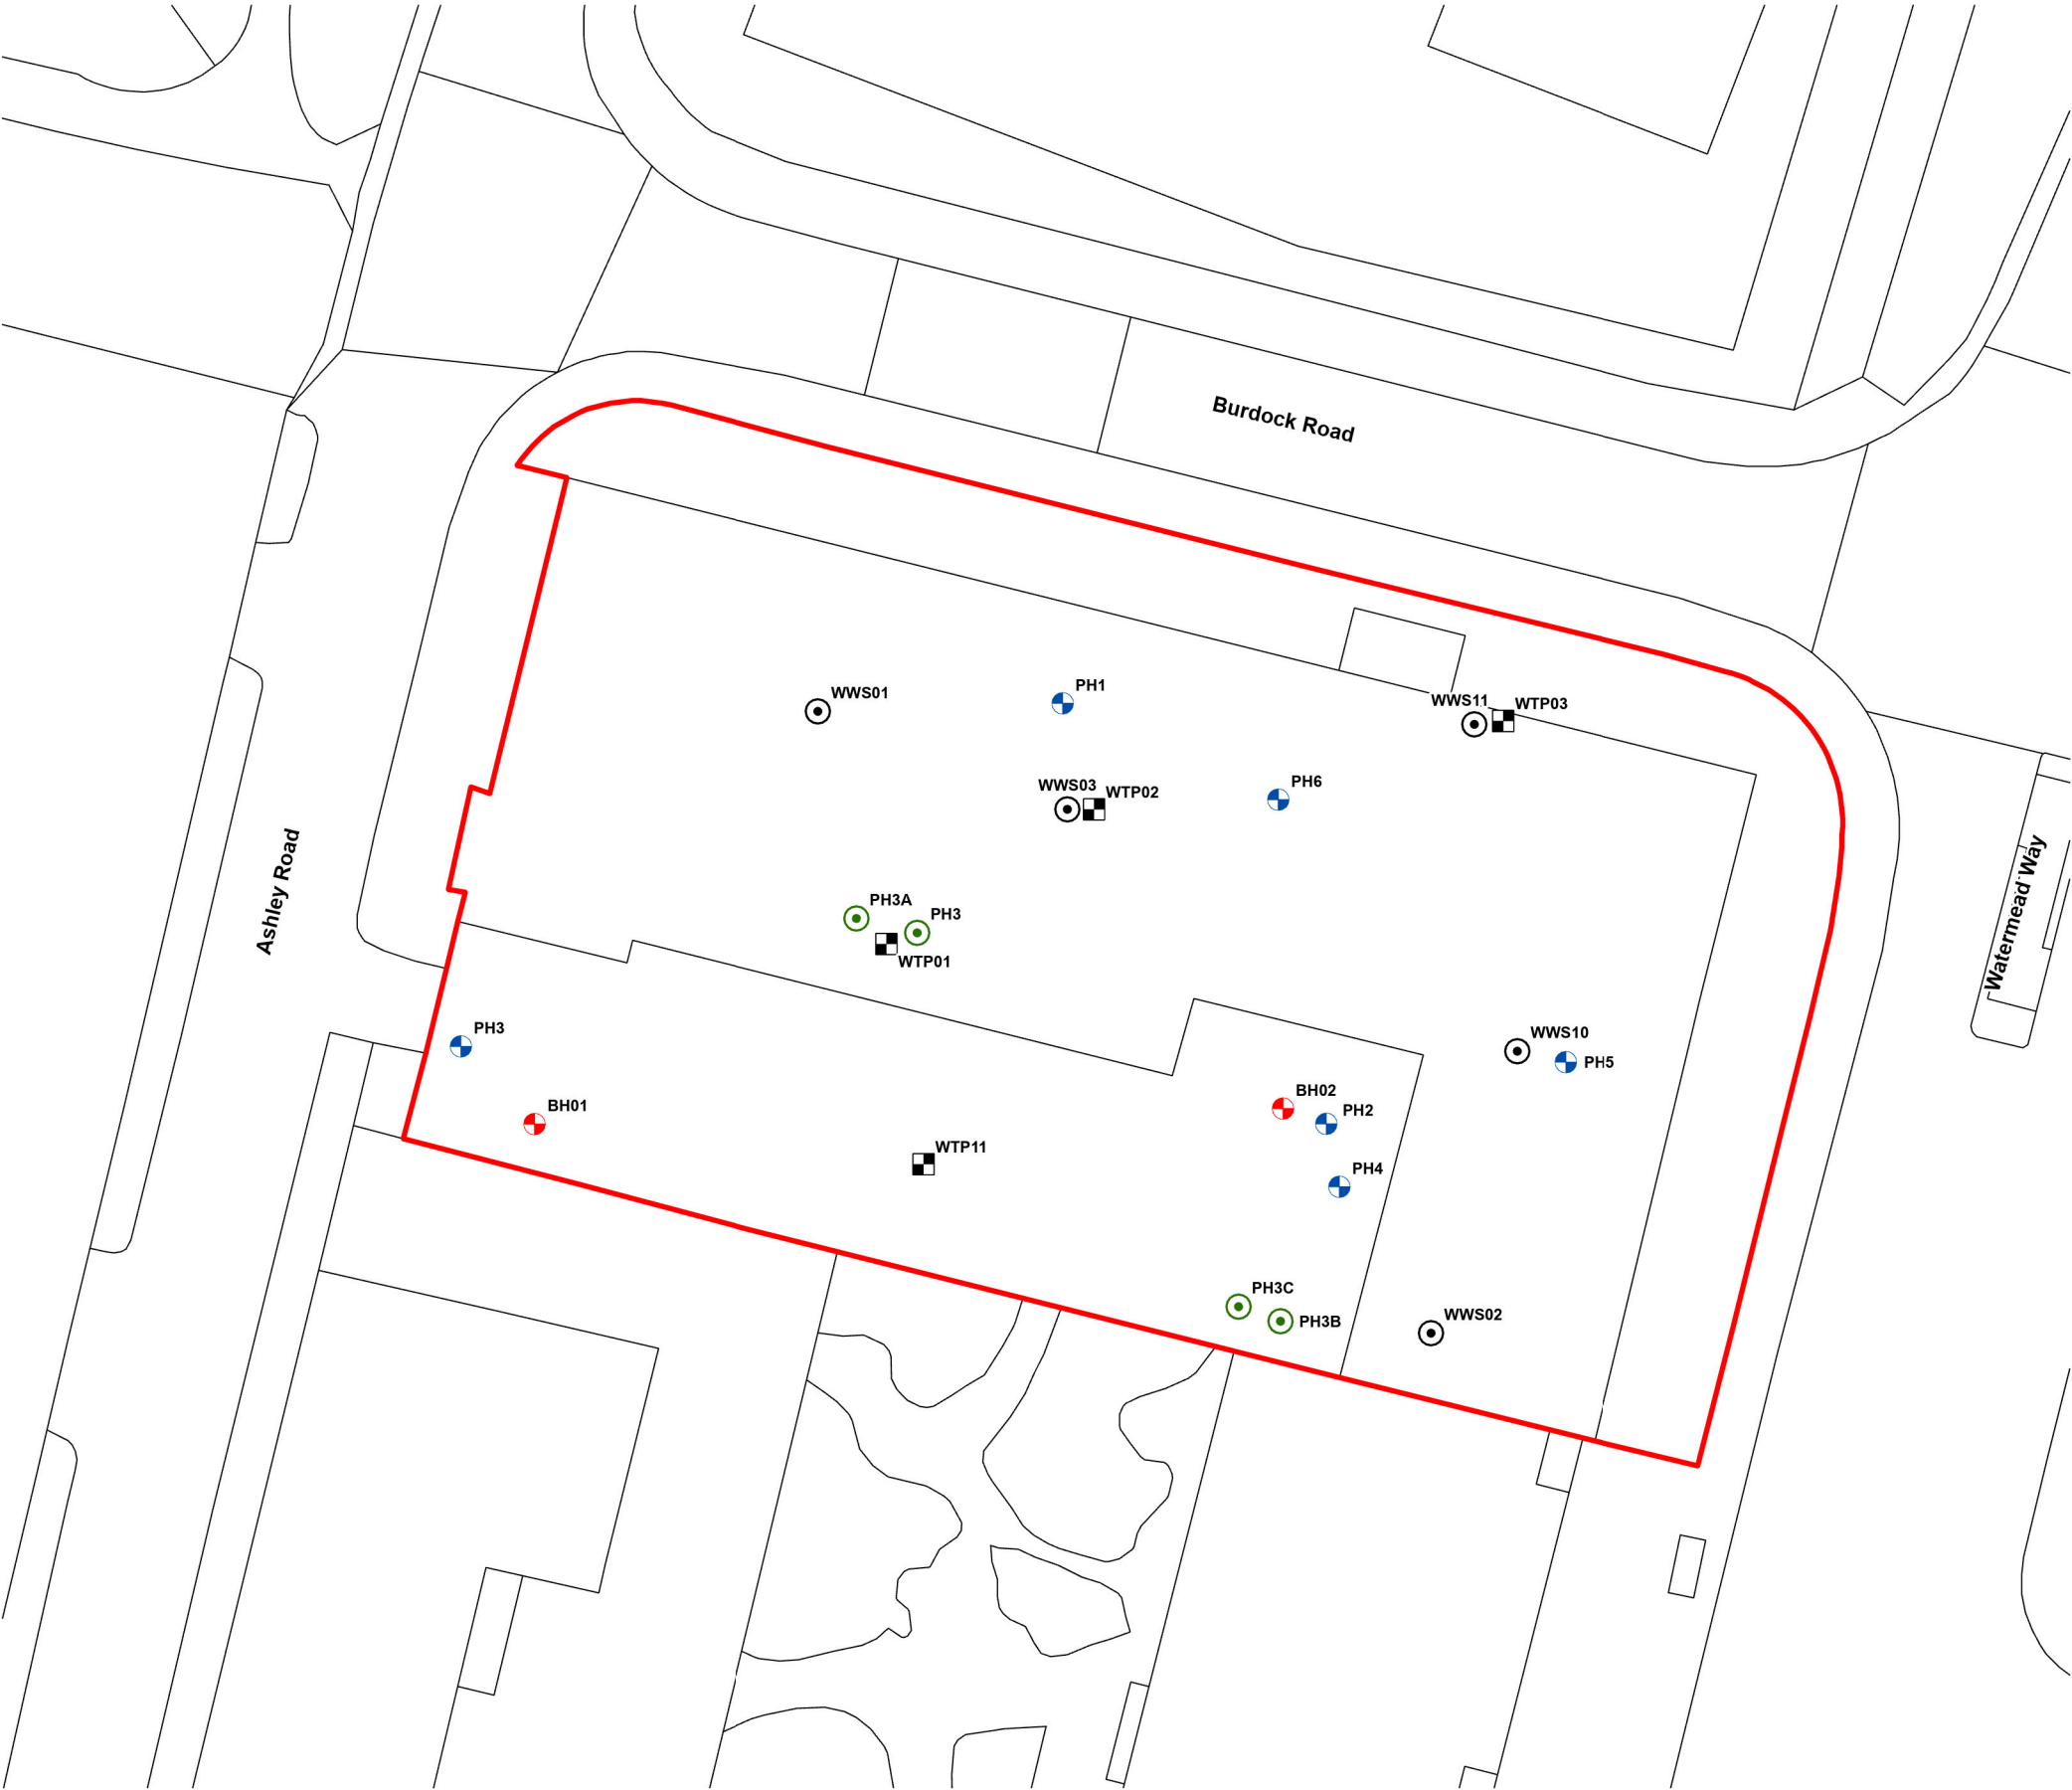
Site Boundary

Waterman GI Locations

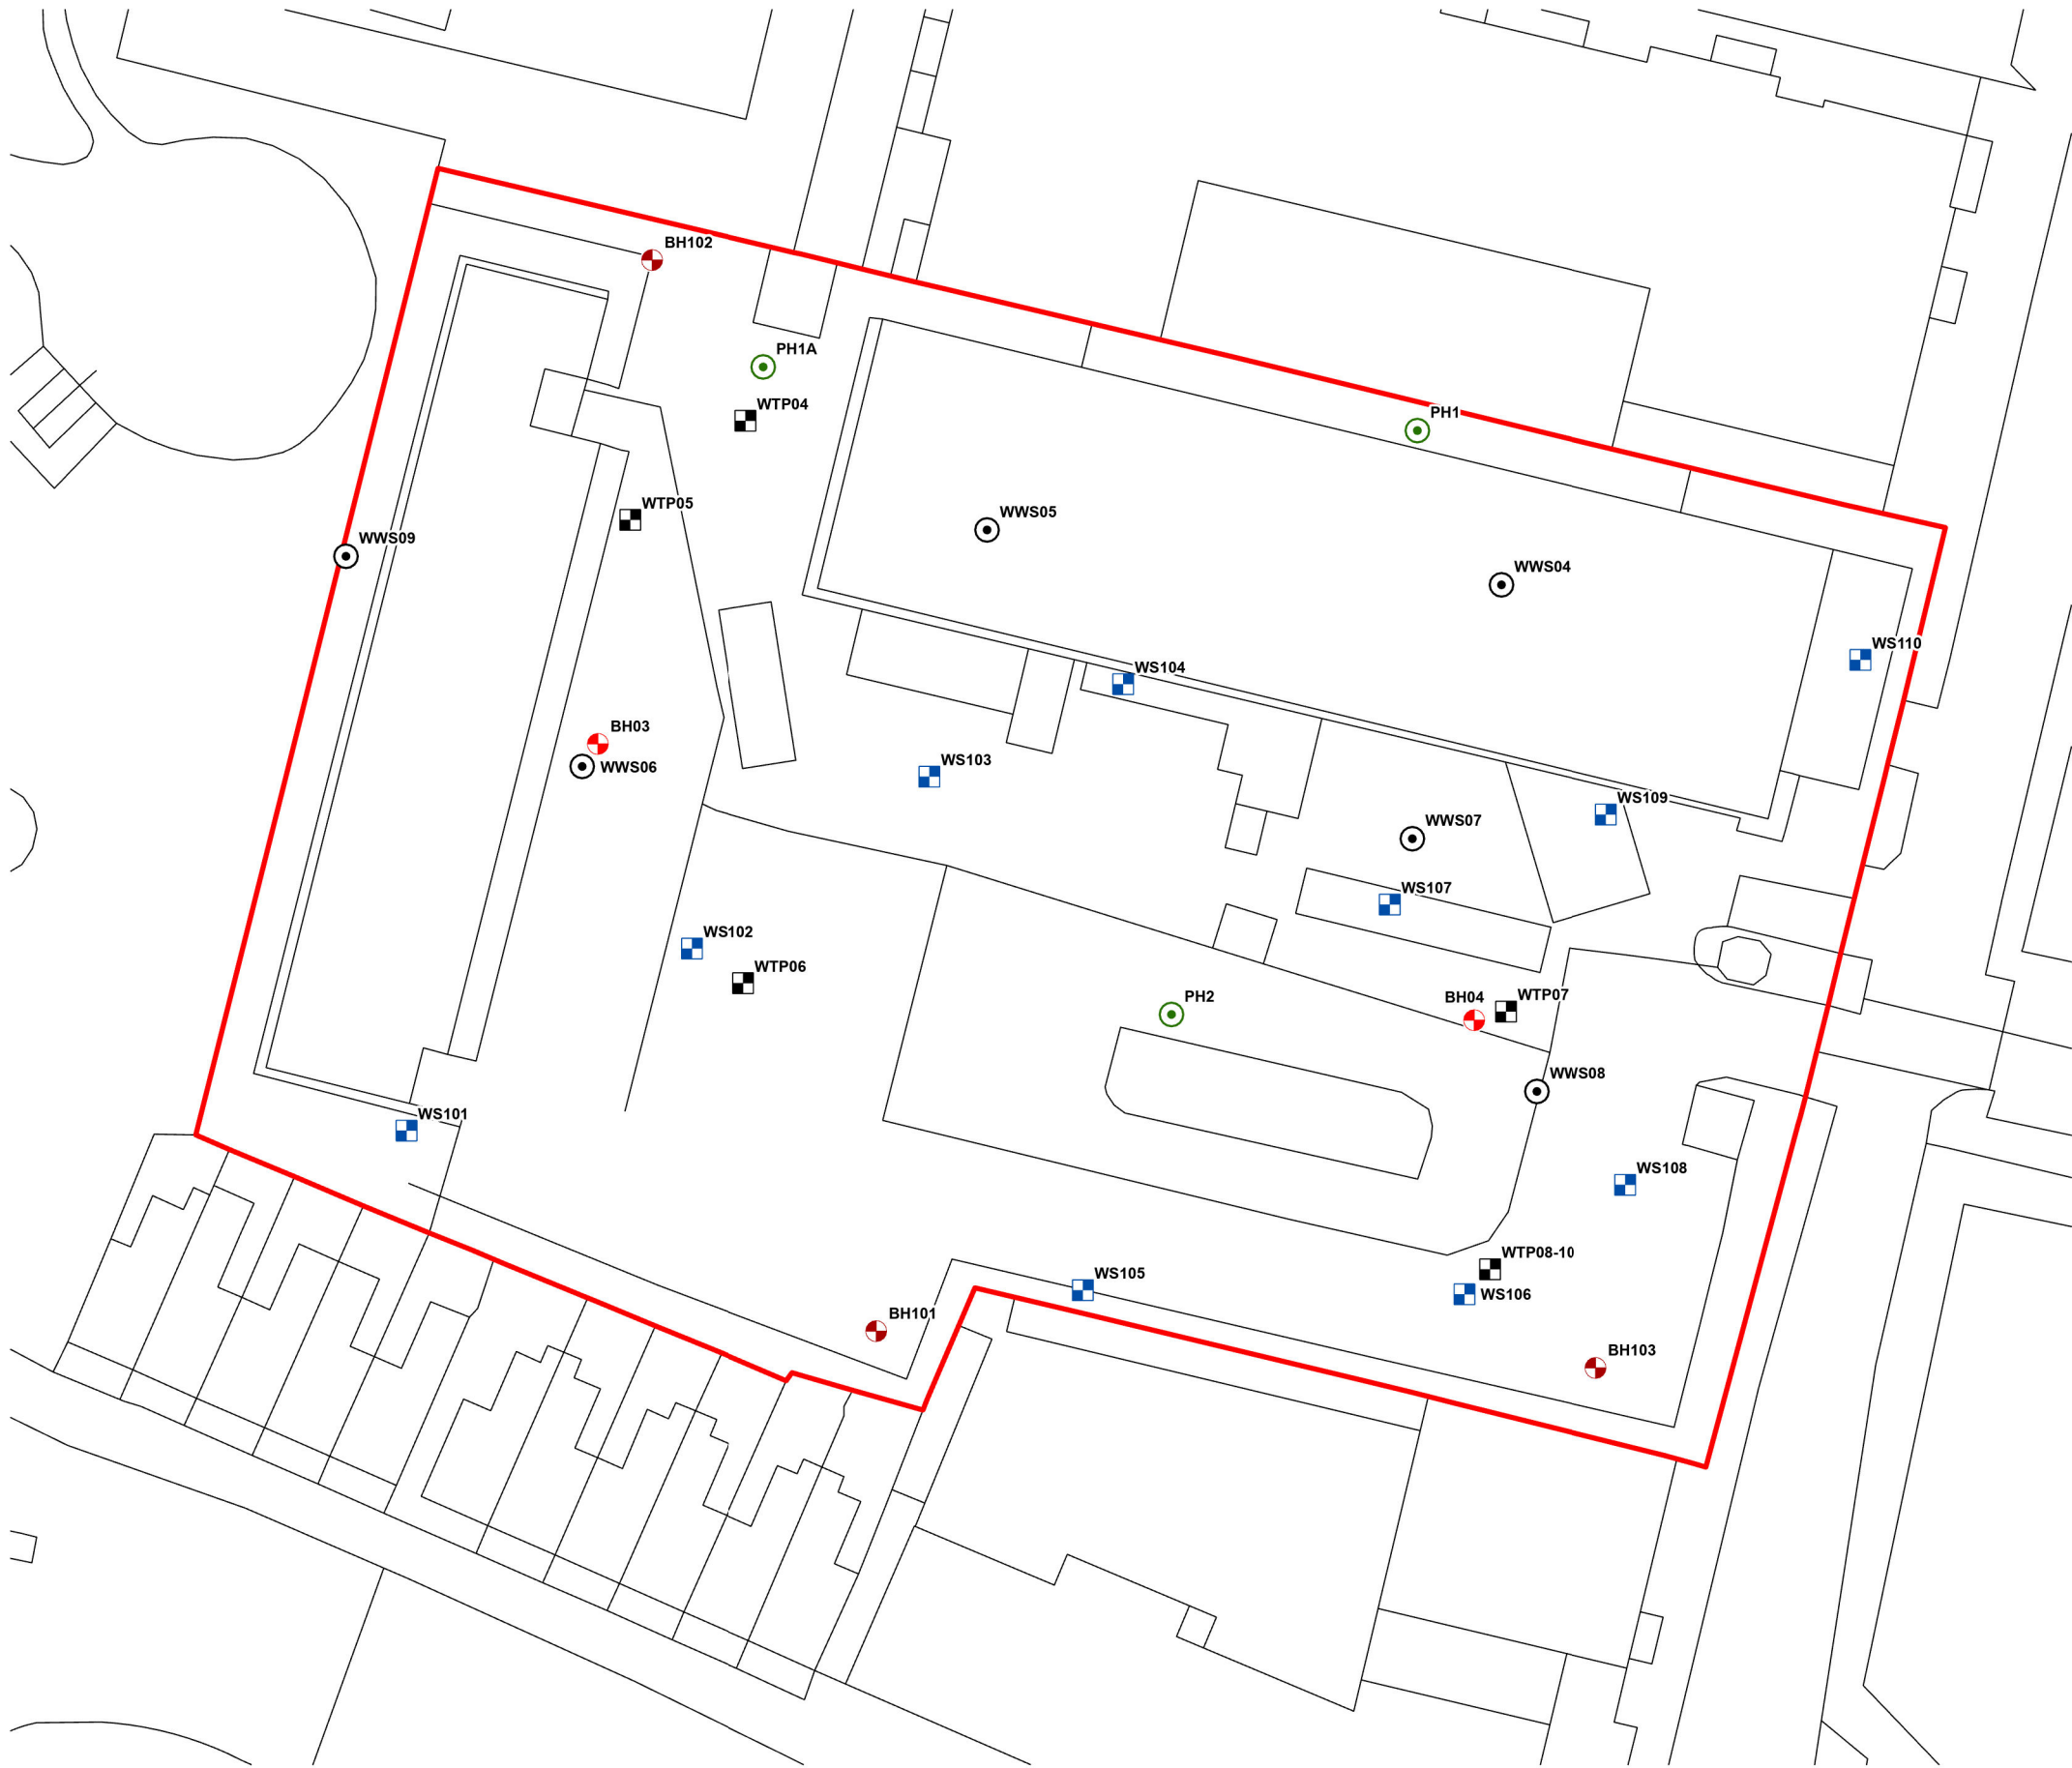
Site Boundary

Waterman GI Locations

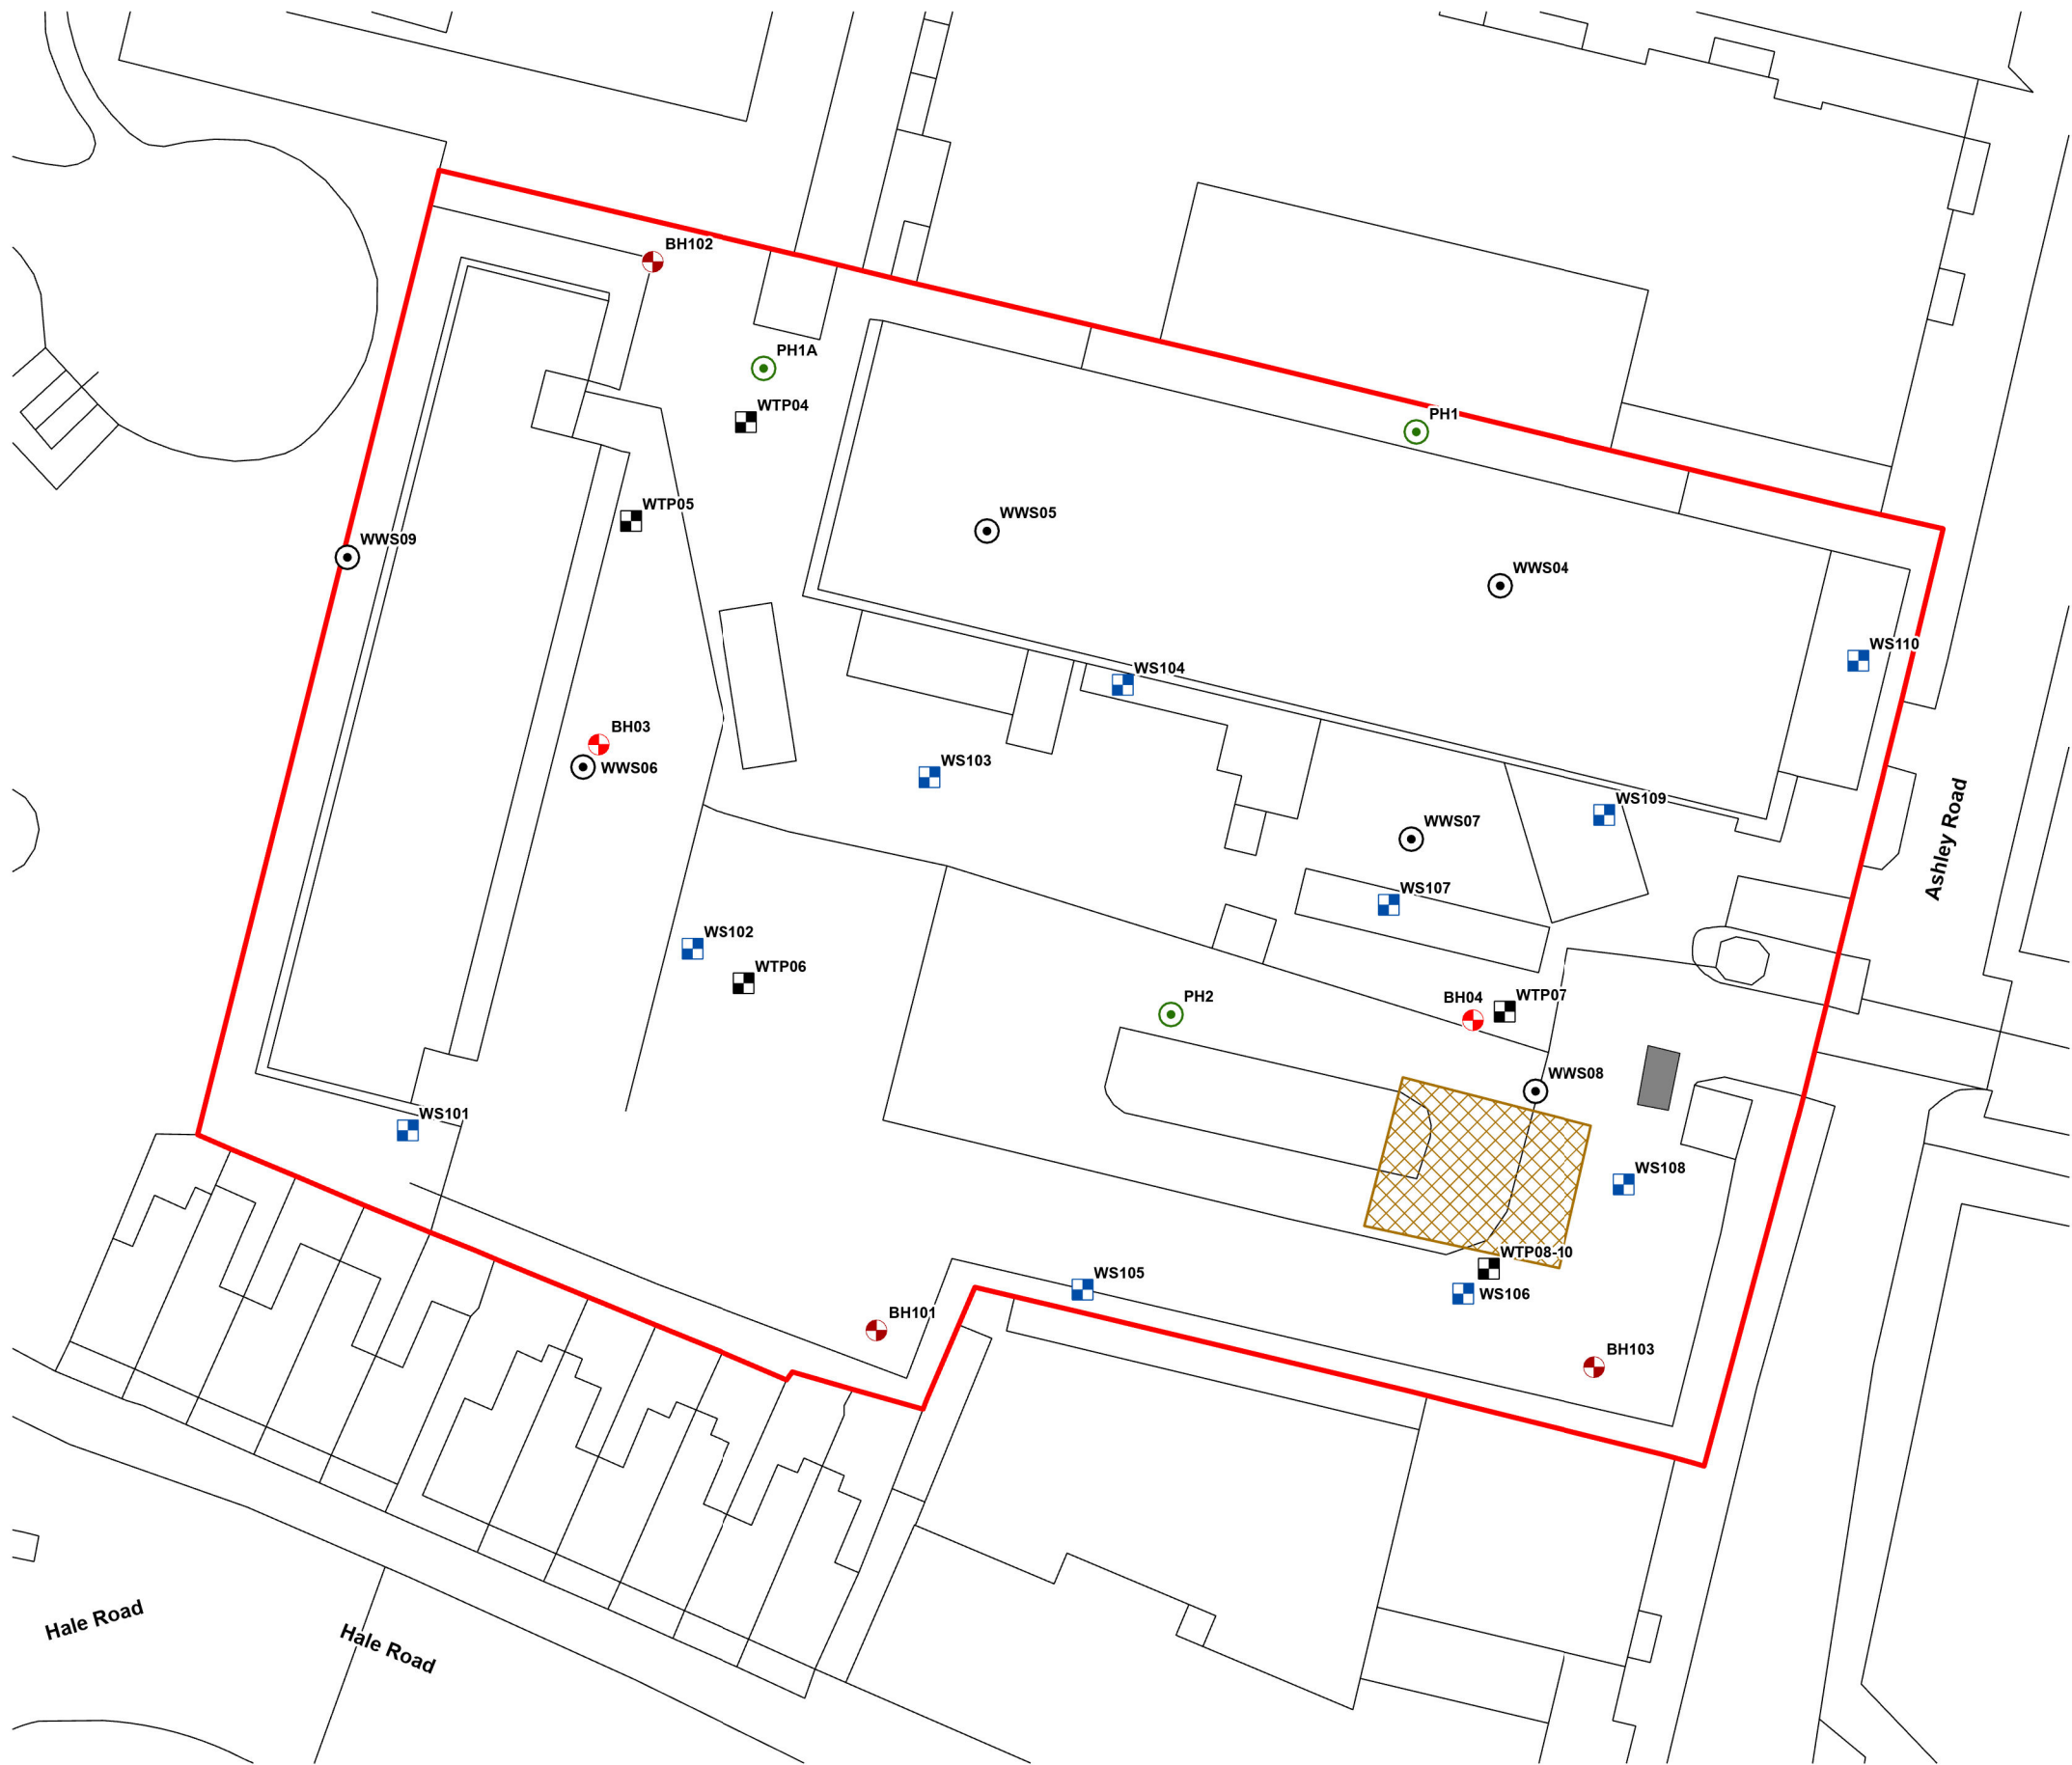
- Site Boundary
- Approximate Area of Below Ground Diesel Tanks and Fuel Lines Remaining in-situ
- Approximate Location of Oil Water Interceptor

Waterman GI Locations

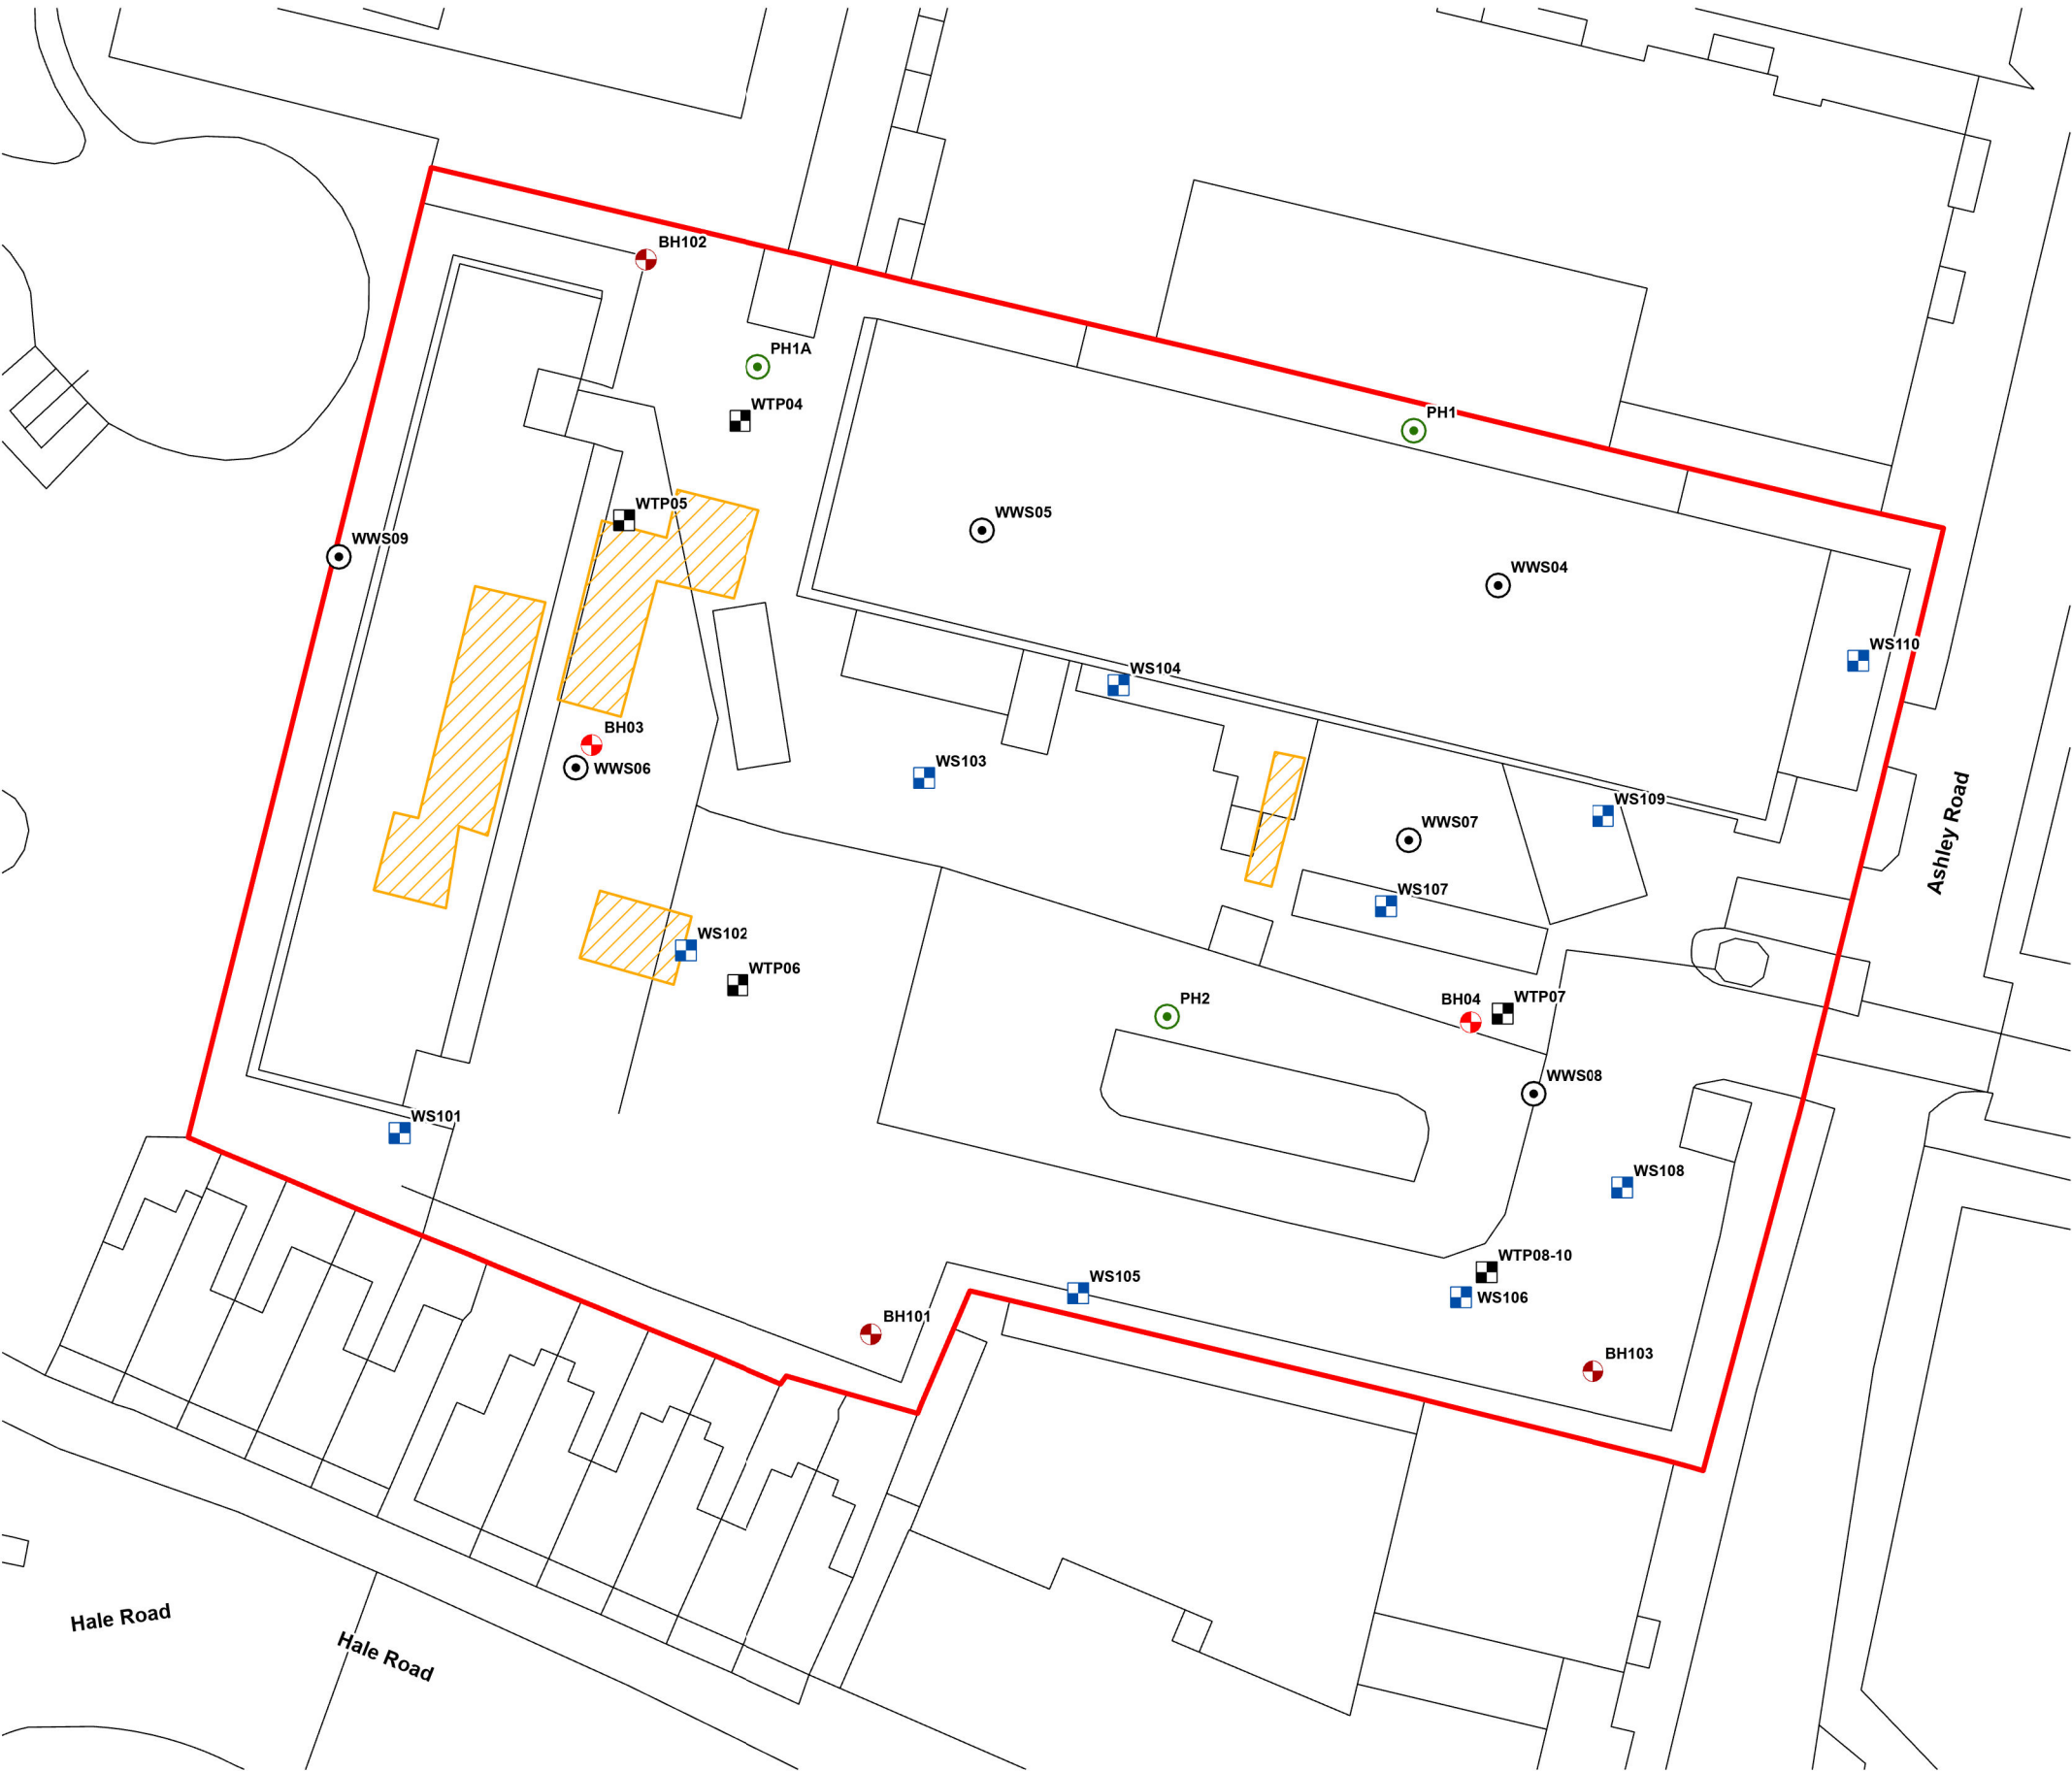
- Site Boundary
- Approximate Location of Tanks at the Historical Printing Ink and Varnish Factory (Circa 1930s to 1960s)
- Waterman GI Locations**
- Trial Pit
  - Window Sample
- RSK GI Locations**
- Deep Borehole Location
  - Shallow Window Sample Location
- Socotec GI Locations**
- Borehole
  - Window Sample

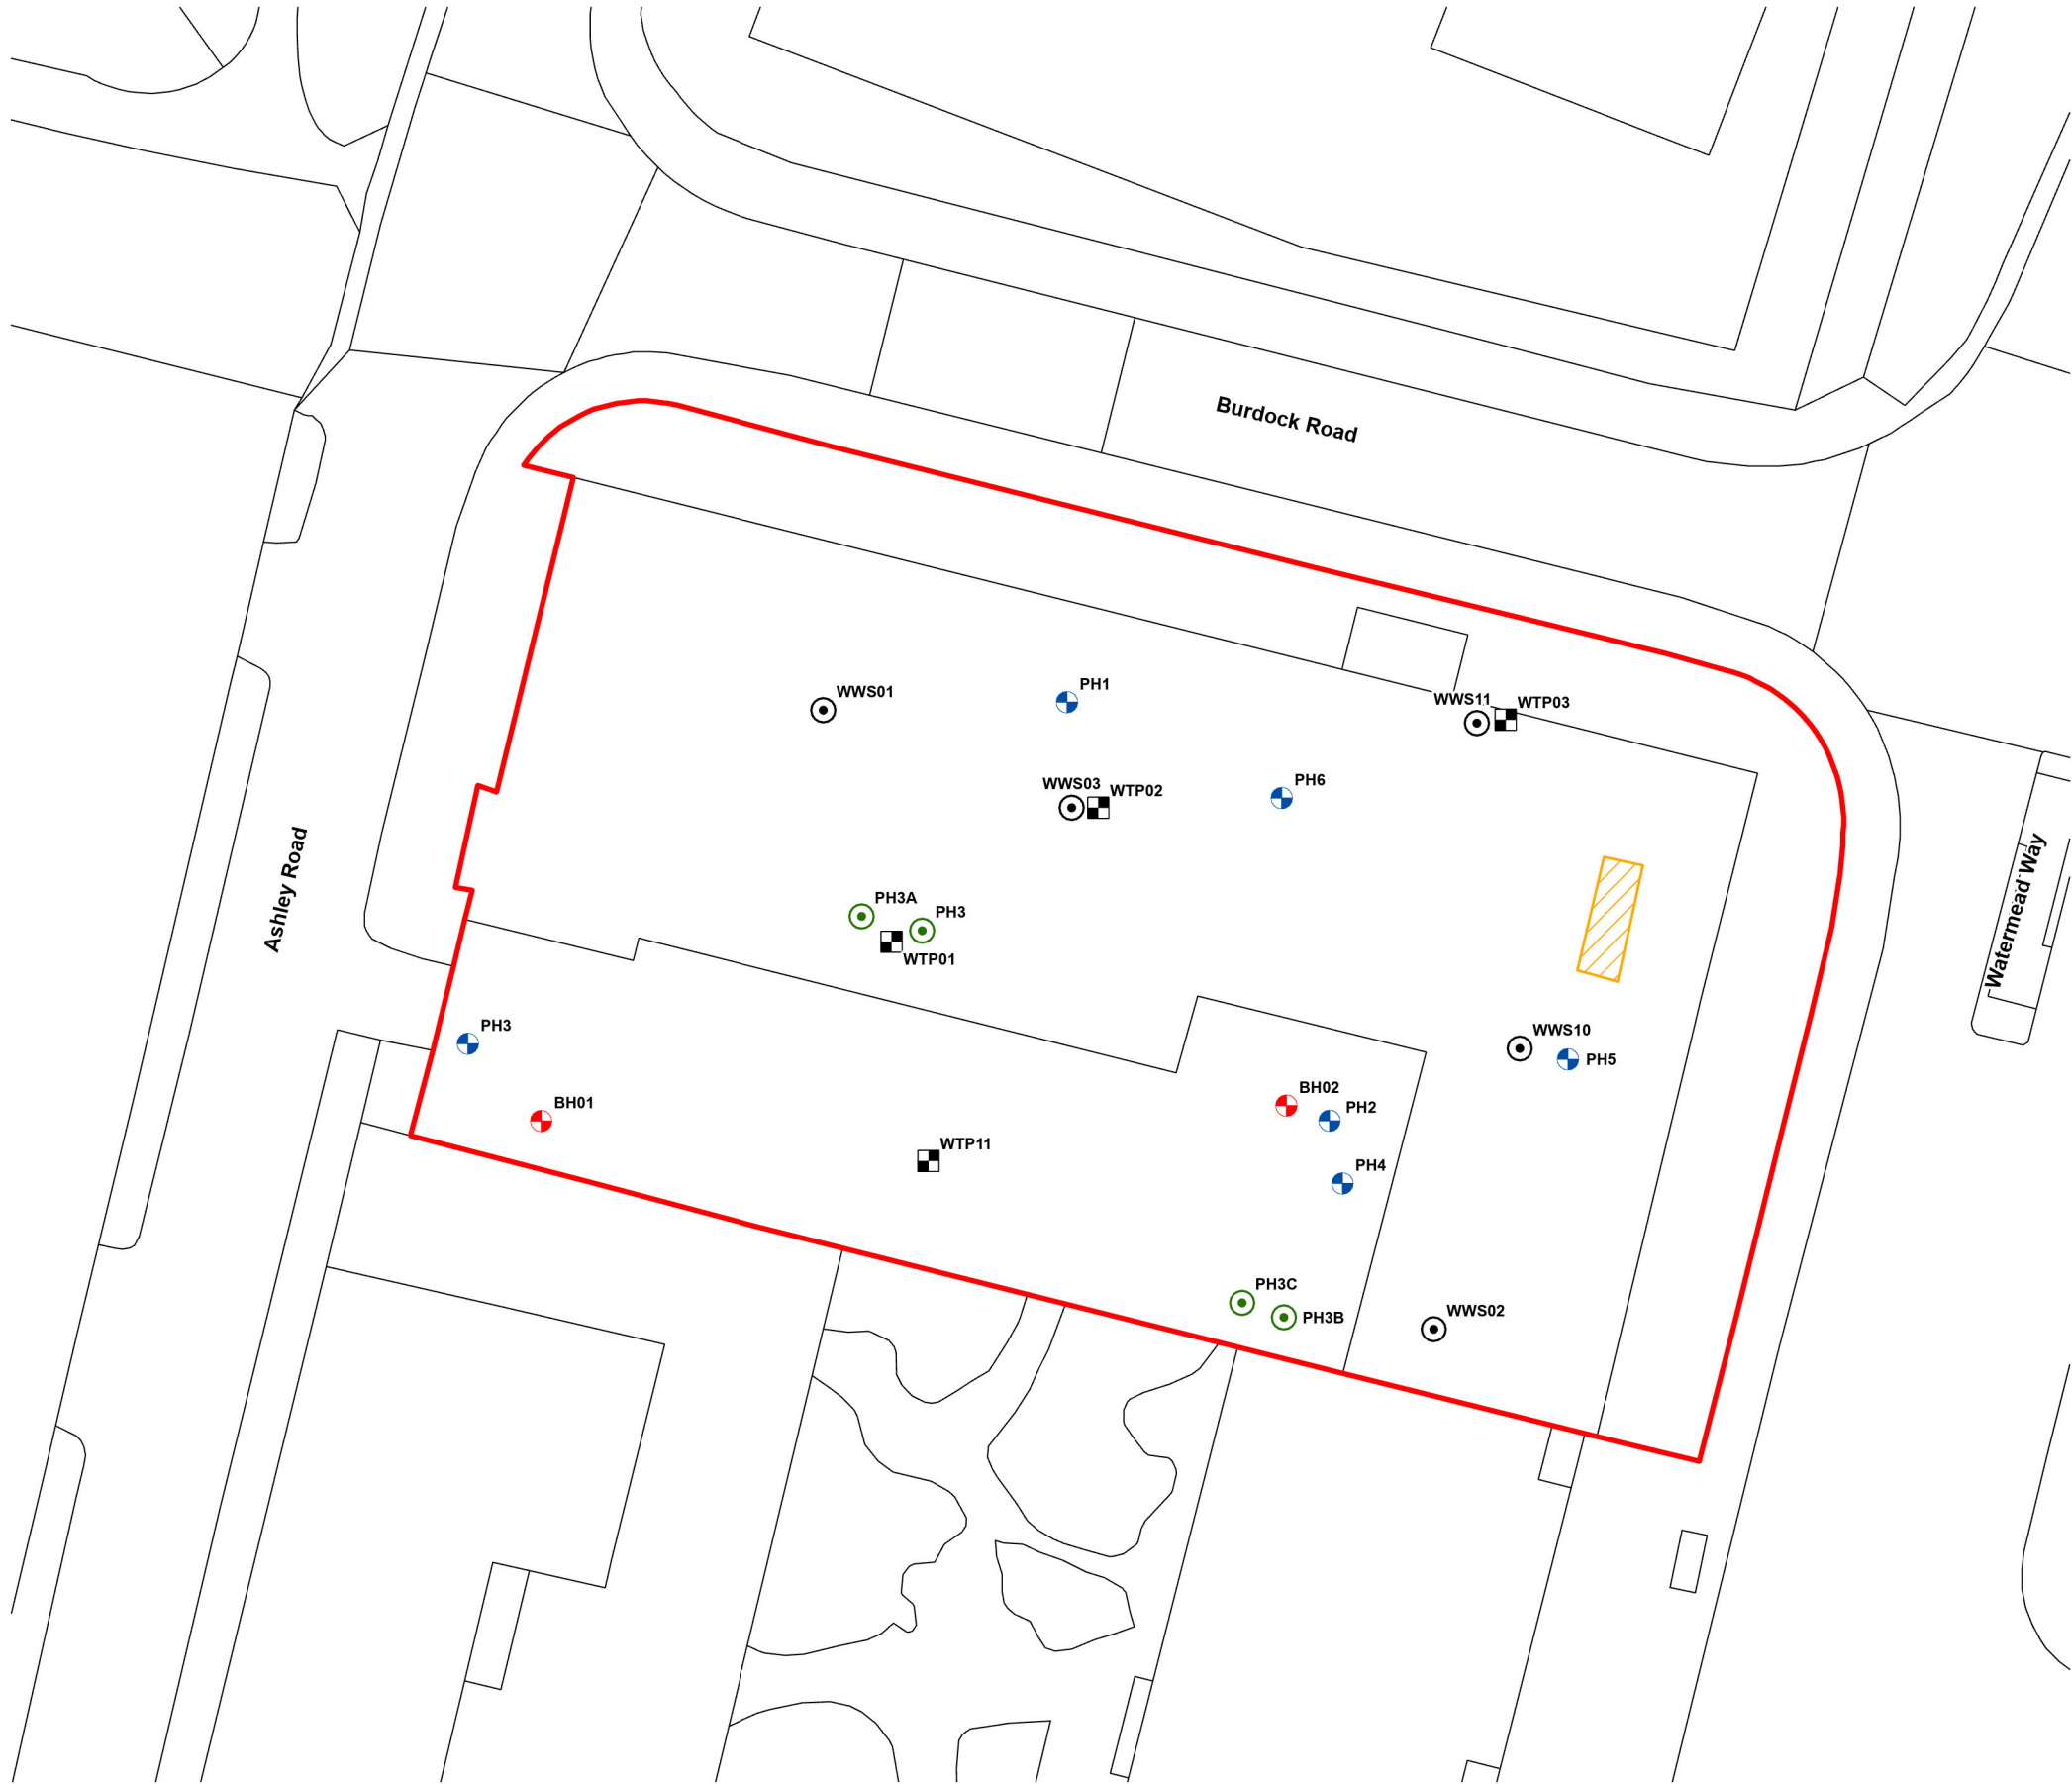
- Site Boundary
- Approximate Location of Potential Historical Tanks (Circa 1960s to 1970s)
- Trial Pit
- Window Sample
- Probe Hole
- Borehole
- Window Samples
