# **Ashley House & Cannon Factory, Ashley Road South, Tottenham Hale, London**

## **Remediation Strategy**

May 2023

**Client Name:** Notting Hill Genesis  
**Document Reference:** WIE16248-100-S-1-2-1-RMS  
**Project Number:** WIE16248

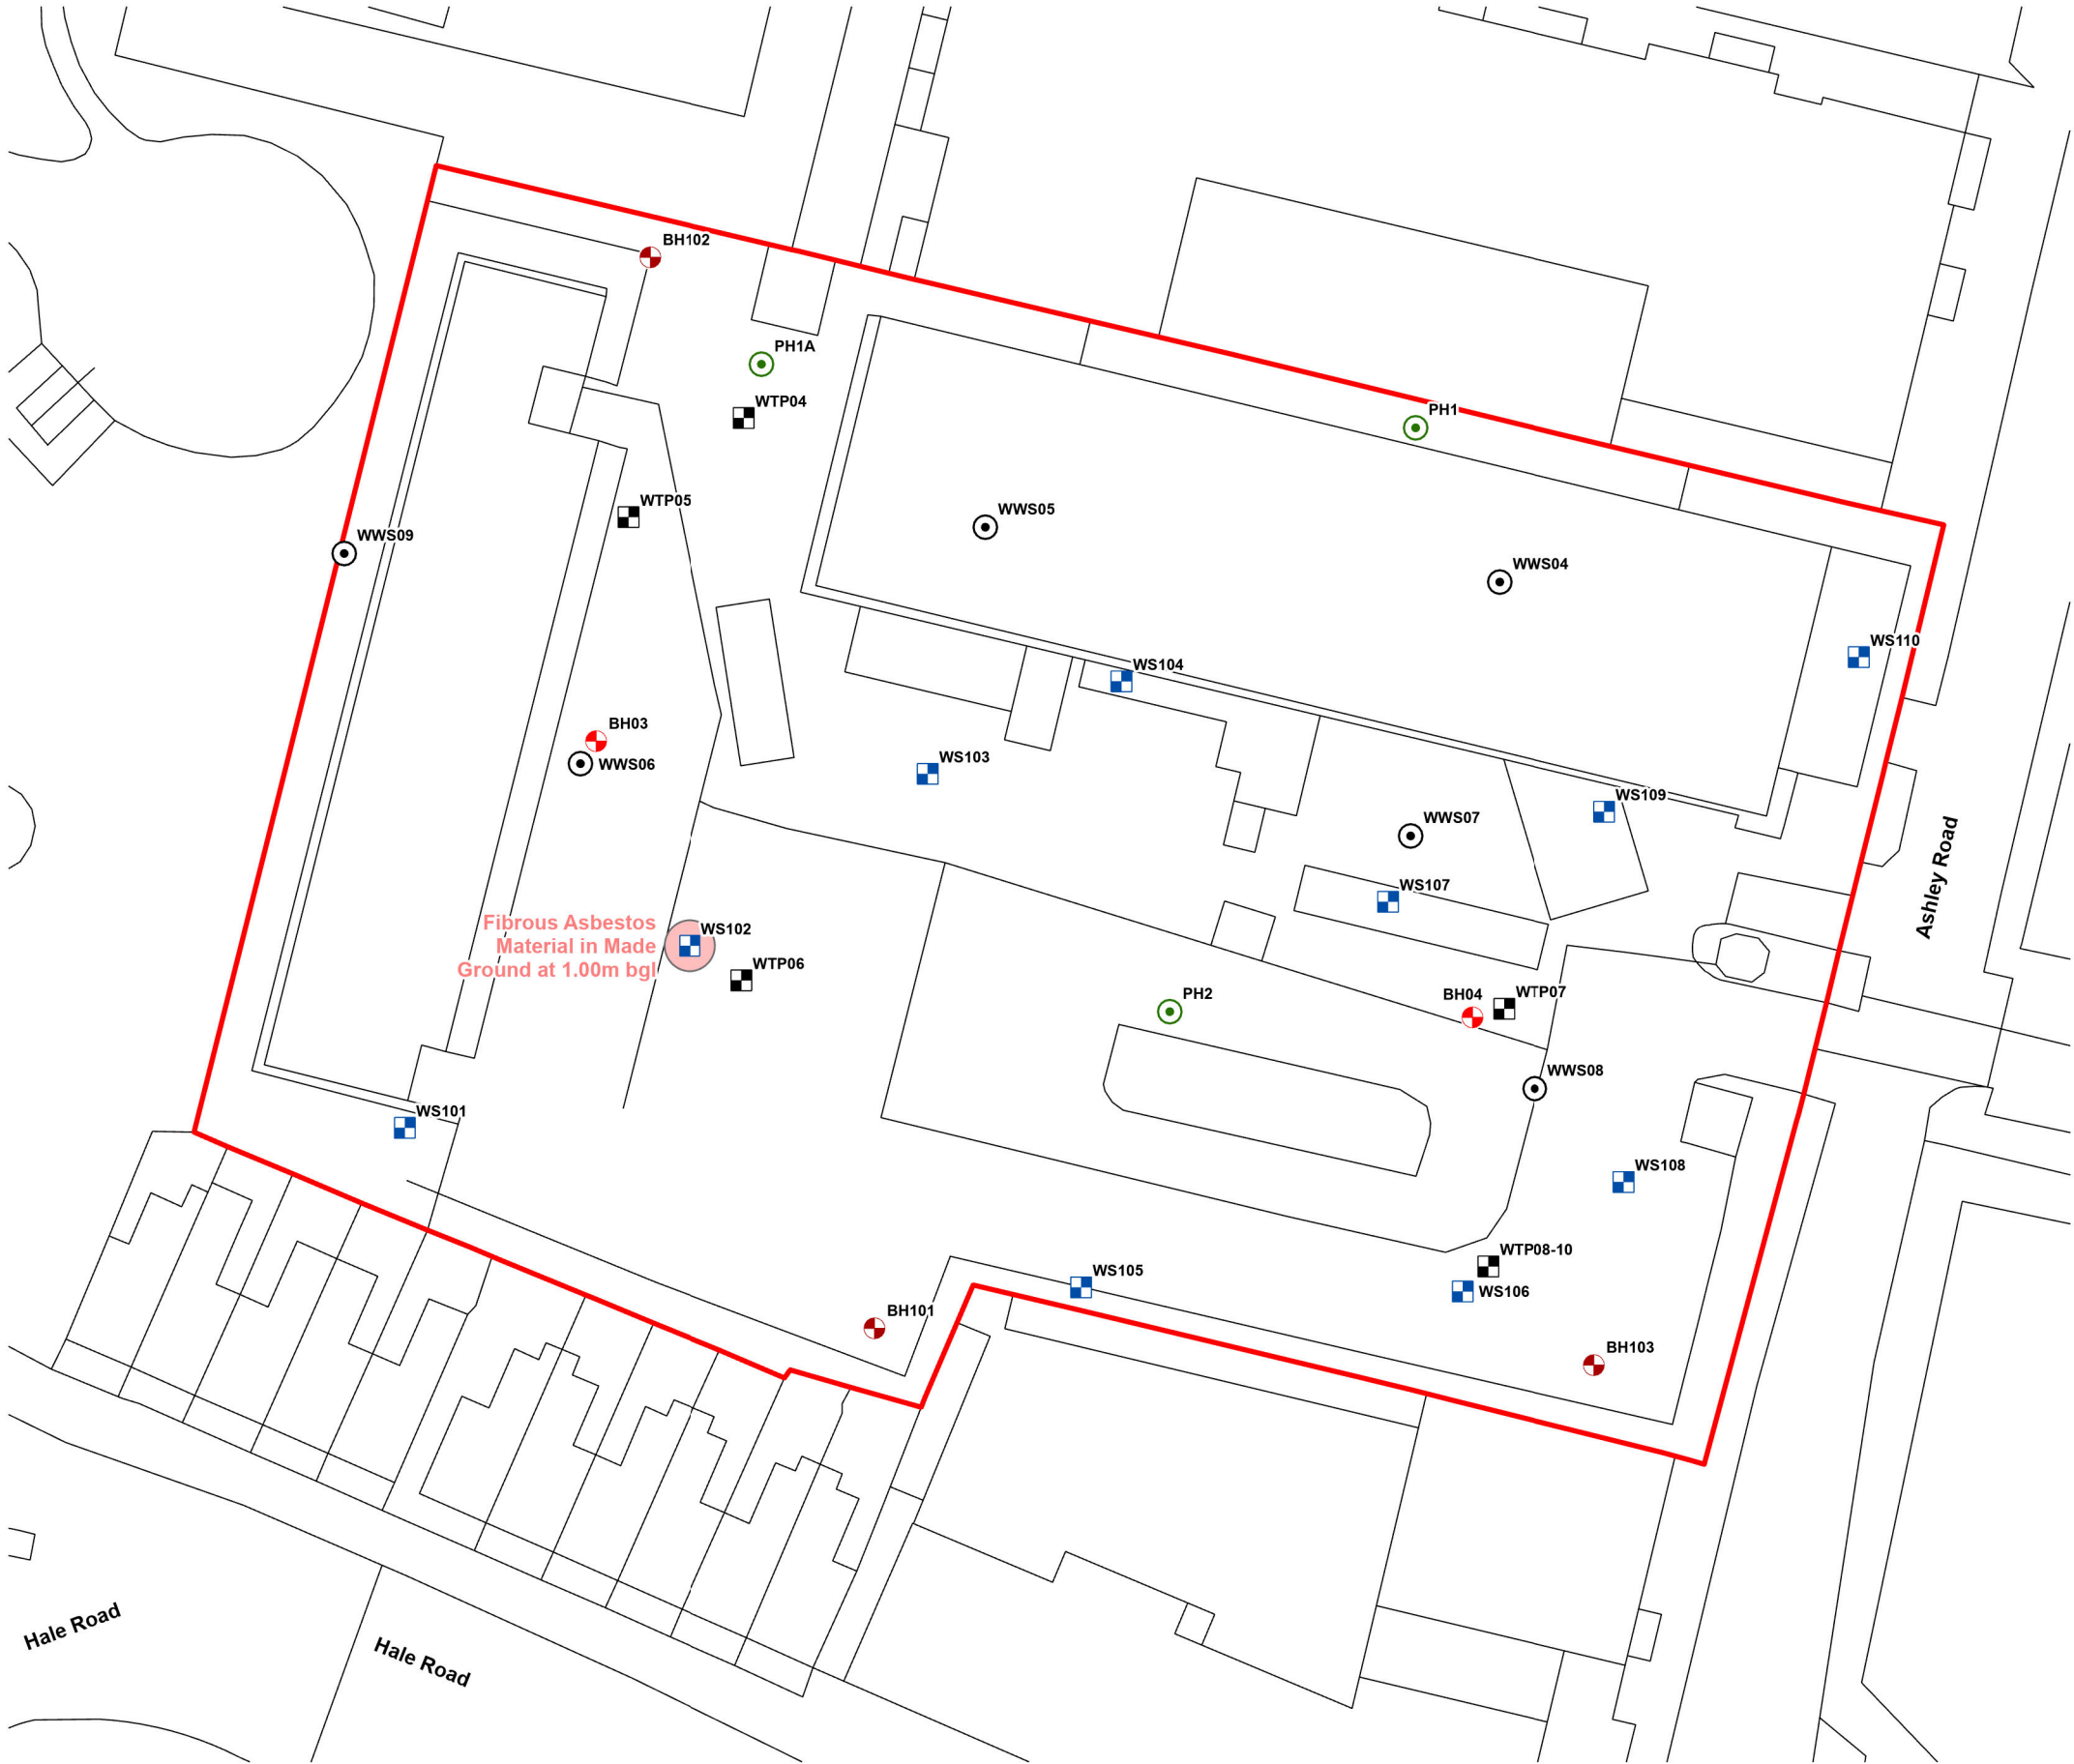
- Site Boundary
- Locations of Visually Identified Asbestos During Ground Investigations
- Trial Pit
- Window Sample
- Deep Borehole Location
- Shallow Window Sample Location
- Borehole
- Window Sample

The ground investigation has recorded asbestos fibres in the Made Ground across the Cannon Factory and Ashley House Site. Fragments of ACMs have also been observed in Made Ground. Plans showing locations where visual evidence of ACMs was recorded is presented in Appendix A.

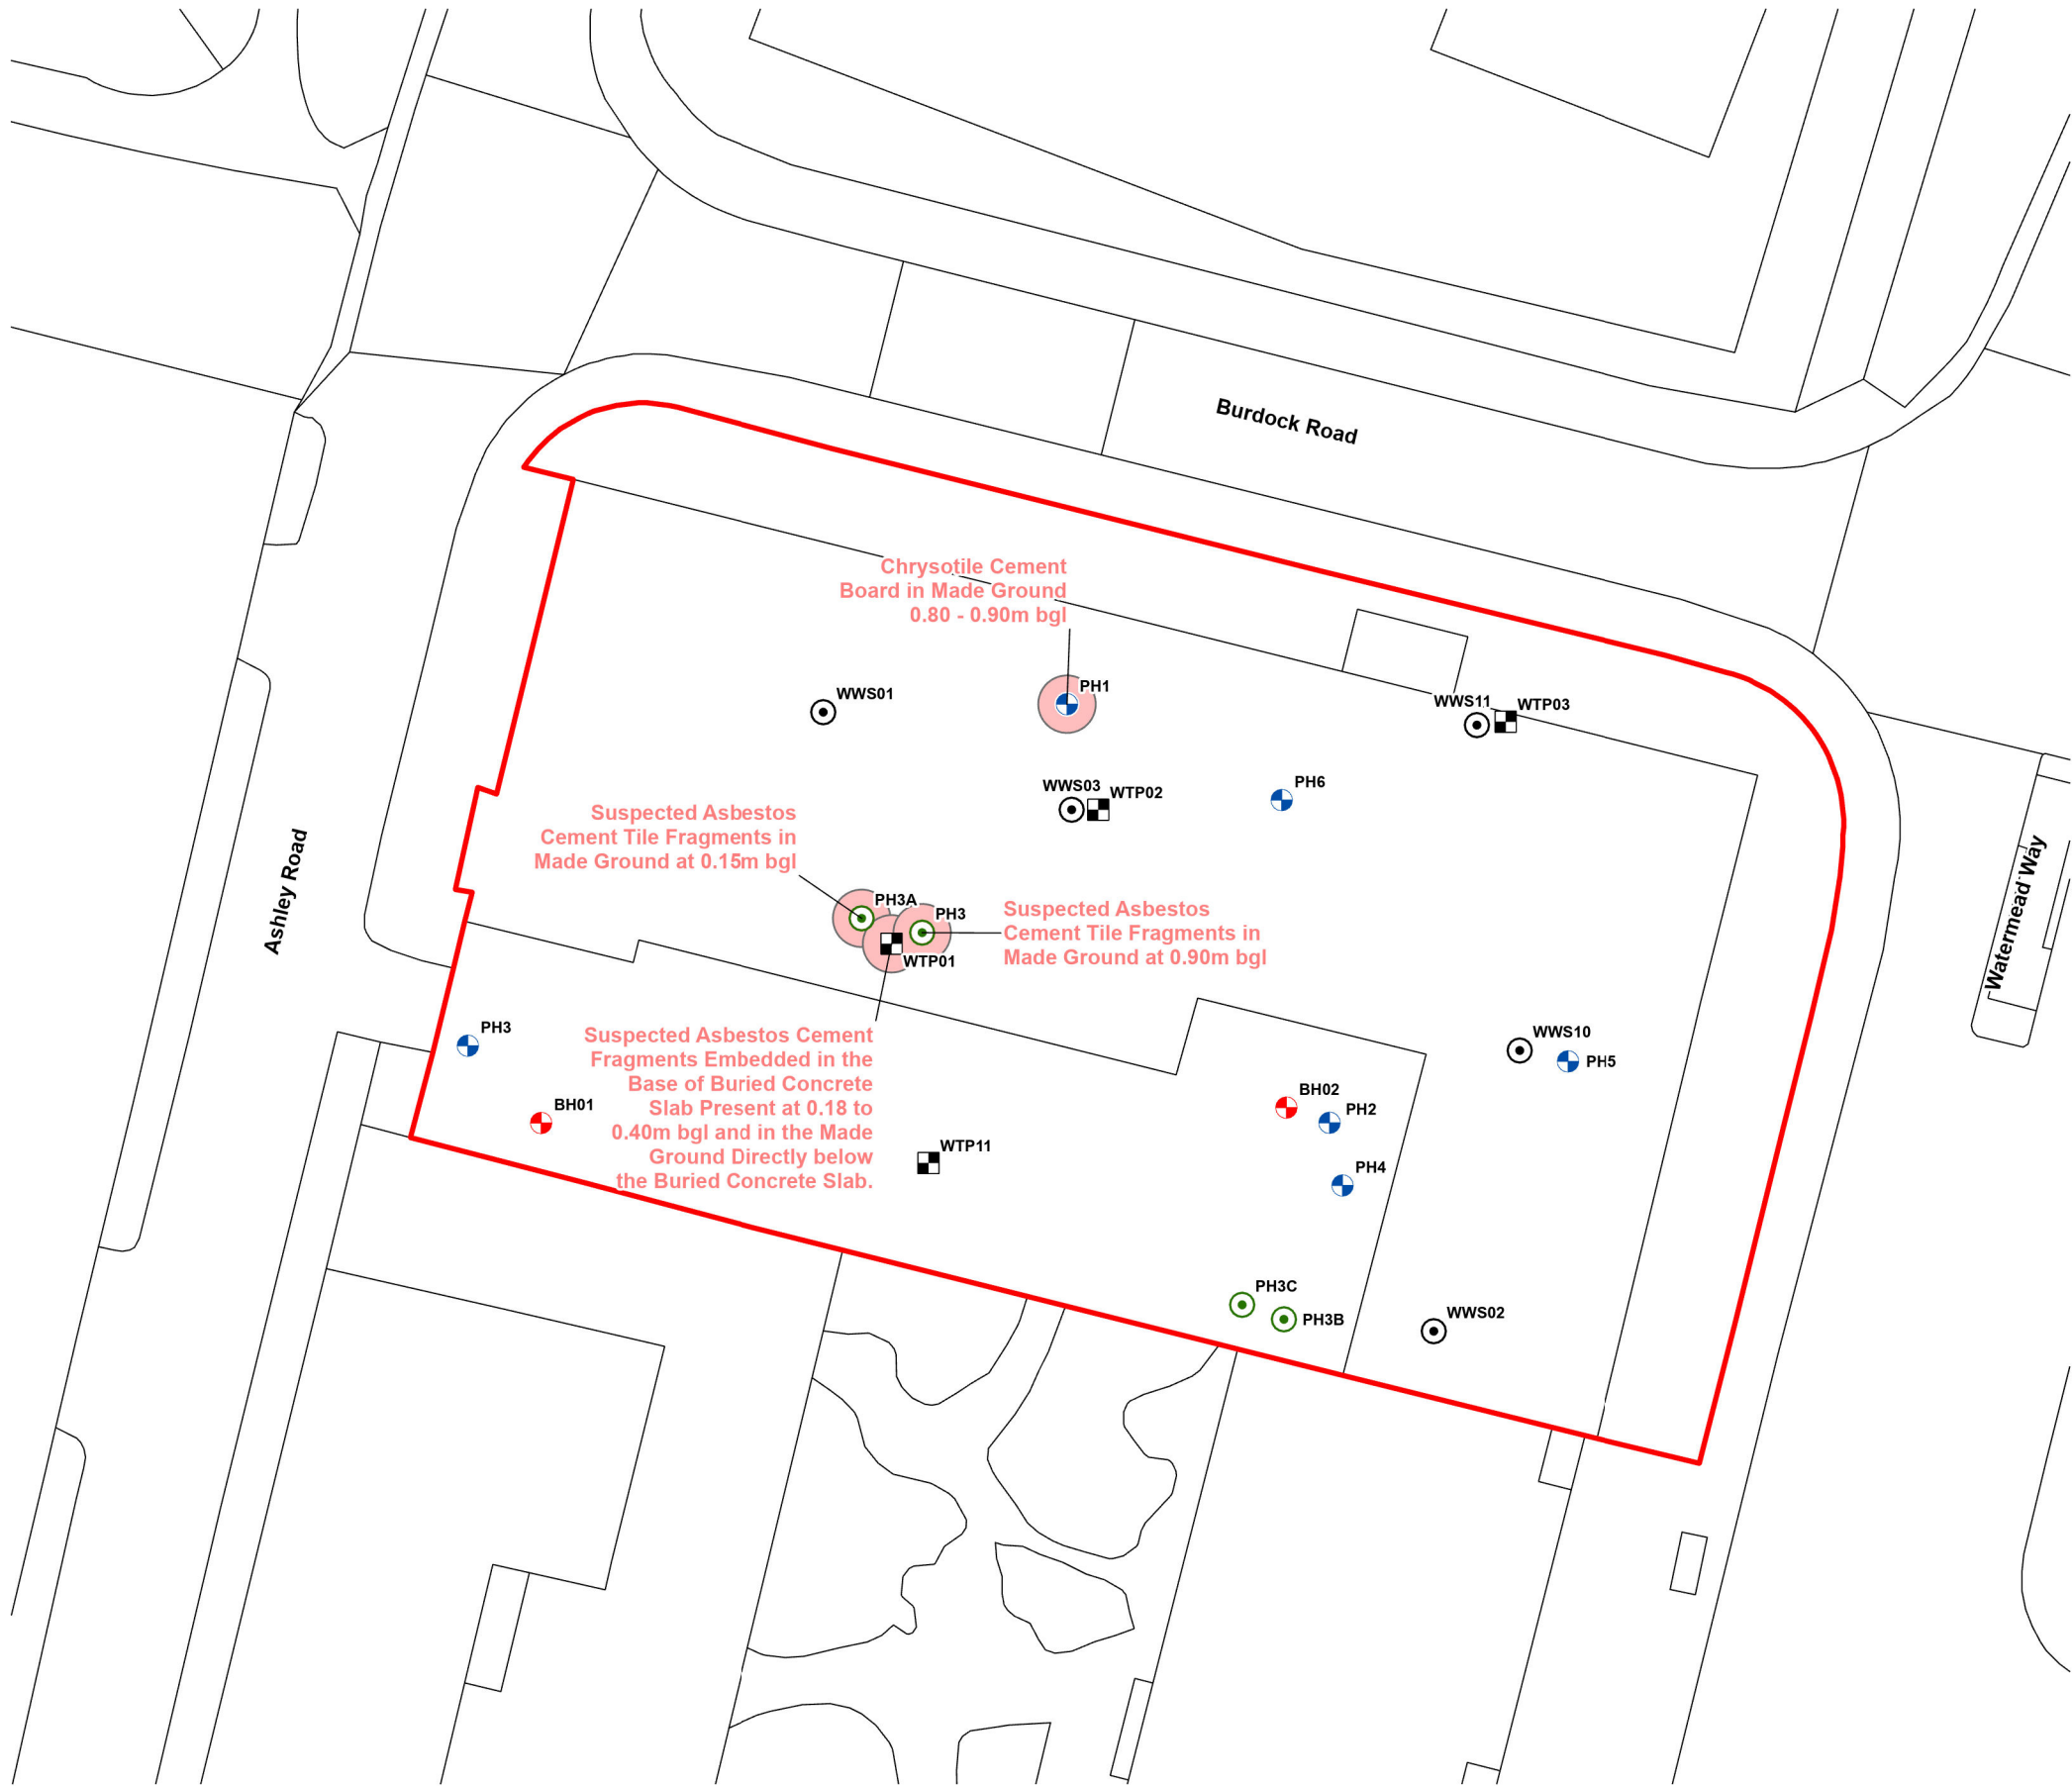
- Site Boundary
- Locations of Visually Identified Asbestos During Ground Investigations
- Trial Pit
- Window Sample
- Probe Hole
- Borehole
- Window Samples

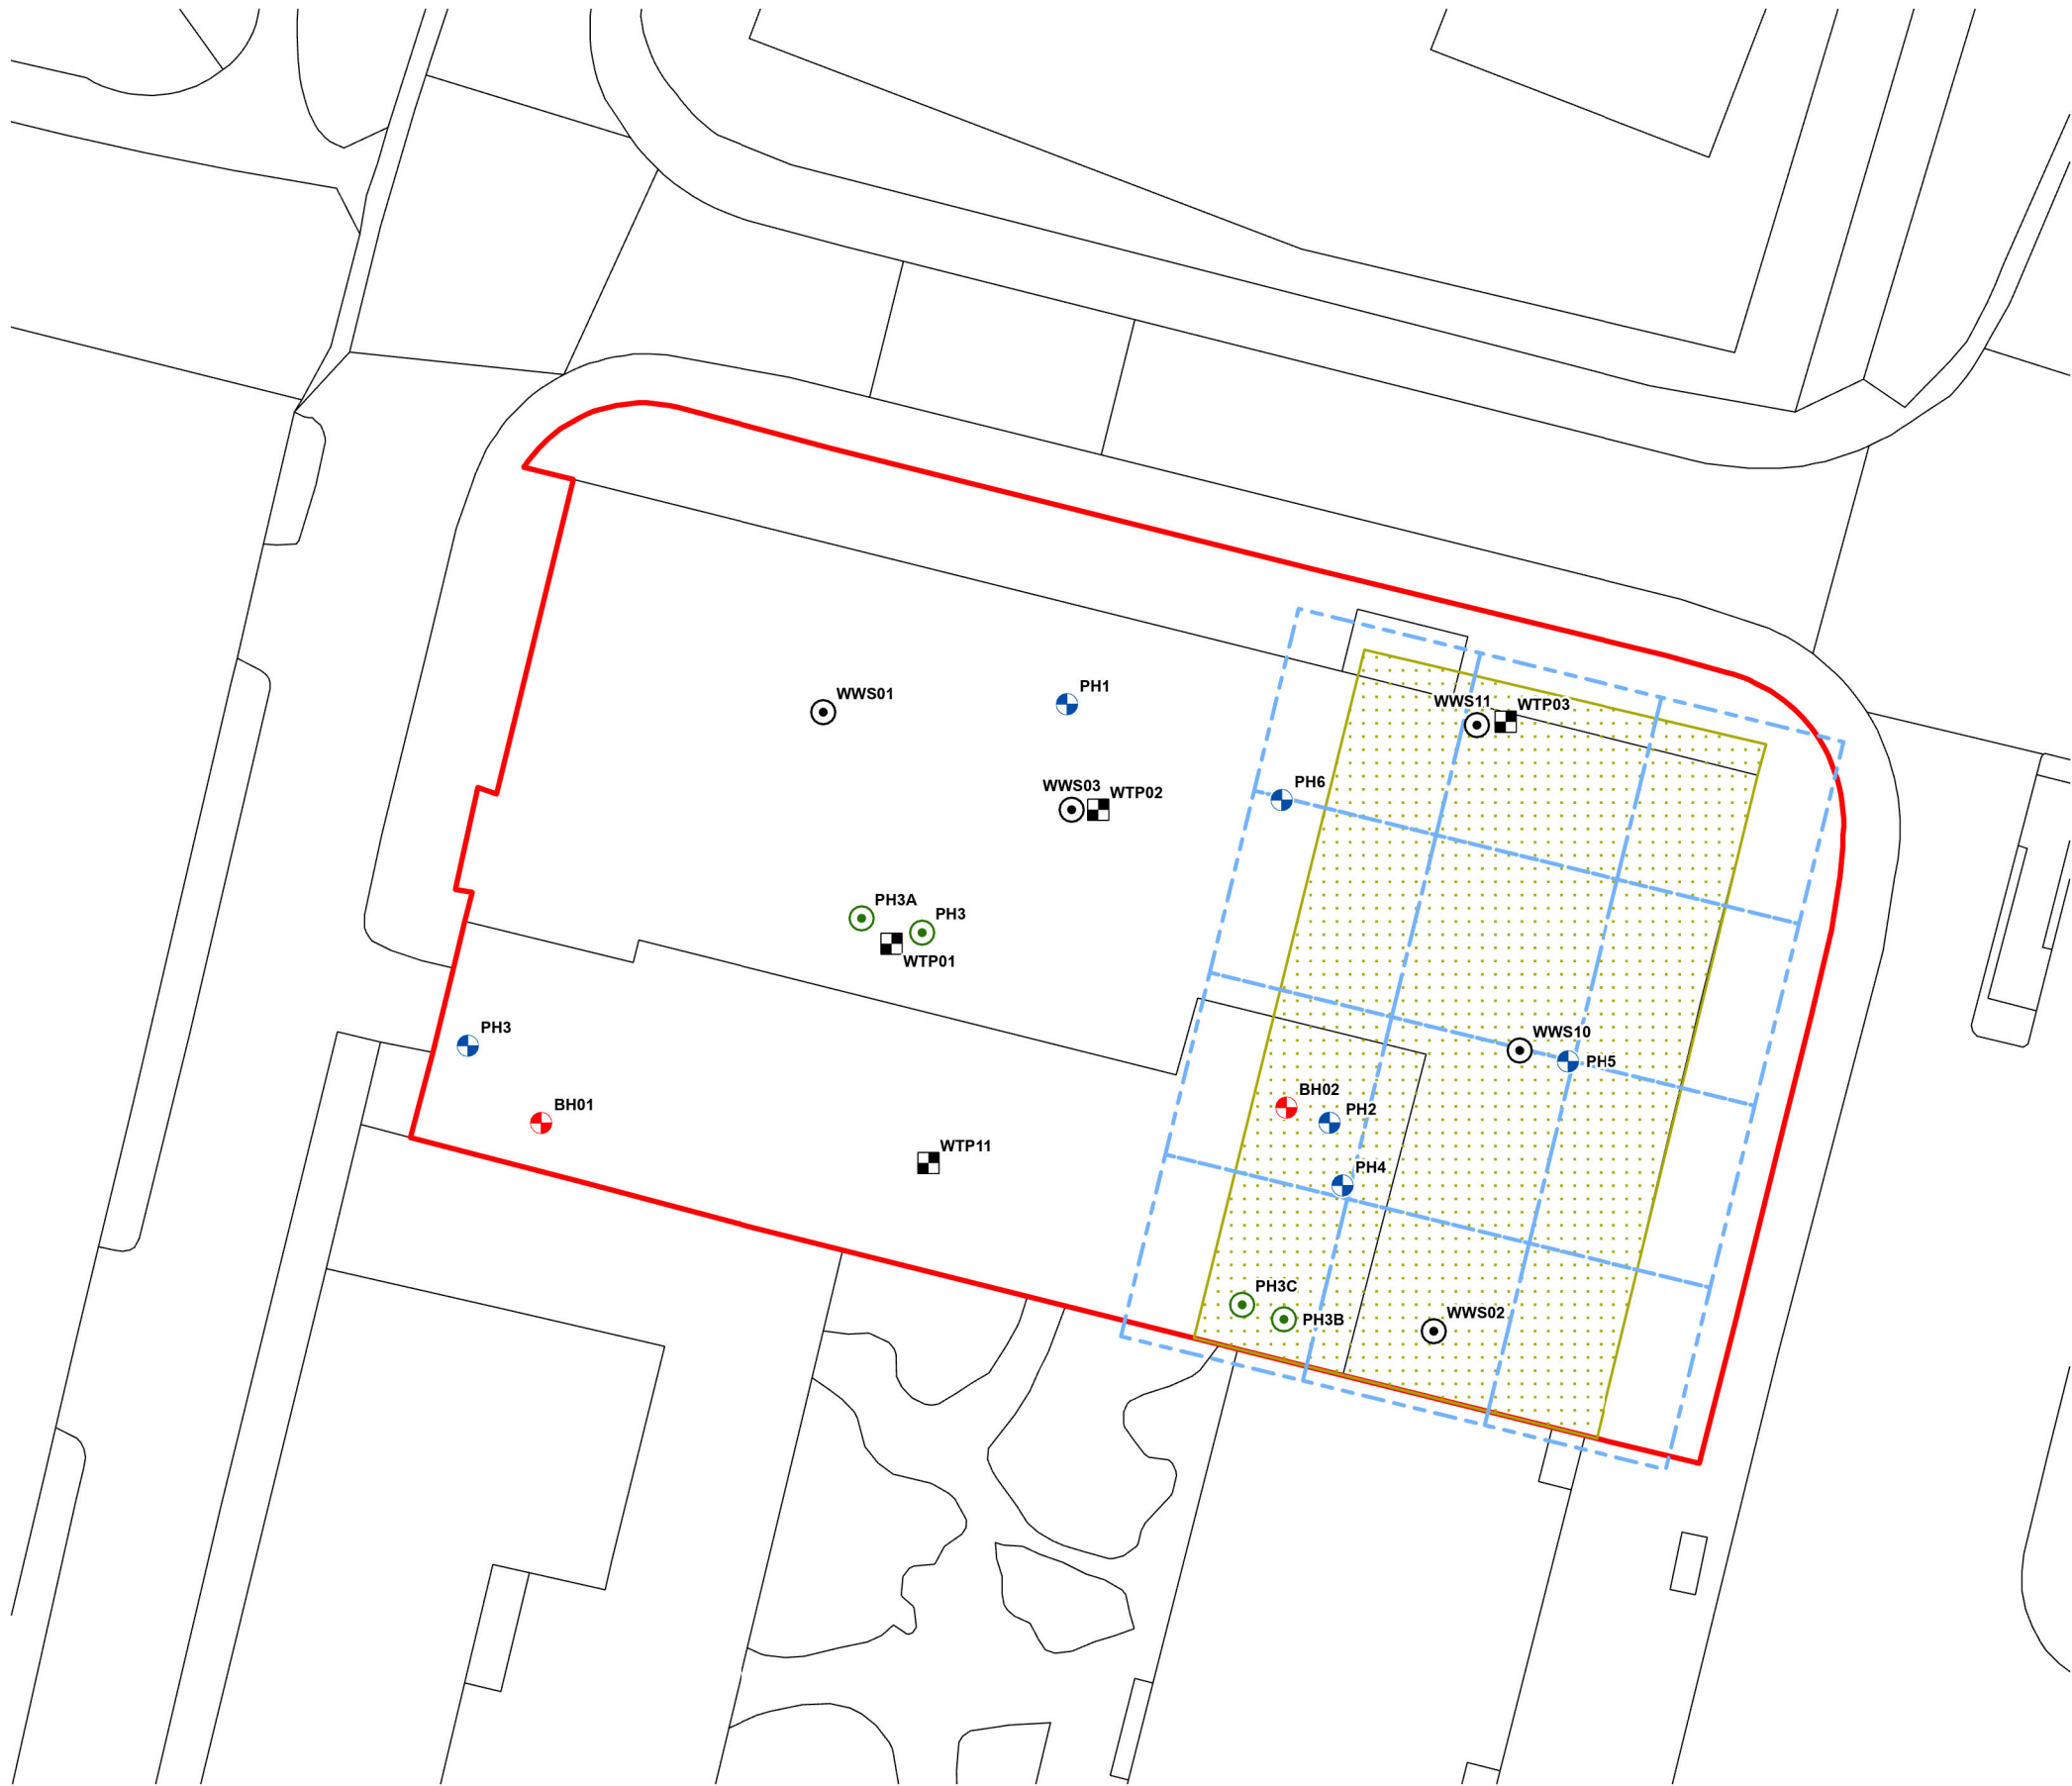
- Site Boundary
- 10m x 10m Grid
- Trial Pit
- Window Sample
- Probe Hole
- Borehole
- Window Samples
- Approximate TPH Source Remediation Area.

Visual evidence of TPH contamination in the Kempton Park Gravel Member smear zone to be excavated.

TPH contamination has been identified in the groundwater smear zone and groundwater of the Kempton Park Gravel Member in the east of the Cannon Factory Site. Remedial measures are required to remove the source of contamination and create betterment of subsurface conditions.

Excavations will advance down to the top of groundwater level in the Kempton Park Gravel Member (about 2.5 – 3.0m bgl). Soils in the groundwater smear zone exhibiting dark staining, hydrocarbon sheens, and/or an oily residue will be excavated.

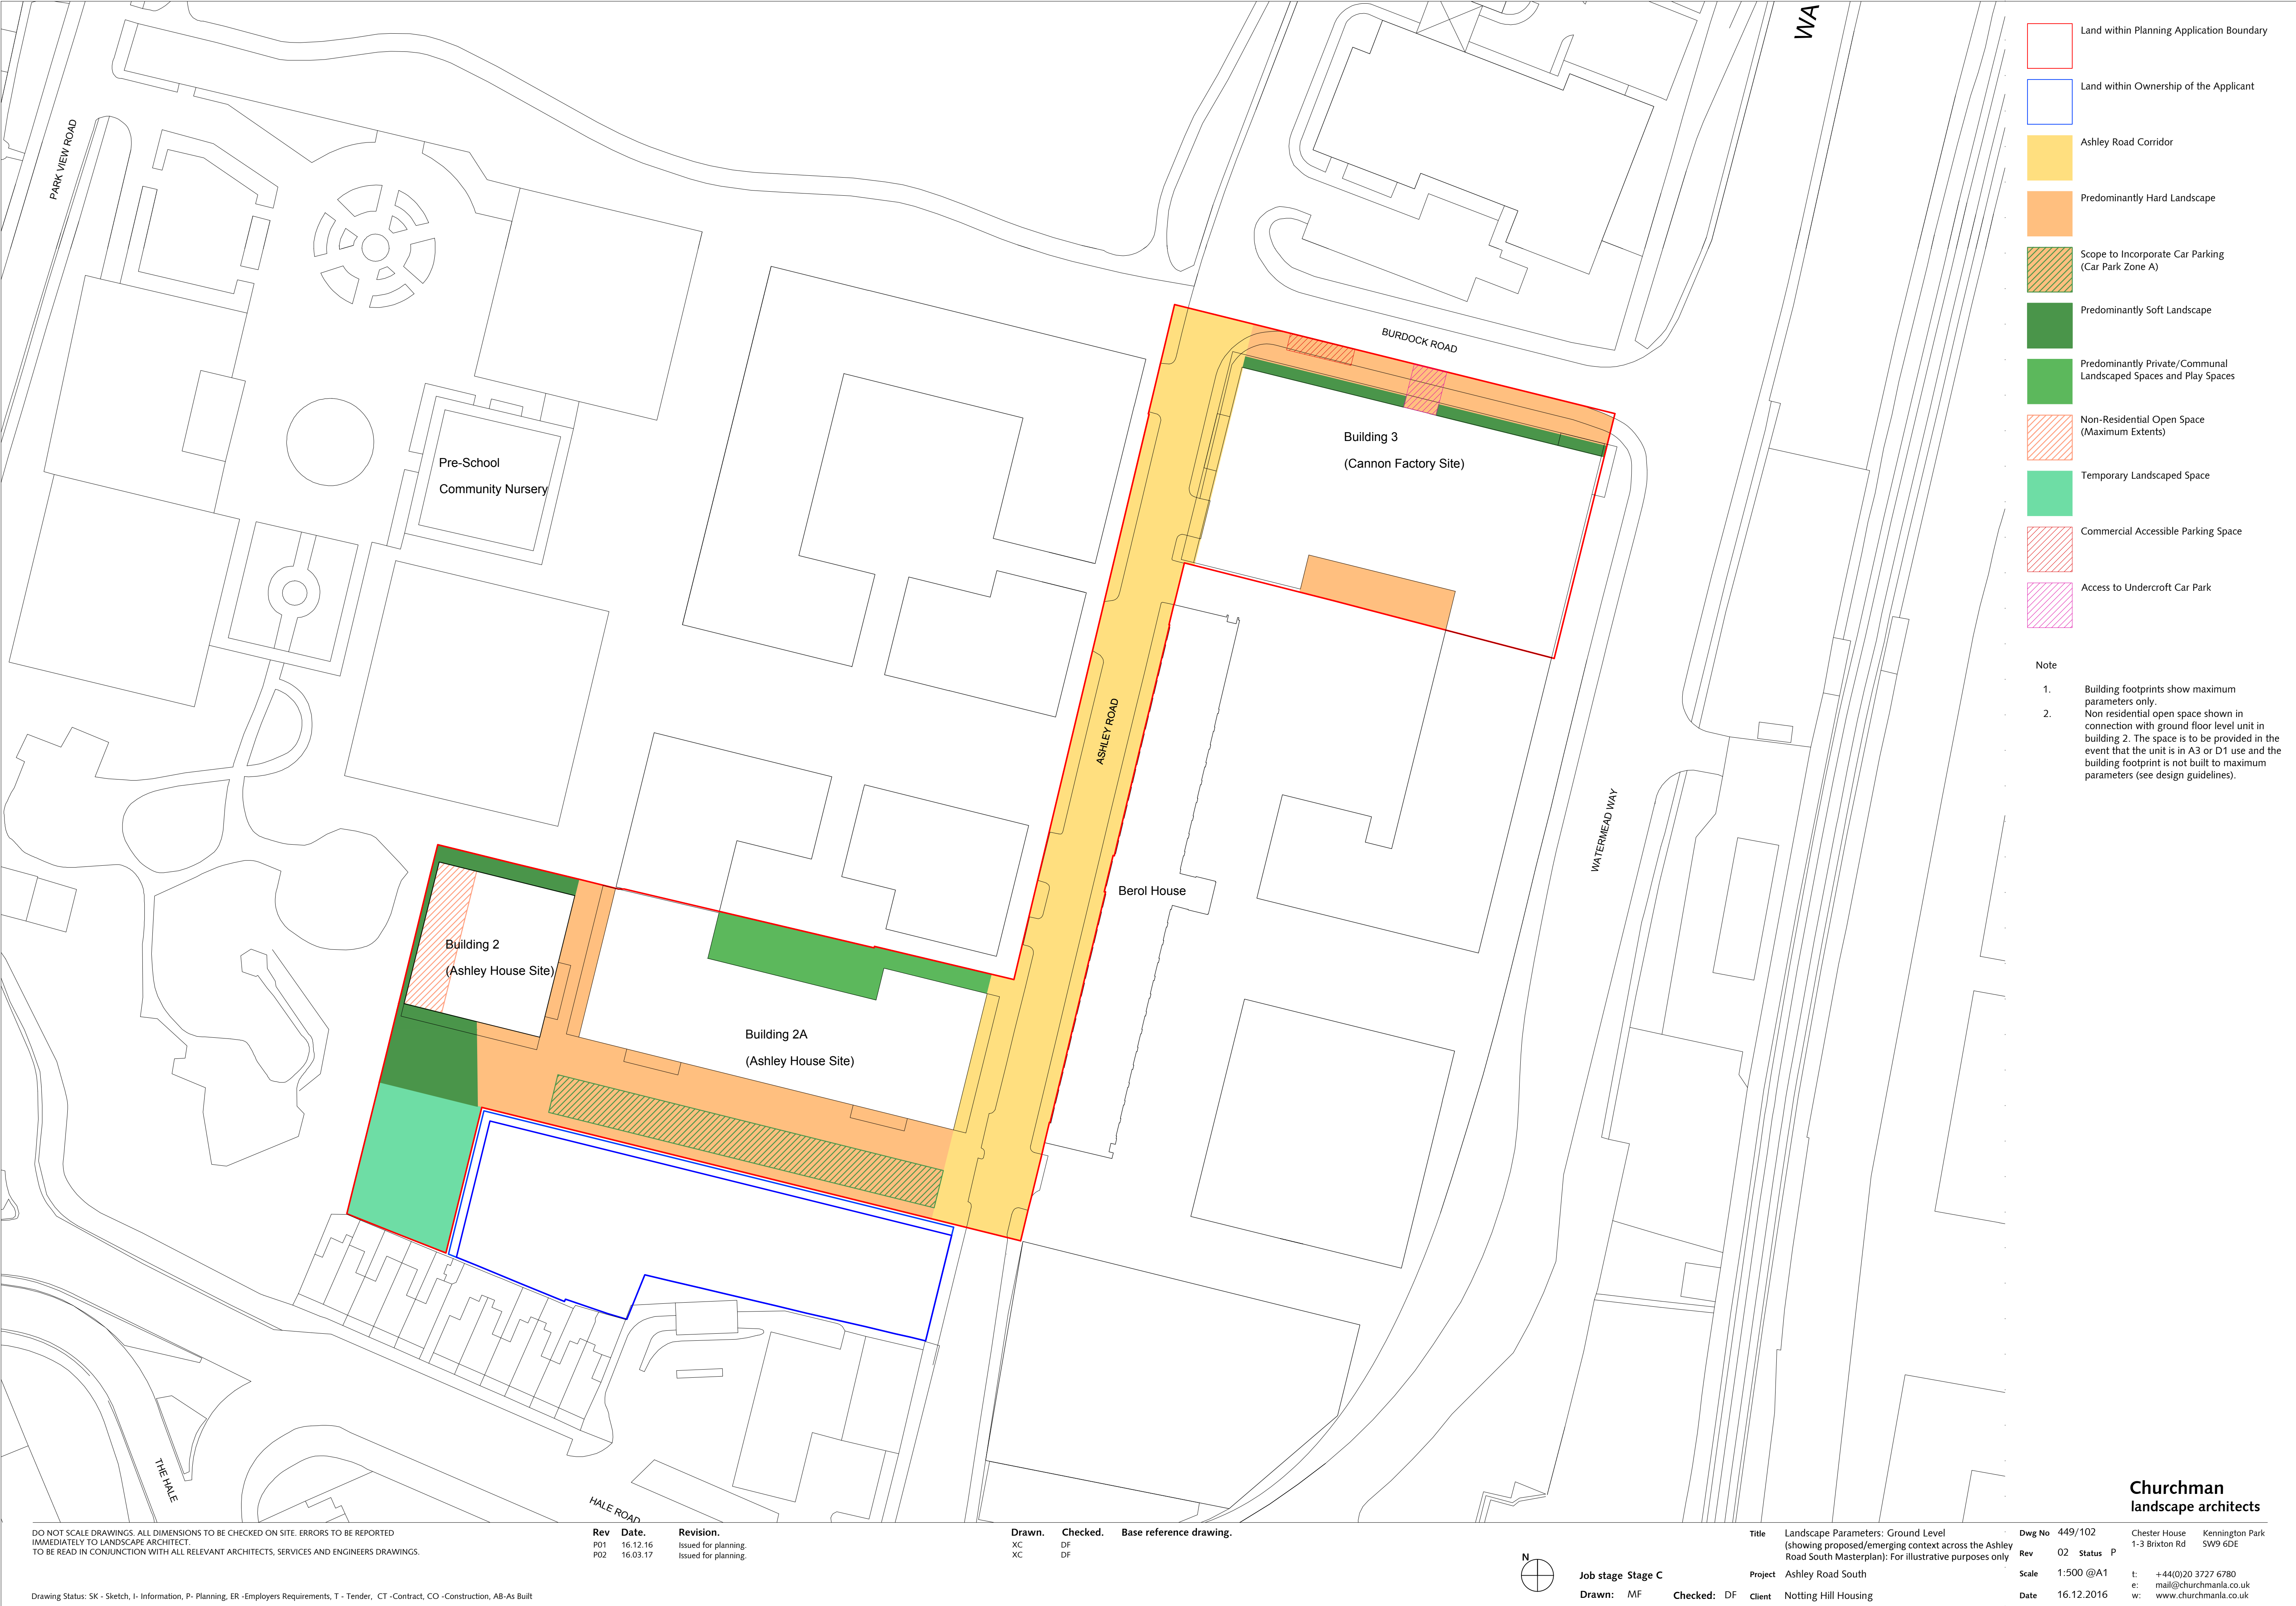
- Land within Planning Application Boundary
- Land within Ownership of the Applicant
- Ashley Road Corridor
- Predominantly Hard Landscape
- Scope to Incorporate Car Parking (Car Park Zone A)
- Predominantly Soft Landscape
- Predominantly Private/Communal Landscaped Spaces and Play Spaces
- Non-Residential Open Space (Maximum Extents)
- Temporary Landscaped Space
- Commercial Accessible Parking Space
- Access to Undercroft Car Park

Proposed landscape parameters are presented in Appendix A.
