**Donald Insall Associates**  
Chartered Architects and Historic Building Consultants

**Hornsey Town Hall and the Gas and Electricity Showrooms**  
Conservation Management Plan: The Broadway Annexe and 26 The Broadway

Revision 0: 05 June 2023

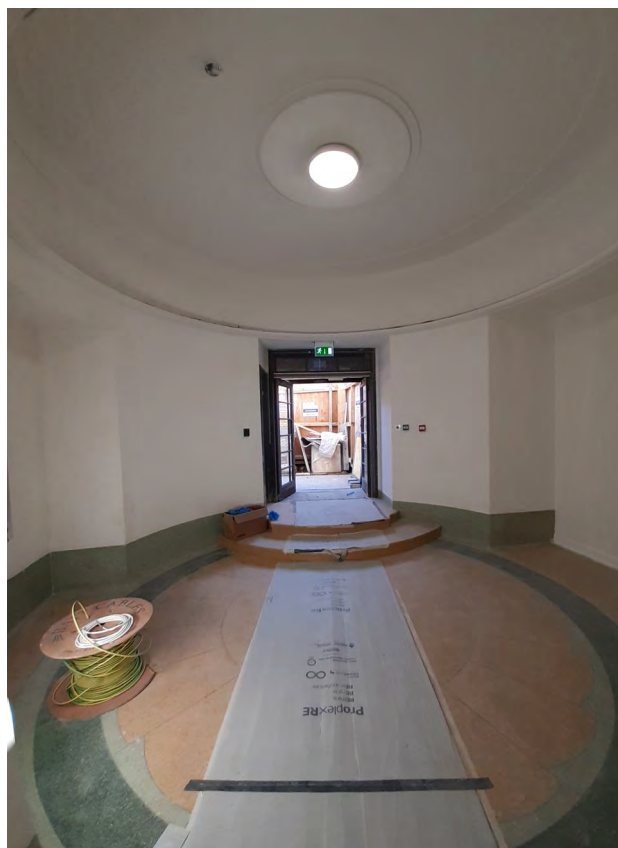
**27** G.01 Entrance Lobby

**Floor:** Patterned terrazzo floor design with green outer ring set within cream pink terrazzo. Vestibule also in cream pink terrazzo with two round edge steps.

**Doors:** Original timber entrance double doors with some original ironmongery. Single timber door with original ironmongery to storeroom from Vestibule.

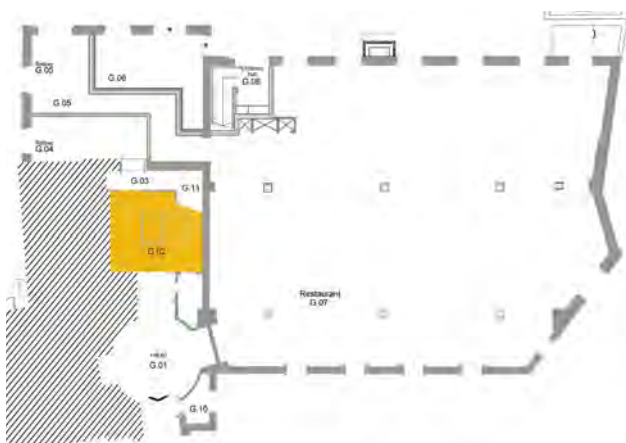
**28** G.02 Stairwell with new lift

**Room: G.02 Stairwell and Lift Lobby [plate 28-28B]****General Description:** Stair well with new lift.**Significance:** Moderate (although the existing stairs are High)**Use:** Stairwell (including new lift).**Ceiling:** Painted plaster with pyramidal lightwell at top.**Walls:** Painted plaster.**Windows:** None.**Doors:** Modern doors to new apartments from stairwell.**Floor:** Terrazzo floors with terrazzo skirting.**Fittings (stair):** Terrazzo stairs with metal balustrade, curved at stair landings.

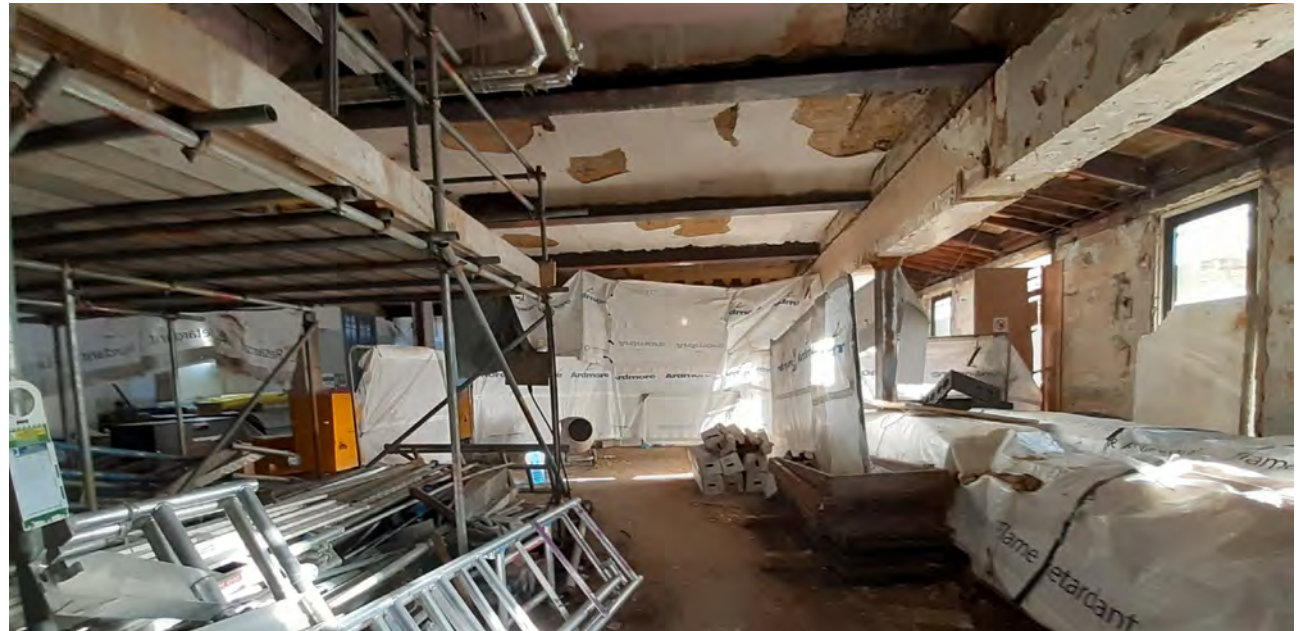
30 G.07 Restaurant, east block

**Ceiling:** All original. Plaster to concrete planks above, with exposed metal beams. Timber cut roof to front area of building (to south). Some areas with exposed RC.

**Walls:** Painted plaster to some areas with exposed brickwork in some areas (paint scheme lower section grey and upper section white). Original metal columns and exposed junctions

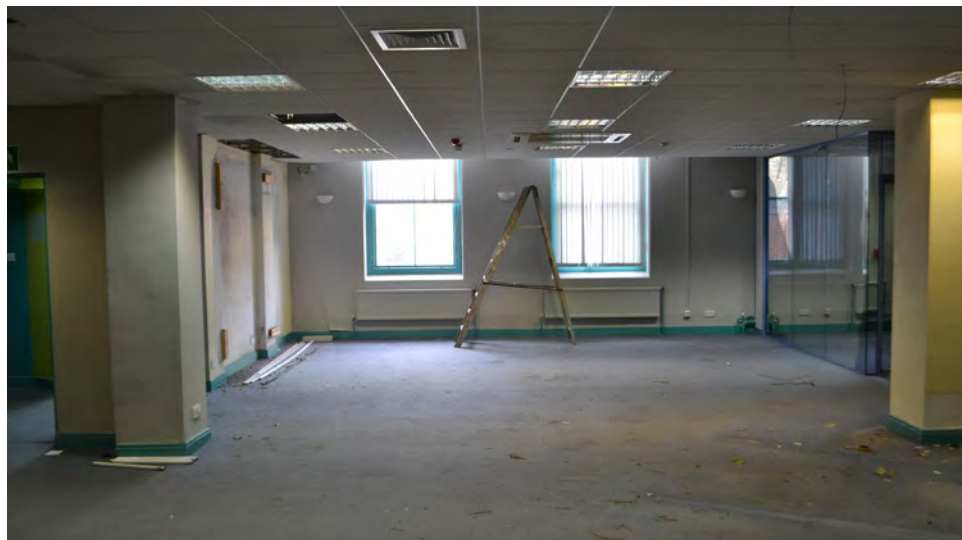
**33** Interior of east block of the Broadway Annexe (former telephone exchange), 2017

**General Description:** No access (under construction). Previous report noted the following: The first floor of the former telephone exchange (which forms a mezzanine level off the main stair) is a large single room (one subdivided) with a coffered ceiling and a central rooflight. A suspended ceiling has been inserted. Also at this level is a single office space with a few historic features including a cornice and an architrave, which are of limited interest
