## STRUCTURAL REPORT

PROJECT: 189 Mount View Road – new build house

JOB NO: 695

DATE: 23.05.23

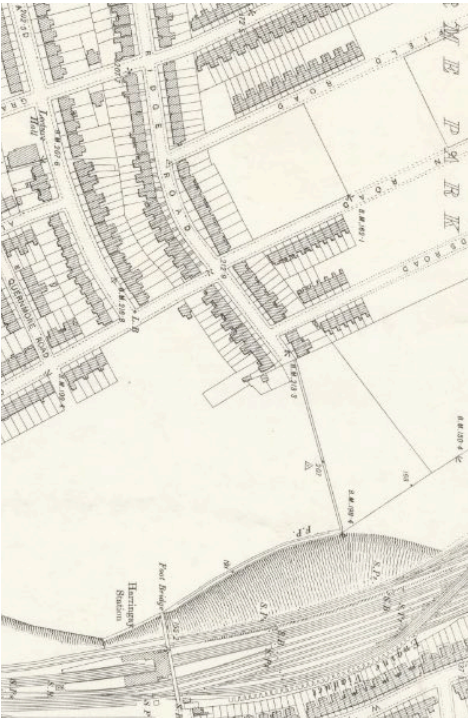
Prior to Mount View Road being developed for housing the area was empty,  
London 1896 Ordnance Survey, National Library of Scotland

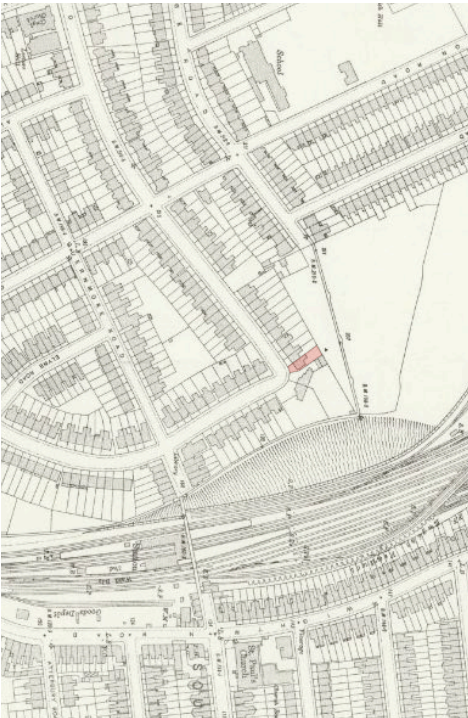
Property is first seen on ordnance survey in 1915.  
London 1915 Ordnance Survey, National Library of Scotland

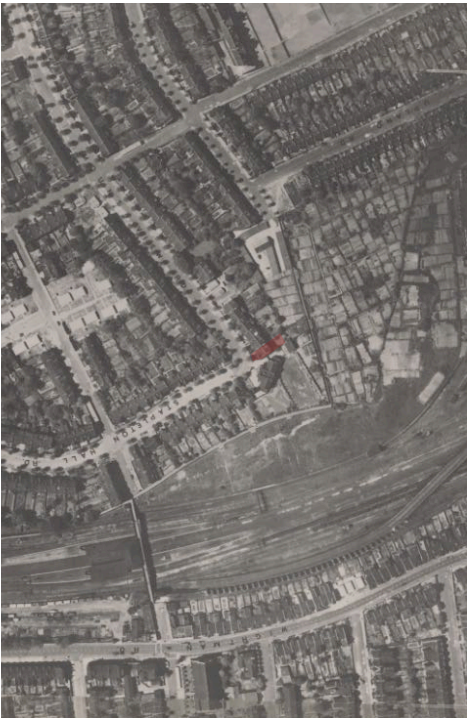
Aerial photo view of property.  
Ordnance Survey Air Photo Mosaics (1944-1950), National Library of Scotland

No. 189 Mount View Road is an end of terrace three storey Victorian house set at the lower eastern end of Mount View Road as the road starts to turn south to become Stapleton Hall Road. The property is understood to have been previously extended at the rear with a single storey rear extension. No structural alterations are proposed to the property as part of construction of the new build house and no structural inspection was carried out of the property. Reference to historical maps indicates that the area was developed during the 1890s from assumed farm land / allotment gardens (refer to historical mapping in appendix A). The property falls outside the mapping of the WW II London damage maps however the property is shown intact on the 1949 post war RAF aerial mapping (refer to appendix A).

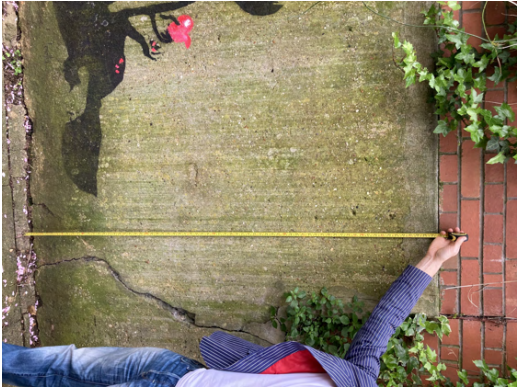
4. Retaining wall of No. 14 Highbank Way Alleyway

Immediately abutting the end of the boundary fence to No.189 is the higher level concrete retaining wall of the rear garden to No. 13 -14 Highbank Way. The top of the concrete wall is approx. 1.6m above the alleyway level – although it then steps down to a lower level. The wall supports a higher level masonry wall and then a timber fence. There are signs of cracking and some movement of this wall – and then immediately to the west, further along the alleyway a series of timber buttress frames have been installed to the face of the boundary retaining wall as it continues along the side of the parking area to the houses on Highbank Way.

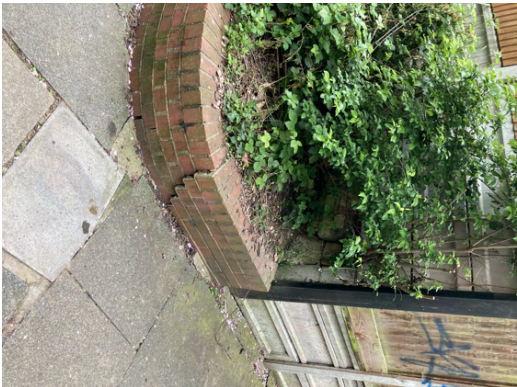
5. Existing brick retaining wall

Along the side of the property there is a concrete post / timber fence (as shown in the photo record sheets in appendix B) which provides a boundary to the retained banked earth planters which run along the side of the property between the boundary and the side alleyway to Highbank Way. The banked soil in these planters is retained by what appear to be 215mm thick solid masonry low level retaining walls. These existing retaining walls vary in height from about 400mm to almost a metre. There is evidence of some movement and cracking in these existing retaining walls (refer to photo 7).

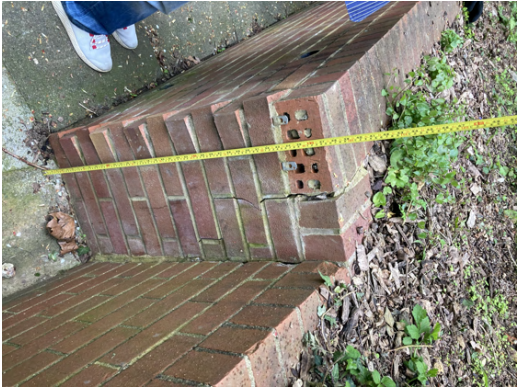
7. Existing brick retaining wall to Highbank Way Alleyway

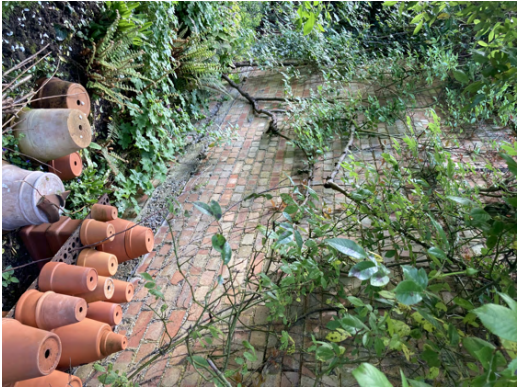
The boundary wall appears to be of solid 215mm thick masonry with a concrete coping and was measured as approximately 3.1m above the Mount View rear garden level.

9. Boundary wall to 11 - 14 Highbank Way

The depth and extent of the existing footings of the boundary wall have not yet been determined, however within the next stage of design development investigation trialpits will be carried out against the face of this wall to determine the depth and extent of the existing foundations to this wall. If the existing foundations are very shallow, the excavations for the new higher level slab build-up may extend below the underside of the existing adjacent footings. If this is the case then a degree of shallow underpinning may be required to ensure that the existing boundary wall footings are extended down below the underside of any excavations for the new slab build-up.

The depth and extent of the existing foundation to this retaining boundary wall will be confirmed by future investigation trialpits. If the existing foundations are particularly shallow then some underpinning may be required to the base of this wall to maintain vertical and lateral support to the existing retained masonry in the permanent condition.

It is anticipated that any underpinning which was found to be required could be completed in a normal sequential manner of dowelled underpins mortar dry packed to the underside of the existing footing without any adverse impact of the stability of the existing boundary wall.

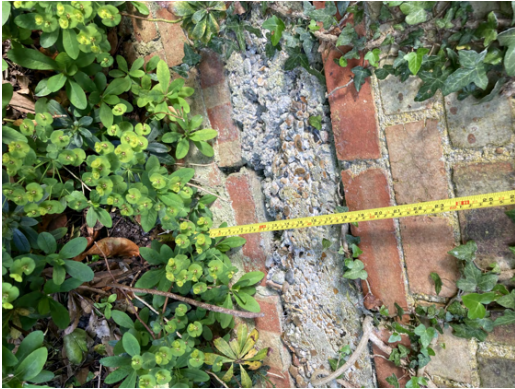
At the base of the wall there is low level masonry up to around 300 – 400mm above the existing garden level and then an approximately 200mm thick poor quality concrete band before the brickwork continues up. At high level there appear to be what could have been intended to be movement joints across the upper 9-10 courses with evidence of cracking leading down from these joints.

10. Base of boundary wall to 11 - 14 Highbank Way

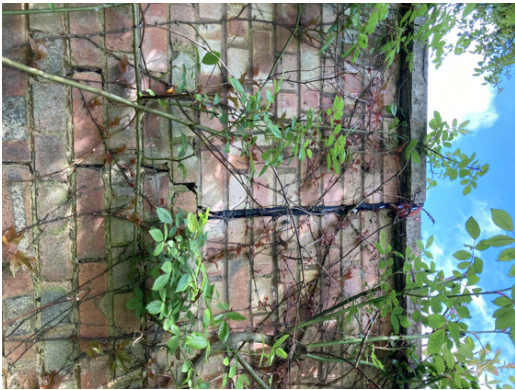
11. Head of boundary wall to 11 - 14 Highbank Way

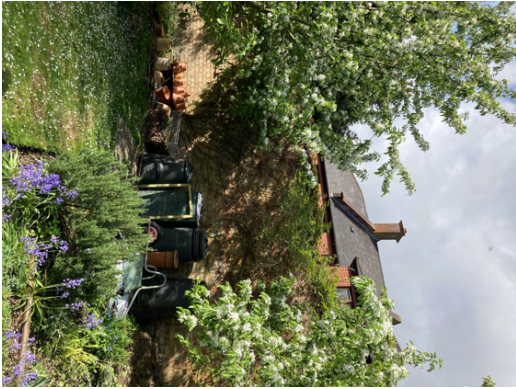
12. View of boundary wall to 11 - 14 Highbank Way

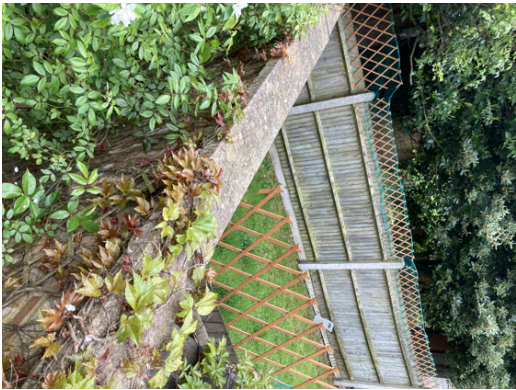
The levels of these adjacent rear gardens is not included within the topographical survey – however by measuring over the top of the wall it appears that these adjoining rear gardens are approx. 700mm - 800mm above the level of the No. 189 Mount View Road garden.

13. View over wall into gardens to 11 - 14 Highbank Way
