## Proposed Development Florentia Clothing Village Extension Vale Road

## Phase II Ground Investigation Report

January 2023  
R-GI-23675-01-03  
Revision 03

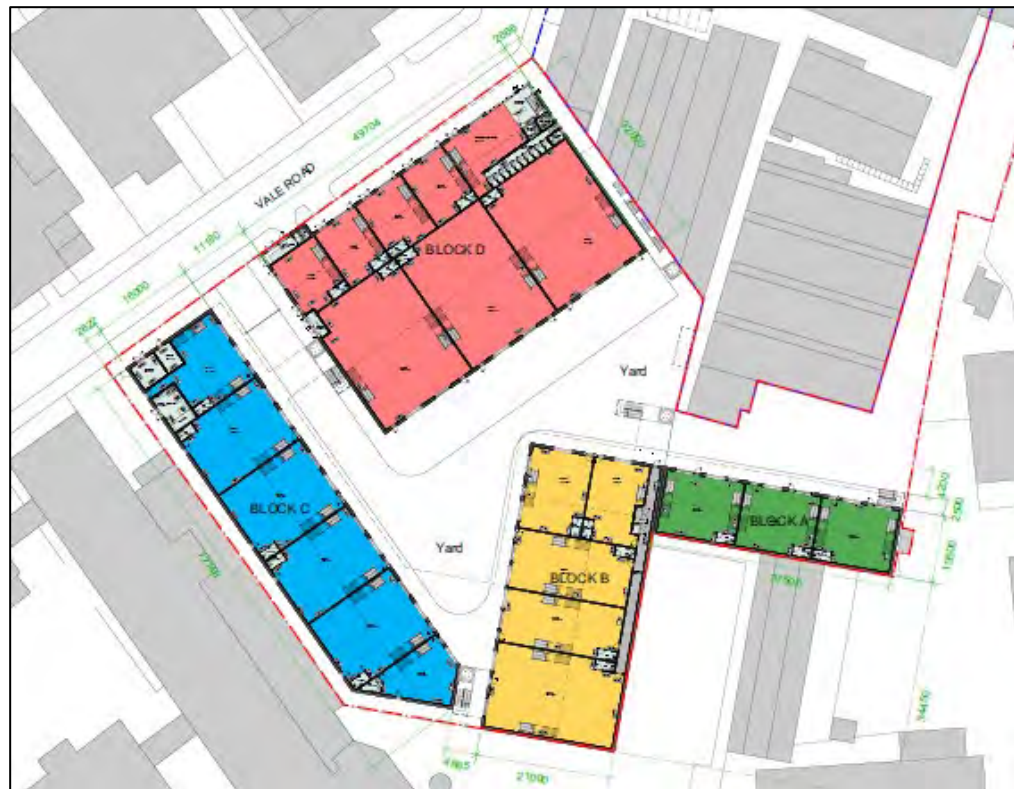
**Figure 3.1a: Development Proposals**

- 3.1.1 Vale Road bounds the Site to the north west with the existing Florentia Clothing Village located to the north east, further light industrial areas are located to the east, south and west.
- 3.1.2 The proposed site layout is shown on Figure 3.1a, an extract from the TurnerWorks Drawing: Proposed Area Summary, which shows the proposed extension to the Florentia Clothing Village.

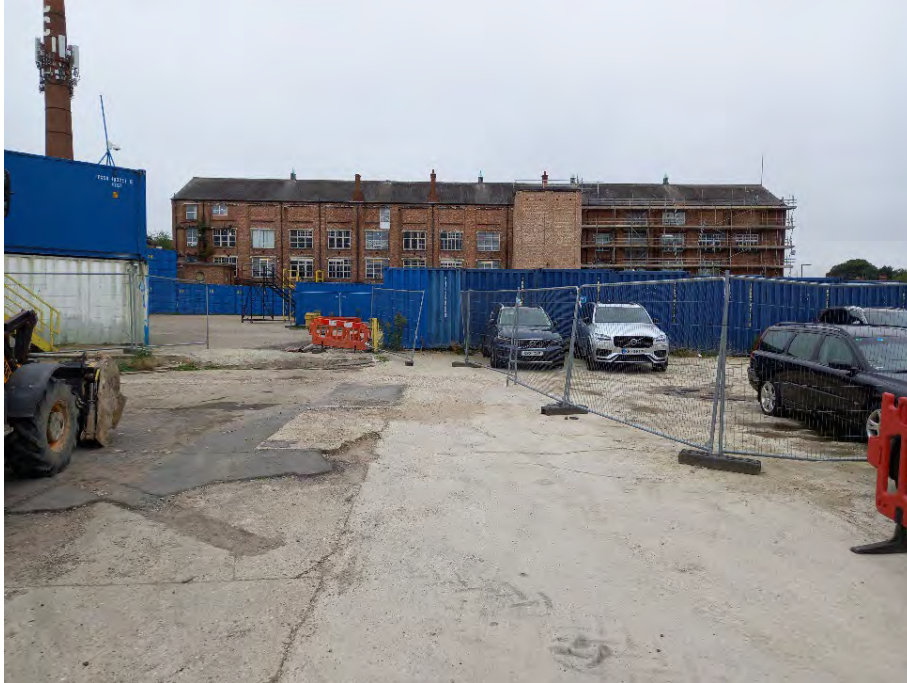
**Photograph 4.1** View from the south of the car park area of the Site, looking west towards the storage containers.

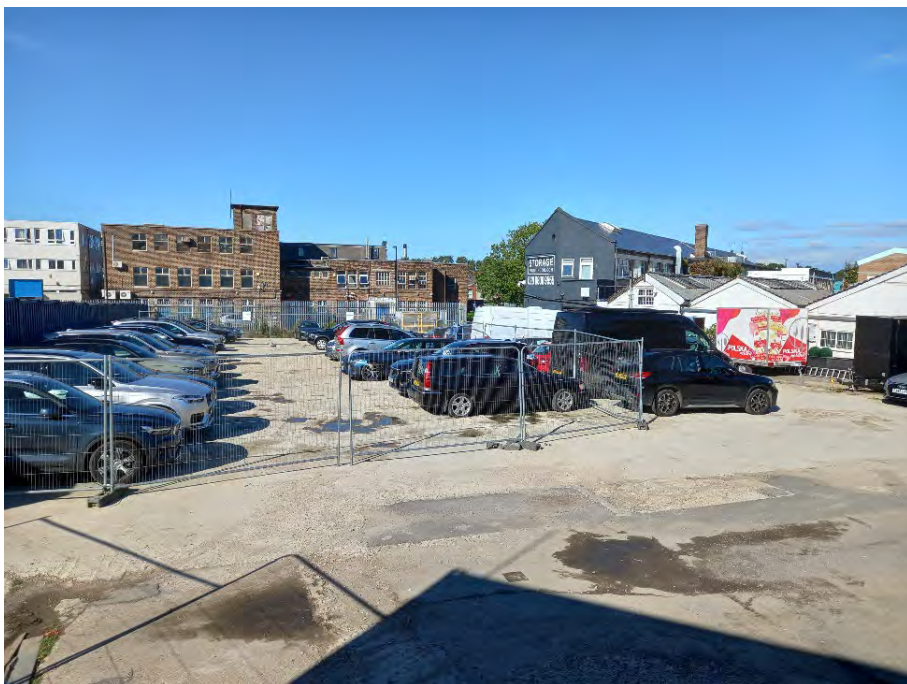
**Photograph 4.2** View from the south of the car park area of the Site looking north.

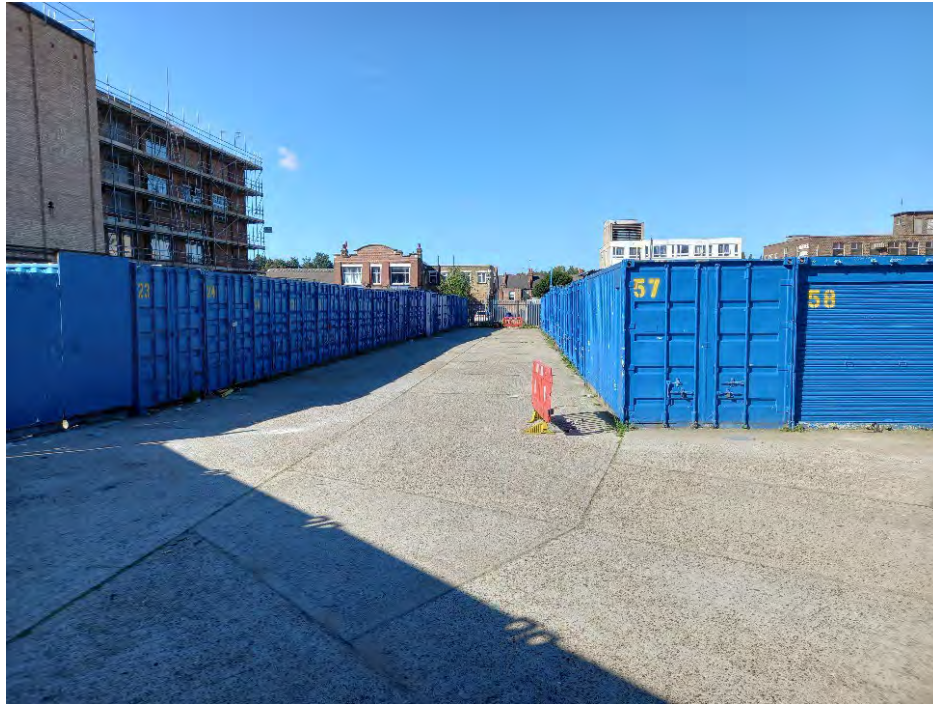
**Photograph 4.3** View from the south of the Site looking north, the storage containers in the right of the picture have been placed up to the western site boundary.

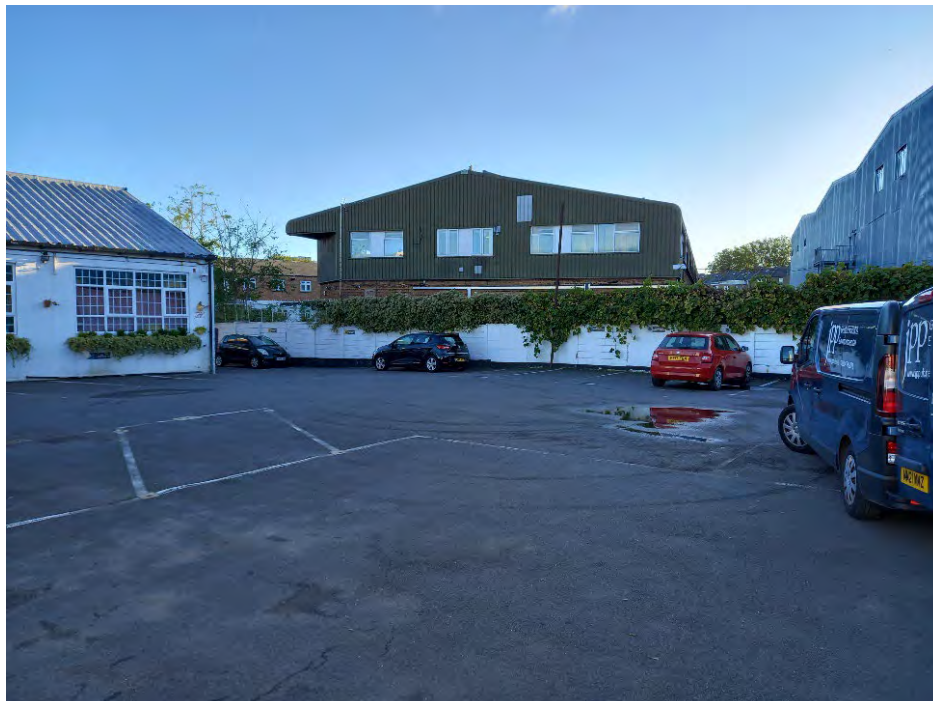
**Photograph 4.4** View from the east of the Site looking east at an area of car parking for the Florentia Clothing Village.
