SCOPE OF REFURB WORKS KEY:  
REFER TO MAKE SPECIFICATION, CONDITION SURVEY & SUPPORTING DOCUMENTS FOR FULL PROPOSAL

PROJECT / DRAWING TITLE  
HORNSEY TOWN HALL  
TOWN HALL & BROADWAY ANNEX  
LONDON N8 9JJ

DRAWING TITLE  
COMMITTEE ROOM F.46  
INTERNAL ELEVATIONS

DATE / DRAWN BY  
13.02.20 JH  
PROJECT / DRAWING NO  
3670-KDS-TH-01-DR-A-42-3520  
SCALE  
1:50 @ A1  
REV  
C1

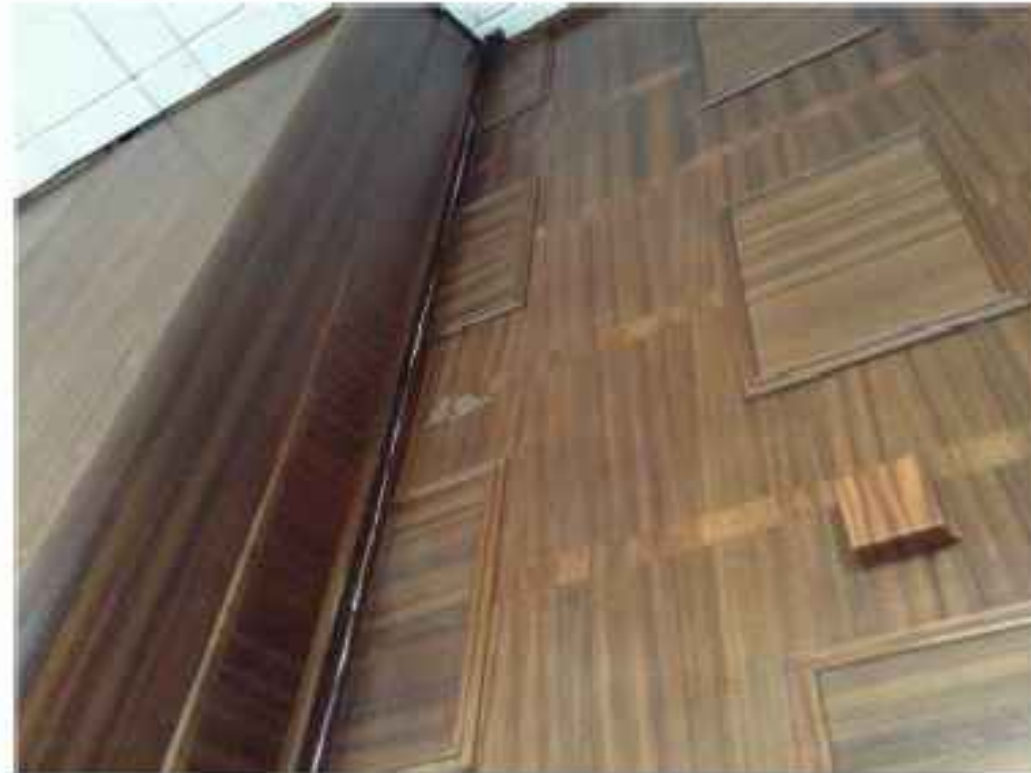
ALT-559

Refurbishment of original veneer wall lining to architectural specification. Existing appears to be a good condition, with the exception of localised damage. An example is the photograph above

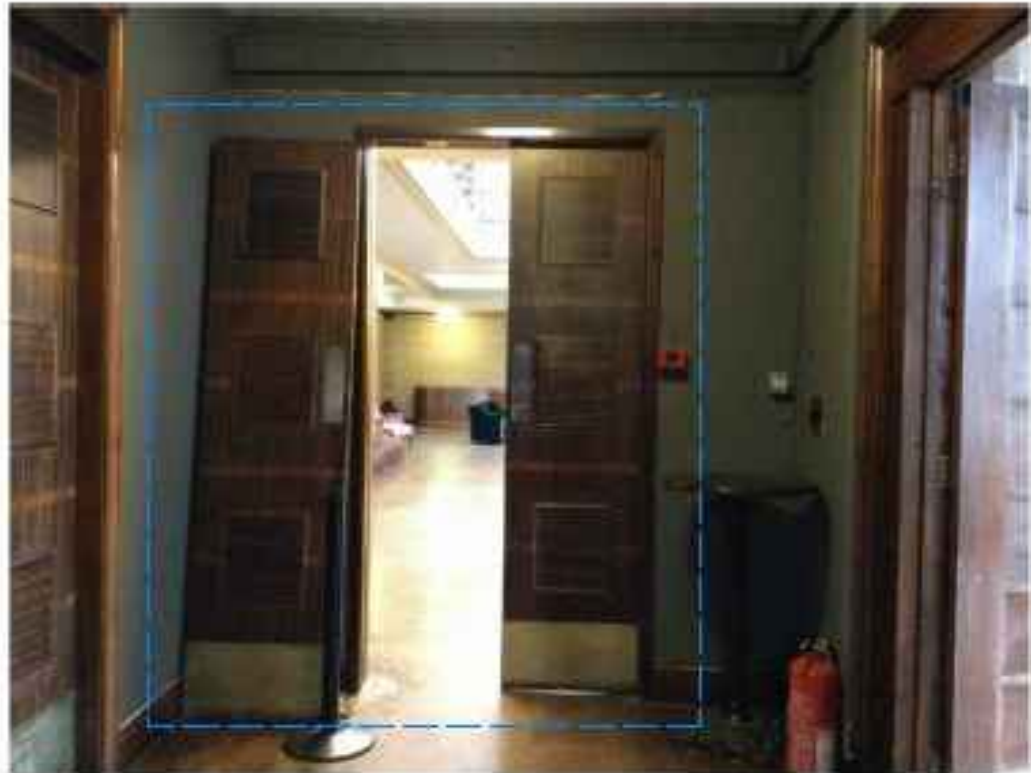
ALT-573

Original doors to be refurbished and reused with original lever handles. The original door has been relocated to the corridor as shown on the photograph above and is to be restored to its original position.

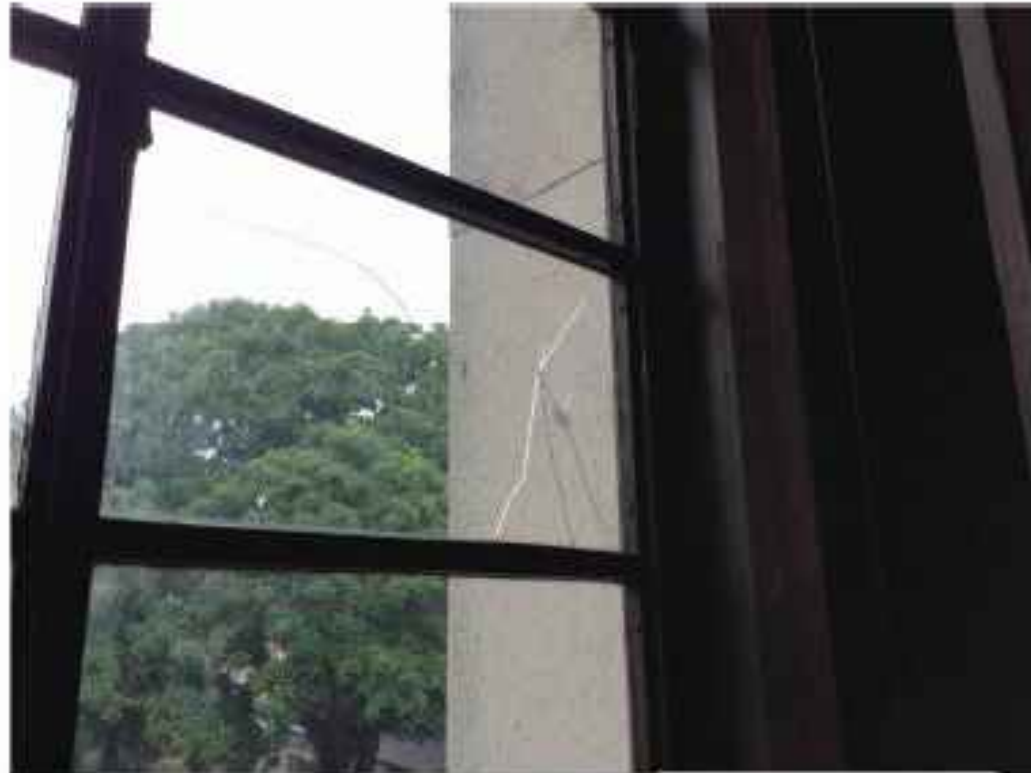
ALT-804

Refurbishment of original bronze framed windows. Refer to the architectural specification. Example of cracked glass. There are two known locations of this in this space. The glass units are to be replaced like for like

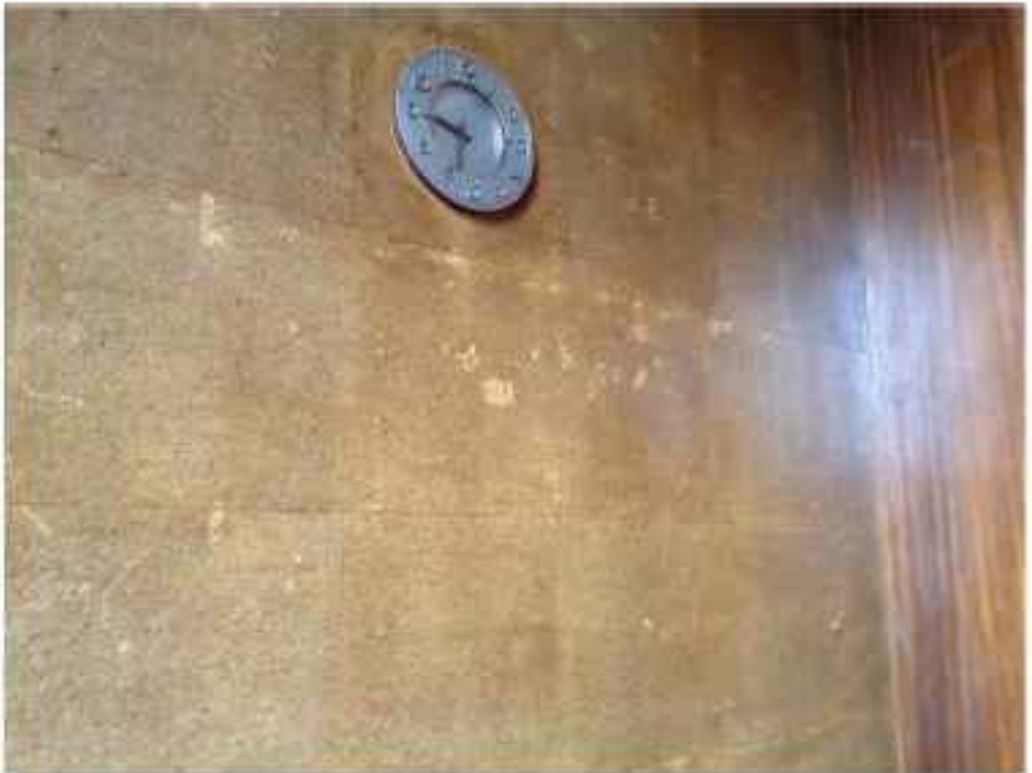
ALT-788 ALT-515

Cork wall finishes to be refurbished. Original clocks to be refurbished.
