# LEVEL MONITORING

## for Subsidence Management Services

**2 Elms Avenue, Muswell Hill, London, N10 2JP**

| Our Ref: | M18000 |

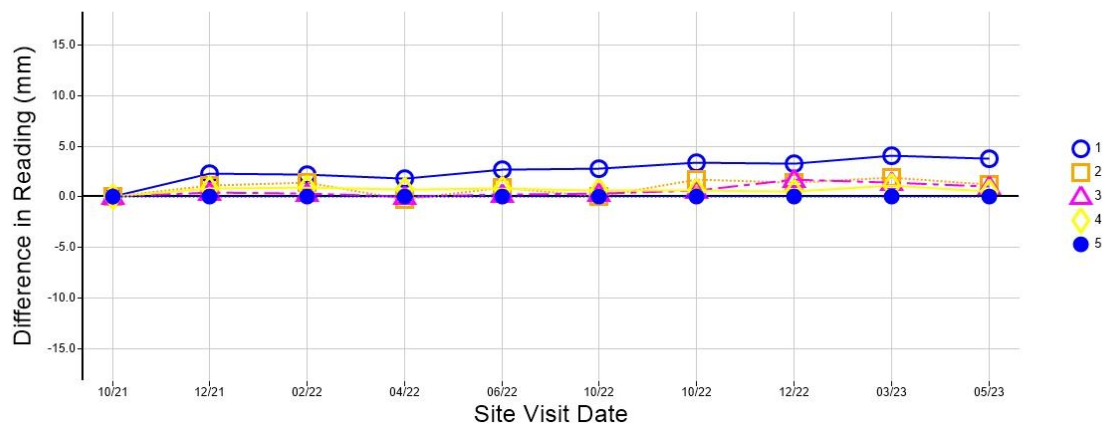
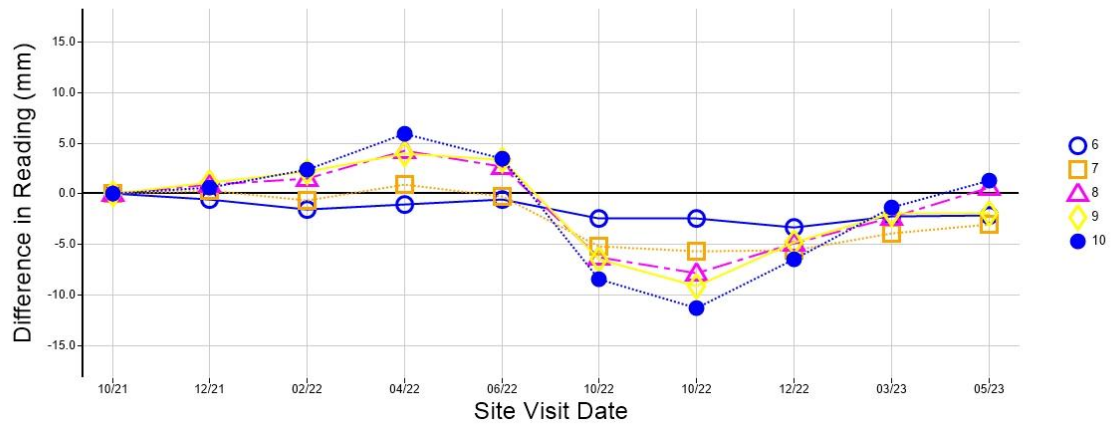
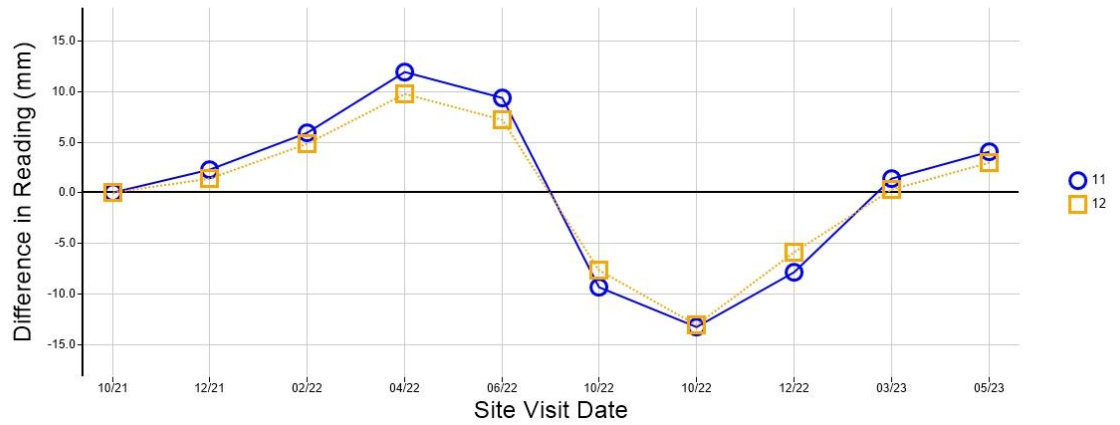
## Level Monitoring Difference Graphs

The following graphs display the progressive movement that each Level Monitoring Station recorded at each separate site visit date to give an overall look at how much the property is moving.

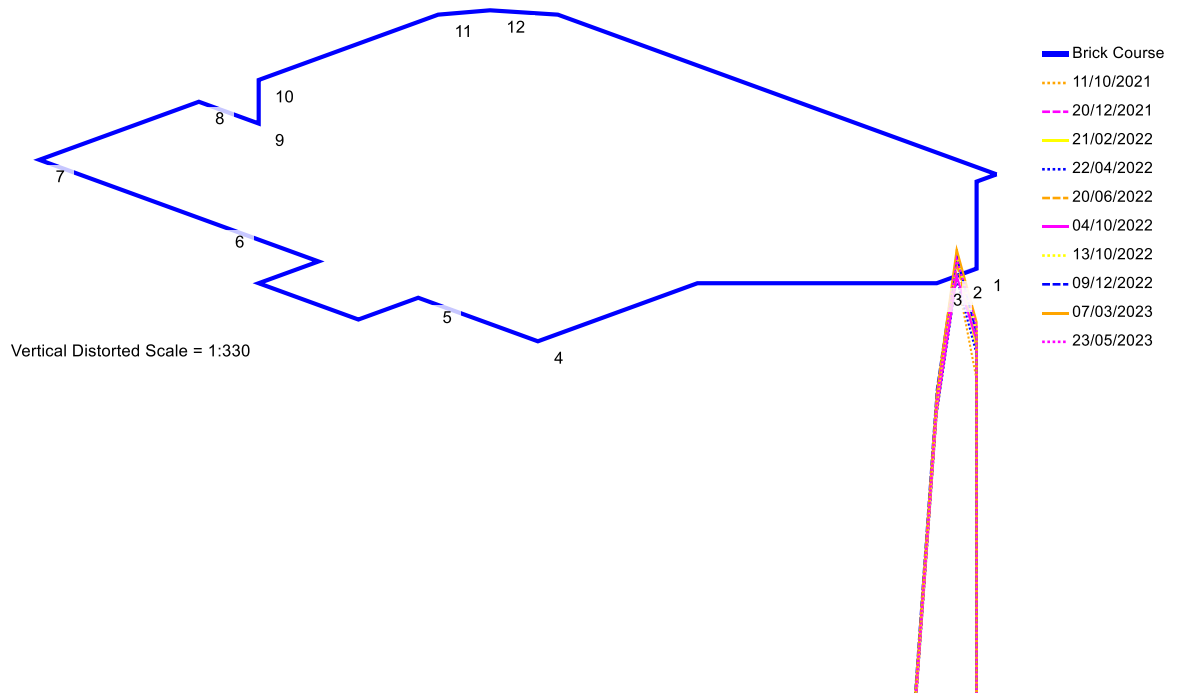
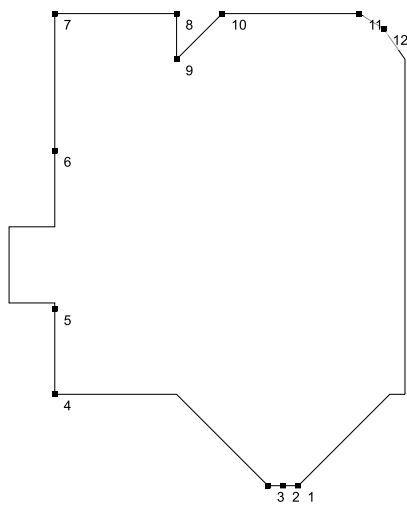
## Level Monitoring Displacement Map

The following image shows an isometric representation of the movement of the property, based on the Level Monitoring Stations that were installed.

Datum is relative to point 5. It has an assumed value of 10.0000m. There is no suitable remote datum available. If this is not suitable, a deep datum is recommended.

Points 1, 2 & 3 on front bay. Points 9 - 12 on bay to rear.
