**The Grove Lawn Tennis Club, Cascade Avenue, Haringey, N10 3PY**

## **Bat Survey Report**

A report for and on behalf of Rok Enterprises Ltd

April 2022

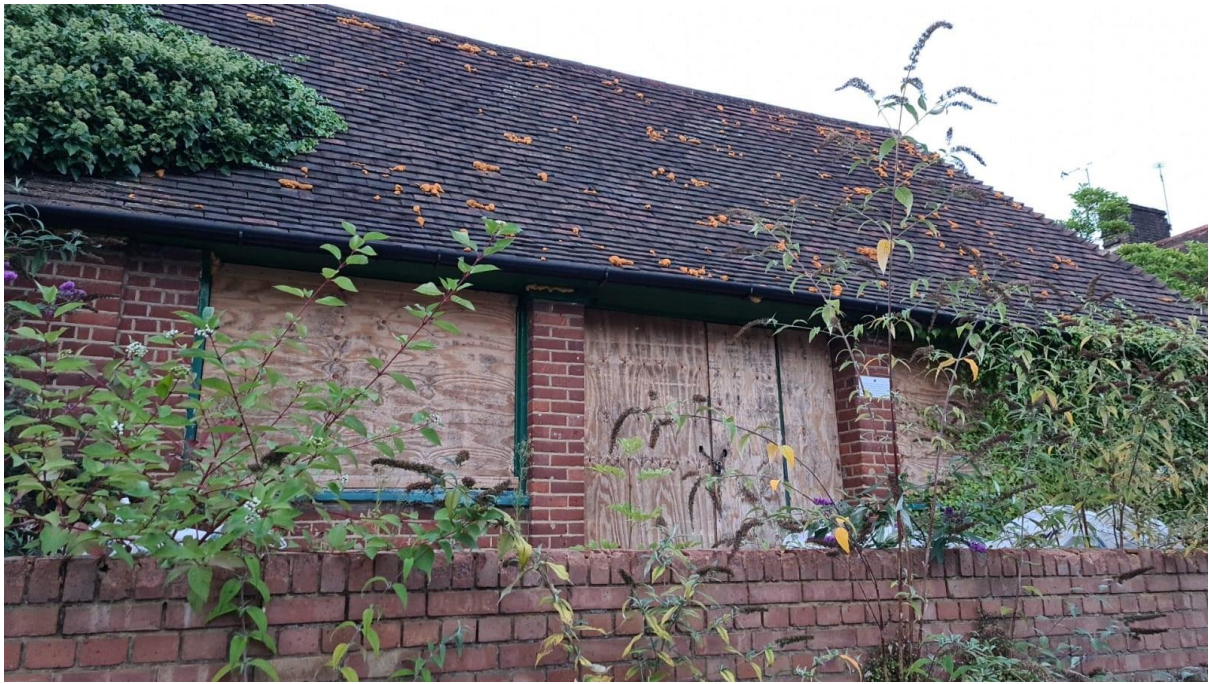
- 4.5 The update inspection on the 24<sup>th</sup> September included a detailed internal inspection of the main roof void, which was not accessible during the initial PEA. The inspection, undertaken by a licensed bat worker, did not identify any bats or evidence of bats. The roof was lined with bitumastic felt but a type of expanding foam had been used throughout the roof void, infilling all possible gaps between the tiles, felt and along the timber rafters and at eaves level.
- 4.6 As such, whilst the building had previously been assessed as having potential for bats, following the update inspection, it was regraded to having negligible potential for bats.

**Plate 1 External view of The Pavilion (foam can be seen across the roof line)**

- 5.1 The surveys did not identify any bat roosts within the building or off-site tree. In addition, following the update inspection, the building was reassessed as being of negligible value for bats due to the presence of the internal foam that has rendered the building as inaccessible and removing any potential roosting opportunities between the tiles. Therefore, although the surveys were constrained due to the lack of access to the rear of the property, this is no longer considered to be a limitation given that the building does not offer potential for bats.
