# Technical Note

**Project:** Phase 3, Clarendon Road, Hornsey

**Subject:** Blocks D1 and D2 Verification Report

**Date:** July 2023

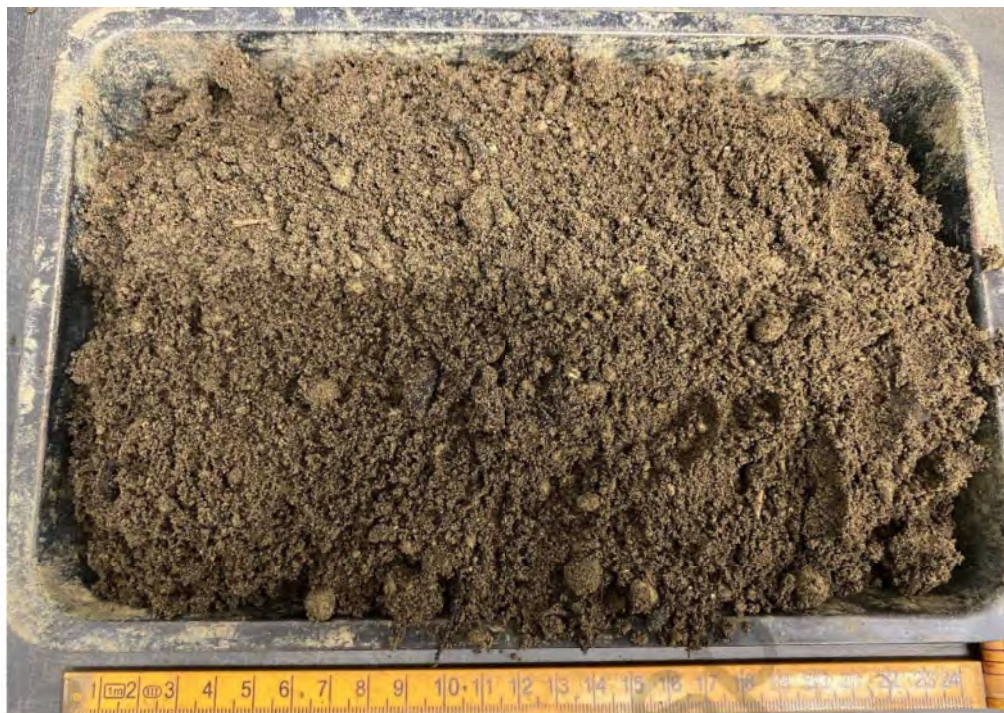
*Plate 1: Topsoil 2: 65/35 Blend Sample*

The sample fell into the *sandy loam* texture class. However, further detailed particle size analysis revealed the sample to have a high proportion of particles in the *very fine* (0.05-0.15mm) fraction. Topsoils such as this are prone to self-compaction when initially placed in a landscape environment, which can lead to limited drainage and poor aeration, particularly if the soil does not display a well-defined structure. To reduce the risk of self-compaction, we recommend placing this soil to a maximum depth of 300mm, which is in line with BS3882:2015, section A.3.

- the topsoil is placed to a maximum depth of 300mm;
- the soil's physical condition is satisfactory and compaction is avoided.

It is important to maintain the physical condition of the soil and avoid structural damage during all phases of soil handling (e.g. stockpiling, resspreading, cultivating, planting, seeding or turfing). As a consequence, soil handling operations should be carried out when soil is reasonably dry and non-plastic (friable) in consistency.

It is important to ensure that the soil is not unnecessarily compacted by trampling or trafficking by site machinery, and soil handling should be stopped during and after heavy rainfall and not continued until the soil is friable in consistency. If the soil is structurally damaged and compacted at any stage during the course of soiling or landscaping works, it should be cultivated appropriately to relieve the compaction and to restore the soil's structure prior to any planting, turfing or seeding.

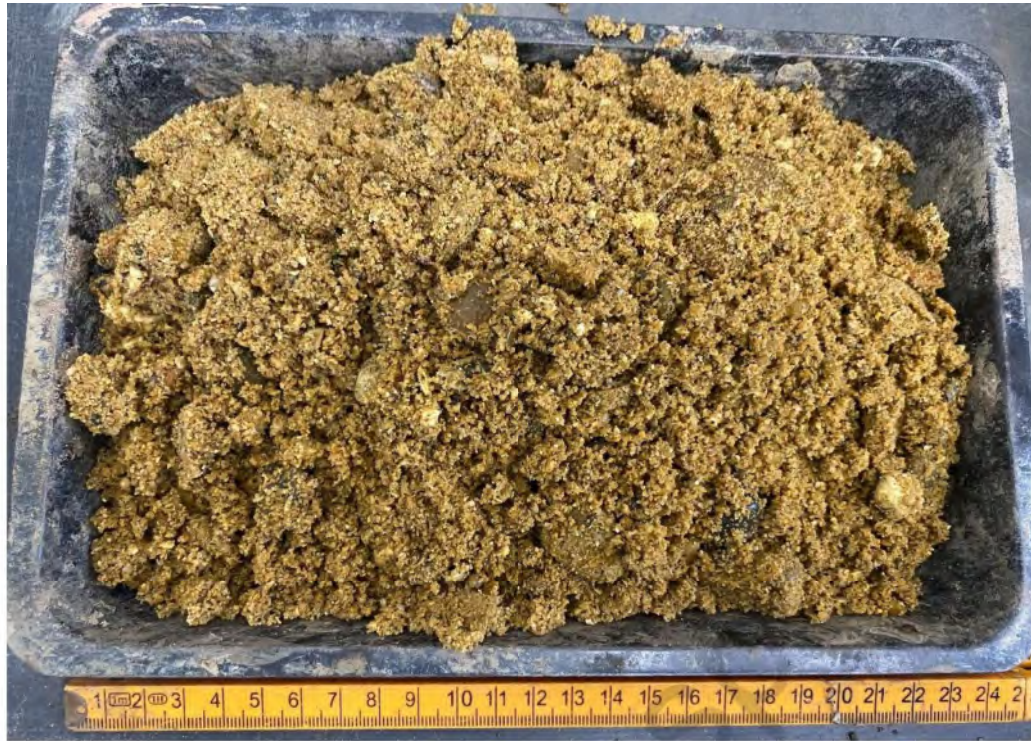
The sample was described as a yellowish brown (Munsell Colour 10YR 5/6), moist, friable, non-calcareous SAND with a single grain structure. The sample was moderately stony, comprising stones up to 35mm in size, and no unusual odours, deleterious materials, roots or rhizomes of pernicious weeds were observed.

*Plate 1: Landscape Subsoil Sample*

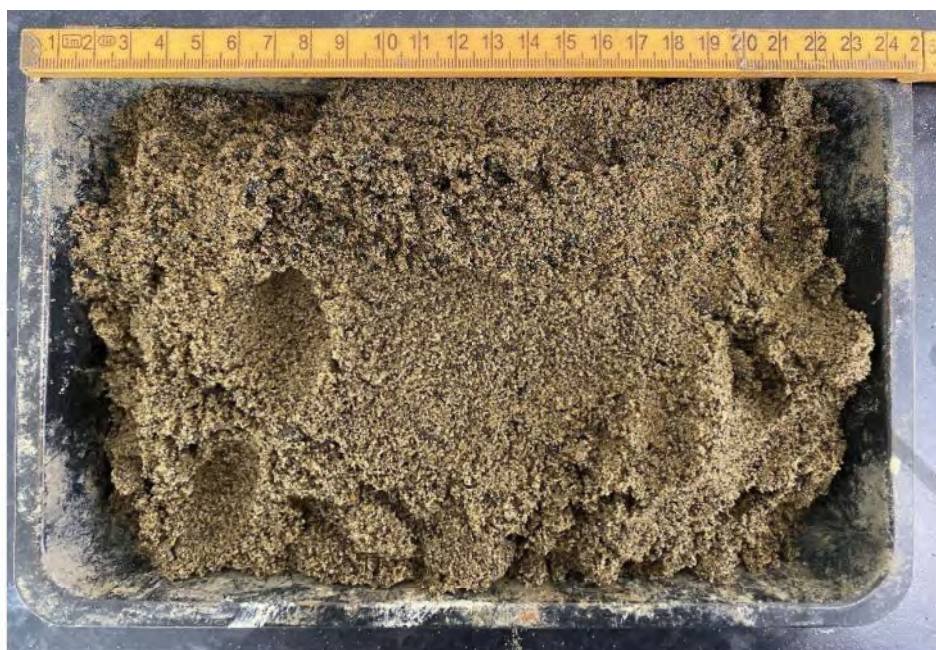
The sample was described as a dark yellowish brown (Munsell Colour 10YR 4/4), slightly moist, friable, non-calcareous SAND with a single grain structure. The sample was virtually stone free and contained a moderate proportion of organic fines. No unusual odours, deleterious materials, roots or rhizomes of pernicious weeds were observed.

Plate 1: Rootzone 80/20 sample

The sample fell into the *sand* texture class. Further detailed particle size analysis found the sample to have a narrow particle size distribution with a predominance of *medium sand* (0.25-0.50mm) and a smaller proportion of *coarse sand* (0.50-1.0mm). This is acceptable for rootzone to be used in high-use grass areas as sufficient porosity levels are maintained in a compacted state and the risk of particle interpacking and surface smearing is minimised.

The sample was strongly alkaline in reaction (pH 8.4). This pH value would be considered suitable for lawn establishment providing grass cultivars are tolerant of alkaline soil conditions.

To conclude, based on our findings, the topsoil represented by this sample may be considered suitable for use as a lawn rootzone provided the physical condition of the topsoil is satisfactory.

The total sand content of the soil and its grading is likely to result in a growing medium which is prone to droughty conditions without supplementary irrigation. The organic matter content of the topsoil (6.1%) should aid in mitigating these risks and help improve the water and nutrient retention of the topsoil, however provision for automatic irrigation should be made, particularly in the drier months.

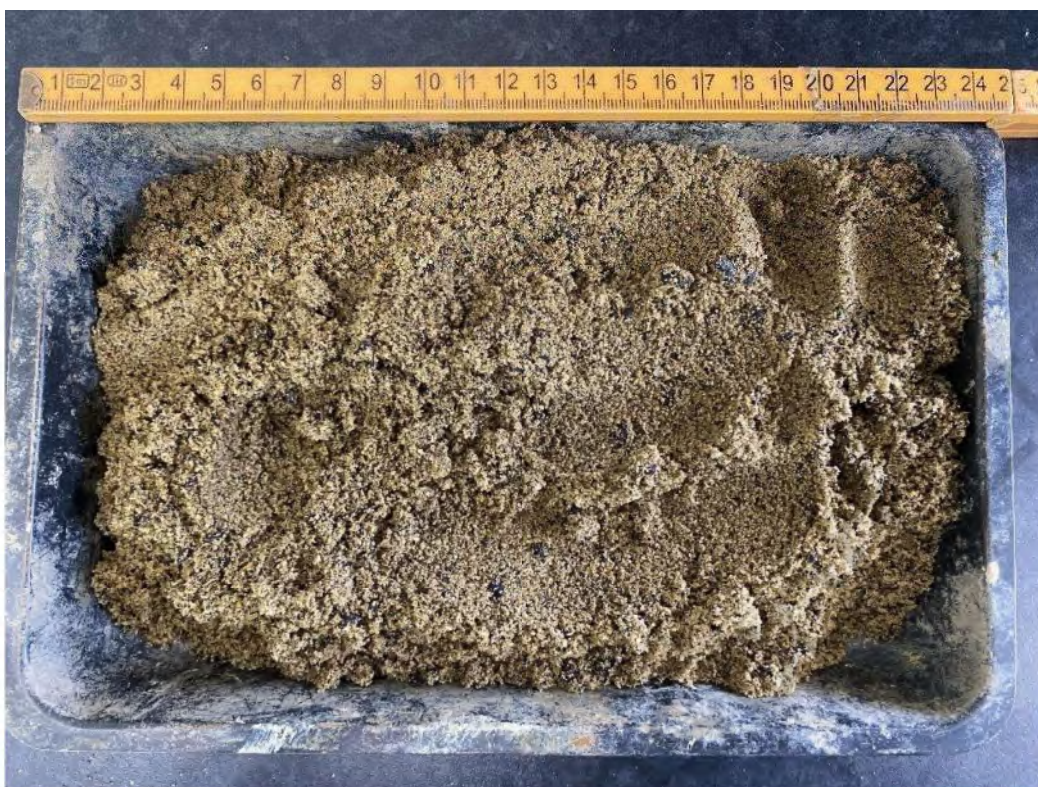
The sample was described as a dark yellowish brown (Munsell Colour 10YR 4/6), slightly moist, friable, non-calcareous SAND with a single grain structure. The sample was virtually stone free and contained a low proportion of organic fines. No unusual odours, deleterious materials, roots or rhizomes of pernicious weeds were observed.

*Plate 1: Lawn Topsoil sample*

The sample fell into the *sand* texture class. Further detailed particle sized distribution found the sample to have a narrow particle size distribution with a predominance of *medium sand* (0.25-0.50mm) and a smaller proportion of *coarse sand* (0.50-1.0mm). This is acceptable for high-use grass areas as sufficient porosity levels are maintained in a compacted state and the risk of particle interpacking and surface smearing is minimised.

The sample was strongly alkaline in reaction (pH 8.3). This pH value would be considered suitable for lawn establishment providing grass cultivars are tolerant of alkaline soil conditions.

To conclude, based on our findings, the topsoil represented by this sample would be considered suitable for use as a lawn topsoil in amenity grass areas provided the physical condition of the topsoil is satisfactory.

The total sand content of the soil and its grading may result in a growing medium which is prone to droughty conditions without supplementary irrigation. The organic matter content of the topsoil (7.0%) should aid in

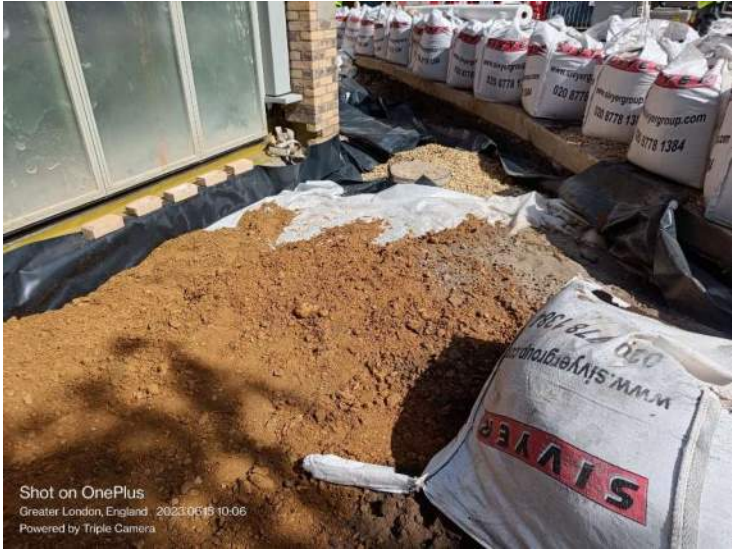
| Photo No. | Date: | |
|---|---|---|
| 1 | 15/06/23 | |

| Photo No. | Date: | |
|---|---|---|
| <b>Description:</b><br><br>Installation of Marker Layer in Zone 2 with overlying sub soil. | | <p>Shot on OnePlus<br/>Greater London, England 2023.06.15 10:06<br/>Powered by Triple Camera</p> |

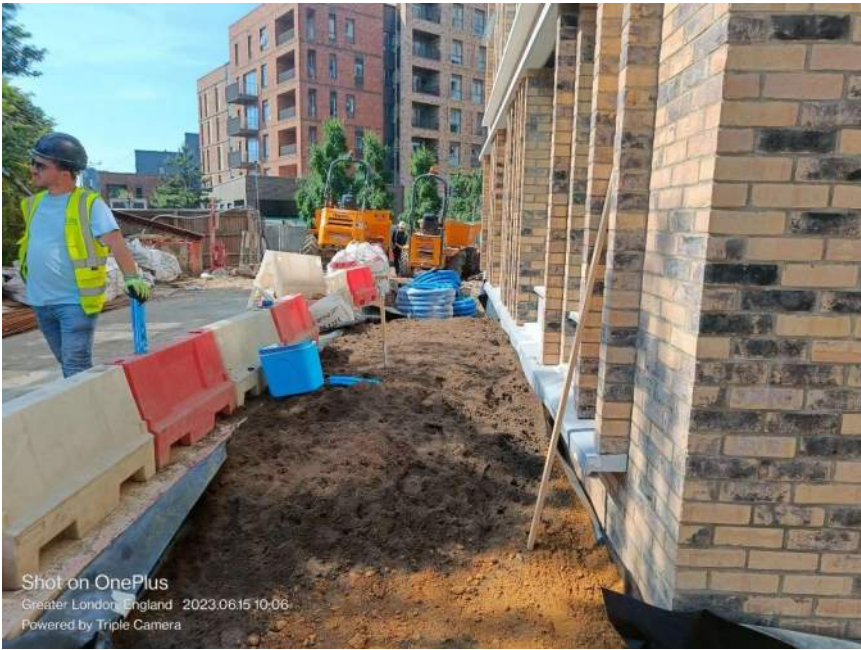
| Photo No. | Date: | |
|---|---|---|
| 2 | 15/06/23 | |

| Photo No. | Date: | |
|---|---|---|
| <b>Description:</b><br><br>Placed subsoil and top soil in Zone 2 | | <p>Shot on OnePlus<br/>Greater London, England 2023.06.15 10:06<br/>Powered by Triple Camera</p> |

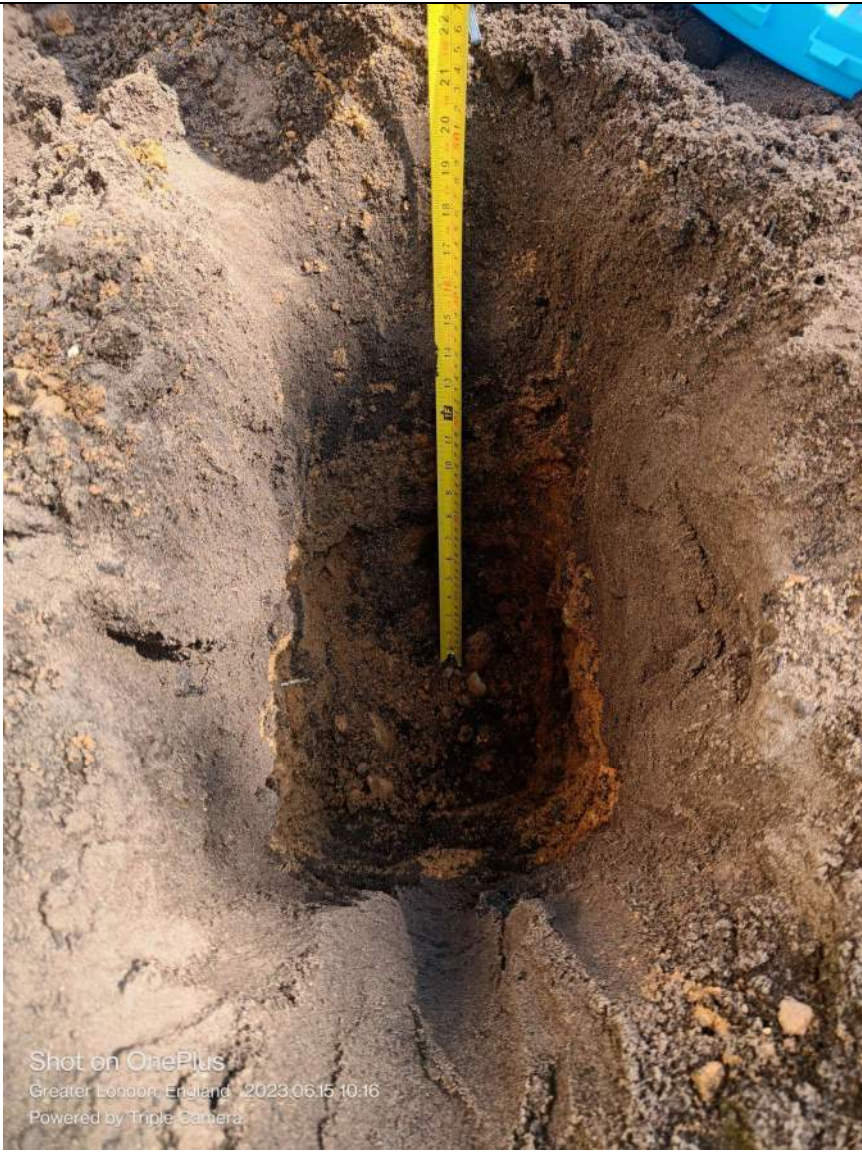
| Photo No.<br>3 | Date:<br>15/06/23 | |

Placed materials were broadly compliant with the depths detailed in Section 3 and Marker Layer was present at a minimum depth of 600 m bgl. However, the topsoil had not been fully placed and a further 100 mm was scheduled to be placed to bring the surface to finish levels. No visual or olfactory evidence of contamination were observed. CBL materials provided by H Sivyer Transport Ltd and sourced from South East Angerstein. Additionally it was noted that the shingle CBL layer was installed below the Marker Layer rather than above it, as detailed within the Remediation Method Statement [2]. This was to allow a full thickness of 600 mm of topsoil and subsoil to be placed and is not considered have any impact on potential risks to future users or the environment.

| <b>Description:</b><br><br>D1-D2 HPT01 including showing topsoil overlying subsoil. Marker Layer observed but not visible in photo. | | |

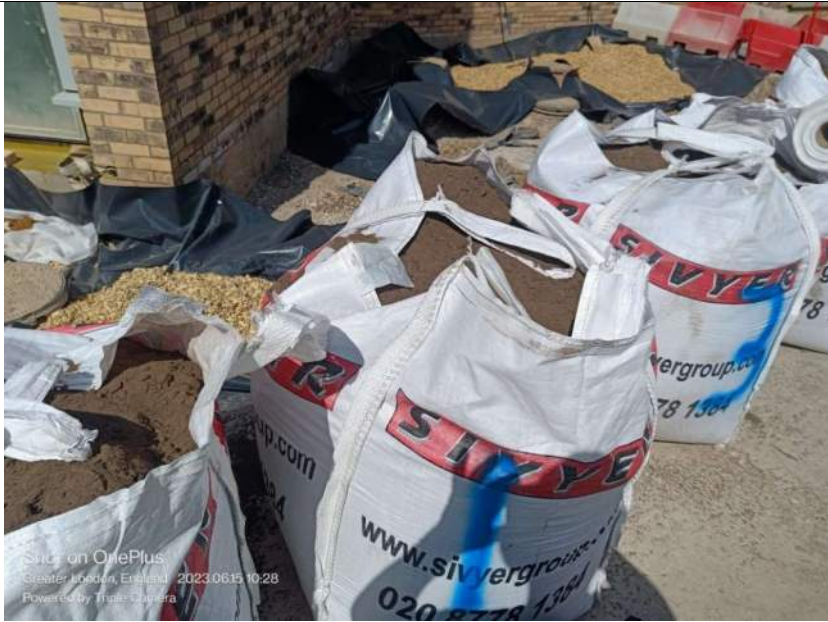
| Photo No.<br>4 | Date:<br>15/06/23 | |

| <b>Description:</b><br><br>D1-D2 Top Soil for<br>Zone 1 and 3. | | |

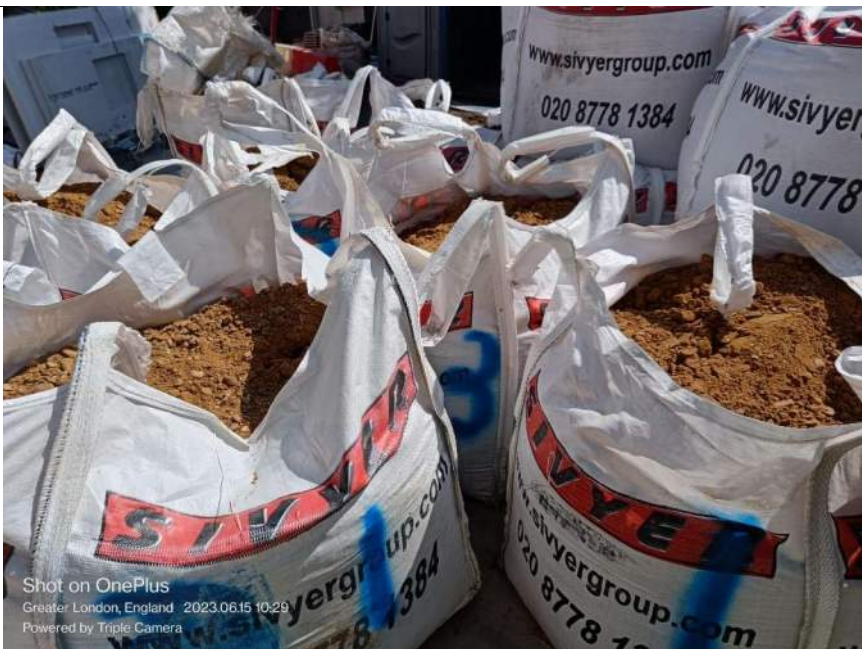
| Photo No.<br>5 | Date:<br>15/06/23 | |

| <b>Description:</b><br><br>D1-D2 Sub soil for<br>Zone 1 and 3. | | |

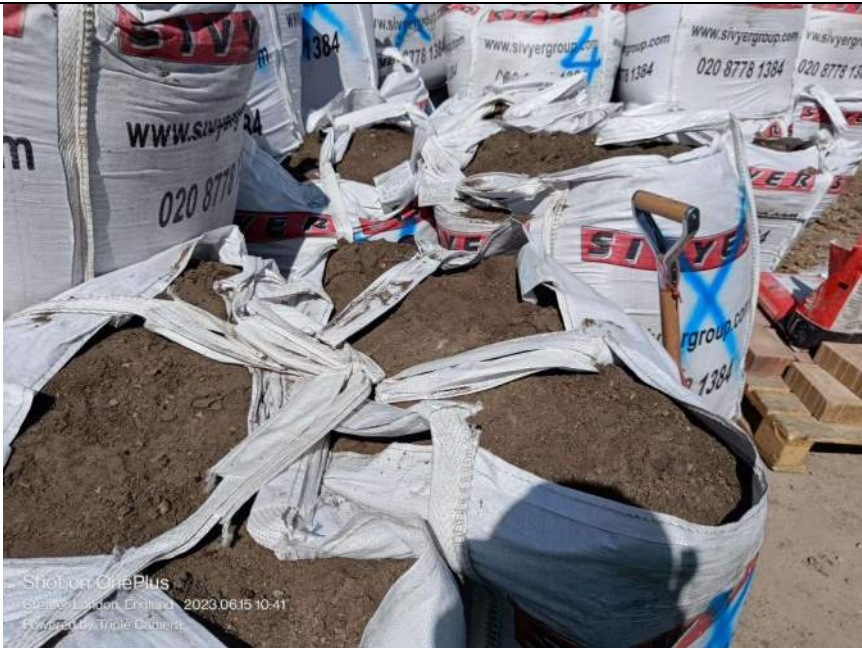
| <b>Photo No.</b><br>6 | <b>Date:</b><br>15/06/23 | |

| <b>Description:</b><br><br>D1-D2 Top soil for<br>Zone 4 and 5. | | |

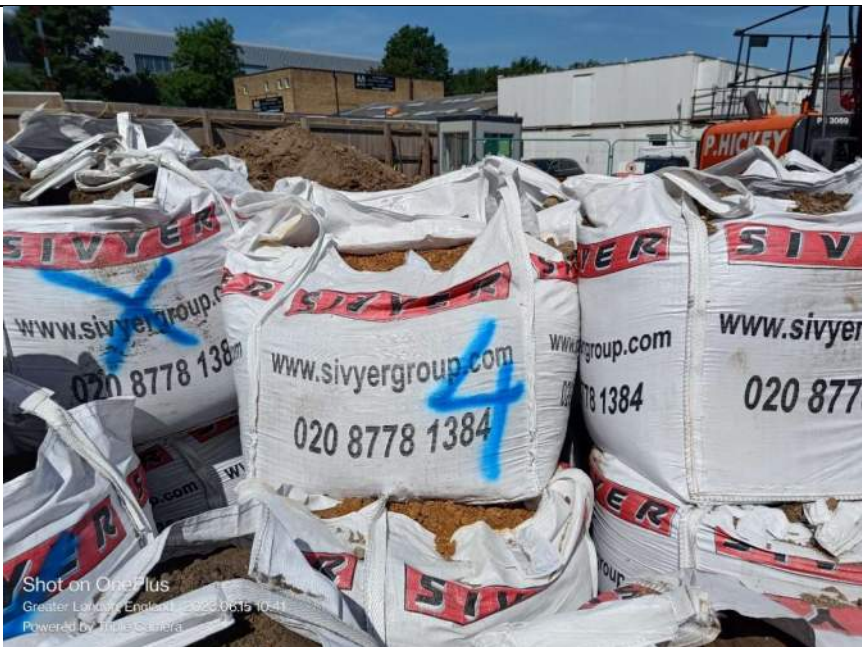
| Photo No.<br>7 | Date:<br>15/06/23 | |

| Description:<br><br>D1-D2 Sub soil for<br>Zone 4 and 5. | | |

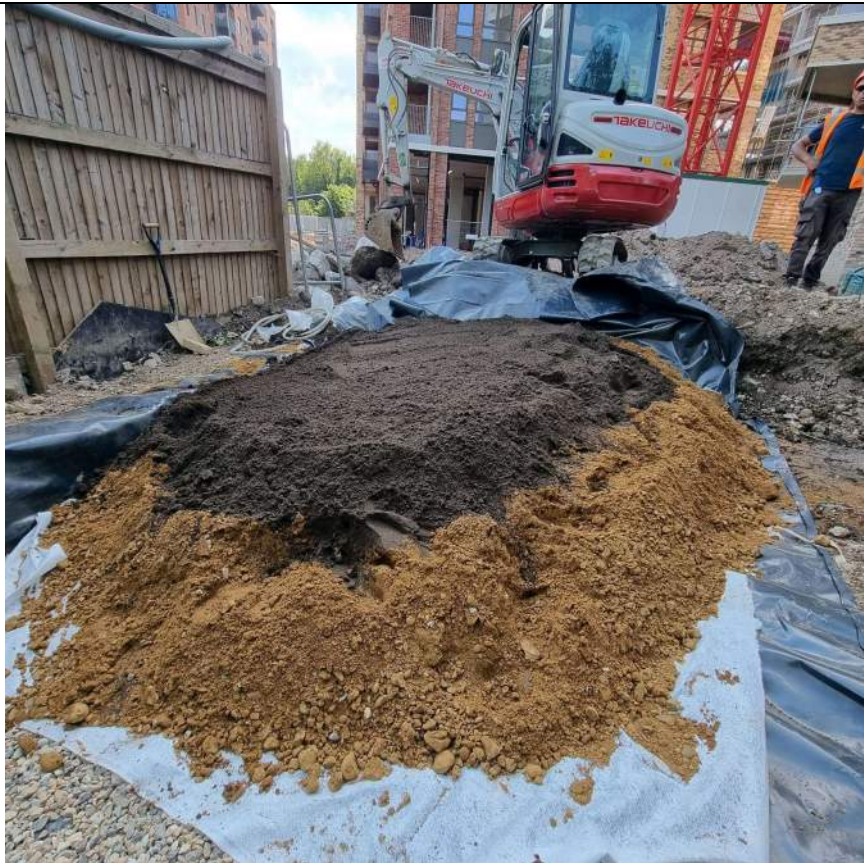
| 8 | 15/06/23 | |

| <b>Description:</b><br><br>D1-D2 Sub soil for Zone 1 installed Marker Layer, sub-soil and top soil. (Photo from contractor) | | |

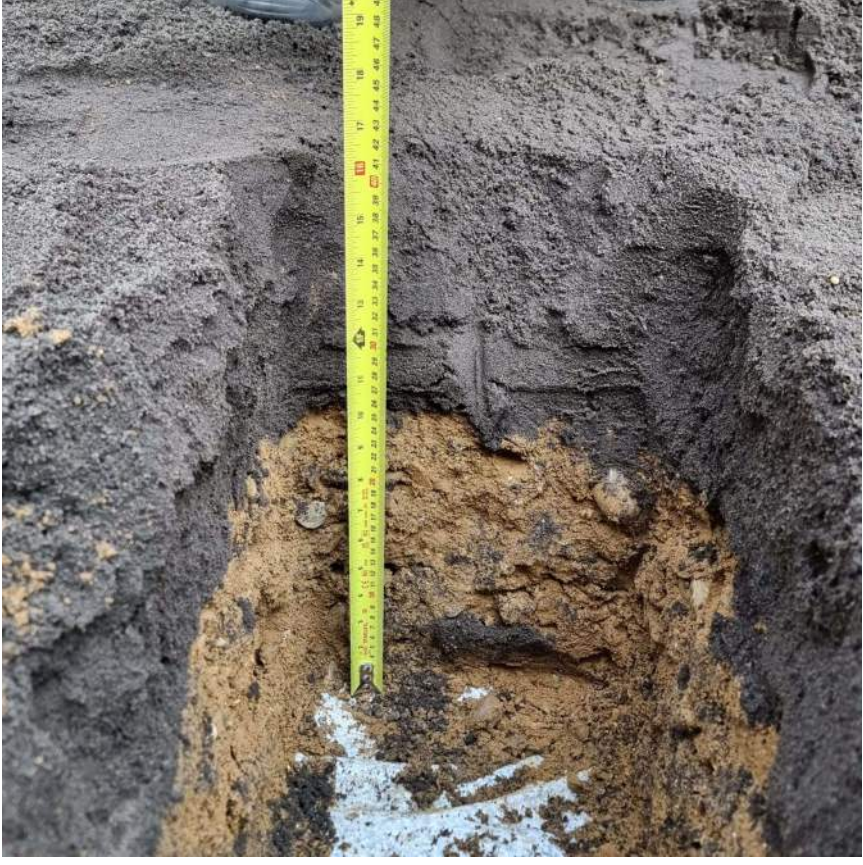
| Photo No. | Date: | |
|---|---|---|
| 9 | 15/06/23 | |

| Photo No. | Date: | |
|---|---|---|
| D1-D2 Sub soil for Zone 1 hand pit. installed Marker Layer, sub-soil and top soil, pending an additional 200 mm top soil to be placed by the contractor. (Photo from contractor) | | |

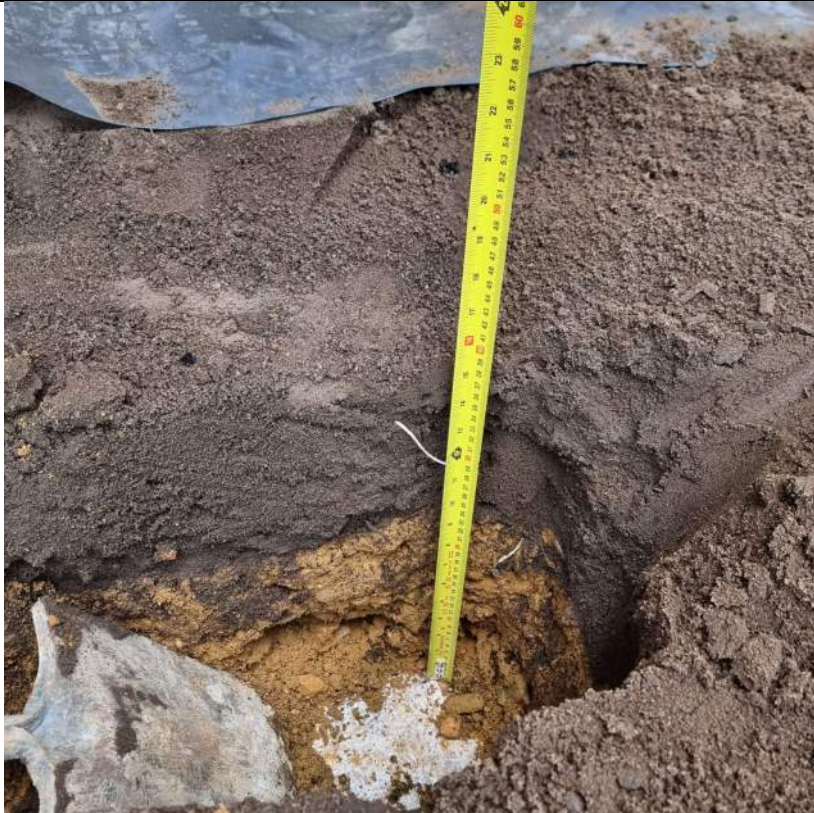
| Photo No.<br>10 | Date:<br>16/06/23 | |

| <b>Description:</b><br><br>D1-D2 Sub soil for<br>Zone 3 hand pit.<br>installed Marker Layer,<br>sub-soil and top soil.<br>(Photo from contractor) | | |

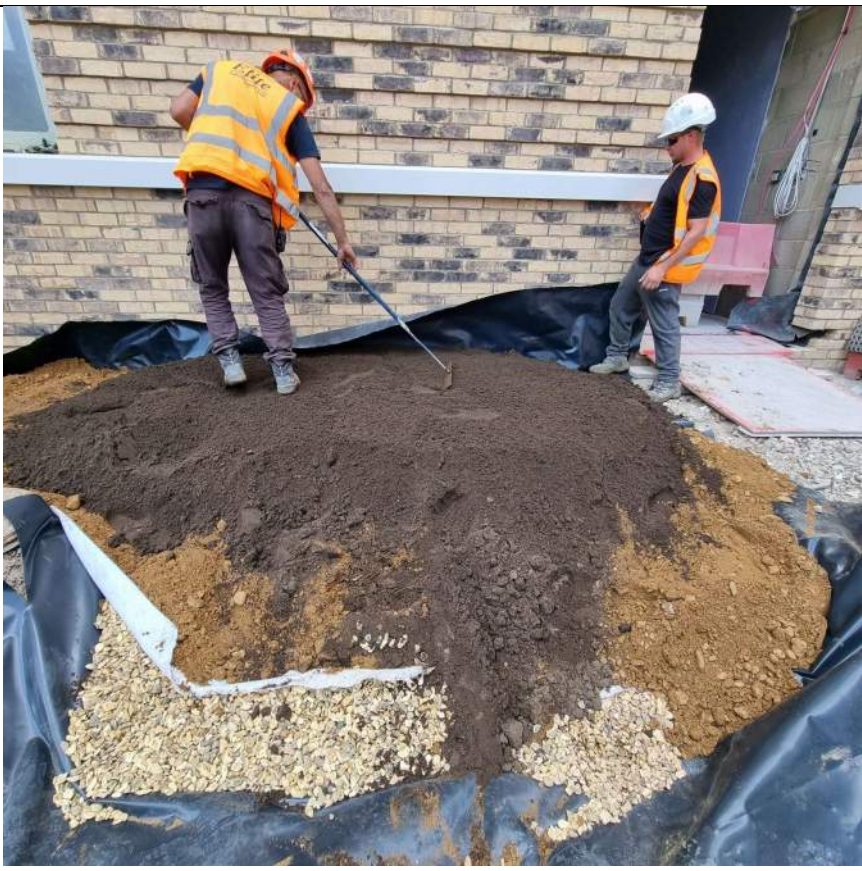
| Photo No.<br>11 | Date:<br>16/06/23 | |

| <b>Description:</b><br><br>D1-D2 Zone 3 installed Marker Layer, sub-soil and top soil. (Photo from contractor) | | |
