**PHASE 1 ENVIRONMENTAL REPORT**  
**of a site at**  
**CORNWALL ROAD, SOUTH TOTTENHAM**  
**for**  
**LONDON BOROUGH OF HARINGEY**

**Project No 2001**  
**Report ref: 2001-P1E-1-B**  
**Issued: 21 December 2020**  
**Revision: B**

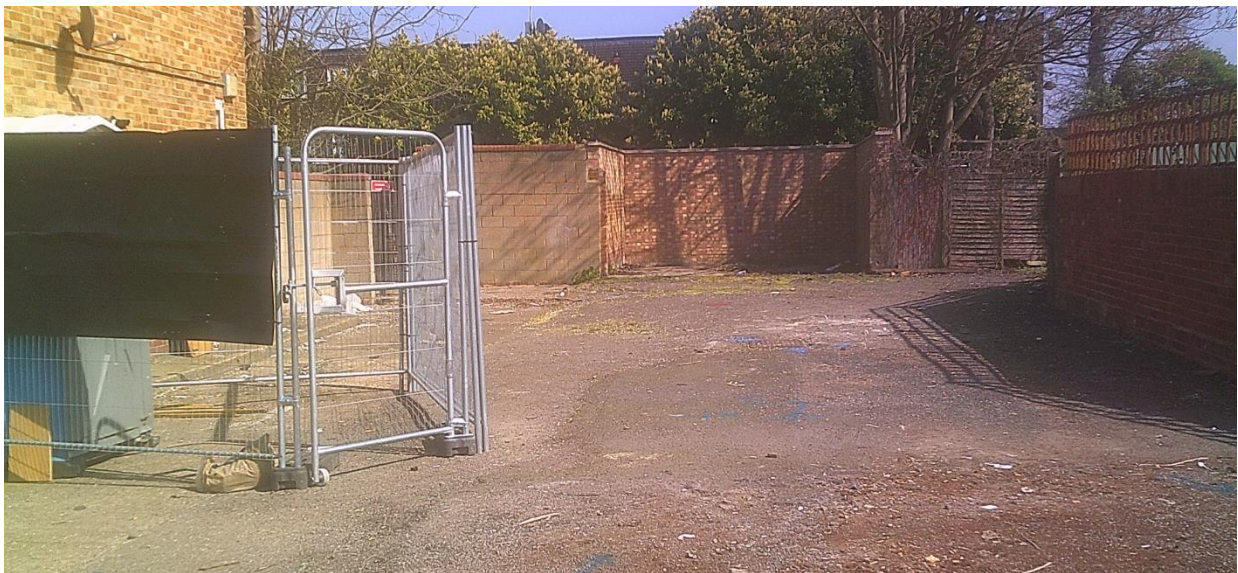
The site is separated into two sections. The western part of the site is generally flat with gentle downward gradients from south to north and from east to west. This part of the site is surfaced with blacktop and areas of concrete paving with manhole covers set in the surfacing. At the eastern edge is a concrete slab formerly the base of a garage block which is now partly demolished with the rear and flank walls remaining. In the southeast corner is an area occupied by the extended gardens of properties in Gorleston Road, which contains some mature trees. The eastern part of the site is flat and level and appears to have loose laid blacktop surfacing which has a covering of weeds and vegetation. There are planting beds along the east and west margins and with mature laurel trees in the eastern bed. There is a mature tree on the southern boundary and some self-planted saplings on the northern boundary.

**View looking east across western part of the site**

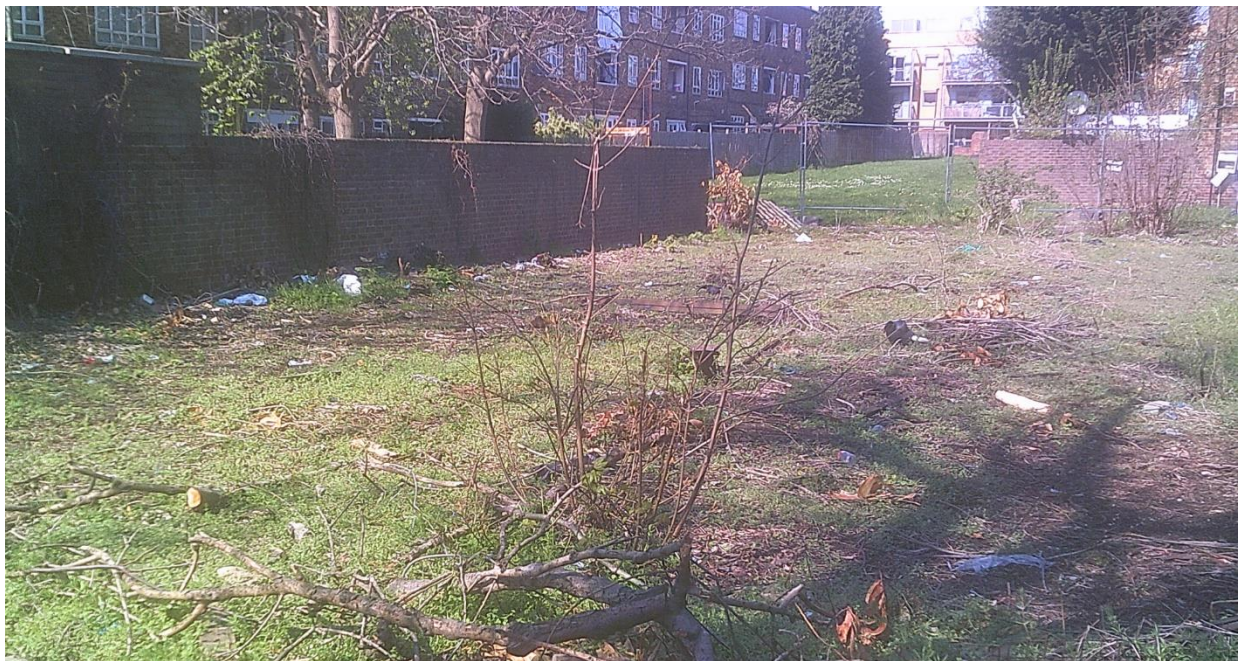
No visual or olfactory evidence of contamination was noted on the site.

**View looking north across eastern part of the site**

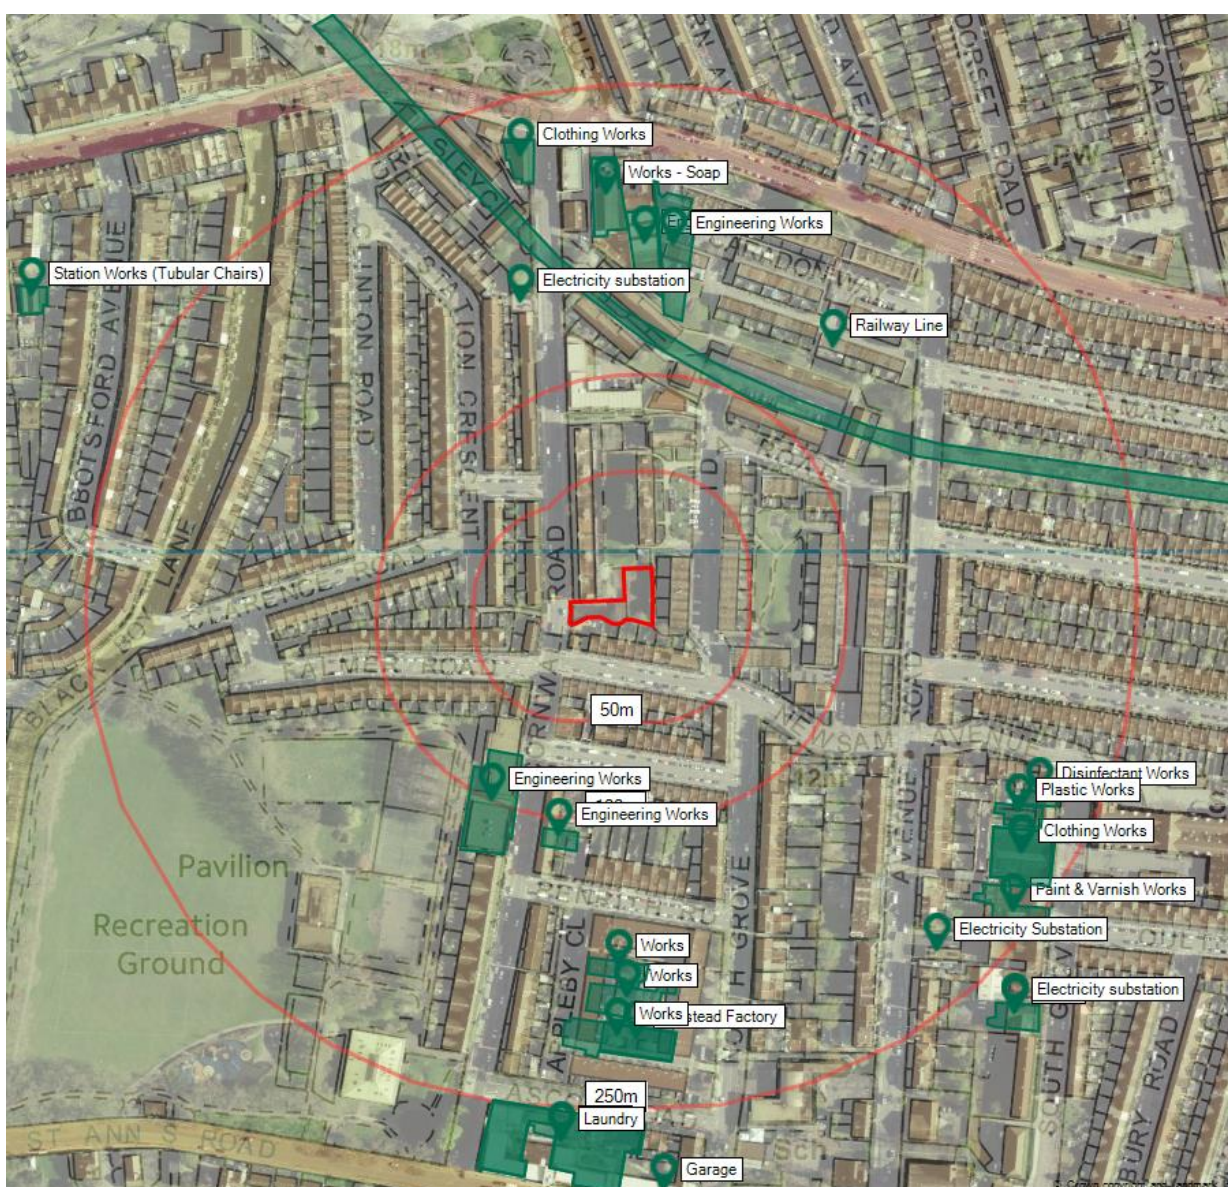
**Figure 2: Potential sources of contamination within 250m of the site**

Potentially contaminating commercial activities have been identified in the vicinity. The general topography falls to the south east. This is assumed to be the general direction of the hydraulic gradient, therefore sources to the north east and within the near vicinity are considered to have the most potential to impact the site. However, there are no sources to the north west within 250m that would potentially impact the site. Some sources to the north have been identified including three former works and an electrical substation, but it is considered that they are too far away to significantly impact the site. Furthermore, the site is not underlain by an aquifer and therefore migration of contaminants to site would only occur via the perched water table, which is considered to be unlikely.

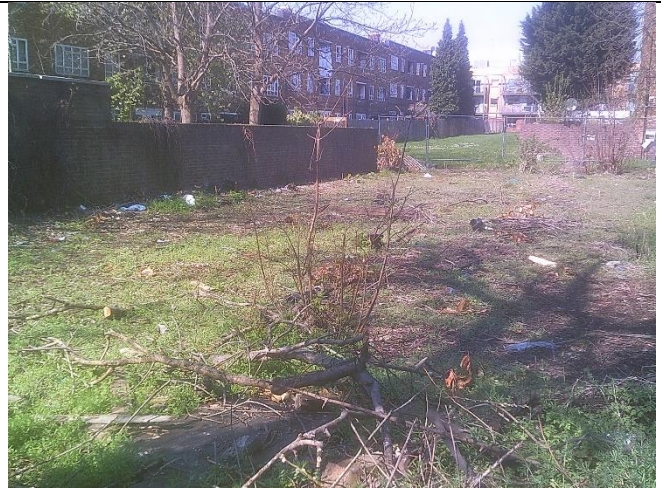
The only other change was on the eastern part of the site which was overgrown with weeds and brambles, some dumped domestic waste was noted and a small heap of asphalt, approximately 1m diameter.

View looking north west from south east corner of eastern part

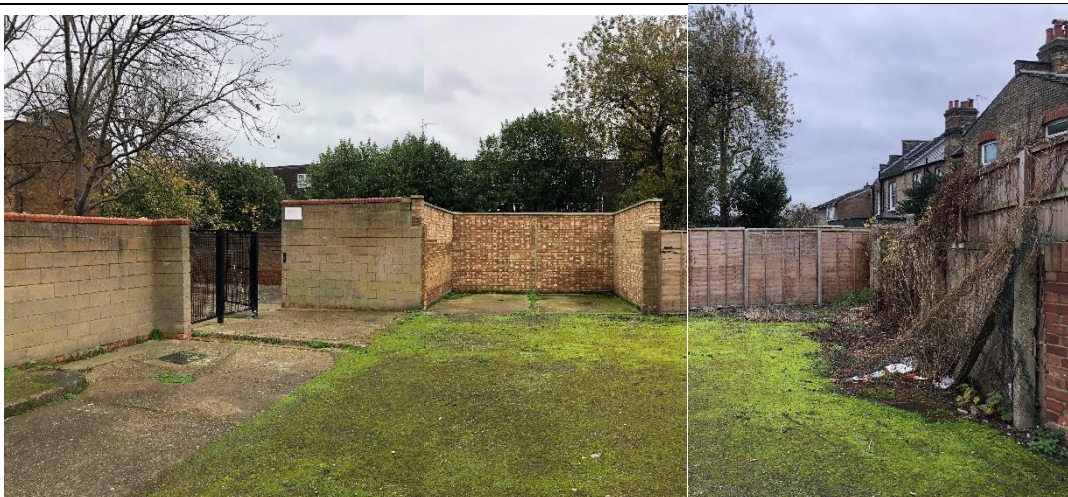
View East from West end of site showing garden fences extending across the Site

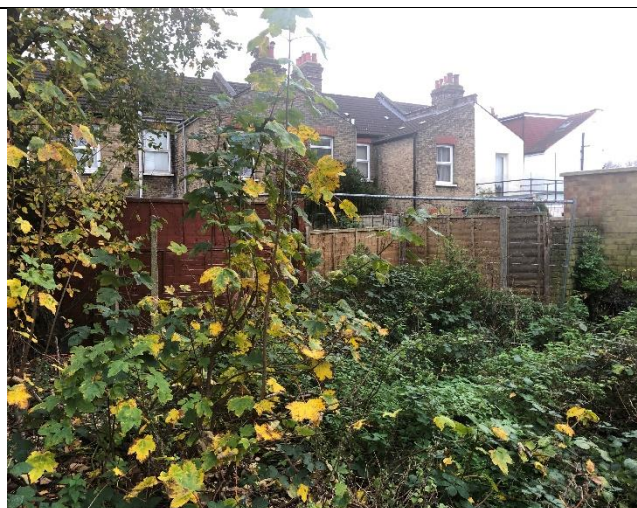
View Southwest into corner of east part of site showing garden fences extending into the Site

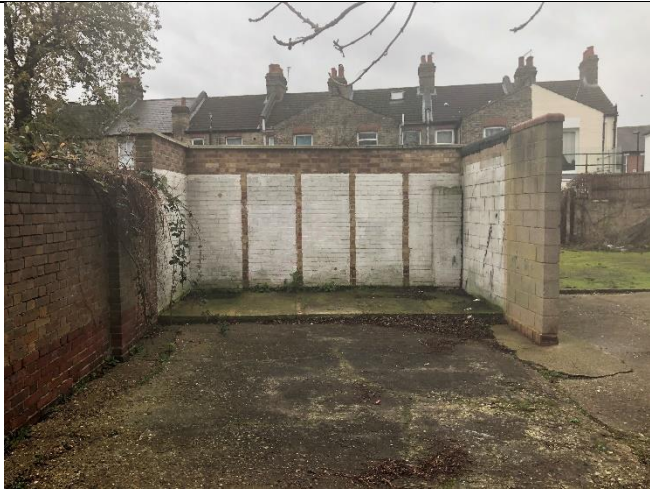
View South into brick structure in middle of Site
