**Tennis Courts adjacent to 38-  
84 Cornwall Road, Tottenham,  
London**

Arboricultural Survey

London Borough of Haringey

February 2020

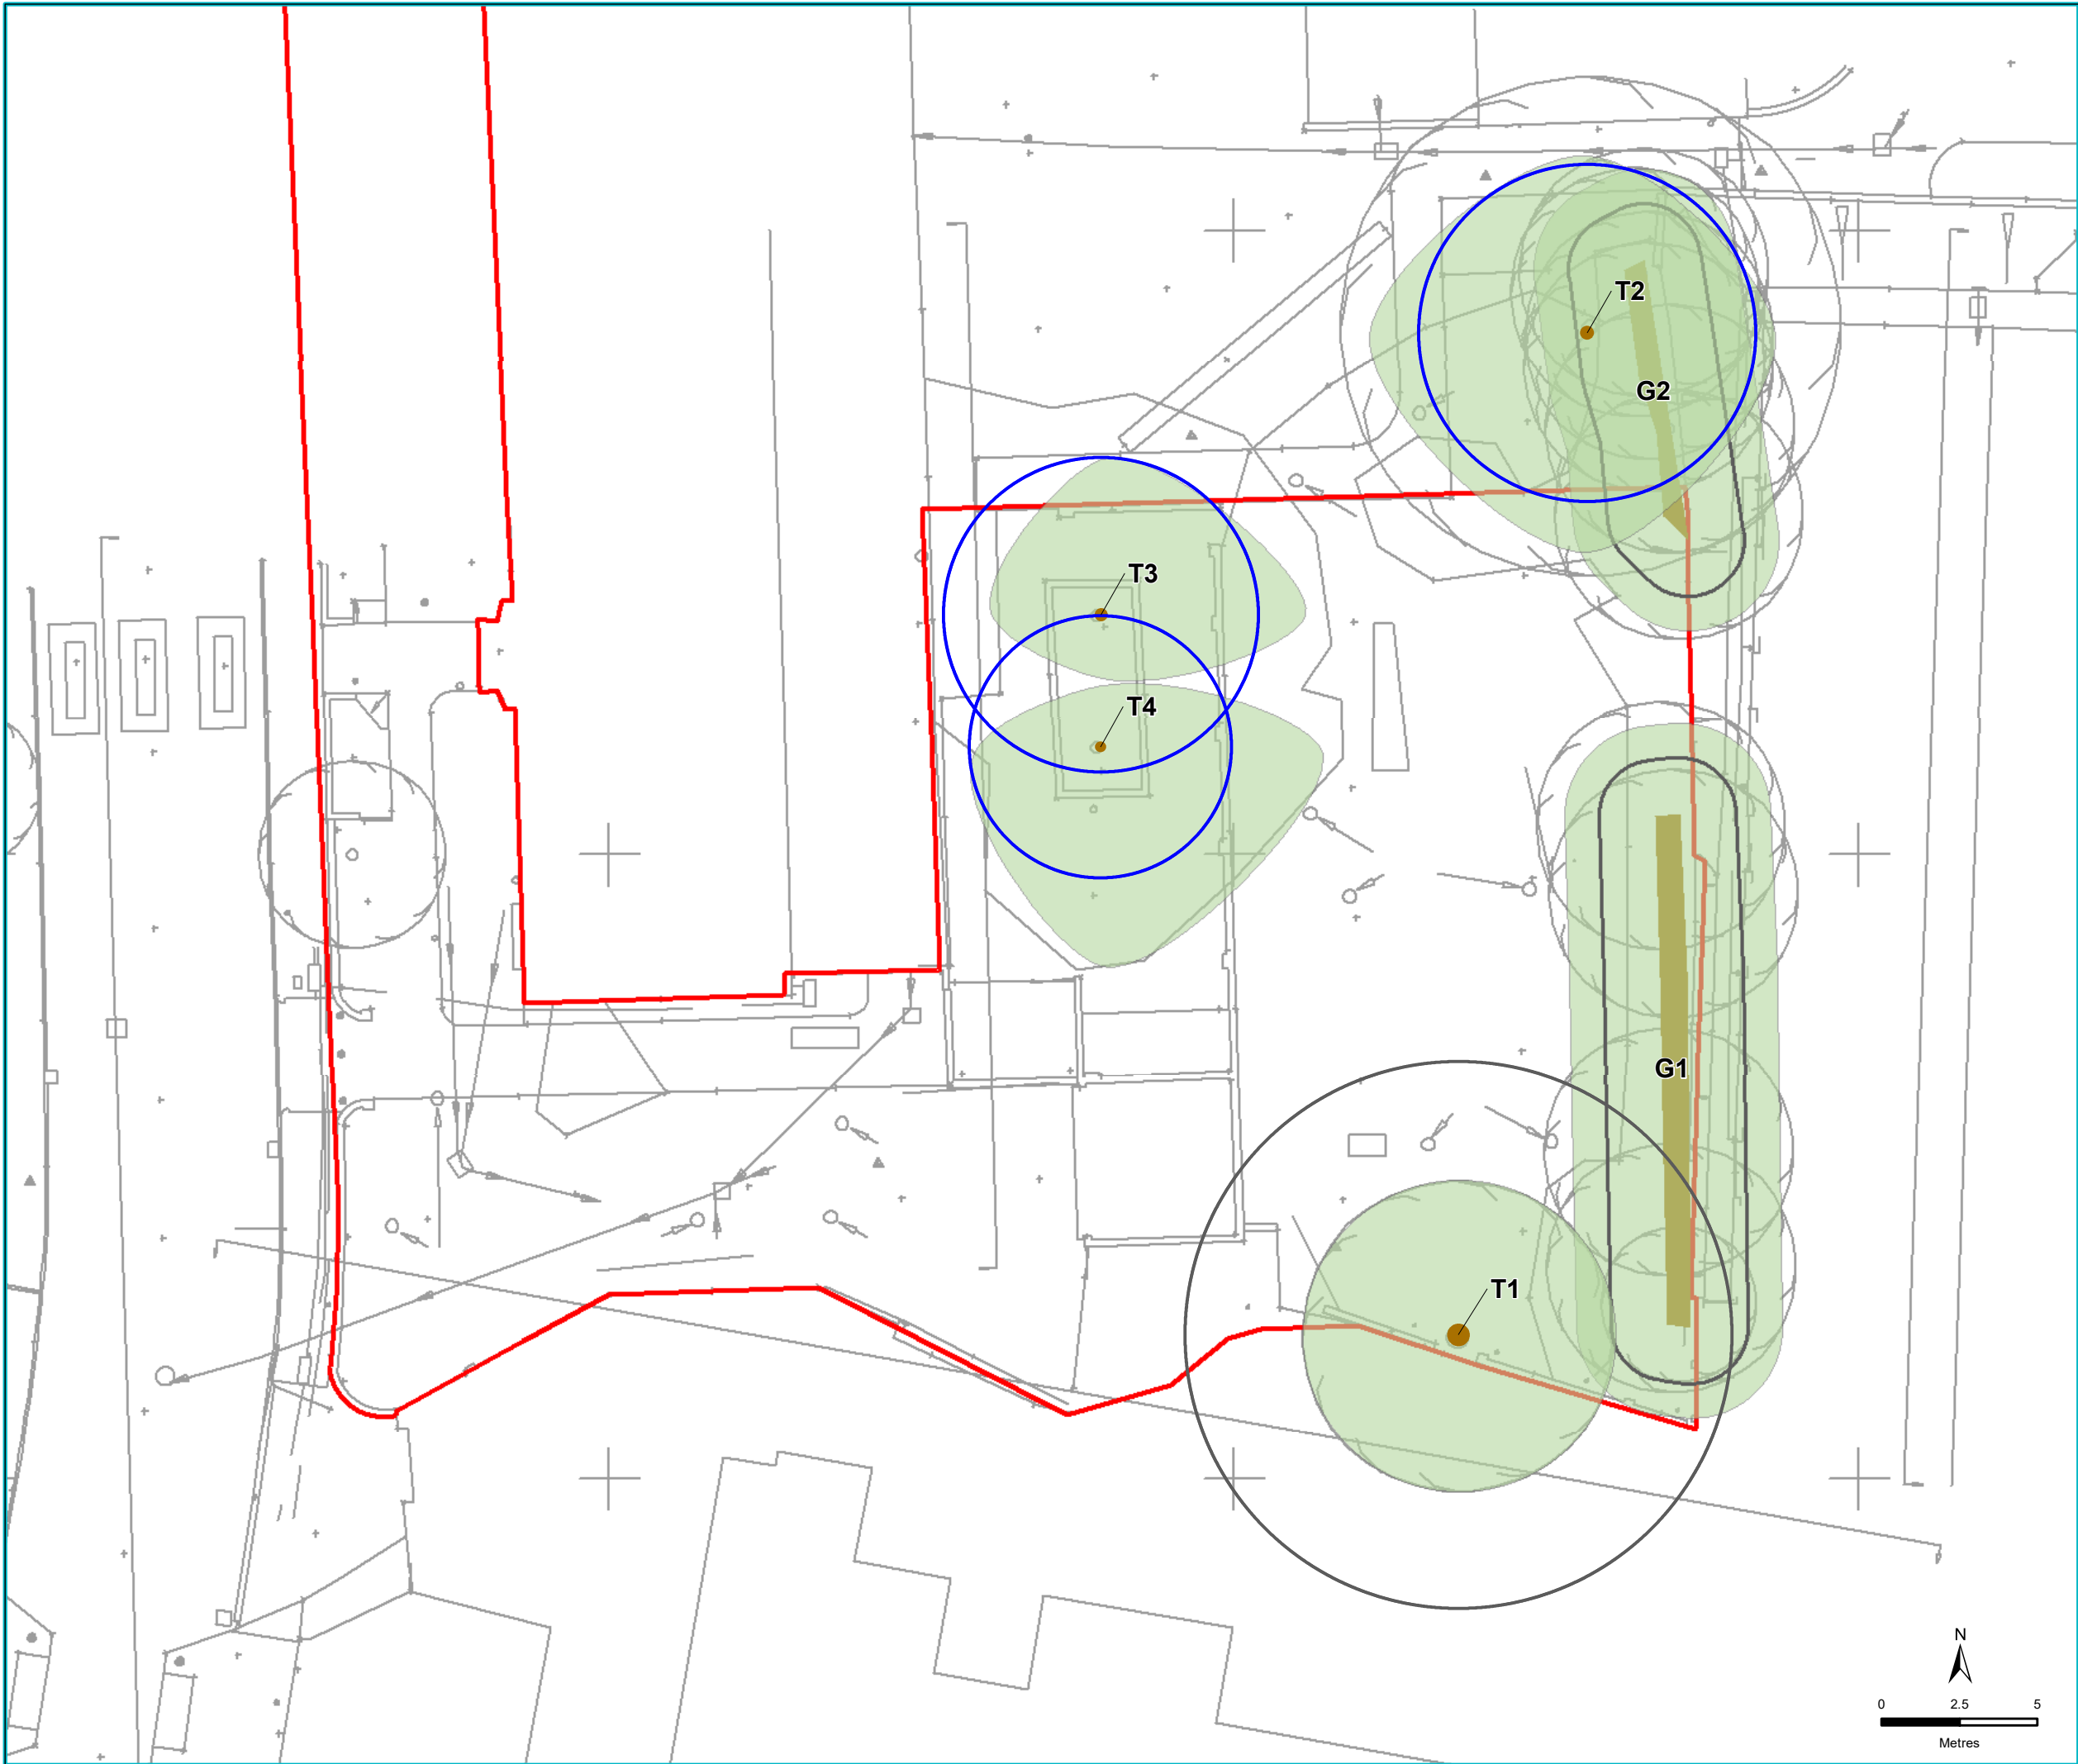
FIGURE 2: TREE CONSTRAINTS PLAN (TCP01)

- 1.1.4 A total of three Category B trees, one Category C tree and two Category C groups of trees were recorded within or adjacent to the site during the survey (see Figure 2) and are listed in the Tree Schedule (see Appendix 1).

- 4.2.2 The RPAs for the trees and groups surveyed can be seen in Figure 2. The actual RPAs, in m<sup>2</sup>, for the individual trees surveyed are shown in Appendix 1.

- 5.2.1 The three Category B trees T2, T3 and T4 are mature ash trees (*Fraxinus excelsior*) located between residential buildings in an area of green space. These trees provide screening between the blocks of flats enhancing the recreational area. The two trees T3 and T4 grow in a small raised planting bed made of brick which has failed and requires repair to prevent any damage being caused to the tree roots set behind the brick walls.

- 5.2.2 The Category C tree T1 is a mature goat willow (*Salix caprea*) located on the southern boundary which has been recently crown reduced. It provides good screening between the site and residential properties to the south and should be considered for retention. It shouldn't however, be considered a constraint to any development as its loss could be offset with compensatory planting along the southern boundary which would in time improve the quality of the screening.

- 5.2.3 The Category C groups of trees, G1 and G2, have undergone minor crown pruning and provide good screening between the site and flats to the east. They should be retained where possible which may require their crowns to be reduced to a more manageable height and spread.
