# GEOSHIELD Verification Report

Phase 3:Clarendon Road, GR DPC installation.

AREA SURVEYED: Threshold Detail - West Elevation - D1

REPORT NUMBER: 005

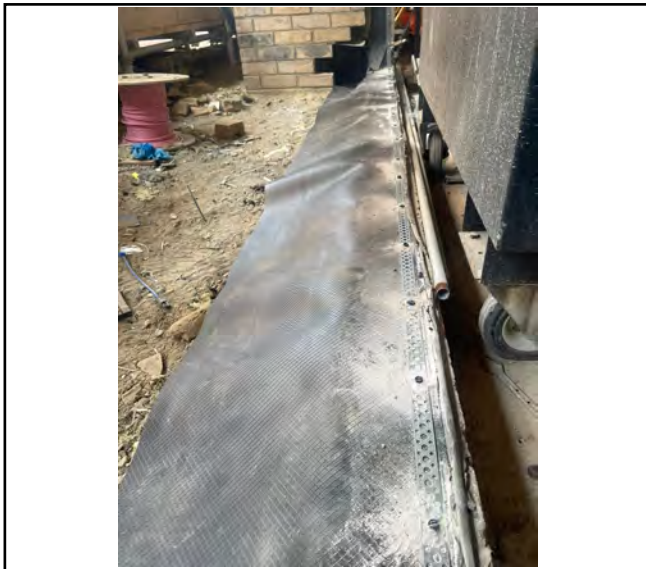
LOCATION/GRID LINE: Threshold Detail - West Elevation - D1

The threshold has been sealed on the west elevation of block D1. Pudlo DPC has

been installed to the threshold area and adhered to the previously installed Pudlo

Self Adhesive Membrane. Double sided butyl tape has been applied underneath the

Pudlo DPC, a termination strap has then been mechanically fixed through the Pudlo DPC and the double sided butyl tape applied to complete the seal. The first photograph above displays an overview of the sealed threshold. The second photograph highlights the double sided butyl tape beneath the termination strap.

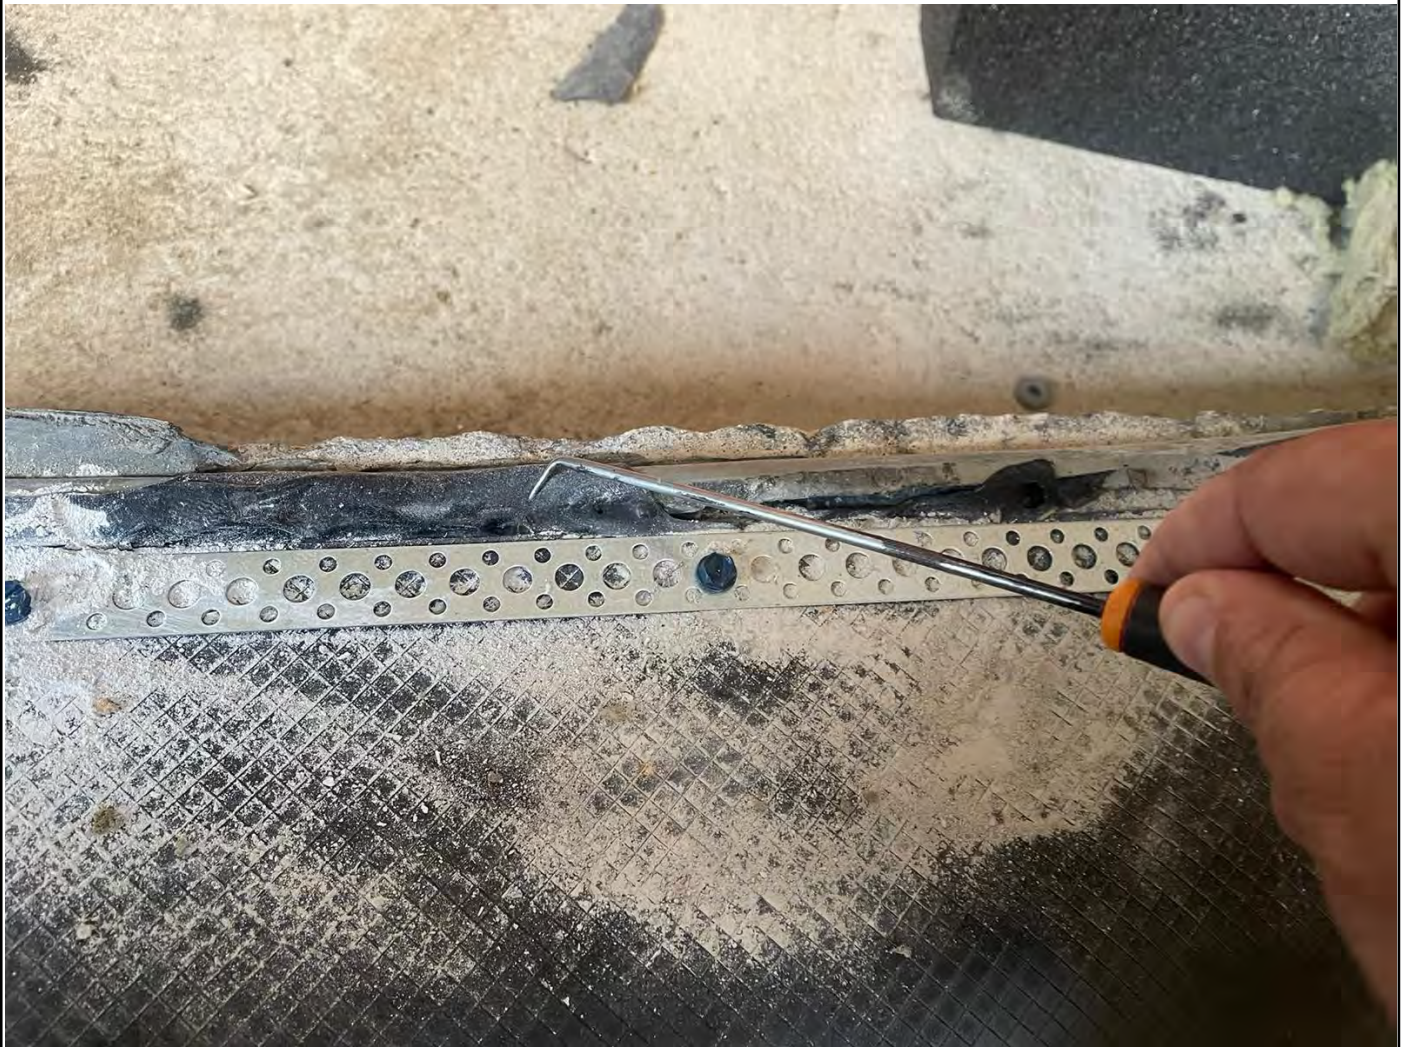
The photograph above displays a mechanical point stress test, also known as a pick and probe test, being conducted on the sealed threshold. A visual inspection and thorough pick and probe tests were carried out on all thresholds in the referenced area, no faults were identified. Tested and verified in accordance with CIRIA 735.

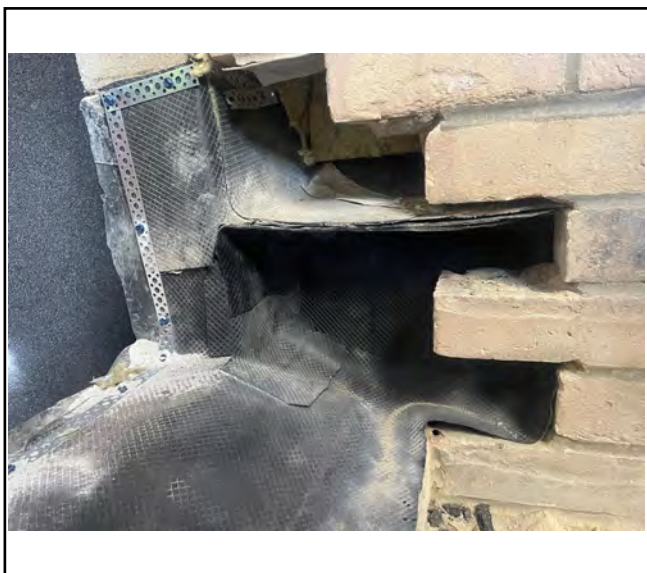
LOCATION/GRID LINE: Threshold Detail - West Elevation - D1

The Pudlo GR DPC has been taken across the threshold, up the cavity and sealed to the cavity tray. The installation has been sealed using double sided butyl tape and termination straps mechanically fixed. The first photograph below evidences the DPC

installed to the cavity tray. The second photograph displays a mechanical point stress test being carried out on the corner returns which has been sufficiently sealed by the qualified installers from Landmark Brickwork.

Tested and verified in accordance with CIRIA 735.

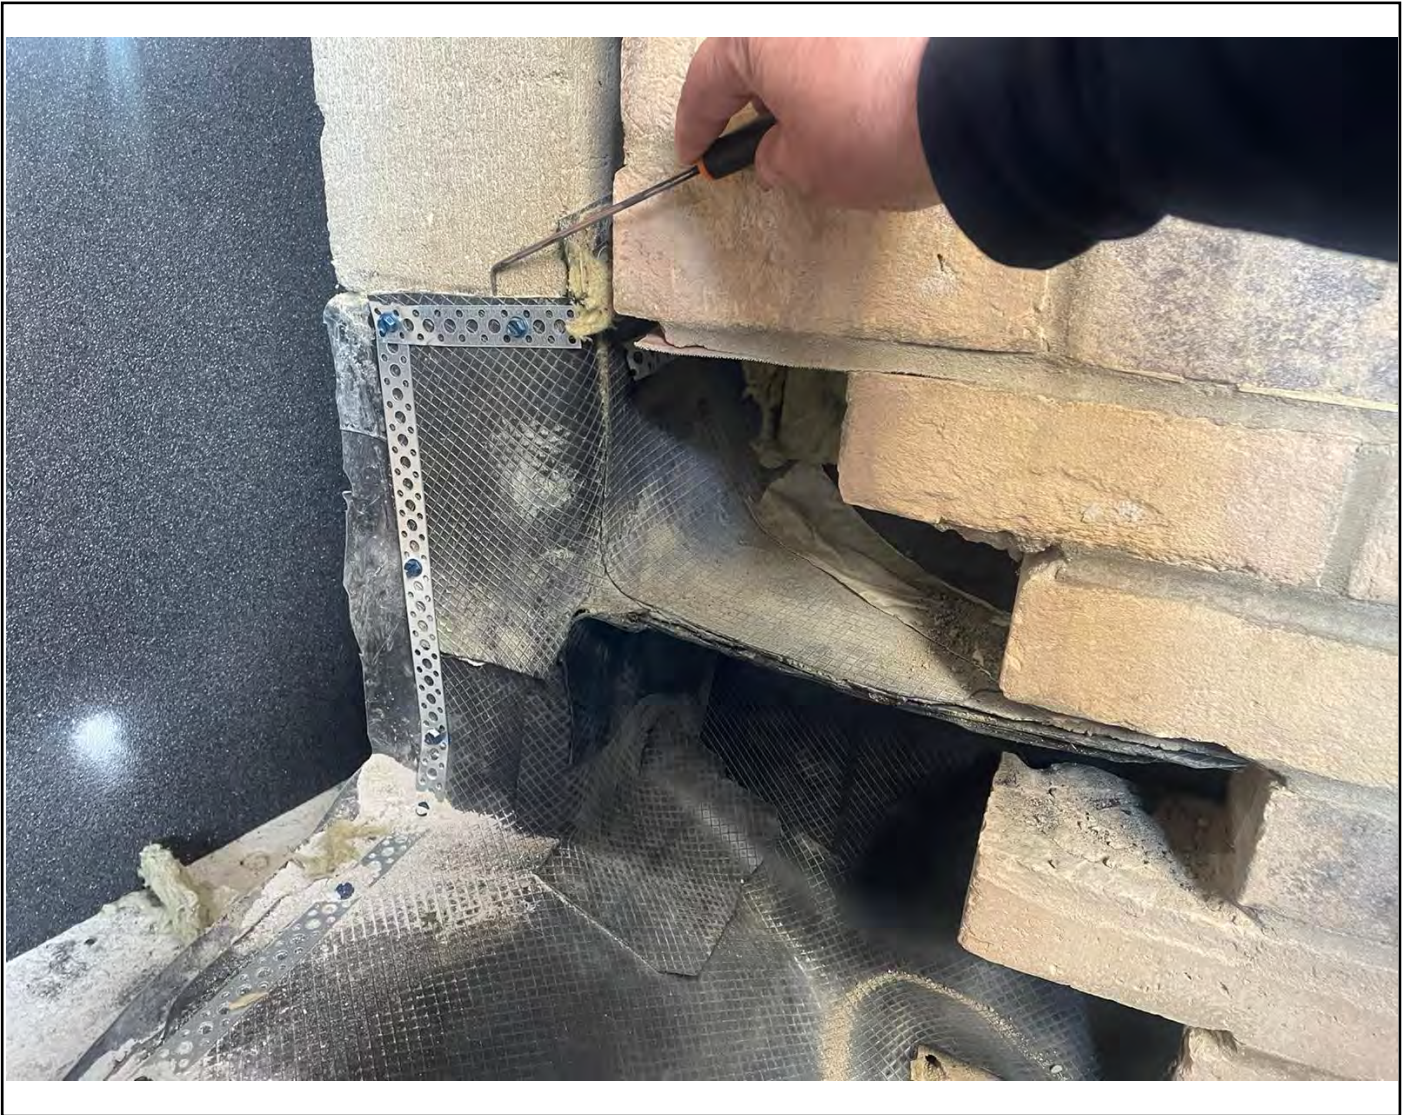
The photograph above displays a mechanical point stress test being carried out on the termination strap that has been installed up the cavity wall. The threshold detail has been successfully sealed to ensure a gas resistant seal is achieved throughout the installation. Tested and verified in accordance with CIRIA 735.

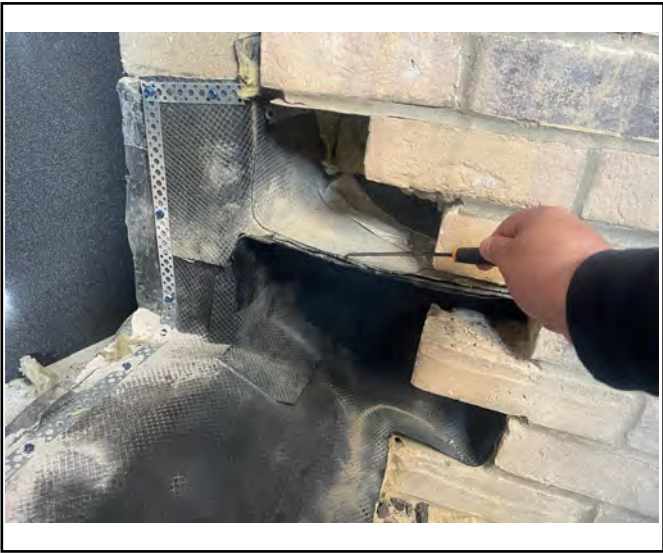
A pick and probe test.

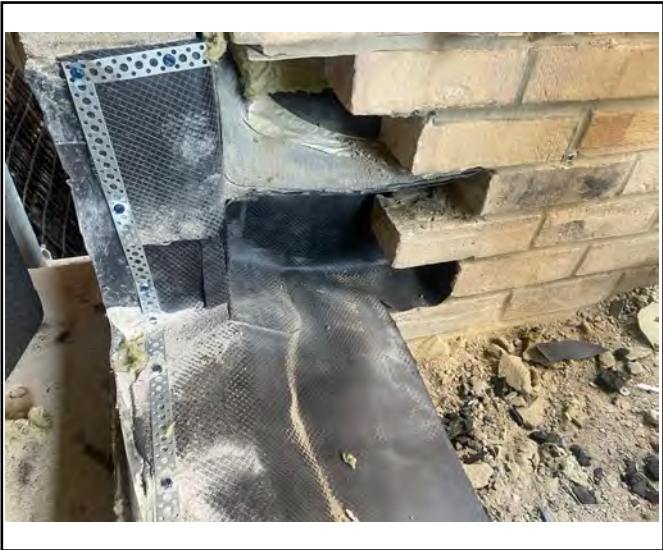
Sealed cavity tray.

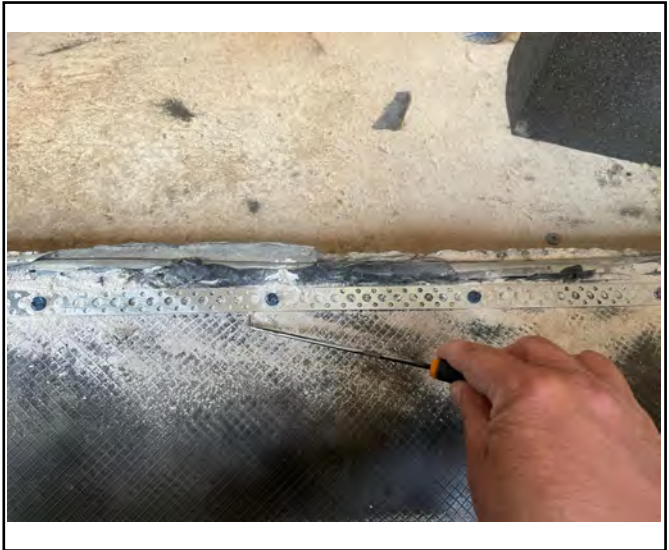
A pick and probe test to a
