## Verification Report

Phase 3:Clarendon Road, GR DPC installation.

AREA SURVEYED: Threshold Detail - Block D1

REPORT NUMBER: 006

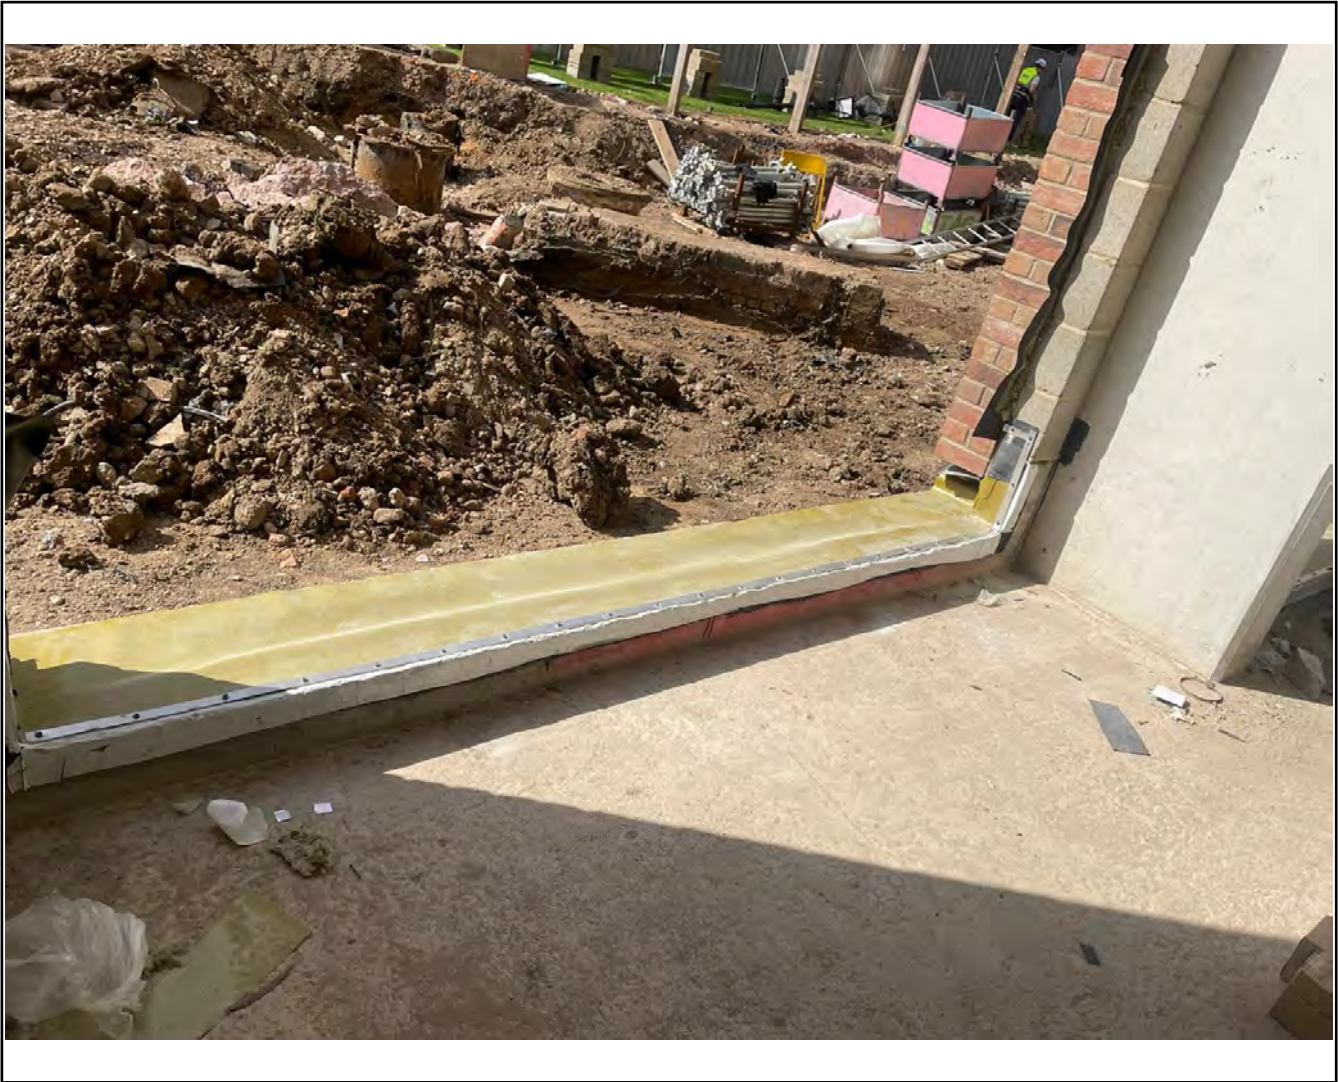
Threshold Detail - Block D1

The photograph above displays an overview of where today's

verification inspection took place on site.

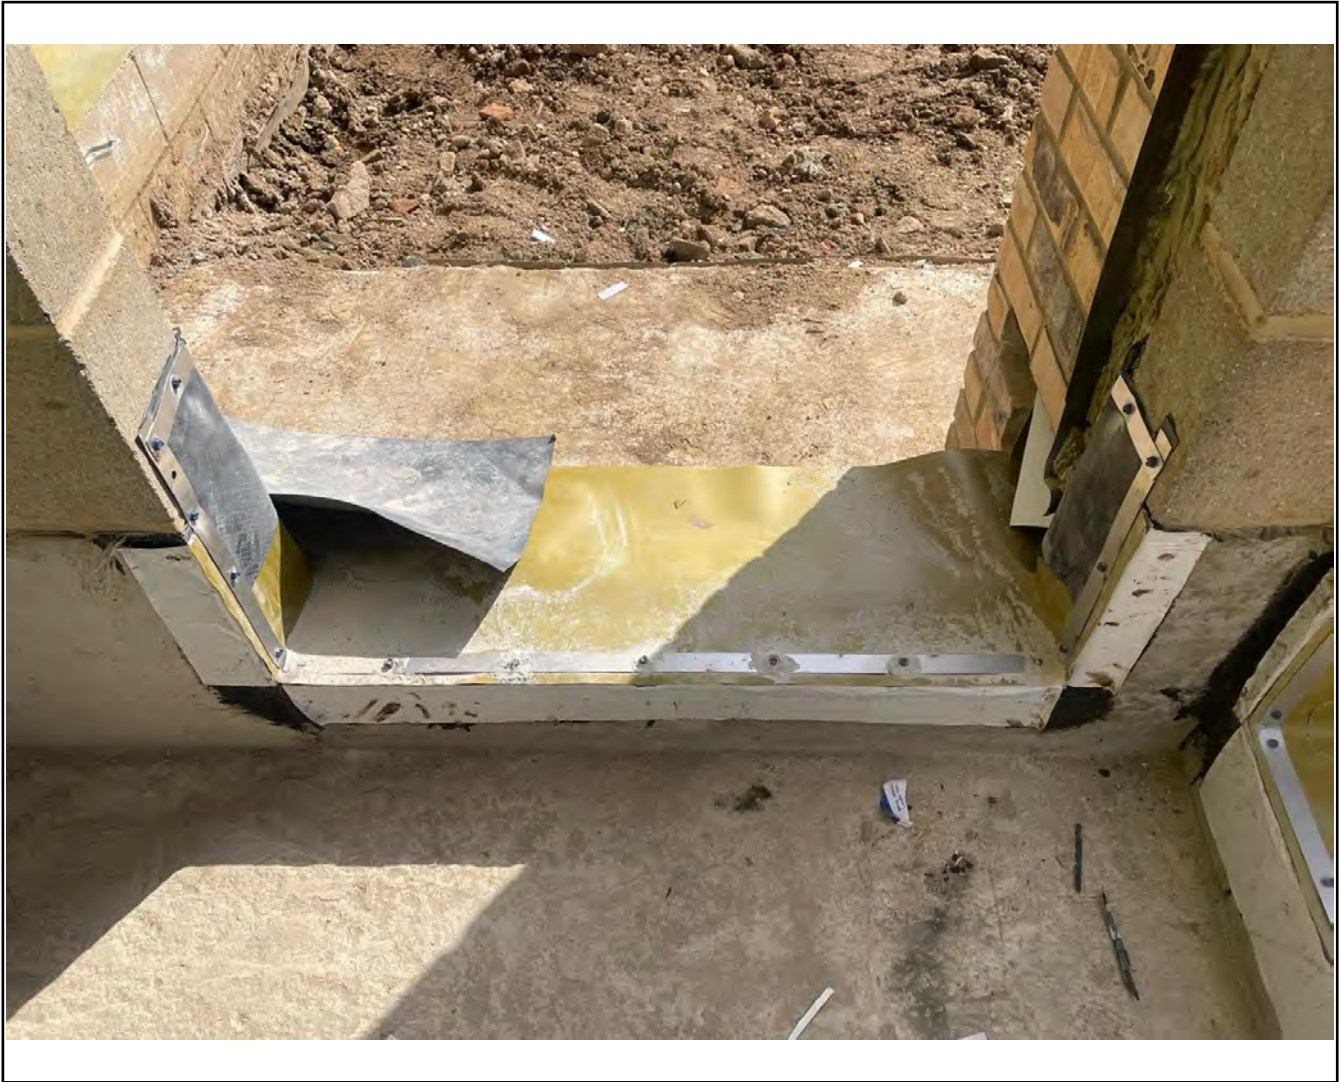
Threshold Detail - Block D1

The photograph above displays an overview of where today's

verification inspection took place on site.

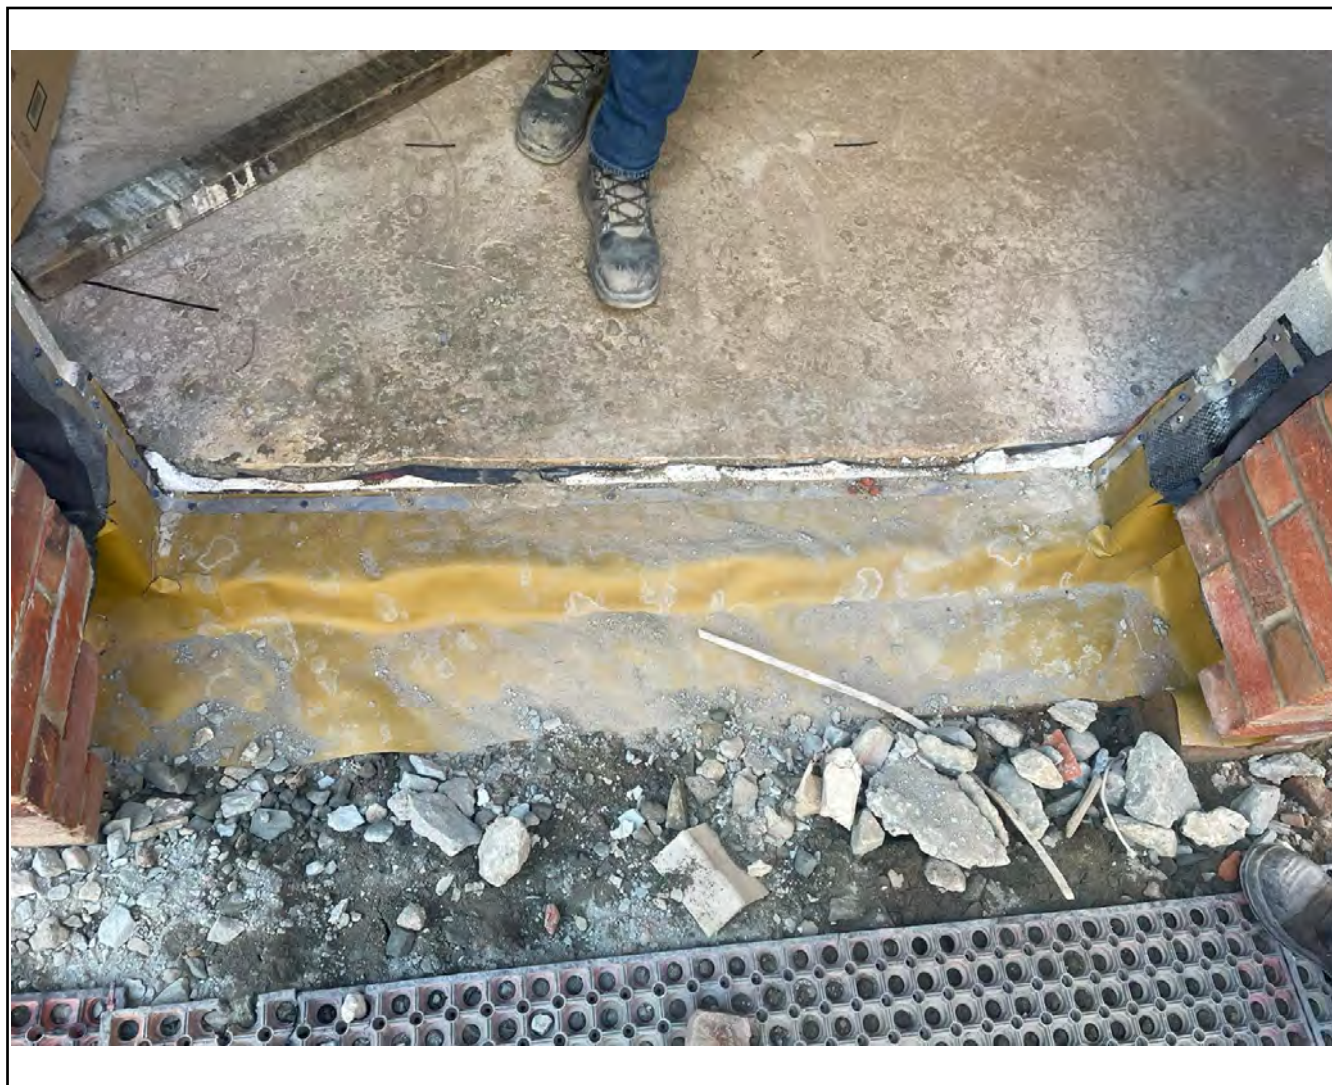
Threshold Detail - Block D1

An alternate overview photograph of where the verification

inspection took place on site today.

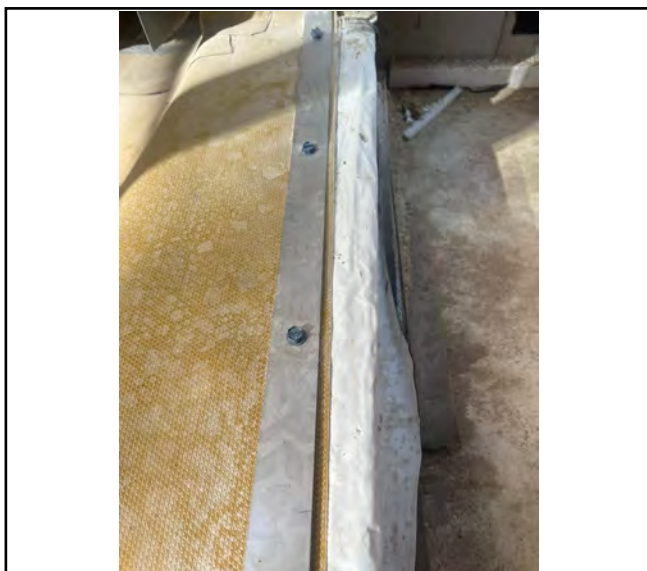
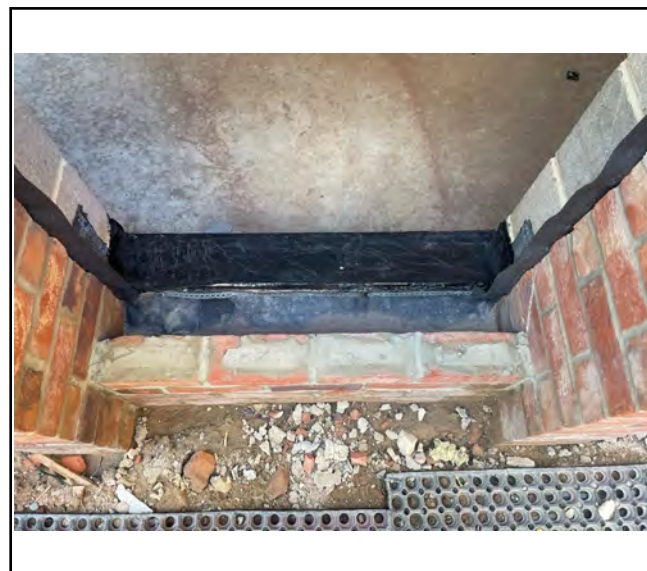
LOCATION/GRID LINE: Threshold Detail - Block D1

The threshold details within Block D1 have been sealed to the design detail using Pudlo DPC or alternatively, Visqueen Ultimate HC Blok. These have been adhered to previously installed self adhesive membrane using double sided butyl tape and

mechanically fixed through the termination strap completing the seal. The first photograph above displays an overview of the termination strap fixed in place. The second photograph displays an overview of the successfully sealed threshold.

Installed in accordance with manufacturer's specifications.

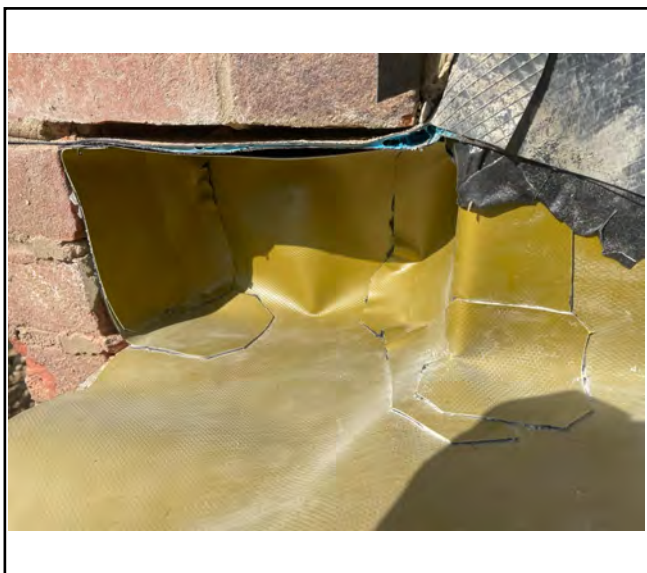
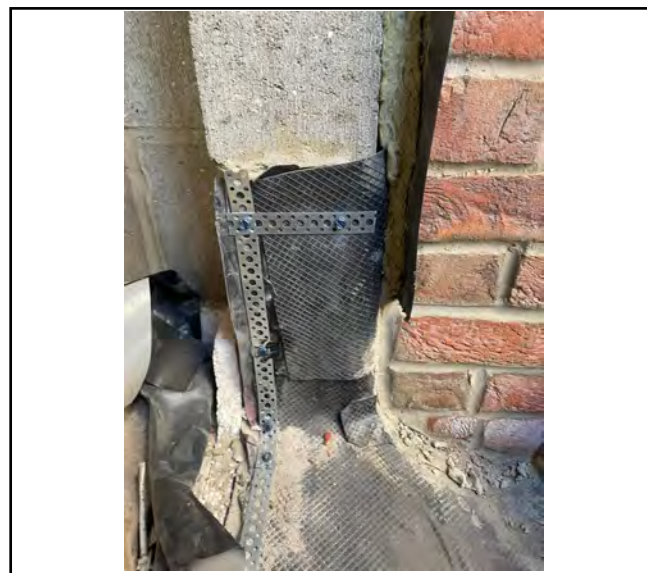
LOCATION/GRID LINE: Threshold Detail - Block D1

The Pudlo DPC has been taken across the threshold, up the cavity and sealed to the cavity tray. The installation has been sealed using double sided butyl tape and termination straps mechanically fixed. The first photograph below evidences the

Visqueen Ultimate HC Blok has been intricately cut and placed inside the cavity to seal the DPC. The second photograph shows the Pudlo DPC taken up the brick work and sealed into the cavity tray. The sealing of threshold details to the cavity tray have been installed in accordance with manufacturer's specifications.

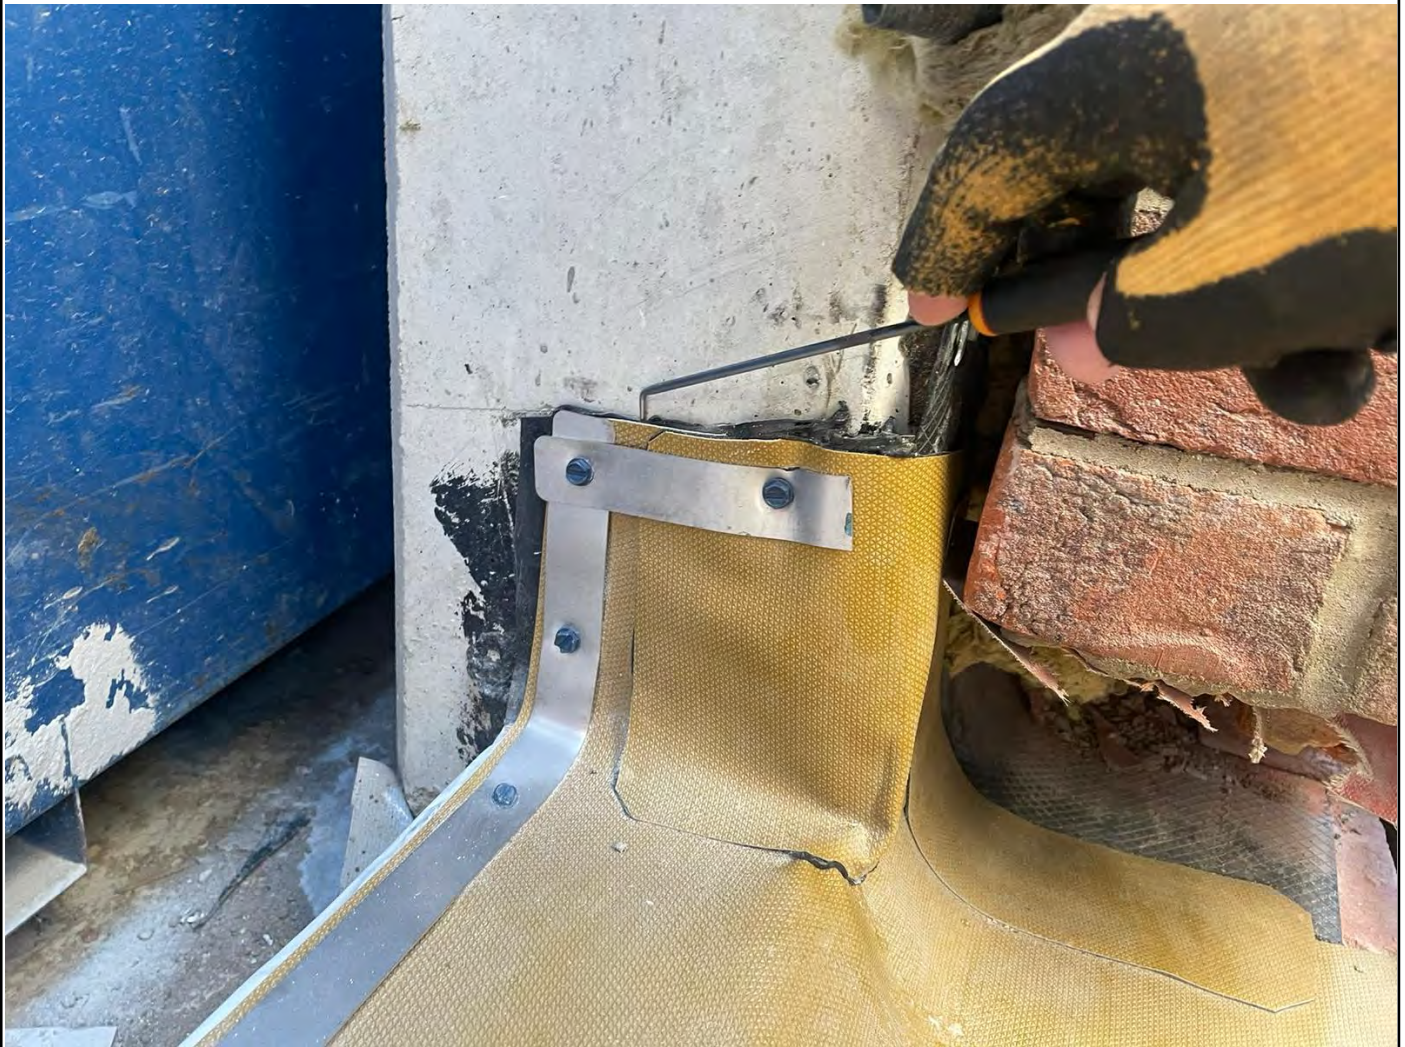
The photograph above displays a mechanical point stress test being conducted

upon the termination strap that has been installed up the cavity wall. The threshold

detail has been successfully sealed to ensure a gas resistant seal is achieved

throughout the installation. Tested and verified in accordance with CIRIA 735.

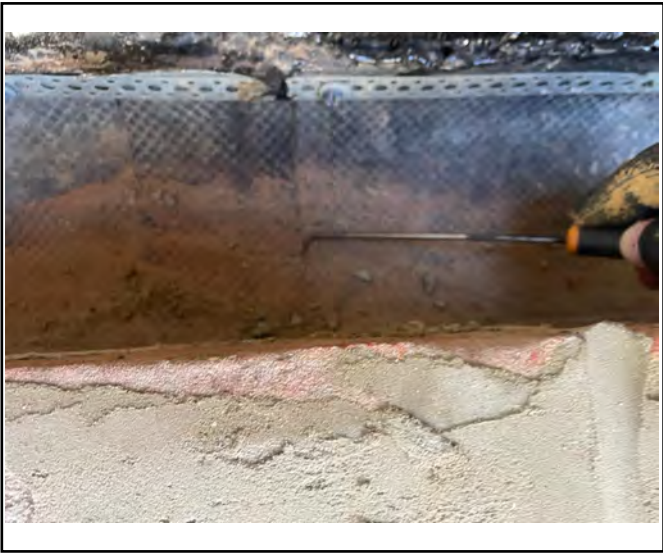
A pick and probe test

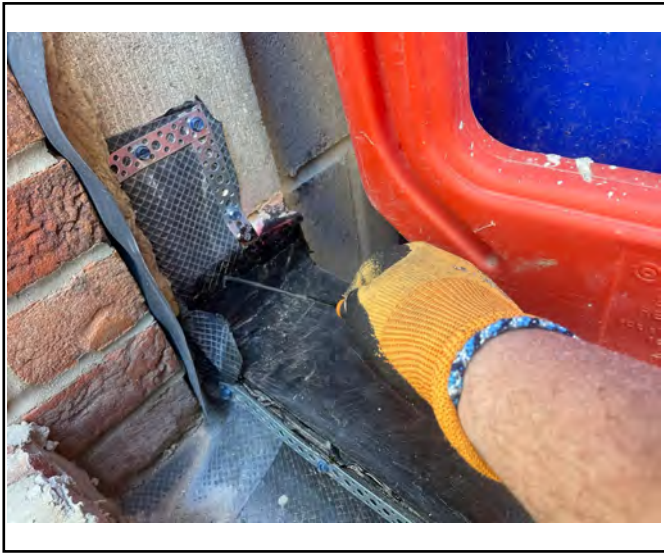
A pick and probe test

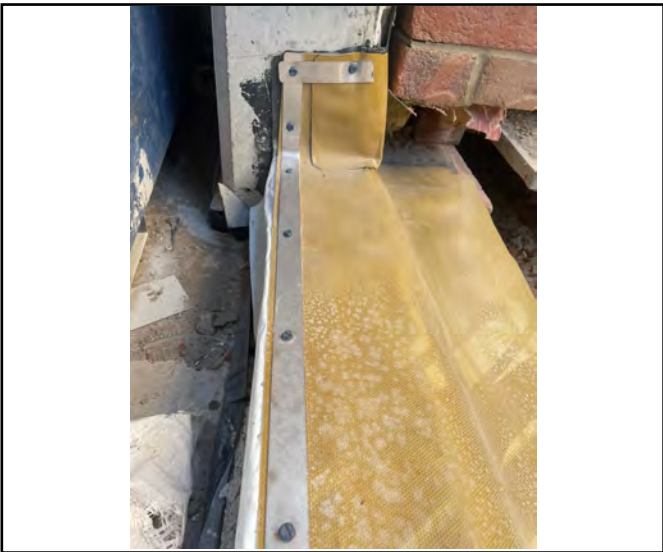
The sealed membrane into the

cavity tray

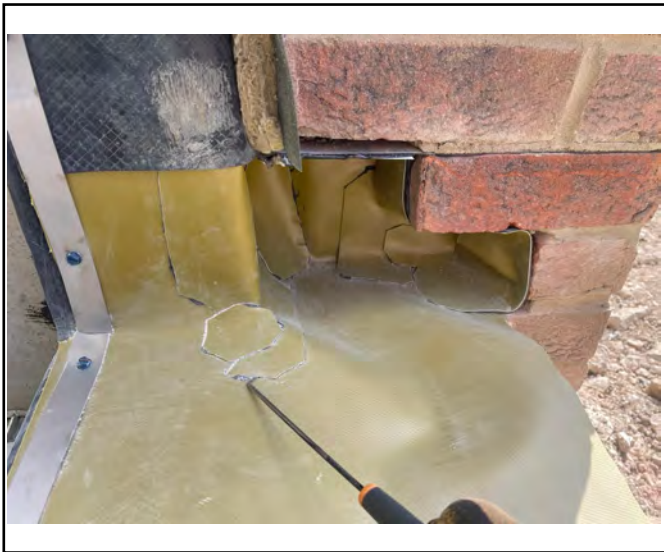
A pick and probe test
