## **PROJECT REPORT CPR2111**

### **Tottenham Hotspur Stadium Development**

#### **PERS Assessment**

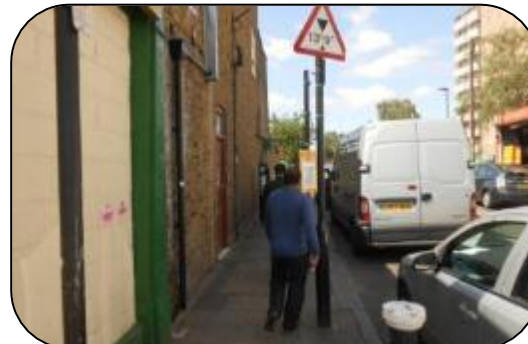
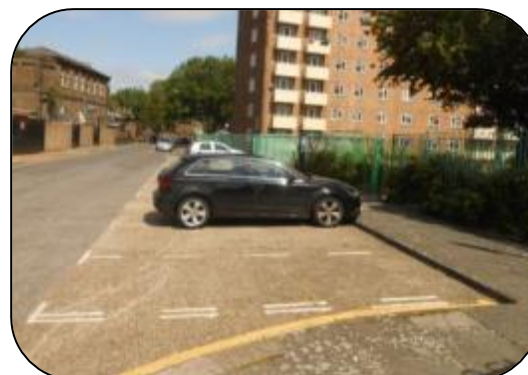
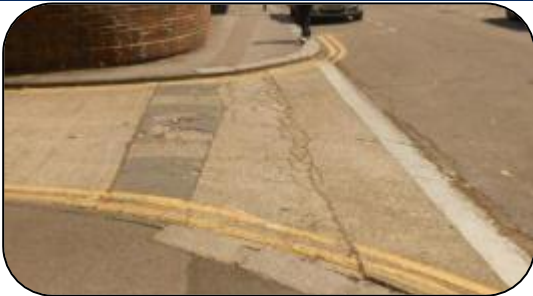
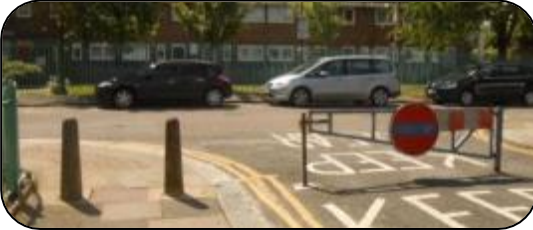
| Descriptor | Ref | RAG | Comments | Photographs |
|---|---|---|---|---|
| Stadium to White Hart Lane Rail Station (via Love Lane) | R1B | -39 | <p>From White Hart Lane Rail Station, this Route runs southbound along Love Lane, eastbound along Whitehall Street and then crosses the A1010 High Road to access the THFC Stadium. The route scored particularly poorly for the parameters: <b>rest points, directness, personal security, legibility</b> and <b>quality of the environment</b>.</p> <p>There is a lack of <b>rest points</b> or seating provision along the route which may impede elderly pedestrians and/or the mobility impaired.</p> <p>With regards to <b>directness</b>, the walking distance of the route is considerably longer than the actual distance between the station and the stadium. In addition, the route deviates around parked cars on both the eastern side of Love Lane and also the northern side of Whitehall Street which might encourage pedestrians to walk in the carriageway in order to minimise their travel distance, which is a safety concern. There are also bollards at both the northern and southern ends of Love Lane, which impede pedestrian movement.</p> <p>The route also scored poorly on <b>personal security</b> as there is no obvious or advertised CCTV and only informal surveillance by passing vehicles which can be sporadic. The southern section of Love Lane in particular feels rather isolated.</p> <p>There are street name plates present, however <b>legibility</b> scored poorly since there was no local area map provided at White Hart Lane Station (only a fairly hidden sign for the Stadium with a distance shown), there is a lack of any proper route signage towards THFC Stadium and tactile information was missing from some crossings.</p> <p>The <b>quality of the environment</b> scored poorly as the route has poor aesthetics, the footway and carriageway surface quality is poor and there is evidence of litter</p> | |

| Descriptor | Ref | RAG | Comments | Photographs |
|---|---|---|---|---|
| | | | <p>and poor frontages.</p> <p>The above issues would need to be addressed in order for this Route to achieve a better overall score.</p> | <br> |

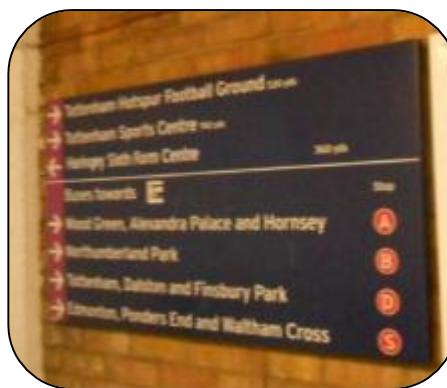
Sign within White Hart Lane Station

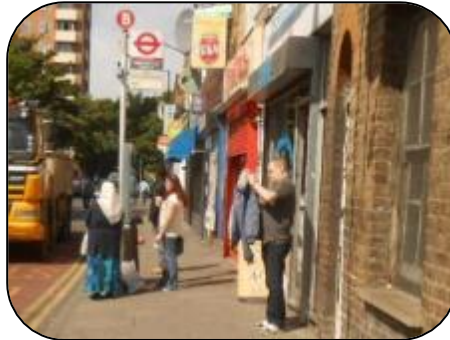
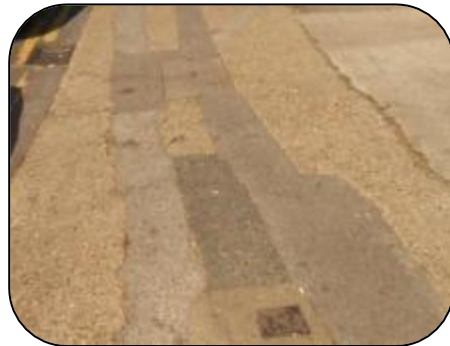
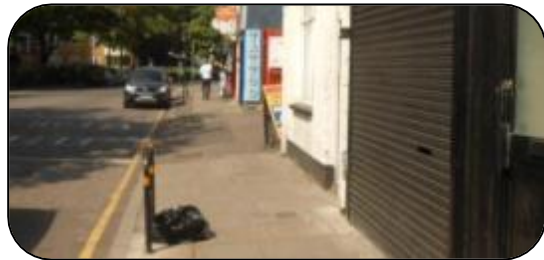
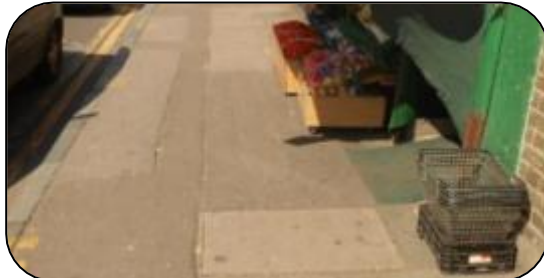
| Descriptor | Ref | RAG | Comments | Photographs |
|---|---|---|---|---|
| N-Side of White Hart Lane, between opp. Love Lane and A1010 | L4 | -67 | <p>This link runs along the northern side of White Hart Lane between (opposite) Love Lane and the A1010. It scored particularly poorly for the parameters: <b>effective width, user conflict, surface quality, obstructions, tactile information</b> and <b>colour contrast</b>.</p> <p>The link is very narrow in places (particularly due to the location of the on-street bus stop) with a reasonable pedestrian flow, and therefore the <b>effective width</b> is substandard. Due to the narrowness of the footway and the need for queuing bus passengers to stand within the footway itself, there is potential for <b>user conflict</b>.</p> <p>The footway <b>surface quality</b> along the link is poor, uneven and broken up in places which looks unsightly and can also result in trip hazards.</p> <p>Street furniture <b>obstructions</b> along the link include Bus Stop B and a Sheffield cycle stand which (particularly if a bicycle was parked there) act to considerably narrow the effective width of the footway. Other obstructions along the link included a stack of shopping baskets and fruit/veg crates on the footway outside a small retail store.</p> <p>There is a lack of <b>tactile paving</b> provision and <b>colour or tonal contrast</b> along the link which can be hazardous for sensory impaired and partially sighted pedestrians. Tactile paving is required to improve legibility for sensory impaired pedestrians.</p> <p>The above issues would need to be addressed in order for this link to achieve a better overall score.</p> | |

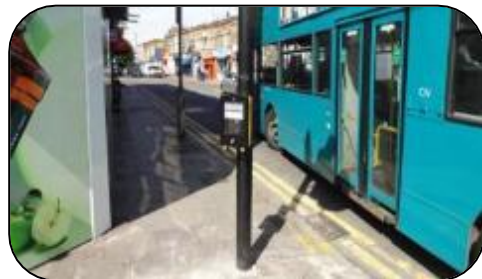
| Descriptor | Ref | RAG | Comments | Photographs |
|---|---|---|---|---|
| S-Side of White Hart Lane, between Love Lane and the A1010 | L3 and L5 | -51 and -61 | <p>These two links run along the southern side of White Hart Lane between Love Lane and the A1010. Both links scored particularly poorly for the parameters: <b>effective width, user conflict, dropped kerbs, obstructions, tactile information</b> and <b>colour contrast</b>.</p> <p>The <b>effective width</b> of the footway is considerably narrow in a number of places along the link due to the location of street furniture (poles, bollards, a phone box and a bus shelter), a large tree with roots and on-street rubbish. Narrow footways are more likely to become congested at peak times.</p> <p>There is potential for <b>user conflict</b> along the link due to the narrowness of the footway and street furniture <b>obstructions</b> around the bus shelter. Pedestrians travelling along the footway might conflict with those waiting for or alighting from a bus.</p> | |

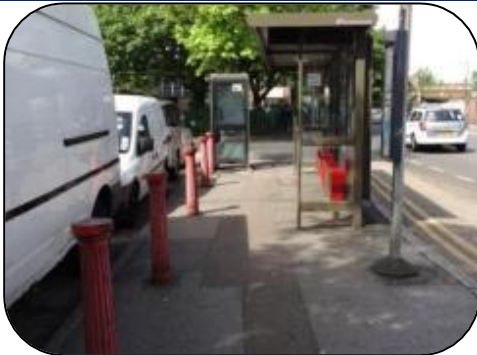
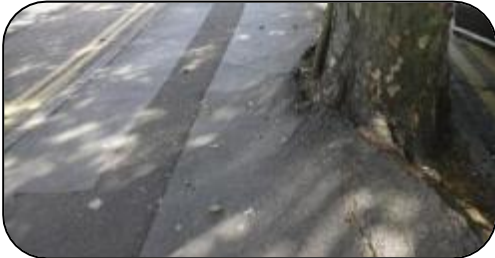
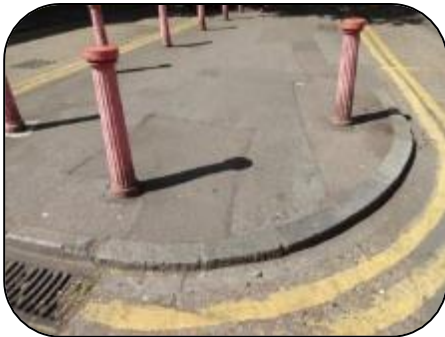
| Descriptor | Ref | RAG | Comments | Photographs |
|---|---|---|---|---|
| | | | <p>There is a lack of <b>dropped kerbs</b> and a poor footway surface quality along the link which cause trip hazards and can cause difficulties for those with mobility impairments such as wheelchair users.</p> <p>There is also a lack of <b>tactile paving</b> provision and a lack of <b>colour or tonal contrast</b> along the link. Tactile paving is required to improve legibility for sensory impaired pedestrians. Colour contrast aids in the navigation, orientation and protection of hazards for partially sighted pedestrians. An obstruction will therefore represent a hazard rather than an inconvenience.</p> <p>The above issues would need to be addressed in order for these links to achieve better overall scores.</p> | |

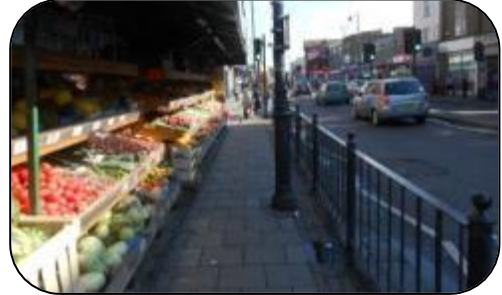
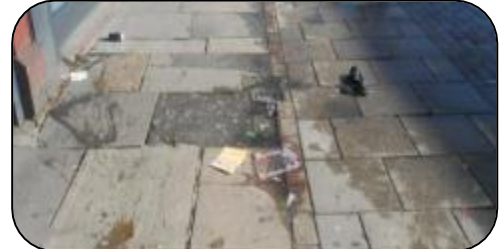
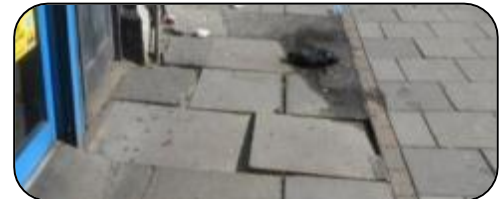
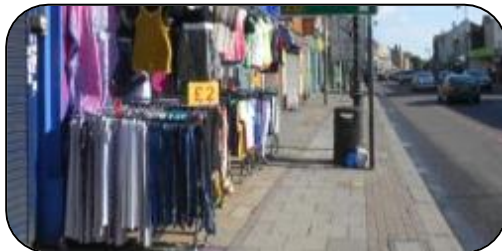
| Descriptor | Ref | RAG | Comments | Photographs |
|---|---|---|---|---|
| W-Side High Road, between Bruce Grove Rail Station and St Loys Road | L38 | -48 | <p>This link runs along the western side of High Road, directly to the south of Bruce Grove Station until it reaches St Loys Road. It scored particularly poorly for the parameters: <b>effective width</b>, <b>personal security</b>, <b>obstructions</b>, <b>permeability</b>, <b>surface quality</b> and <b>maintenance</b>.</p> <p>The link's <b>effective width</b> is reduced below acceptable dimensions in several places. Particularly noticeable is the interaction between street furniture and commercial displays and poorly positioned clusters of lamp columns and street furniture which lower the width available to pedestrians to around 1m. The link is used regularly by shoppers and those navigating along the High Road. The medium level of pedestrian flows mean the available footway width is inadequate in parts.</p> <p><b>Personal security</b> scored poorly along the link. While the link sees high pedestrian flows and traffic movements, there are several attractors of anti-social behaviour. These include two pubs and some fast food restaurants. There is also no advertised CCTV.</p> <p><b>Obstructions</b> along the link include poorly positioned street furniture which is not sufficiently aligned to the rear or front of the footway. This blocks the footway and impacts on the effective width as mentioned. The degree of <b>user conflict</b> with users travelling in opposite directions and those using local shops is increased by these obstructions.</p> <p>The link scored poorly for <b>permeability</b> because of the busy traffic conditions and the presence of pedestrian barriers on the edges of the footway. Since there are trip attractors on both sides of the road, informal crossings were observed with pedestrians having to make use of improvised central road markings as a refuge.</p> <p>The <b>surface quality</b> of the link is poor due to a lack of <b>maintenance</b>. The grey flagged paving is uneven in parts, to the extent that it presents a considerable trip hazard in areas where the paving is loose/uneven. Manhole covers also present a trip hazard. Drainage appears to be inadequate with evidence of ponding along the</p> | |

| Descriptor | Ref | RAG | Comments | Photographs |
|---|---|---|---|---|
| | | | footway. | |

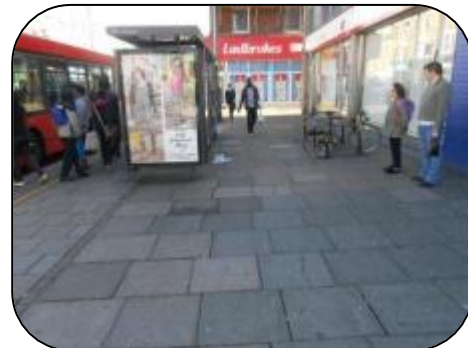
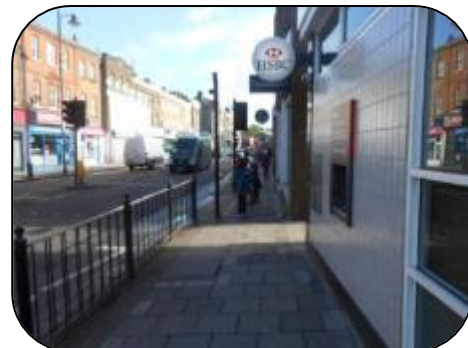
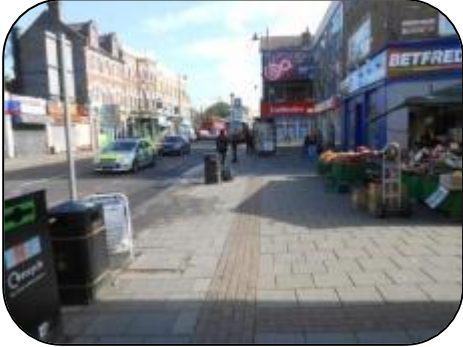
| Descriptor | Ref | RAG | Comments | Photographs |
|---|---|---|---|---|
| W-Side High Road,<br>between Bruce<br>Grove Rail Station<br>and Forster Road | L39 | -38 | <p>This link is on the opposite side of the High Road to L38 above, and scored negatively against the same parameters. Both links had similar issues with regards to <b>permeability</b>, <b>surface quality</b> and <b>maintenance</b> and L39 also suffered from similar (but less severe) issues for <b>effective width</b>, <b>obstructions</b>, and <b>personal security</b>. The only parameter in which this link scored worse than L38 is in <b>dropped kerbs</b>, due to several instances of upstands on the kerbs.</p> <p>As with L38, the link scored poorly for <b>permeability</b> because of the busy traffic conditions and the presence of pedestrian barriers on the edges of the footway.</p> <p>A lack of <b>maintenance</b> along the link and the unevenness of the footway surfacing meant that it scored poorly for <b>surface quality</b>. There was also unevenness of flagged paving, manhole covers which presented a trip hazard and drainage which appeared to be inadequate.</p> <p>The <b>effective width</b> is poor in parts, with obstructions reducing the footway width to two metres along sections of the link. <b>Obstructions</b> such as a bus shelter and cycle parking contribute to this reduced width, creating a narrowing, and impact on the movements of pedestrians. Some A-boards also encroach on the pedestrian space.</p> <p><b>Personal security</b> suffers from similar issues to L38 in that there are some</p> | |

| Descriptor | Ref | RAG | Comments | Photographs |
|---|---|---|---|---|
| | | | attractors of antisocial behaviour, including takeaways and betting shops. In comparison to L38, there are no pubs on this side of the road which reduces the risk of anti-social behaviour to a degree. There is also a lack of formal surveillance despite the informal provision from high pedestrian and traffic flows. | |

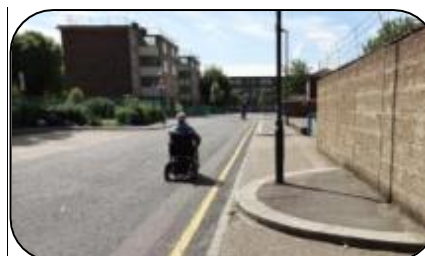
- The **effective width** of footways was substandard or non-existent along some links which raises safety issues since pedestrians can be forced to walk (or travel) in the carriageway. The narrow width of the footways can also mean that there is a lack of available space to provide or align street furniture such as lighting columns and signage. Footway widths were narrowed in some areas due to the provision of infrastructure such as bus

stops and bollards, and in other locations due to on-street parking spaces being installed within the footway space. This parameter is particularly pertinent given the expected increase in pedestrian footfall as a result of the new stadium development plans.

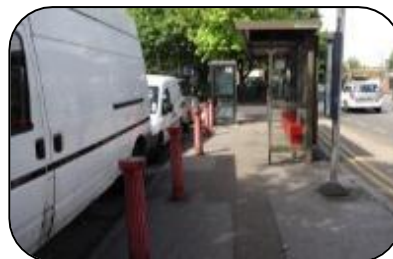
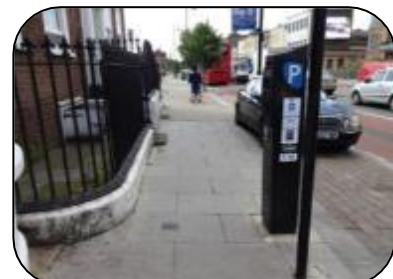
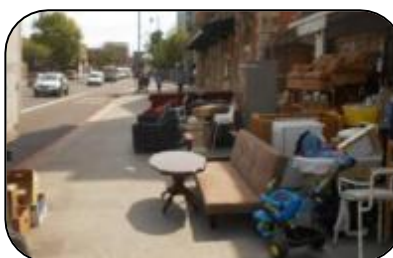
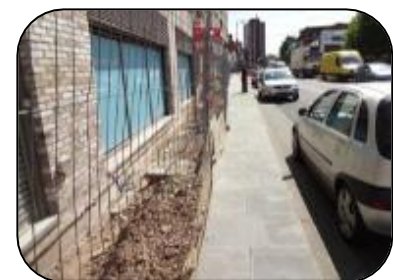
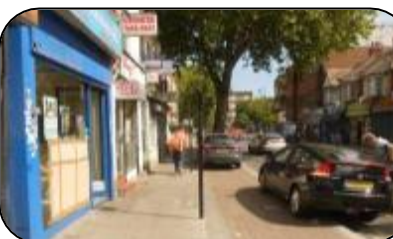
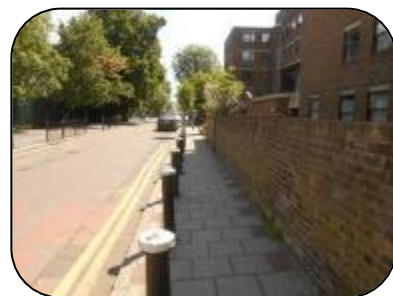
- There were instances where on-street footway works were taking place during the audit which had (temporarily) narrowed the effective footway width.
- There are sections of on-street car parking or loading bays along High Road which have been installed within part of the footway space. These act to reduce the effective footway width and can present a hazard to pedestrians when the vehicle is manoeuvring into / out of the space onto/off the kerb.

- At the south-east corner of the stadium, there are a high number of bollards which are aligned within the footway. These reduce the effective footway width and might cause pedestrians to walk within the carriageway where there is more space available.

- **Legibility** is poor generally within the area because there is a lack of signage to help pedestrians to navigate. The only consistent and clear signage provided is the street name plates. There are occasional landmarks identified on signage, such as the local library, but these are not provided frequently. Signage towards the stadium was particularly lacking.

Legibility was the worst scoring parameter for the Routes because pedestrian signage and wayfinding is currently non-existent or inconsistent around the audit area. As suggested in the previous 2010 study, it is recommended that a coherent wayfinding system is installed along the key walking routes. To ensure that the system is coherent and easy to use it is suggested that it is designed in line with the Legible London wayfinding systems (see <https://tfl.gov.uk/info-for/boroughs/legible-london> for more information). These wayfinding systems use a network of information boards (called monoliths) and finger posts with detailed walking maps that are orientated to the user's point of view and walking time radii. Monoliths and finger posts are designed to guide crowds and encourage walking. Installing Legible London boards at the key arrival nodes in particular would considerably improve the PERS scores.

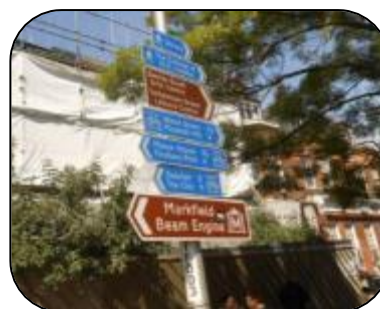
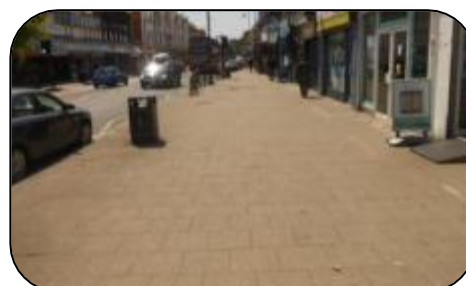
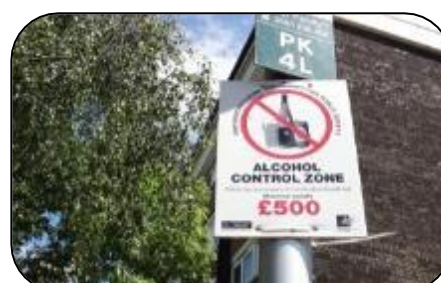
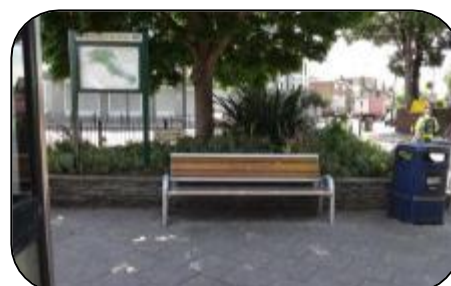
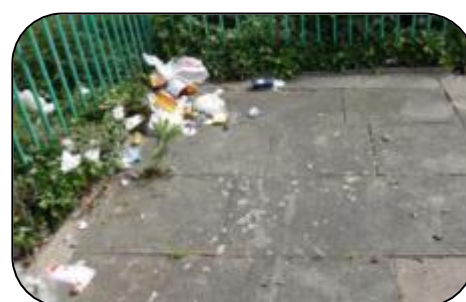
- **Colour contrast** is poor along many of the links where there is a lack of colour or tonal contrast and no differentiation between the tactile paving and the surrounding paving. Additionally, a lot of tactile paving was charcoal in colour, which contrasts poorly with the grey tarmac / flagged paving surfaces.

- **Personal security** consistently scored poorly, with only five instances of a Green RAG status. The reasons for this include poor aesthetics and run down shops, which reduce the overall sense of safety. The level of anti-social behaviour is also perceived to be high, due to the large number of pubs and takeaways as well as evidence of broken bottles and other litter. The area contains several loci of street drinking, even in the day, such as parks and public seating. This behaviour can be intimidating, especially after dark.

- **Maintenance** was lacking on a lot of the links. The footway surface quality varied from modern consistent paving to older more uneven provision, however most footways suffered from a lack of cleaning and maintenance. There is regular staining around all public seating and litter was very apparent in some places, especially on links with commercial properties nearby. In some places, there was also evidence of leaf litter.

Observations were made along various links of litter, gum stains and evidence of ponding. It is recommended that increased street cleaning takes place to clear the footways of litter and that resurfacing takes place to deal with ponding issues. Some areas showed a feeling of neglect, with poor quality surface materials and poor / old street furniture which combined to provide a poor visual appeal and results in an area where pedestrians may not want to linger. Enhancement of the public realm, including the refitting of street furniture and the addition of landscaping, would aid in creating a more aesthetically pleasing environment.

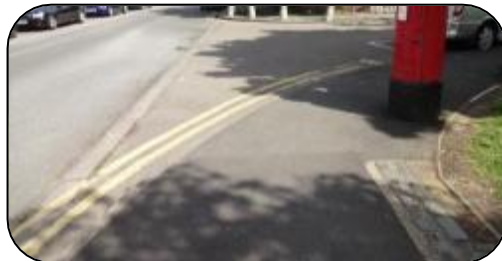
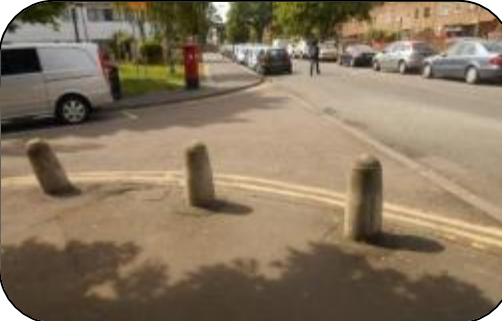
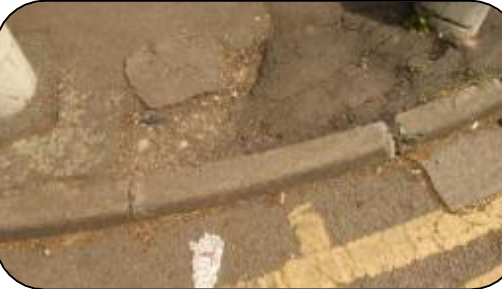
| Descriptor | Ref | RAG | Comments | Photographs |
|---|---|---|---|---|
| Crossing Fairbanks Road, south of junction with Chesnut Road | C99 | -37 | <p>This crossing over Fairbanks Road lacks basic provision for pedestrians, especially for those who are mobility or sensory impaired. The crossing scored particularly poorly on <b>performance, legibility for sensory impaired people, dropped kerbs</b> and <b>obstructions</b>.</p> <p>The <b>performance</b> of the crossing is poor because of the lack of any traffic control and the obstructions to lines of sight, from both parked cars (on Fairbanks and Chesnut Road) and from the wooden hoarding around the adjacent demolition site. These issues are further compounded by the lack of any <b>dropped kerbs</b>, which creates a trip hazard and an impedence to access for mobility impaired users. There is a lack of any tactile paving provision which makes the <b>legibility</b> and crossing of the road difficult for those who with <b>sensory impairments</b>. It is recommended that dropped kerbs and tactile provision are installed so that the legibility of the area is improved.</p> <p>Bollards are present on the eastern side of the waiting area which cause <b>obstructions</b> to pedestrian movements across the crossing. Those with pushchairs or wheelchair users may have particular difficulties navigating past these bollards. There is also have no tactile warnings and due to their height they can be removed from the natural line of sight and could hazardous to those who are sensory impaired.</p> <p>There is a lack of <b>dropped kerbs</b> on both sides of the crossing which presents a trip hazard and also causes difficulties to wheelchair users and those with pushchairs.</p> <p>The above issues would need to be addressed in order for this Crossing to achieve a better overall score.</p> | |

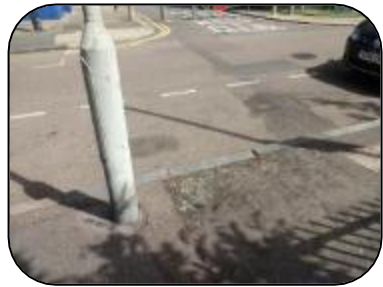
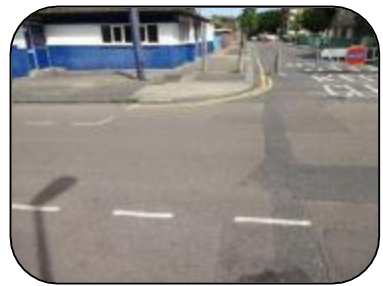
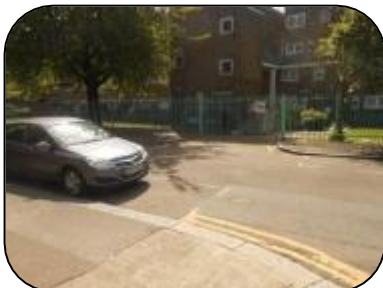
| Descriptor | Ref | RAG | Comments | Photographs |
|---|---|---|---|---|
| Crossing Whitehall Street, west of junction with Love Lane; and east of junction with Love Lane | C40 and C42 | -22<br>and<br>-16 | <p>These are both informal crossings across Whitehall Street and are very similar in provision. The crossings both scored particularly poorly on <b>legibility, legibility for sensory impaired people</b> and <b>dropped kerbs</b>.</p> <p>The crossings are in a setting where there is no formal provision to cross Whitehall Street. The <b>legibility</b> parameter scored poorly because it is not obvious where to cross. The crossings lack any infrastructure or delineation with the exception of poor quality light grey surfacing on the northern side of Whitehall Street (part of a crossing over Love Lane) which is not intended for use with these informal crossings. Coloured surfacing and markings should be used where appropriate to delineate a safe crossing.</p> <p>The crossings have no <b>dropped kerbs</b> and there is also a lack of tactile paving provision. This makes it difficult for those with mobility or sensory impairments to cross the road. Due to the informal nature of the crossings and the lack of any appropriate formal provision in this area, the <b>legibility for sensory impaired people</b> is poor.</p> <p>The informal crossing locations which were observed to be used by pedestrians have parked cars on both sides of Whitehall Street. This is likely to create user conflict and impede lines of sight at most times of the day, together with a complete lack of space ownership, contributing to a poor crossing <b>performance</b>.</p> | |

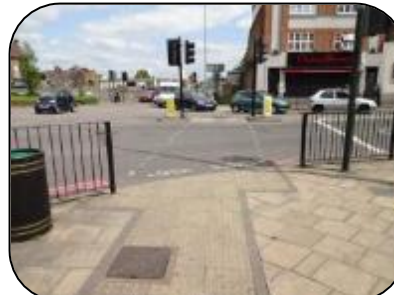
| Descriptor | Ref | RAG | Comments | Photographs |
|---|---|---|---|---|
| Crossing Fore Street, south of junction with A406 and Sterling Way | C4 | -21 | <p>This crossing scored particularly poorly for <b>crossing provision</b> and <b>delay</b> because the unsignalised crossing type is considered to be unsuitable at this location. It crosses the southern arm of a busy junction, where traffic flows are heavy and fast moving. The uncertainty over traffic approach speeds and movements induces considerable delay, especially for those who are less able to cross the road. It is therefore recommended that this junction is signalised so that the safety of pedestrians is improved.</p> <p>The crossing also scored negatively for <b>capacity</b> and <b>performance</b>. Crossing here is mostly undertaken in two stages, utilising the central refuge. The <b>capacity</b> of the refuge is not sufficient given the observed pedestrian flows, and the traffic is moving in such close proximity to the refuge. This contributes to a lack of space ownership and safety concerns for pedestrians, and results in a poor crossing <b>performance</b>.</p> <p><b>Legibility for sensory impaired people</b> also scored negatively because the tactile paving provision is incorrect for this type of crossing (i.e. unsignalised). This has the potential to mislead sensory impaired pedestrians and raises safety concerns.</p> | |

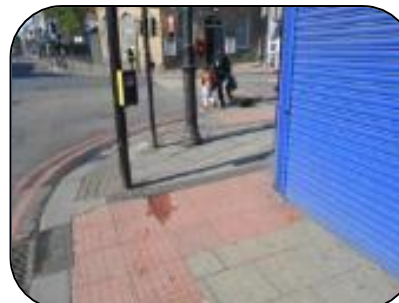
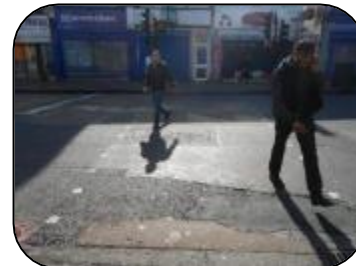
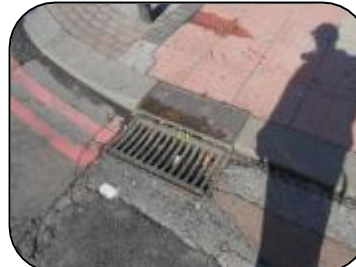
| Descriptor | Ref | RAG | Comments | Photographs |
|---|---|---|---|---|
| Crossing A1010 (High Road), north of junction with Bruce Grove | C89 | -16 | <p>This crossing scored particularly poorly against the parameters: <b>delay</b>, <b>dropped kerbs</b>, <b>surface quality</b> and <b>maintenance</b>.</p> <p>The crossing provides only five seconds of green time and five further seconds of blackout time to pedestrians. This is a short time allowance for crossing, especially since the crossing is single stage and over four traffic lanes. This results in considerable <b>delay</b> to those waiting to use the crossing.</p> <p>The <b>dropped kerbs</b> are acceptable on the eastern waiting area, but there are some issues with the upstand and gradient. On the western side, there is a large upstand on the kerb which is a trip hazard for those using the crossing. <b>Surface quality</b> is also particularly poor on this western edge of the crossing where a gully presents a</p> | |

| Descriptor | Ref | RAG | Comments | Photographs |
|---|---|---|---|---|
| | | | <p>trip and slip hazard, particularly in conjunction with the high upstand on the kerb.</p> <p><b>Maintenance</b> scored poorly due to the poor surface quality of the carriageway, slight ponding on the northern side and also evidence of gum staining and litter.</p> | |

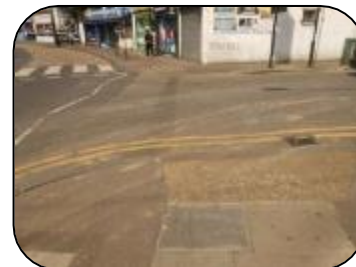
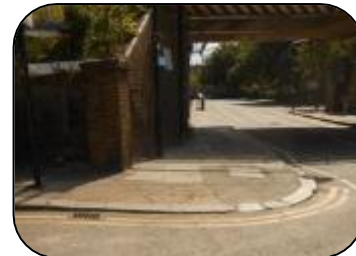
| Descriptor | Ref | RAG | Comments | Photographs |
|---|---|---|---|---|
| Crossing Pretoria Road, north of junction with White Hart Lane | C37 | -15 | <p>This crossing scored particularly poorly in relation to <b>surface quality, legibility</b> and <b>legibility for sensory impaired people</b>.</p> <p>The <b>surface quality</b> is poor, with different materials used, a lack of consistency in surface type and undulations and uneven surfaces which represent a trip hazard. The different surface types make the crossing difficult to navigate for those with visual impairments.</p> <p><b>Legibility</b> scored poorly because the crossing has no delineation or infrastructure to indicate its presence, or to encourage users to cross at a certain point.</p> <p>The lack of tactile paving provision puts those with a <b>sensory impairment</b> at risk, and this is compounded by the lack of colour contrast.</p> | |

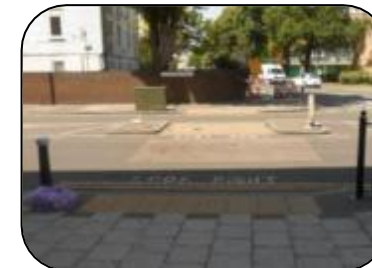
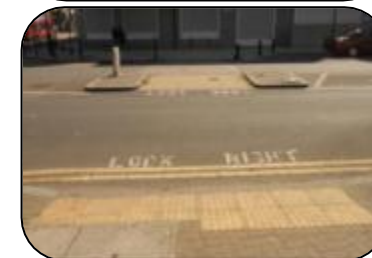
| Descriptor | Ref | RAG | Comments | Photographs |
|---|---|---|---|---|
| Crossing Willoughby Lane, south of junction with Park Lane / Park Avenue Road | C69 | -13 | <p>This unsignalised crossing over a busy road scored particularly poorly for <b>performance</b>, but it also scored negatively across six other parameters which included <b>crossing provision</b> and <b>delay</b>.</p> <p>The traffic on Willoughby Lane travels at a high speed with a medium flow and, despite the presence of a central refuge, the <b>crossing provision</b> is not deemed to be safe at this location. The crossing <b>performance</b> scored poorly due to a lack of space ownership and lack of pedestrian priority which means that vehicles do not slow down to allow pedestrians to cross. In addition, Willoughby Lane has parking on both sides which can impact on lines of sight and further reduces the safety of the crossing. <b>Delay</b> scored poorly due to a combination of the above reasons. The lack of priority impacts on delay as does the infringement on lines of sight.</p> <p>By comparison, the crossing further north (C67) across Willoughby Lane is a zebra crossing which is much better suited for this context and, as a result, scored much higher (+48). Both crossings are used by pedestrians to access Northumberland Park Station which is located directly to the east, and so high volumes of pedestrian flows can be expected to use these crossings. It is therefore recommended that crossing C69 is upgraded to provide an improved and safer crossing provision.</p> | |

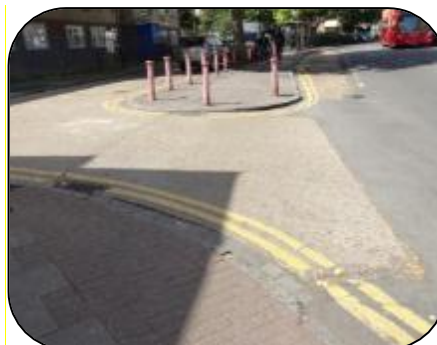
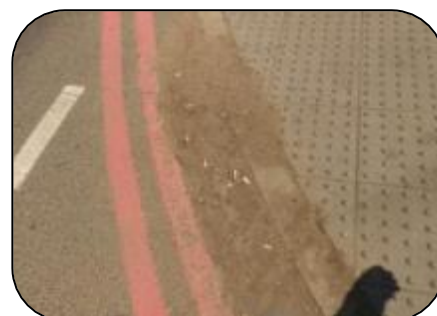
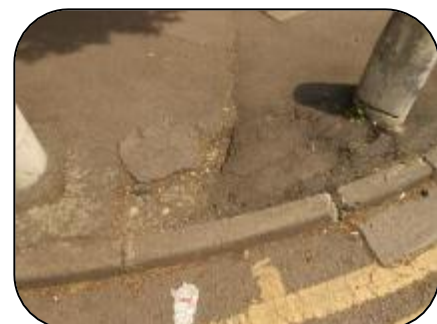
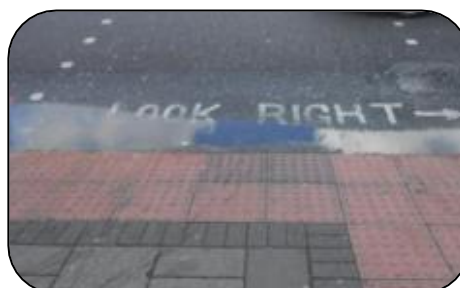
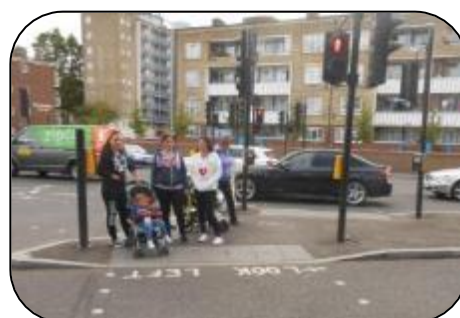
- A high number of crossings provided no **legibility for sensory impaired people**, and this was particularly the case across side roads away from the High Road. The lack of tactile paving presents a considerable hazard to those who are visually impaired and trying to cross the road.

- **Maintenance** and cleanliness was considered to be low in some areas. This is mostly due to evidence of litter, seasonal foliage and gum stains which could easily be remedied.

- **Surface quality** was poor in some locations, particularly across side roads away from the High Road. There was evidence of uneven cracked surfaces, an inconsistency of materials used which varied in quality and also instances of poor reinstatements and poor drainage which resulted in ponding. Providing and maintaining a good surface quality is required so that potential trip and slip hazards are minimised.

- There was a considerable amount of **delay** at some of the crossings. In some locations this was due to unsignalised crossings over busy main roads, where high traffic speed and volumes combined with long crossing distances (up to four traffic lanes) made crossing difficult and unsafe. In these cases, the crossing type should be re-assessed.

- At some signalised crossings, delay occurred due to a very short green time and associated blackout phase which did not provide enough time for pedestrians to cross safely. Delay should be minimised where possible so that pedestrians are not encouraged to cross the road before the pedestrian phase where the likelihood of conflict is

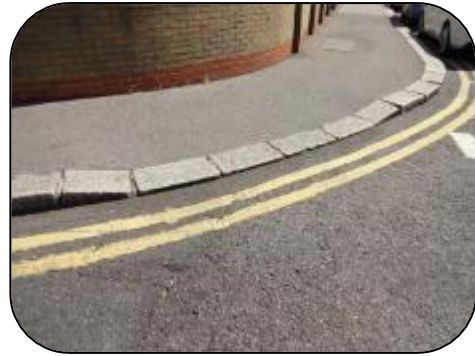
- **Dropped kerbs** scored poorly at some crossings. In some places, there was a lack of dropped kerb provision and high kerb upstands which can cause accessibility issues for wheelchair or pushchair users. Some existing dropped kerbs were not flush with the carriageway which can present a trip hazard. It is recommended that improvements are made so that the dropped kerbs are flush, aligned and have adequate capacity to cope with pedestrian flows.

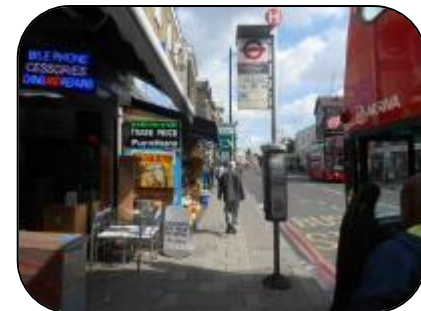
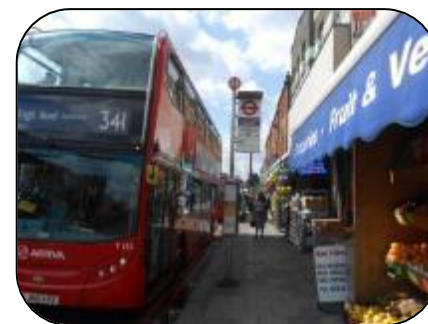
| Descriptor | Ref | RAG | Comments | Photographs |
|---|---|---|---|---|
| Bus Stop H - Tottenham High Road | PT18A | -22 | <p>This bus stop scored poorly with regards to <b>waiting area comfort, infrastructure to the waiting area, quality of the environment</b> and <b>maintenance and cleanliness</b>.</p> <p><b>Waiting area comfort</b> scored poorly since the lack of a bus shelter means that waiting passengers have to congregate around the flag pole on the footway, and there is no protection from adverse weather conditions. The available space for waiting is very small and is limited further by commercial goods on the footway and resultant user conflict.</p> <p>There is a poor provision of <b>infrastructure to the waiting area</b> via local crossings, with the nearest crossing being approximately 25 metres walking distance to the south. The footway surfacing on approach to the bus stop is of poor quality and in need of repair, and there are some uneven surfaces which present trip hazards.</p> <p>The area around the bus stop is fairly unpleasant to wait in, with traffic noise and fumes from the busy High Road which impacts on the <b>quality of the environment</b>. The aesthetics of the area surrounding the bus stop are poor, with poor quality private frontages. The bus stop scored poorly for <b>maintenance and cleanliness</b> because the area feels neglected with evidence of ponding, collections of debris, litter on the footway and no provision of a bin.</p> | |

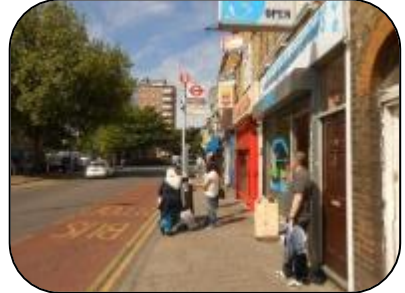
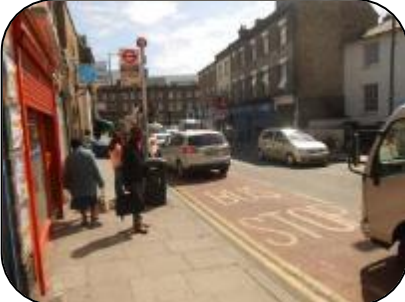
| Descriptor | Ref | RAG | Comments | Photographs |
|---|---|---|---|---|
| Bus Stop B - White Hart Lane Station | PT7 | -11 | <p>This bus stop scored particularly poorly in relation to <b>quality of the environment</b> and <b>waiting area comfort</b>.</p> <p>The <b>quality of the environment</b> is low because of significant amounts of litter, poor quality frontages and due to the adjacent road which has traffic noise and there are fumes from queuing traffic. In addition, the footway is of poor quality and is uneven in places.</p> <p>The <b>waiting area comfort</b> scored poorly since there is no provision of a shelter and the bus stop is exposed to the elements. The adjacent footway is narrow and there is a high flow of pedestrians, which acts to limit the capacity of the waiting area and increase user conflict.</p> | |

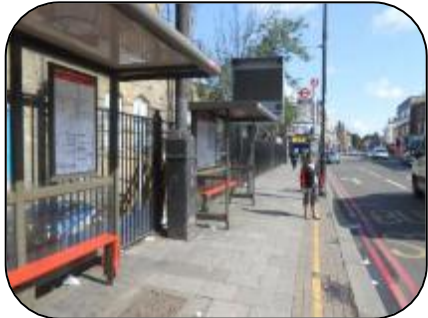
| Descriptor | Ref | RAG | Comments | Photographs |
|---|---|---|---|---|
| Bus Stop J - Bruce Grove Station | PT17 | +3 | <p>This bus stop scored particularly poorly in relation to <b>infrastructure to the waiting area, quality of the environment</b> and <b>maintenance and cleanliness</b>.</p> <p><b>Infrastructure to the waiting area</b> scored poorly because of the lack of any convenient crossing provision to access the bus stop. The nearest formal crossing point is approximately 25 metres to the north of the bus stop. The footway quality is generally poor with unevenness and trip hazards.</p> <p><b>Quality of the environment</b> is reduced by the poor aesthetics of the frontages, poor quality of materials surrounding the waiting area and the traffic noise and fumes nearby. There is also a poor level of <b>maintenance and cleanliness</b> as the shelters are in a poor state of repair and are dirty and scratched with graffiti. The area around the shelters also has lots of litter present, despite the bin provided.</p> | |

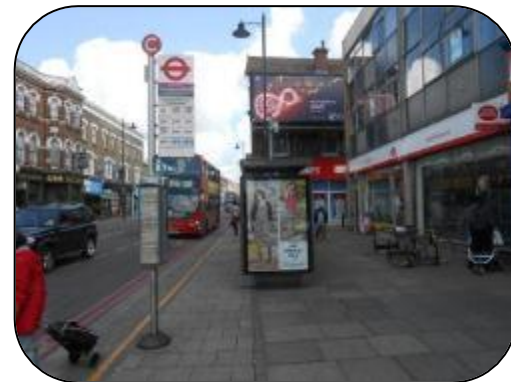
| Descriptor | Ref | RAG | Comments | Photographs |
|---|---|---|---|---|
| Bus Stop C -<br>Tottenham High<br>Road | PT18 | +5 | <p>This bus stop also scored particularly poorly in relation to <b>infrastructure to the waiting area, quality of the environment</b> and <b>maintenance and cleanliness</b>.</p> <p>The <b>infrastructure to the waiting area</b> parameter scored poorly because of the lack of adequate access to the bus stop via pedestrian crossings, the nearest of which is approximately 30 metres walking distance to the south. The footway quality is generally poor with unevenness and trip hazards.</p> <p><b>Quality of the environment</b> and <b>maintenance and cleanliness</b> are inadequate for very similar reasons to PT17 above. Traffic noise and fumes, in addition to poor frontages reduce the environmental quality. The poor maintenance of the shelters and the lack of cleanliness of the surrounding area reduce these parameter scores.</p> | |

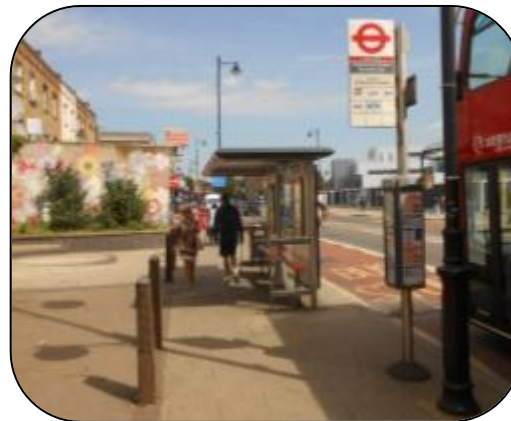
| Descriptor | Ref | RAG | Comments | Photographs |
|---|---|---|---|---|
| Bus Stop T –<br>Tottenham<br>Hotspur Football<br>Club | PT10 | +15 | <p>This bus stop achieved slightly negative scores in relation to <b>information to the waiting area, infrastructure to the waiting area, safety perceptions</b> and <b>security measures</b>.</p> <p><b>Information to the waiting area</b> was marked down because the bus stop identification letter (T) was missing from the pole and no local area map was provided within the shelter.</p> <p><b>Infrastructure to the waiting area</b> received a negative score due to uneven footways in places which represent trip hazards and a narrow footway near the bus shelter which leads to conflict with other pedestrians.</p> <p>There was a small amount of graffiti observed and no provision of a public telephone nearby which led to a negative score for <b>safety perceptions</b> and <b>security measures</b> picked up a negative score due to a non-operational surveillance camera on a lighting column and the lack of a telephone nearby.</p> | |

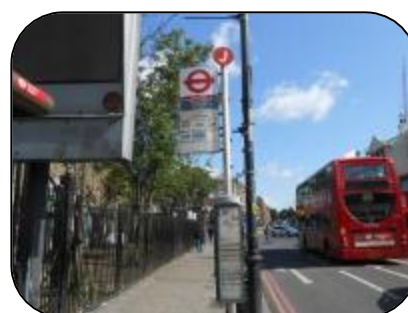
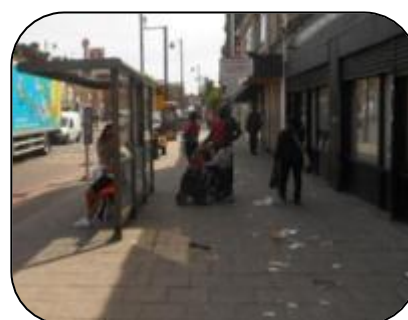
- **Quality of the environment** was inadequate at some locations due to poor quality frontages and traffic fumes and noise from the main road.
- **Infrastructure to the waiting area** scored poorly for some bus stops due to a lack of available convenient crossing points over busy roads. Pedestrians may therefore have to detour to reach a formal crossing point in order to access the bus stop. These issues are exacerbated where the footways are narrow and in a poor state of repair.
- **Maintenance and cleanliness** scored poorly since some of the bus shelters were dirty and not properly

maintained. Despite there being bins present, there was often litter surrounding the bus stops.
