**APPENDIX B****INFORMATION FROM ENVIRONMENT AGENCY, 14-07-2015**

**Enquiry regarding Redevelopment of THFC stadium**

**023971 Northumberland  
Development Project**

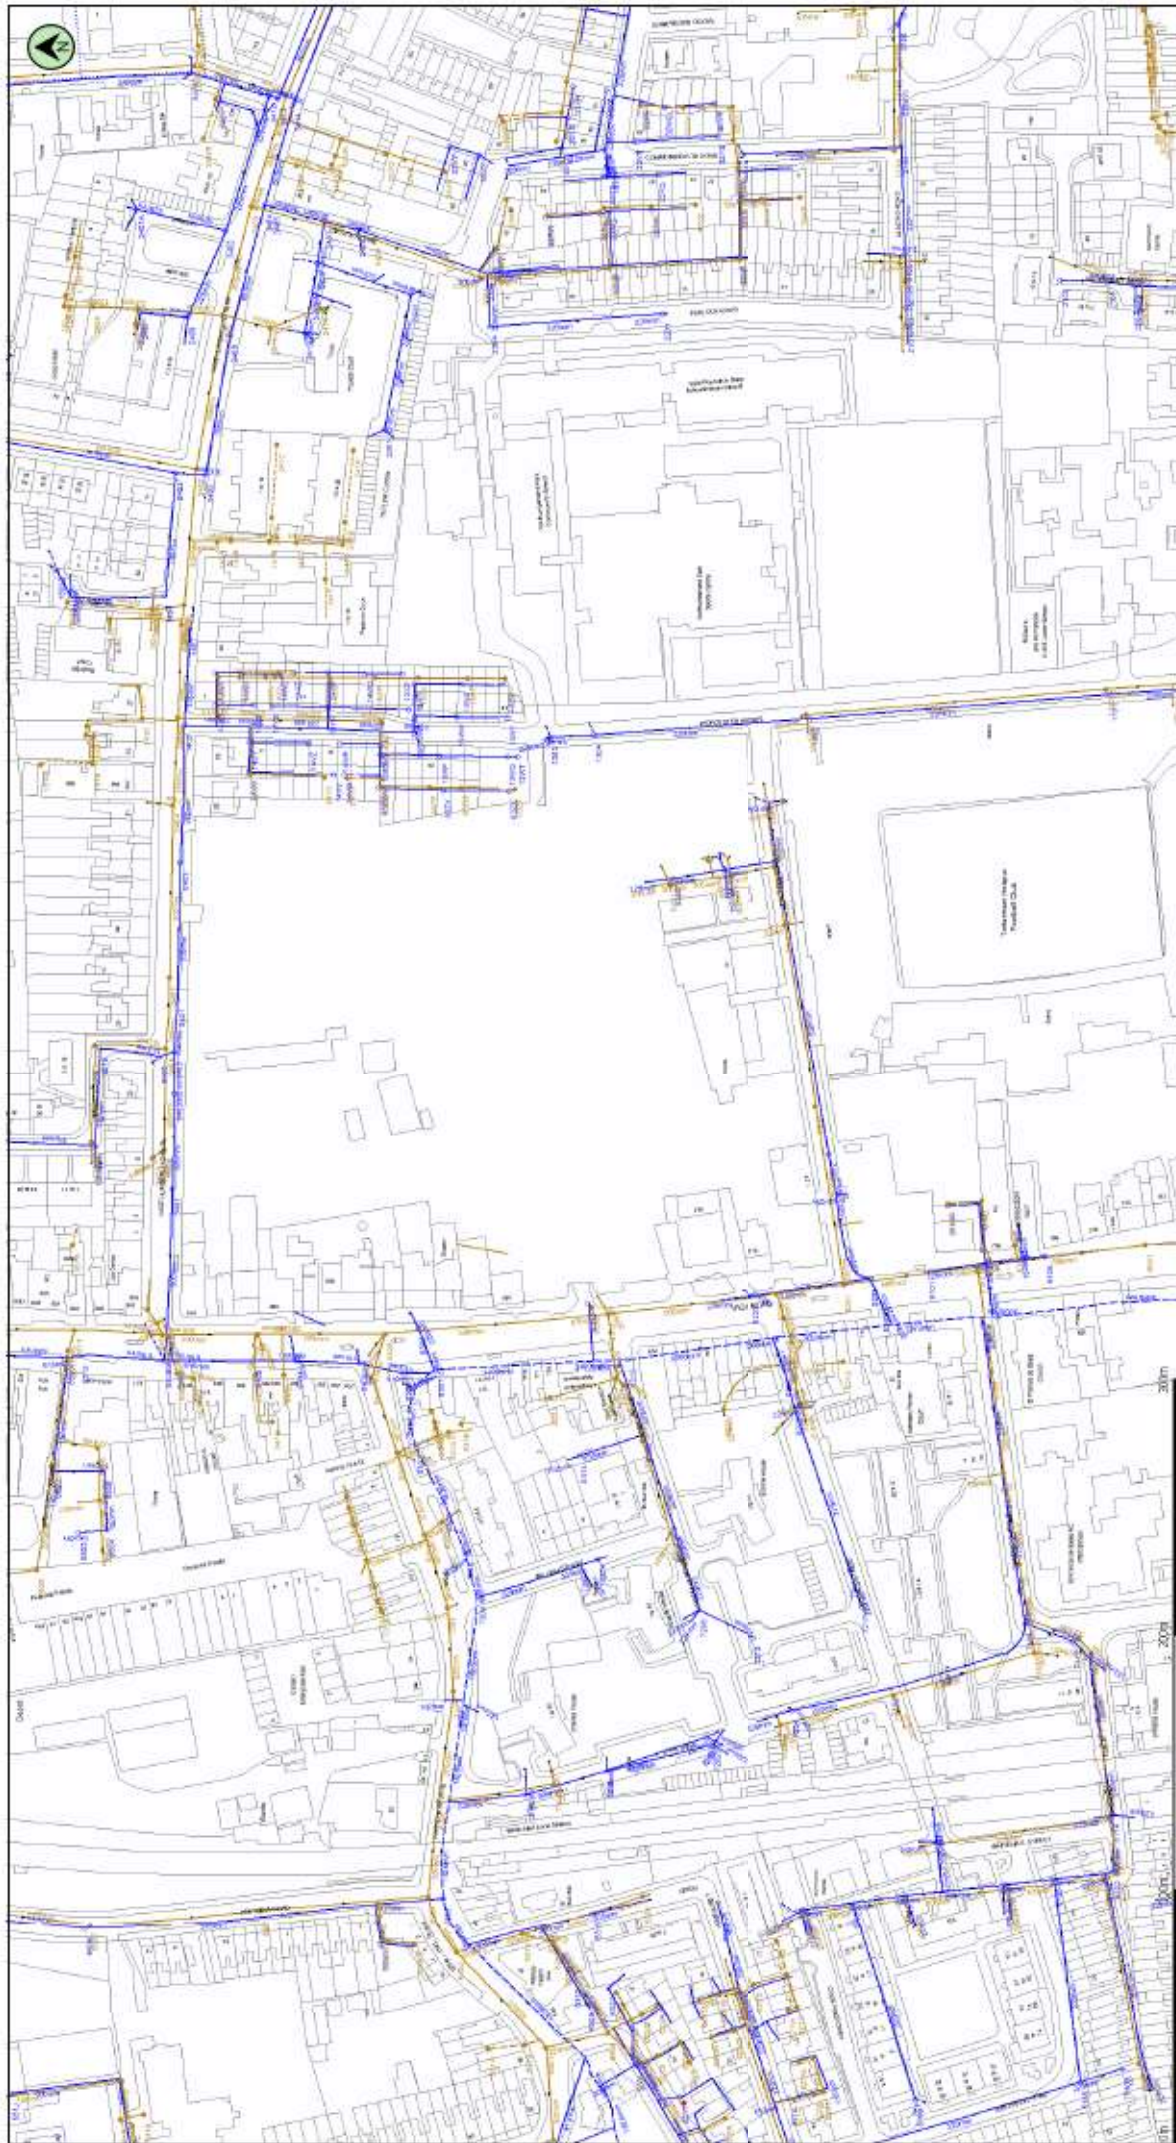
### **THAMES WATER ASSETS**

(c) Crown Copyright and database rights 2012 Ordnance Survey 100018345 Date: 18/06/15 Scale: 1:2000 Map Centre: 53983, 191315 Data updated: 28/03/15 Wastewater Plan A3

Based on the Ordnance Survey Map with the sanction of the Controller of H.M. Stationery Office License Number: 100018345. This map is to be used for the purpose of showing the location of Thames Water pipes only. Any other uses of the map data or other copies are not permitted. The position of the apparatus shown on this plan is given without obligation and warranty, and the accuracy cannot be guaranteed. This information is valid for the date printed. Service pipes are not shown but their presence should be anticipated. No liability of any kind whatsoever is accepted by Thames Water for any error or omission. The actual position of mains and services must be verified on site before any works are undertaken.

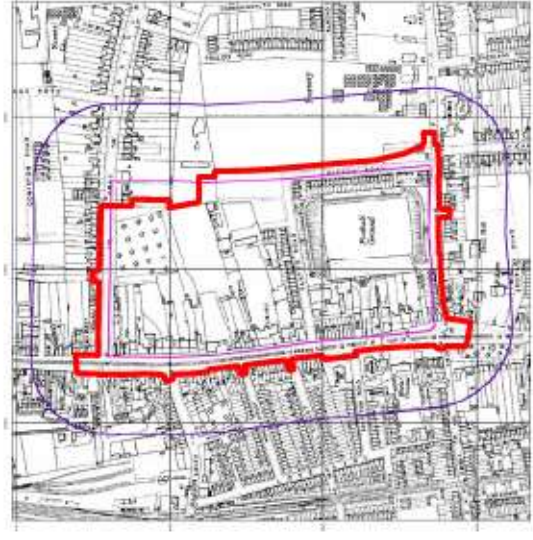
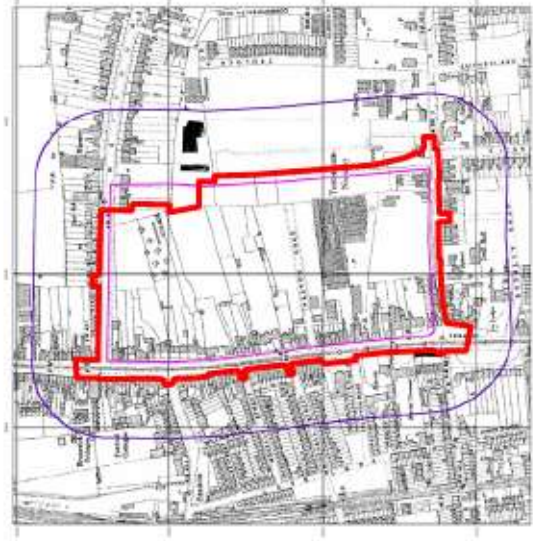
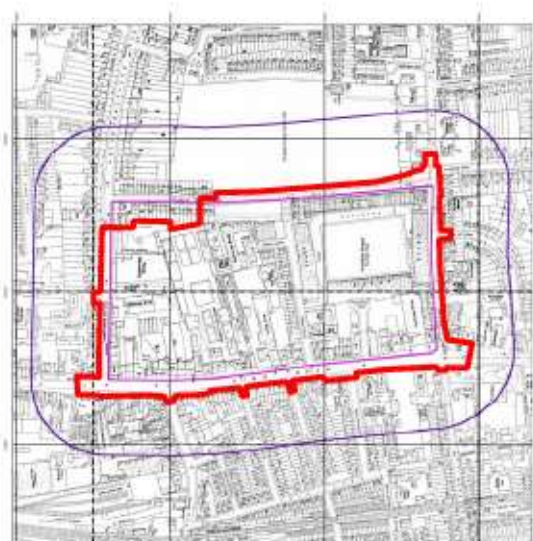
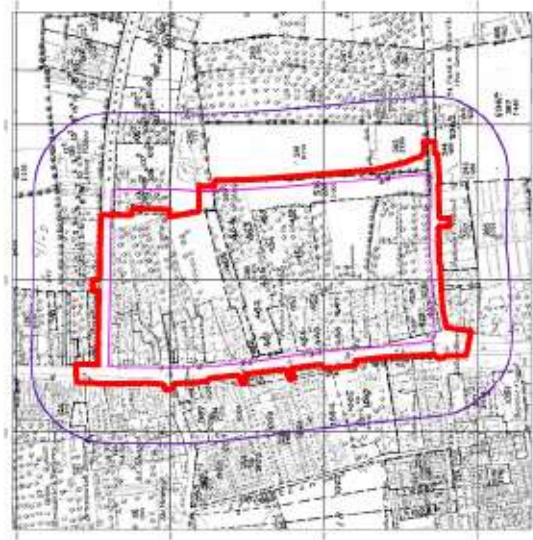
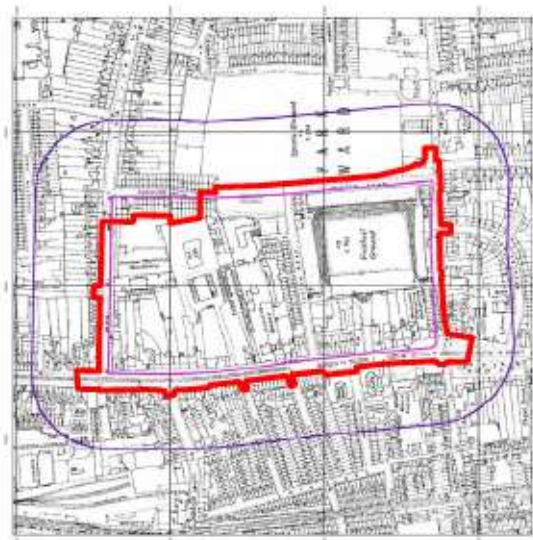
Notes  
WHERE NOT ACCESSIBLE PRESUMED TO BE INDUSTRIAL

Inspection of the 1935 Middlesex 1:2500 and 1955-56 Ordnance Survey Plan maps indicate that during this period, some significant areas of demolition occurred within and near the development site. The main clearance areas were to the north and south of Church Lane, 40m southwest of the site. In these areas, high density terrace housing and a convent was replaced post-war by much lower density developments including a TA Centre. Small sections of terrace housing had been demolished from 40m west of the site. These demolitions could have been as a result of bomb damage during World War II.
