## Appendix 11.1

### 2018 VERIFICATION REPORT

**THFC Stadium and Hotel**  
**Verification Report**

**031627**

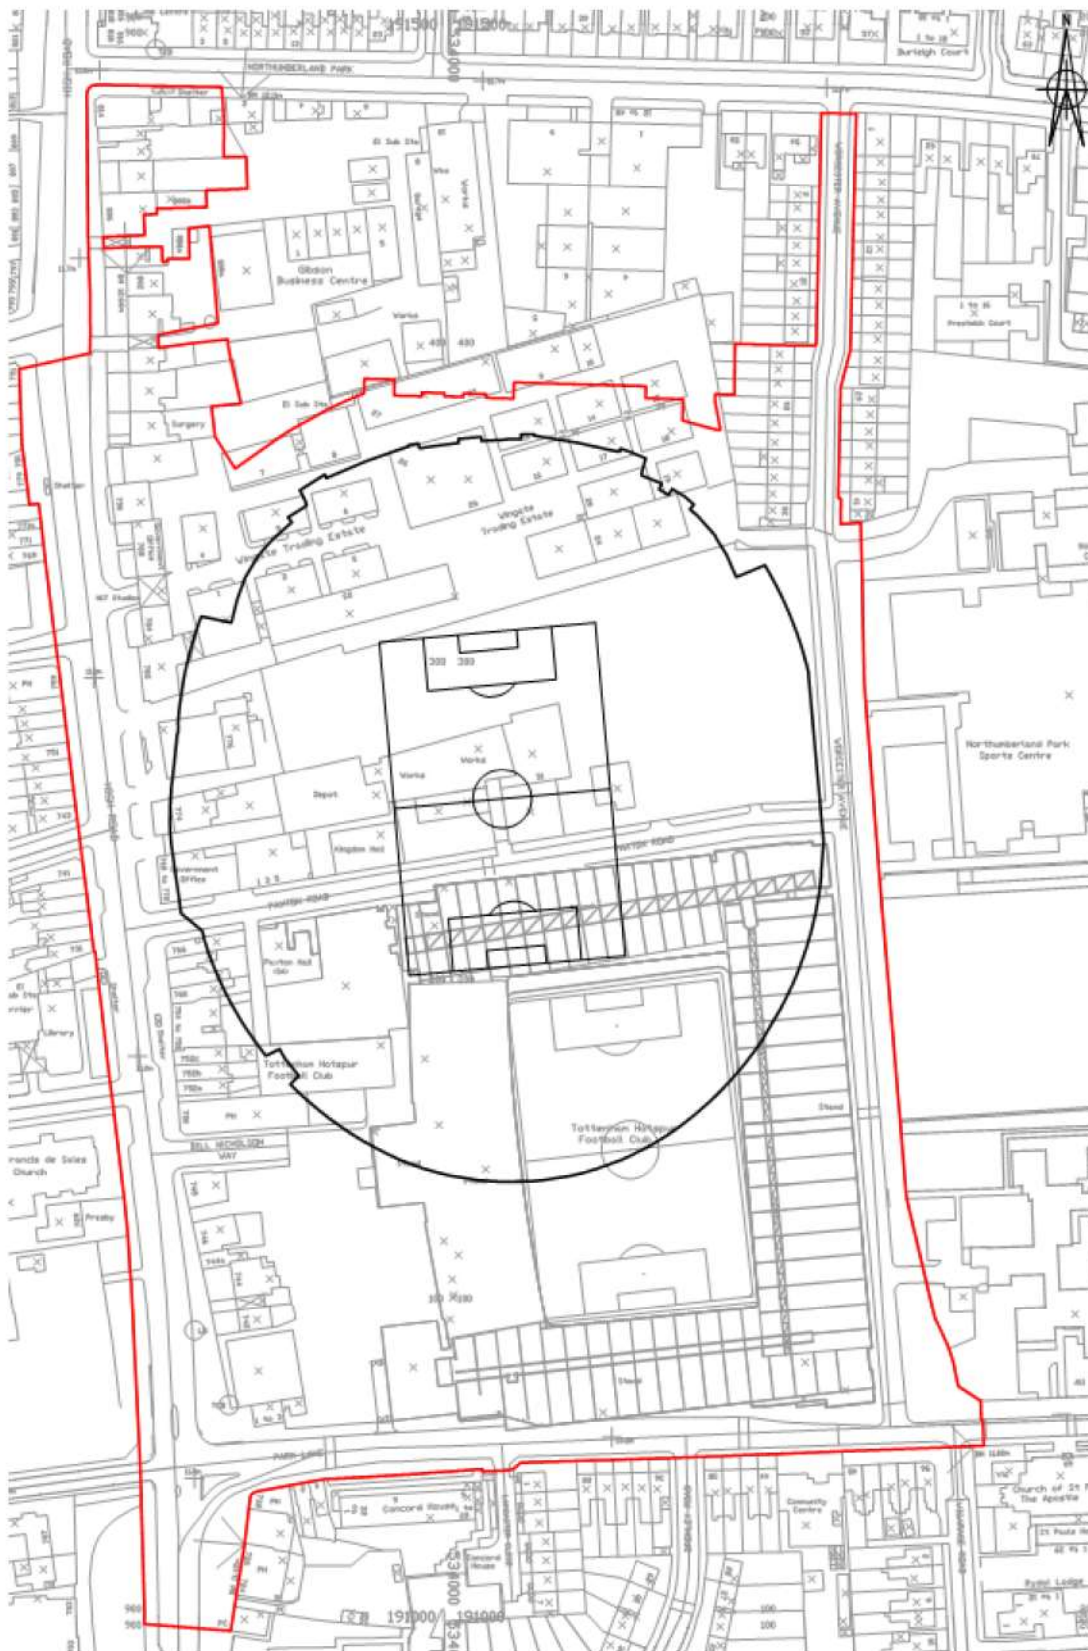
Figure 2-2 – Redline boundary

The development site is located in Tottenham, within the London Borough of Haringey, North London. The approximate Ordnance Survey National Grid Reference for the centre of the site is 534010, 191270. The site occupies some 8 ha, its location is shown in Figure 2-1 below. The Site redline boundary for the discharge of the relevant planning conditions as detailed in Section 1.2 above is provided in Figure 2-2.

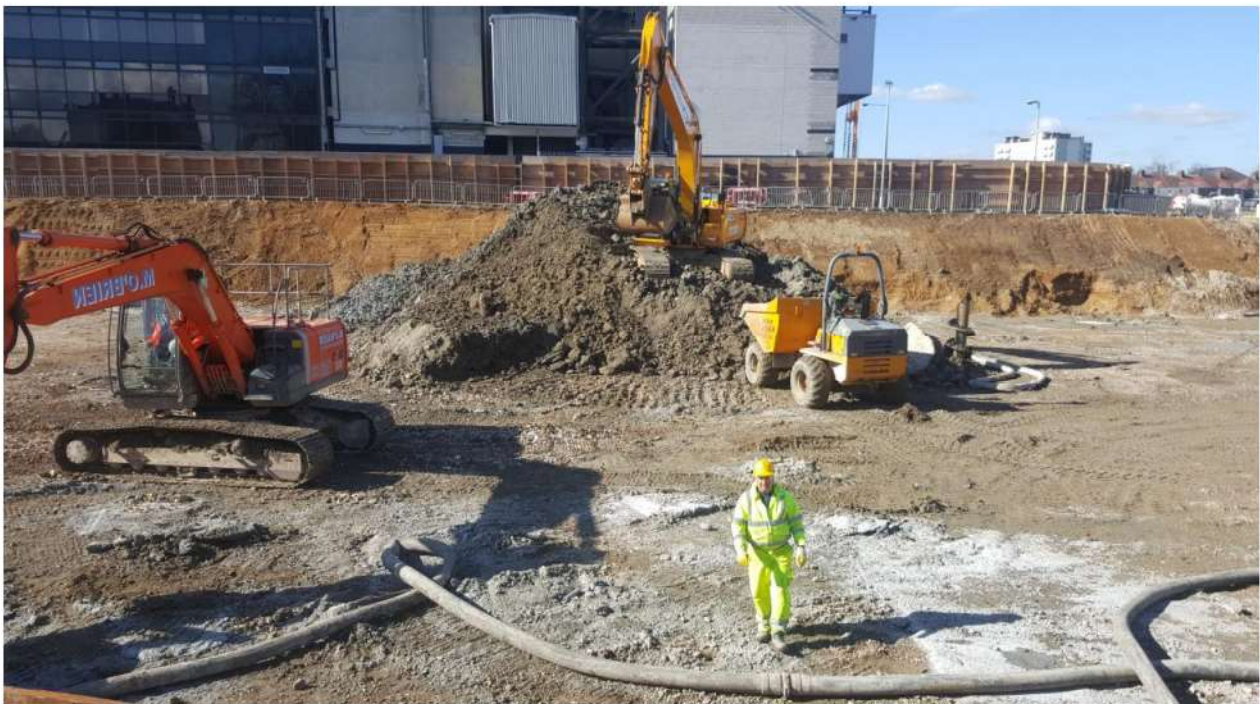
#### 3-1 – Wetting down of haulage routes shown during Enabling Works excavation of the basement

During the earthworks a good standard of health, safety and hygiene was adopted in accordance with the site Health and Safety plan. This good practice ensured that the potential risks to construction workers and occupiers of neighbouring buildings, associated with contact and ingestion of Made Ground released into air as dust was appropriately mitigated i.e. dust control measures such as wetting down haulage routes and washing down of vehicles were adopted.

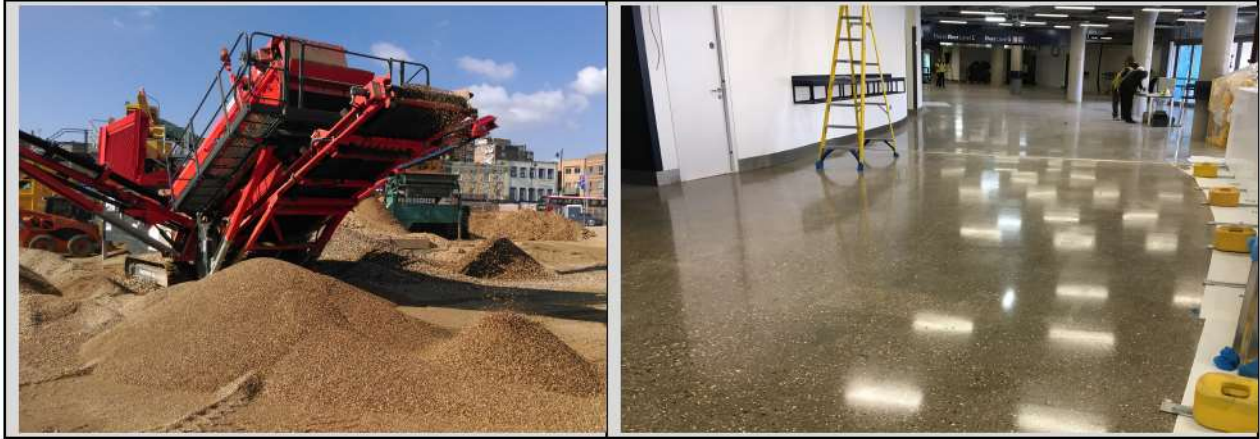
**Figure 3-2 - Gravel washing plant and polished gravel slab using recovered excavated gravel from site at level one of the stadium west stand**

Two separate material management plans were required under the CL:AIRE Waste Code of Practice scheme to facilitate the material movements described in Table 3-1. The first provided in Appendix B is to allow the movement of Made Ground from site to form a noise bund at Guy Lodge Farm. The second provided in Appendix C is to allow the re-use of the site won gravel and sand in concrete for constructing the stadium. Concrete created using site won gravel and sand was mainly used to form the basement slabs but some was also used on the upper levels and made a feature of by polishing the concrete as illustrated in Figure 3-2.

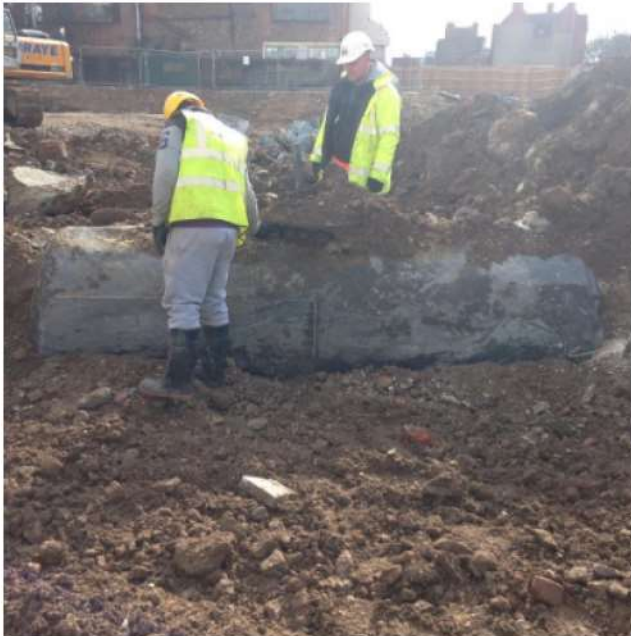
An underground fuel tank was discovered in the west of the site as shown in Figure 4-6 on the 4/3/15. This tank contained liquid which appeared to be a hydrocarbon. The tank was pumped out by tanker and the liquid appropriately disposed of. Some slightly hydrocarbon impacted soil was present around the tank this was excavated and segregated for offsite disposal. The tank was then removed from site and the whole area was later excavated as part of the western basement car park excavation.

**Figure 4.1 - UST containing liquid discovered during basement excavations on the 4/3/15**

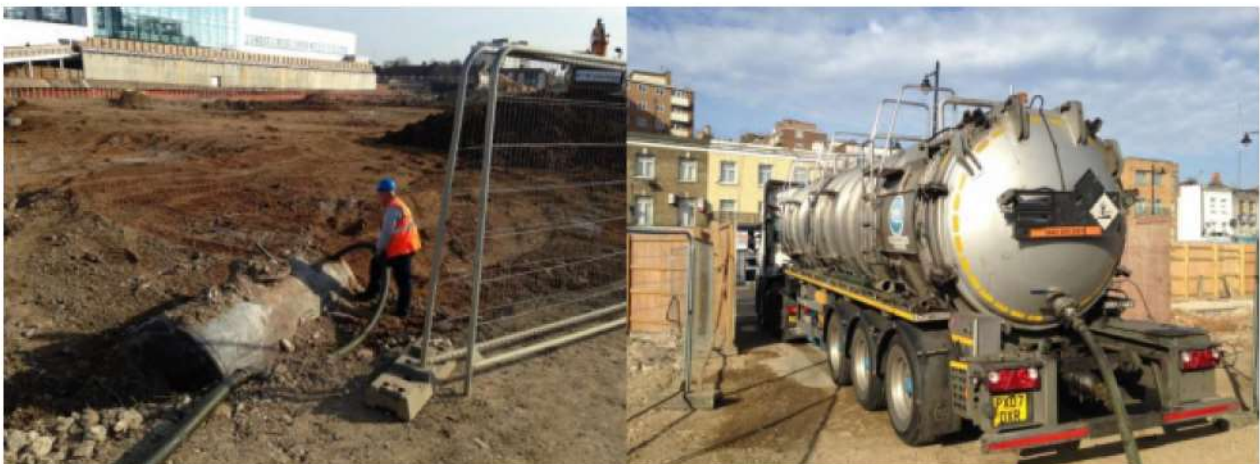
**Figure 4.2 – Emptying of the UST on the 11/3/15 to tanker for disposal**

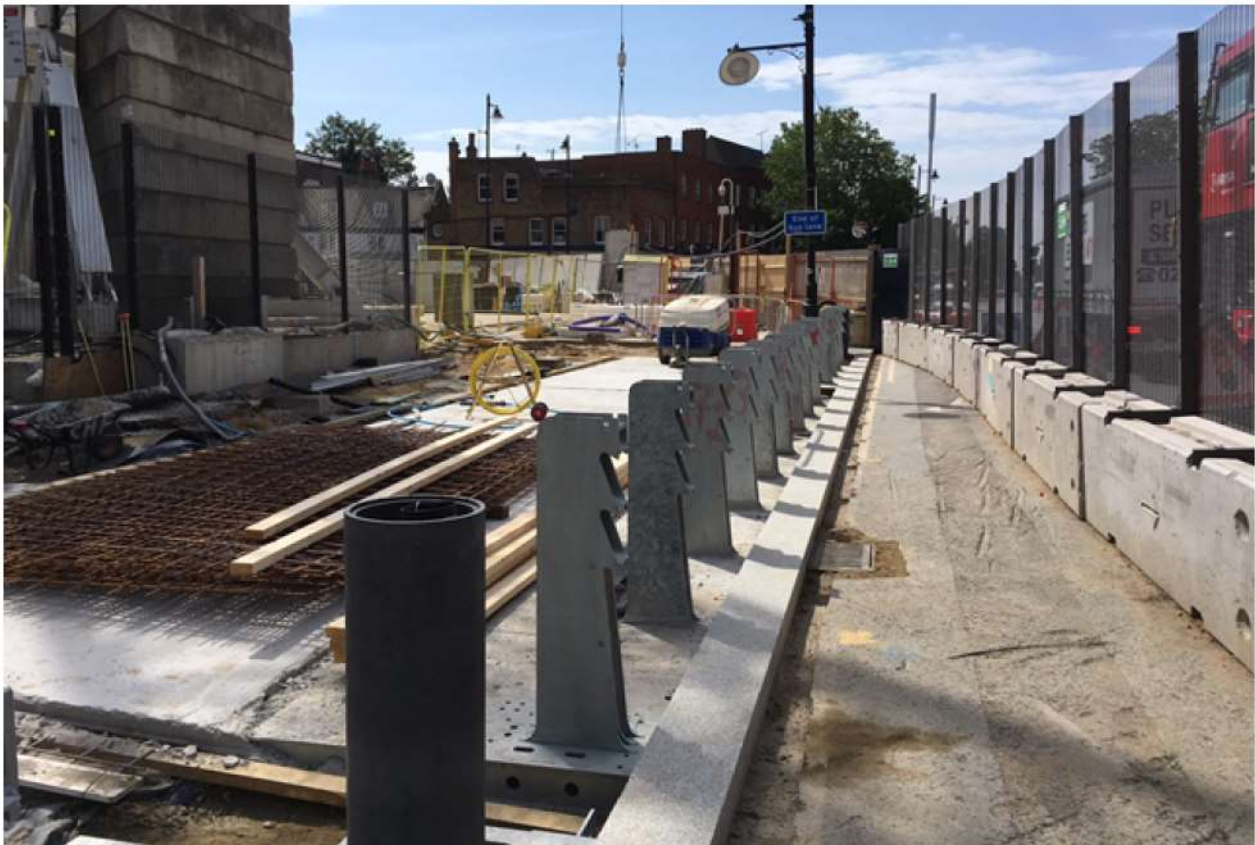
The scheme does not include any landscaped areas which are directly in contact with in-situ soils. Self-contained planters containing imported topsoil are located above concrete slabs in locations shown in Plate 1. All other external areas are surfaced with various block paving often underlain by concrete as shown in Figure 4-3 and detailed in Plate 1. There is therefore no viable pathway between site users and underlying soils in the landscape areas or other external areas.

**Figure 4-3 External hardstanding finishes being completed, block paving yet to be installed when this image was taken**

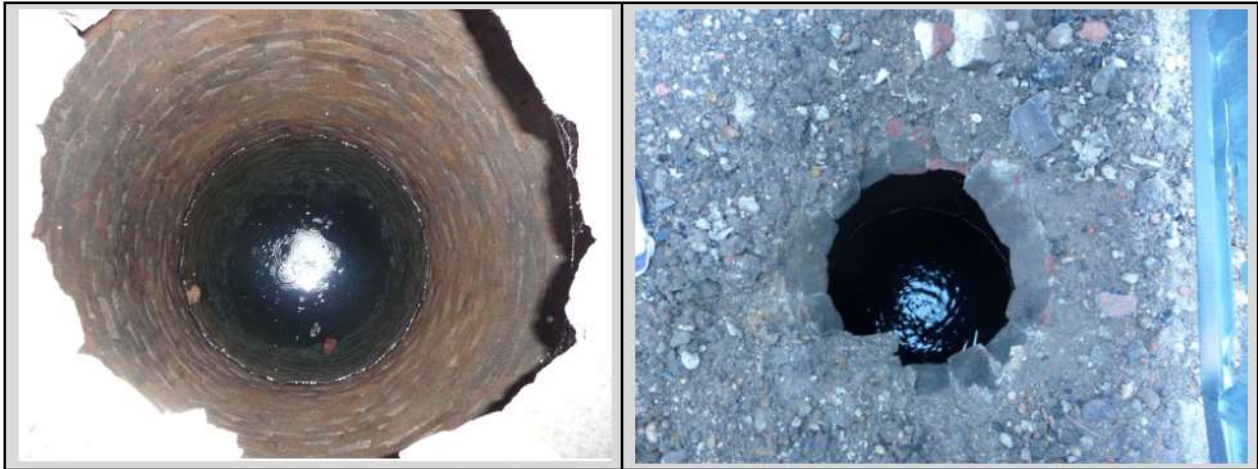
A water well of approximately 5.5m depth was encountered in the southwest part of the site (NGR TQ 33946 91097) during demolition works. This was considered to be a potential pathway for migration of contamination, and as such was decommissioned by means of backfilling with gravel and sealing using a concrete cap.

**Figure 4-4 – Former water well encountered during excavations**

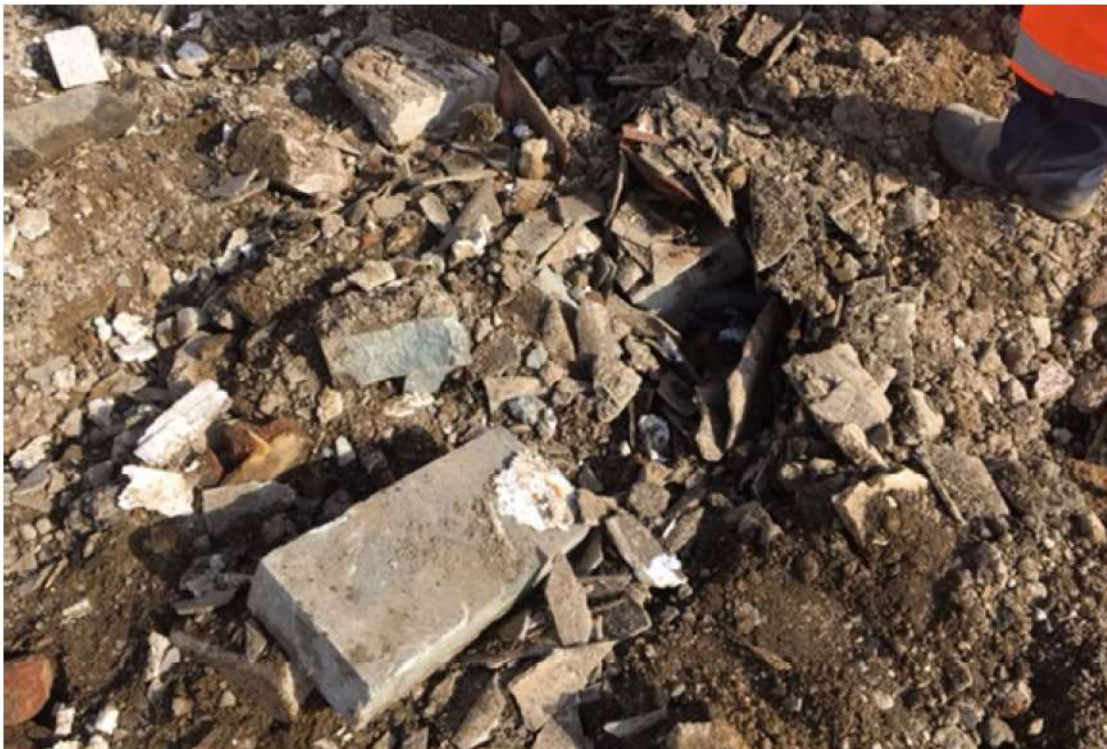
A small area of broken asbestos sheeting was discovered in the south of the former White Hart Lane Stadium car park on the 4/7/17 as the area was being reduced to formation. The area was cordoned off and a specialist asbestos removal company engaged. They removed the bulk asbestos cement sheets and picked the asbestos sheet fragments from the soil and paced in bags for disposal. The soil in the area was then excavated down to formation levels and disposed offsite.

**Figure 4-5 – Broken asbestos sheeting**

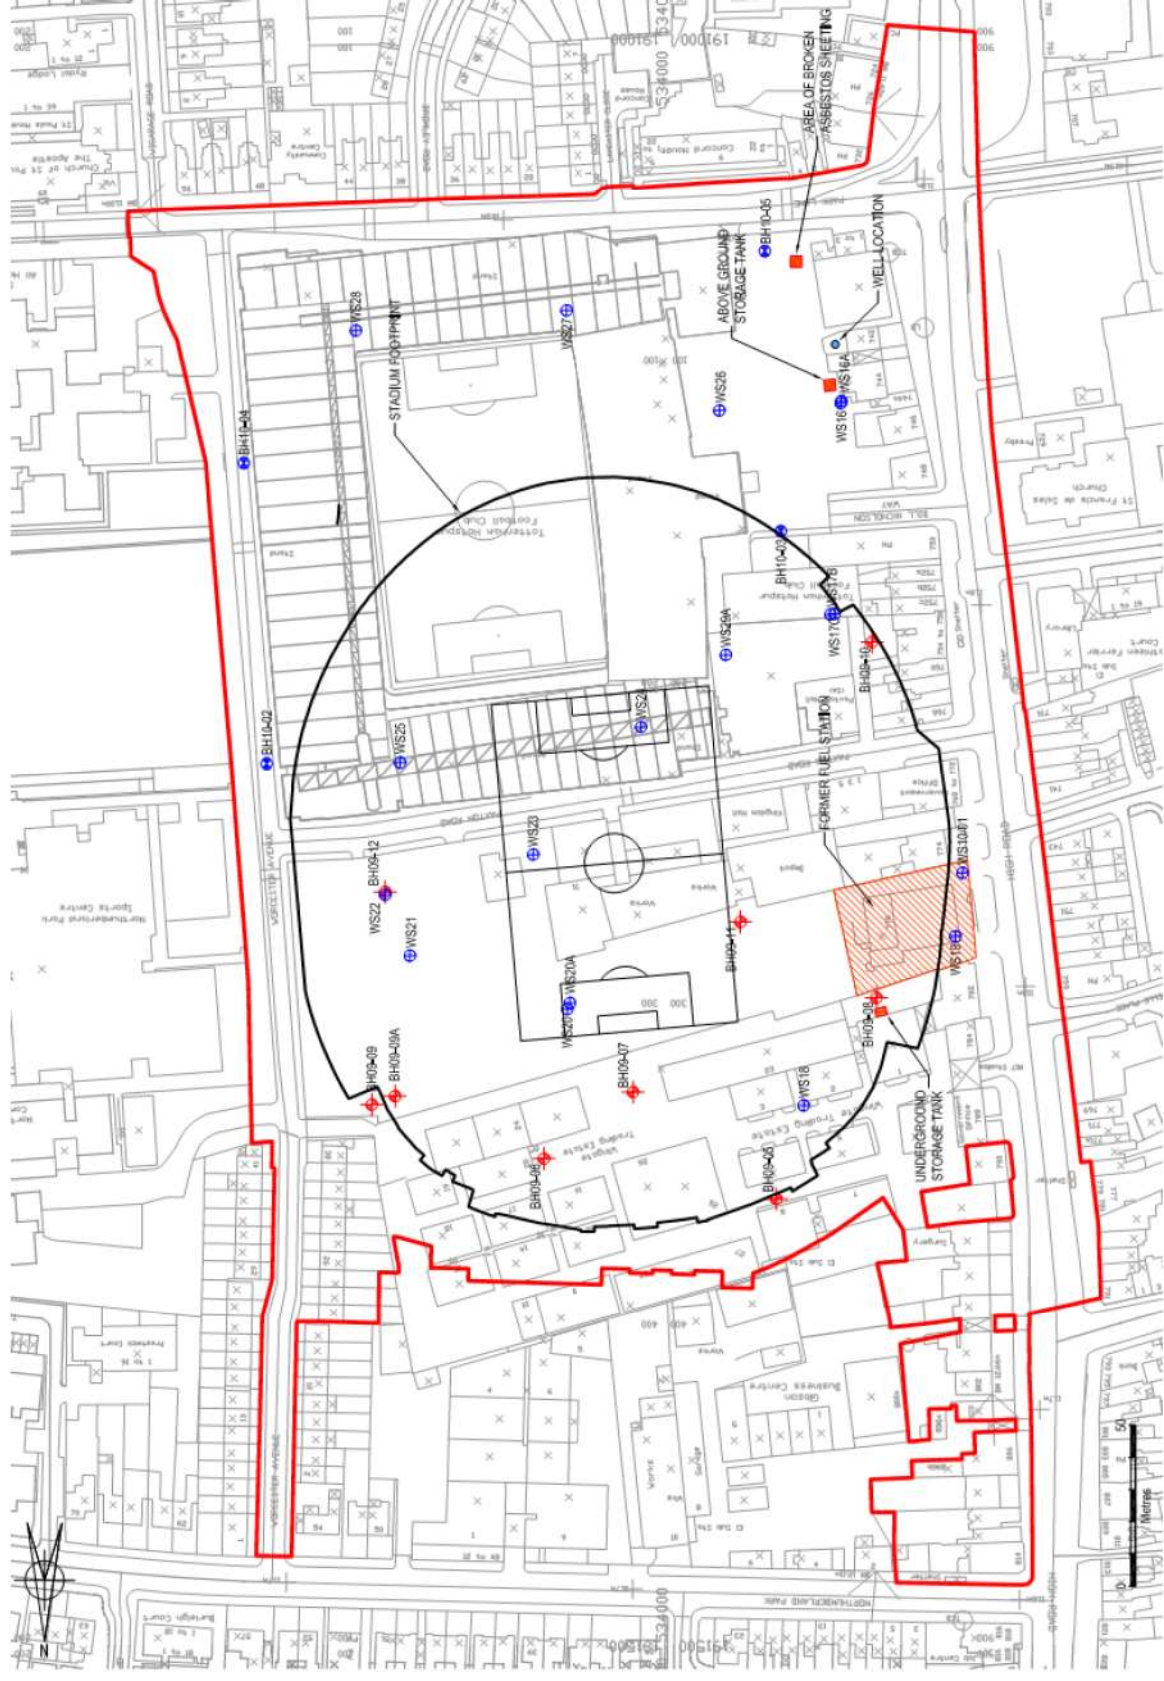
Figure 4-6 - Plan showing remedial works items locations

No unexpected contamination was encountered during excavation works. The below sections outline specific issues and items that were encountered and the works undertaken to deal with them. Figure 4-6 illustrates their locations. It should be noted that on removal of the electrical substation concrete slab there was no evidence of contamination impact in the underlying ground which was subsequently excavated to form the western part of the stadium basement. Hydrocarbon contamination of site materials noted in Sections 4.2 and 4.3 below were present between 3-4m above the basement formation level and it was very clear through visual and olfactory means that hydrocarbon impact extended no further than 1.0m below the source areas. The basement formation level was therefore well below the area of hydrocarbon impacted materials in the three locations identified (by at least 2m). No visual or olfactory evidence of contamination remained at basement formation level.
