Existing Building

Areas of Historical Significance

Key Internal Spaces - Lobby

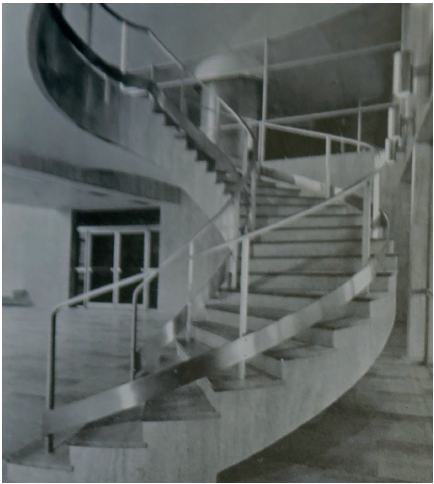
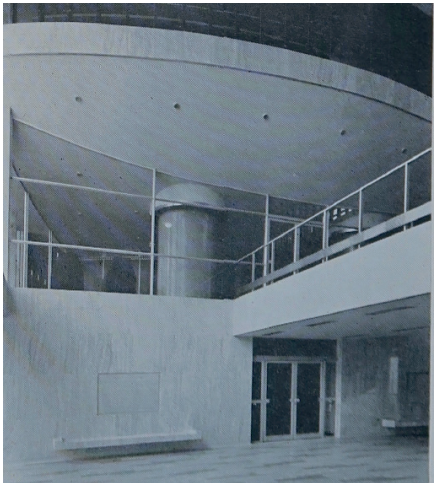
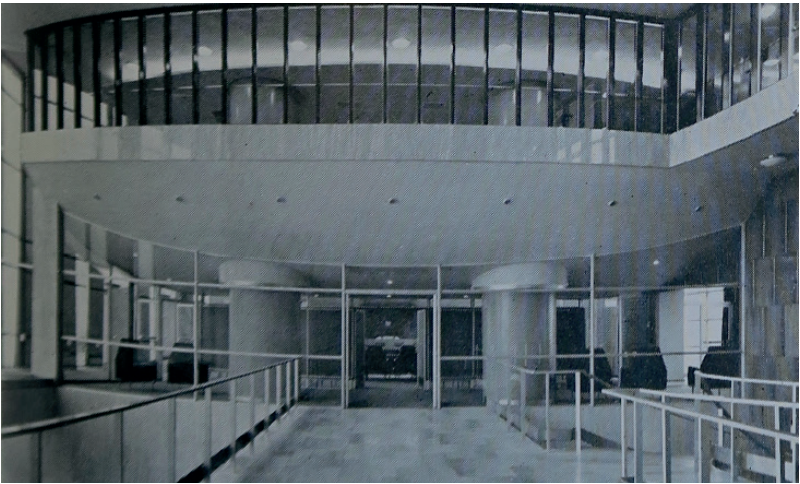
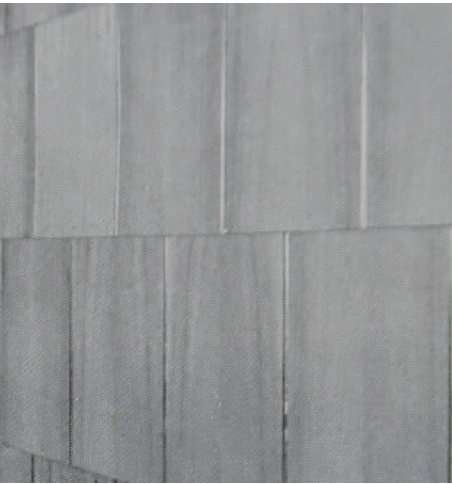
Historical Images

- Features**
- Triple height atrium
  - Self-supporting, Spiral staircase with link bridge to Council Chamber
  - Glazed to promote transparency
  - Memorial Plaque
  - Garden adjacent to entrance

- Materiality**
- Travertine stone cladding
  - Timber wall panelling with brass inlays
  - Stone tiled flooring

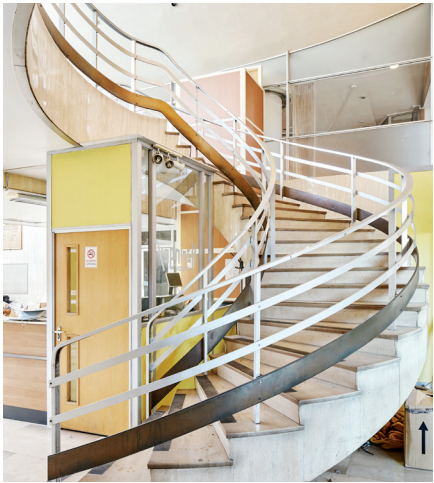
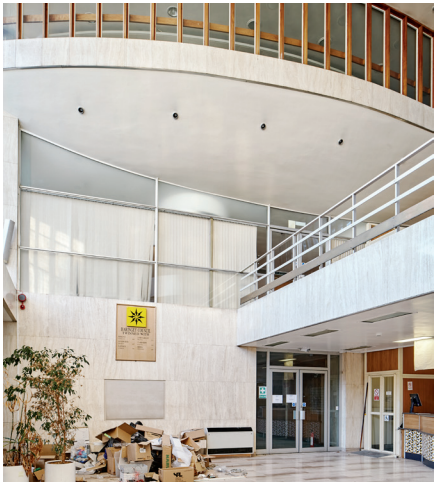
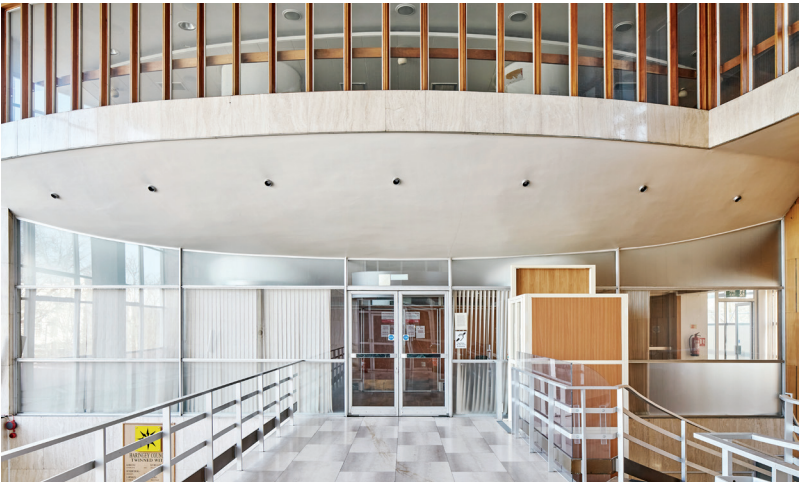
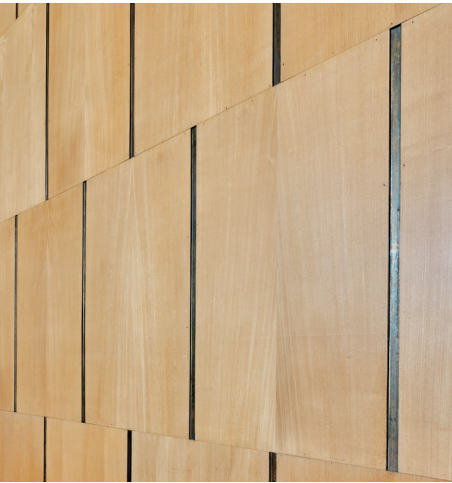
- Pre-Enabling Works Condition**
- Extensive cracking/chipping in stone tiled flooring
  - Brass inlays tarnished
  - Spotlights and recessed strip-lights in bridge require upgrading

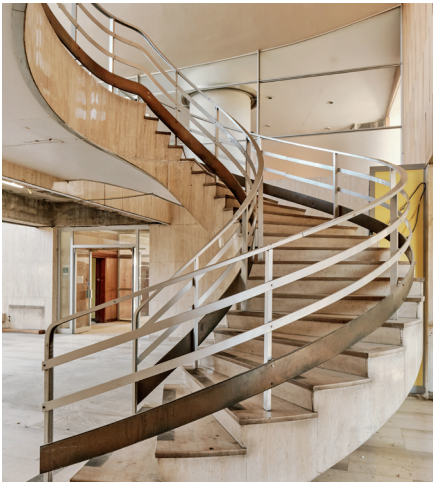
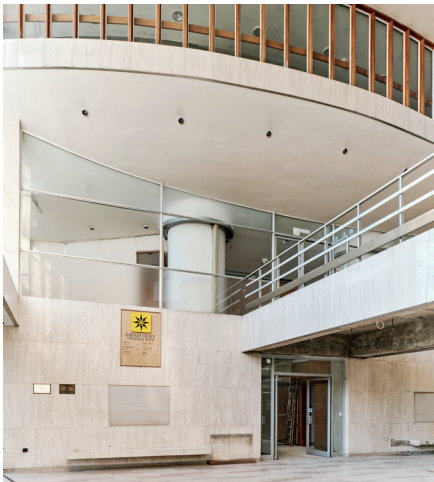
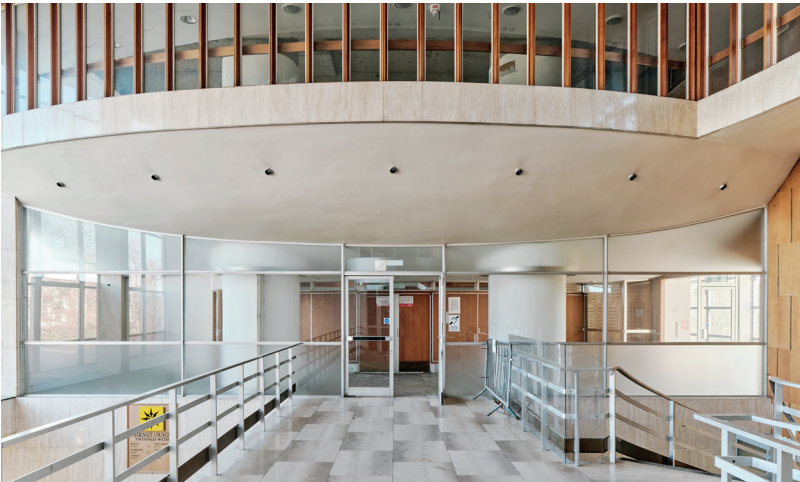
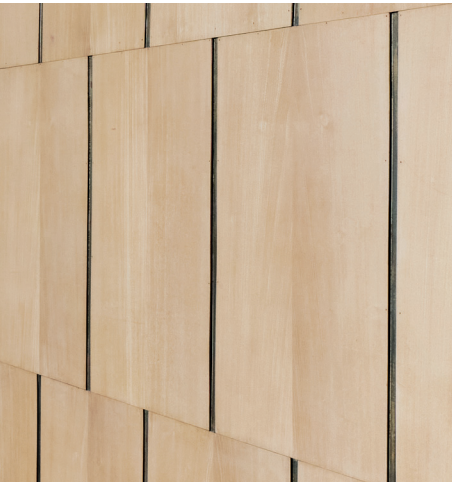
- Post-Enabling Works Condition**
- Ceiling below bridge removed
  - Carpet Removed & Blinds Removed
